Visual Site Inspection Report

Project Name	H-600 Pipeline Spread G	AFE	124300137	Spread	H-600 Pipeline Spread G
Contractor	Precision			Report #	18076
Inspector	Len Kruizenga			Date/Time	6/3/2019 8:00 AM
Permit #	TBD	Inspection Type	VA SWPP	Station Begin	12005+00
State	VA	Inspection Area	Full	Station End	12005+00
County	Giles	Ground	Dry	Temperature (°F)	65.00
Municipality	N/A	Weather	Sunny	Rain Gauge (in)	0.60
				Rain Accumulation Time (days)	2.00

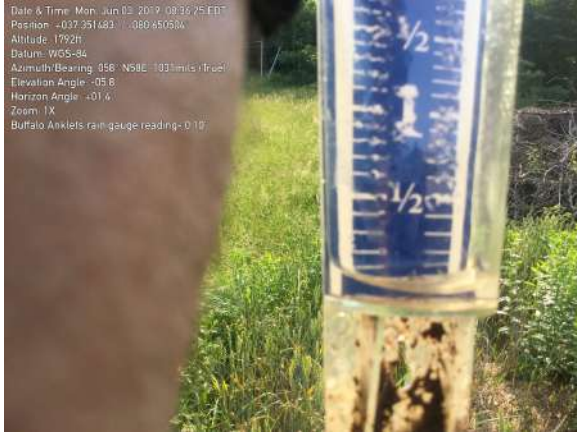
A/E	124300137	Date/Time	6/3/2019 8:00 AM	Report #	18076
Pictures					
<p>Date & Time: Mon Jun 03 2019 09:35:25 EDT Position: -037.251483 / -080.450584 Altitude: 1792ft Datum: WGS-84 Azimuth/Bearing: 056° NS8E 1031mils (True) Elevation Angle: -05.6 Horizon Angle: -01.4 Zoom: 1X Buffalo Anklets rain gauge reading- 0.10"</p>

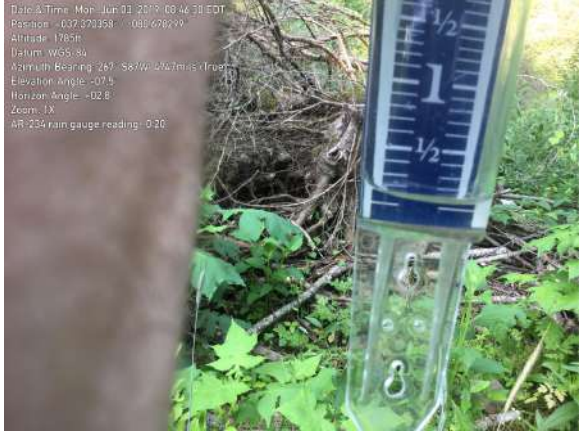
<p>Date & Time: Mon Jun 03 2019 08:46:38 EDT Position: -037.270358 / -080.678279 Altitude: 1765ft Datum: WGS-84 Azimuth/Bearing: 247° S87W 2467mils (True) Elevation Angle: -07.5 Horizon Angle: -02.8 Zoom: 1X AR-234 rain gauge reading- 0.20"</p>

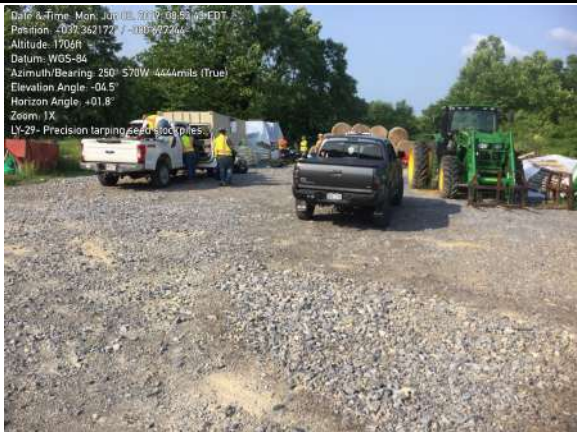
GPS Location	37.34	Field Station#	10677+00	GPS Location	37.37
Description	Buffalo Anklets rain gauge reading- 0.10"		Description	AR-234 rain gauge reading- 0.20"	
<p>Date & Time: Mon Jun 03 2019 09:04:21 EDT Position: -037.362172 / -080.676582 Altitude: 1700ft Datum: WGS-84 Azimuth/Bearing: 250° S70W 4444mils (True) Elevation Angle: -04.5 Horizon Angle: -01.8 Zoom: 1X LY-29- Precision tarping seed stockpiles, at LY-29, Arnold's portion of the yard.</p>

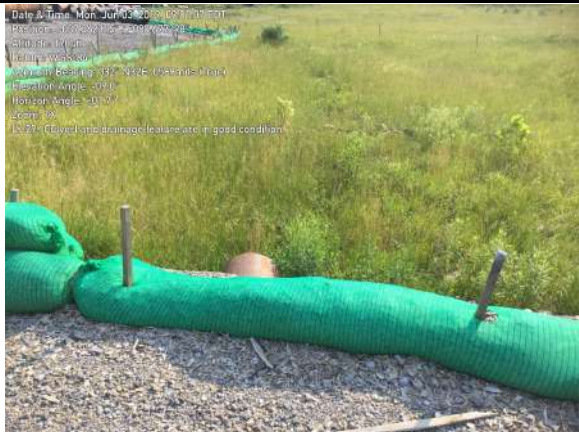
<p>Date & Time: Mon Jun 03 2019 09:07:01 EDT Position: -037.362172 / -080.676582 Altitude: 1700ft Datum: WGS-84 Azimuth/Bearing: 337° N32E 0444mils (True) Elevation Angle: -09.0 Horizon Angle: -01.7 Zoom: 1X LY-29- Culvert and drainage feature are in good condition.</p>

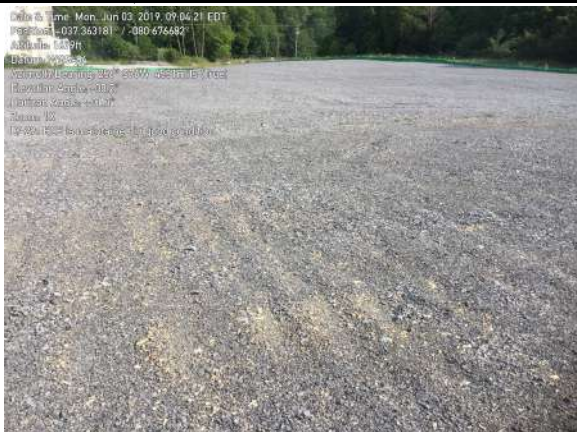
GPS Location	37.36	Field Station#	12005+00	GPS Location	37.36
Description	Precision crew tarping seed stockpiles, at LY-29, Arnold's portion of the yard.		Description	LY-29- culvert and drainage feature are in acceptable condition.	
<p>Date & Time: Mon Jun 03 2019 09:04:21 EDT Position: -037.363181 / -080.676582 Altitude: 1639ft Datum: WGS-84 Azimuth/Bearing: 280° S60W 3600mils (True) Elevation Angle: -03.7 Horizon Angle: -01.7 Zoom: 1X LY-29- RCE is in maintained in acceptable condition.</p>

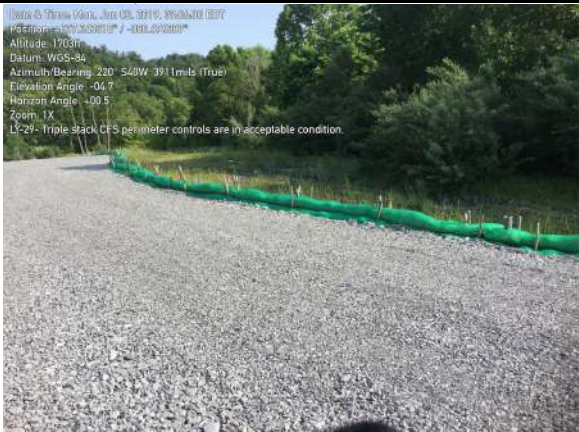
<p>Date & Time: Mon Jun 03 2019 09:04:21 EDT Position: -037.363181 / -080.676582 Altitude: 1700ft Datum: WGS-84 Azimuth/Bearing: 280° S40W 3911mils (True) Elevation Angle: -04.7 Horizon Angle: -00.5 Zoom: 1X LY-29- Triple stack CFS perimeter controls are in acceptable condition.</p>

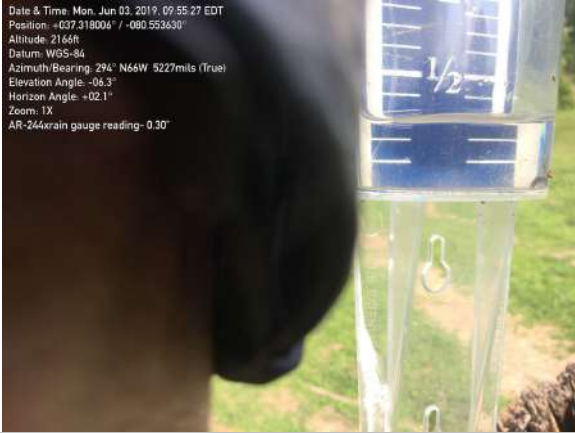
<p><small>Date & Time: Mon, Jun 03, 2019, 09:55:27 EDT Position: +037.318004° / -080.553630° Altitude: 2166ft Datum: WGS-84 Azimuth/Bearing: 294° N64W 5227mils (True) Elevation Angle: -06.3° Horizon Angle: +02.1° Zoom: 1X Kow Camp rain gauge reading- 0.30"</small></p>

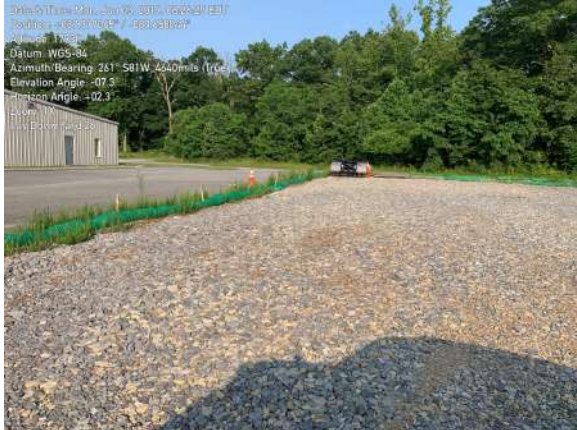
GPS Location	37.18	Field Station#	12005+00	GPS Location	37.18	Field Station#	12005+00
Description	See photo for GPS location. 18 inch compost filter sock in place.			Description	See photo for GPS location. Containment in place around fuel cell.

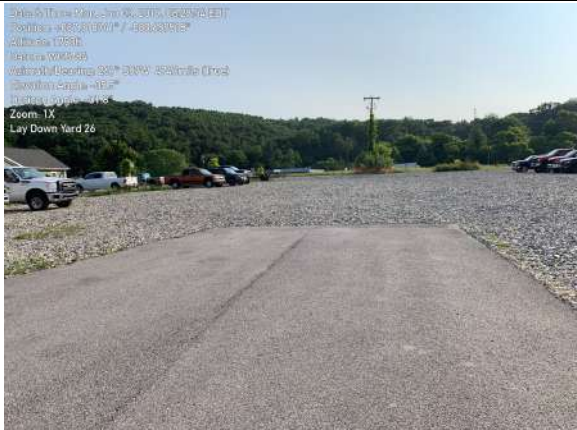
GPS Location	37.18	Field Station#	12005+00	GPS Location	37.18	Field Station#	12005+00
Description	See photo for GPS location. RCE in place.			Description	See photo for GPS location. Triple stack 12 inch CFS in place.

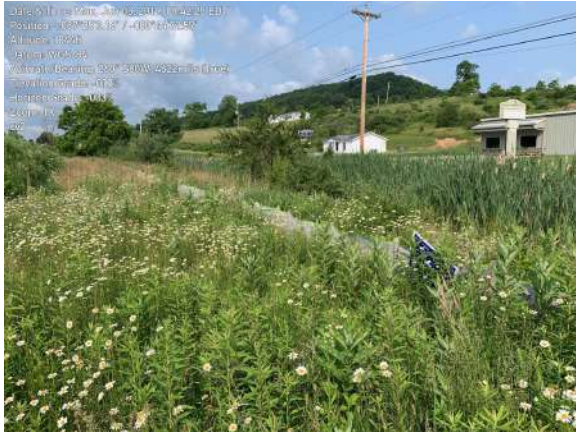
GPS Location		37.24		Field Station#		+37		GPS Location		37.24		Field Station#		+37	
Description		ECD's for S-Cv2						Description		ECD's and ROW conditions

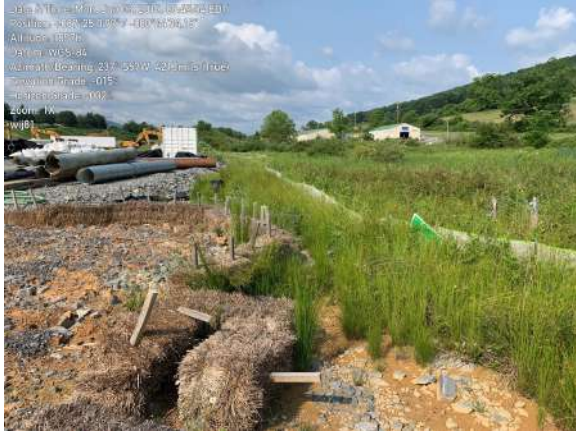
GPS Location		37.24		Field Station#		+37		GPS Location		37.24		Field Station#		+37	
Description		ECD's for WJ81						Description		Secondary containment

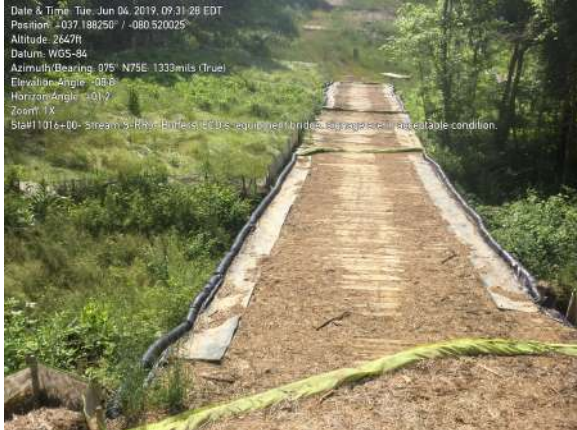
AFE	124300137	Date/Time	6/4/2019 7:26 AM	Report #	18149		
Pictures							
<p>Date & Time: Tue, Jun 04, 2019, 09:31:28 EDT Position: -037.186250° / -080.520025° Altitude: 2647ft Datum: WGS-84 Azimuth/Bearing: 075° N75E 1333mils (True) Elevation Angle: -08.8° Horizon Angle: -01.2° Zoom: 1X Sta#11016+00- Stream S-RR5- Equipment bridge, ECD's, buffers, signage are in acceptable condition.</p>

GPS Location	37.32	Field Station#	11016+00	GPS Location	37.32	Field Station#	10992+93
Description	Stream S-RR5- Equipment ridge, ECD's buffers, signage are in acceptable condition.			Description	P1 perimeter controls, triple stack end treatments on steep slope are in acceptable condition.

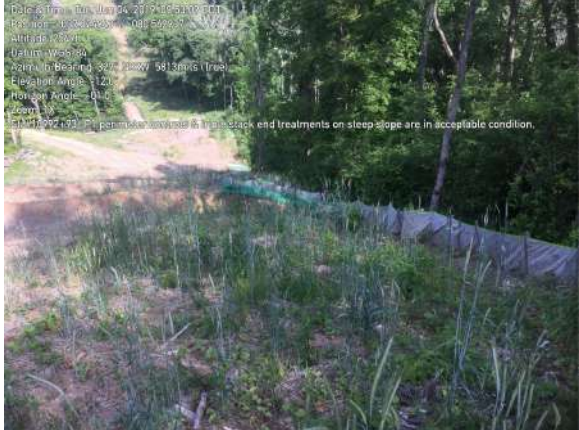
<p>Date & Time: Tue, Jun 04, 2019, 09:50:10 EDT Position: -037.186250° / -080.520025° Altitude: 2647ft Datum: WGS-84 Azimuth/Bearing: 322° N22W 5813mils (True) Elevation Angle: -12.1° Horizon Angle: -04.2° Zoom: 1X Sta#10992+93- P1 perimeter controls, triple stack end treatments on steep slope are in acceptable condition.</p>

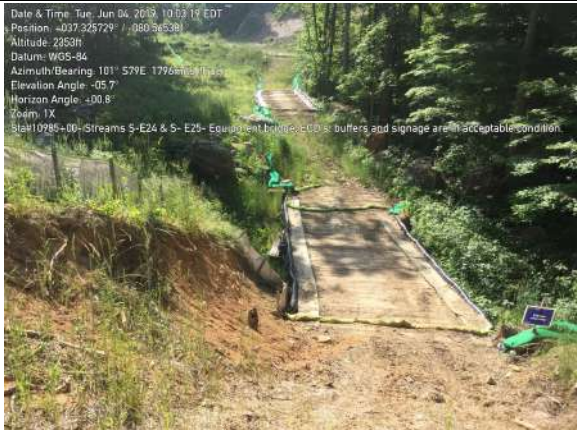
<p>Date & Time: Tue, Jun 04, 2019, 10:13:19 EDT Position: -037.325729° / -080.516381° Altitude: 2353ft Datum: WGS-84 Azimuth/Bearing: 101° S79E 1796mils (True) Elevation Angle: -05.7° Horizon Angle: -00.8° Zoom: 1X Sta#10985+00- Streams S-E24 & S-E25- Equipment bridges, ECD's, buffers and signage are in acceptable condition.</p>

GPS Location	37.32	Field Station#	10985+00	GPS Location	37.32	Field Station#	10965+00
Description	Streams S-E24 & S-E25- Equipment bridges, ECD's, buffers & signage are in acceptable condition.			Description	Karst ECD's are in acceptable condition.		
<p>Date & Time: Tue, Jun 04, 2019, 10:26:16 EDT Position: -037.329112° / -080.569356° Altitude: 2149ft Datum: WGS-84 Azimuth/Bearing: 357° N47W 4569mils (True) Elevation Angle: -04.5° Horizon Angle: -01.3° Zoom: 1X Doe Creek Farms- Cattle crossed gate still open to row.</p>

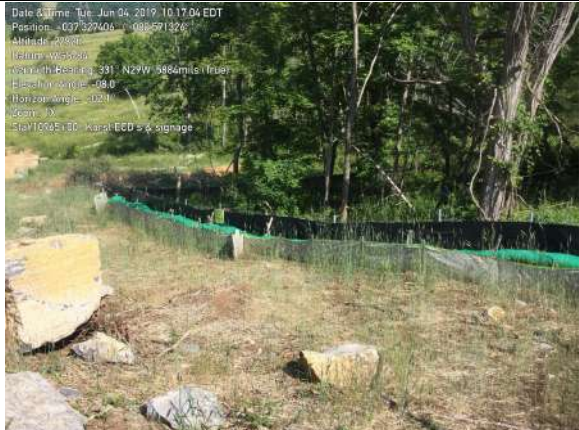
<p>Date & Time: Tue, Jun 04, 2019, 10:17:04 EDT Position: -037.327406° / -080.591326° Altitude: 2353ft Datum: WGS-84 Azimuth/Bearing: 331° N29W 5866mils (True) Elevation Angle: -08.0° Horizon Angle: -02.0° Zoom: 1X Sta#10965+00- Karst ECD's & signage</p>

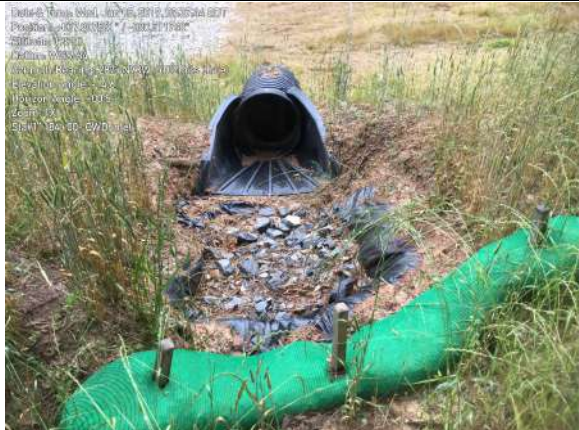
<p>Date & Time: Wed, Jun 05, 2019, 09:25:04 EDT Position: -037.301387, -080.511501 Altitude: 19.0ft Datum: WGS-84 Azimuth Bearing: 326° 26.2W, 6100mils (True) Elevation Angle: -12.2 Horizon Angle: -00.5 Zoom: 1X Staff 11184+00: CWD inlet</p>

GPS Location	37.30	Field Station#	11191+50	GPS Location	37.30	Field Station#	11184+00
Description	Drainage feature, equipment bridge, ECD's, signage are in acceptable condition			Description	CWD inlet.		
<p>Date & Time: Wed, Jun 05, 2019, 09:32:25 EDT Position: -037.307428, -080.511833 Altitude: 19.71ft Datum: WGS-84 Azimuth Bearing: 302° 55.0W, 5367mils (True) Elevation Angle: -10.7 Horizon Angle: -02.7 Zoom: 1X Staff 11184+00: CWD outlet into plunge pool. ECD's.</p>

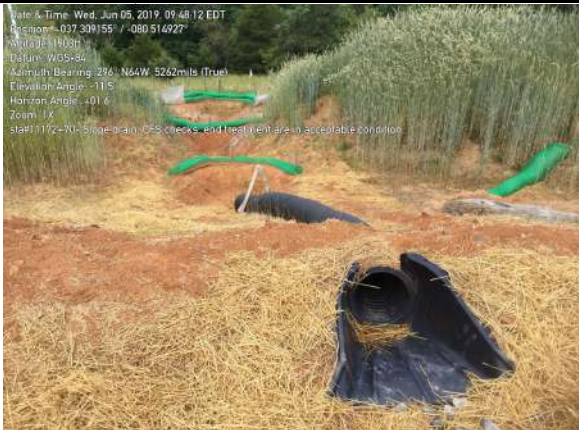
<p>Date & Time: Wed, Jun 05, 2019, 09:48:12 EDT Position: -037.301557, -080.516927 Altitude: 19.0ft Datum: WGS-84 Azimuth Bearing: 286° 16.4W, 5262mils (True) Elevation Angle: -11.5 Horizon Angle: -01.6 Zoom: 1X Staff 11172+70: Slope drain, CFS checks, end treatment are in acceptable condition</p>

GPS Location	37.30	Field Station#	11184+00	GPS Location	37.30	Field Station#	11172+70
Description	CWD outlet into plunge pool.			Description	Slope drain. CFS checks, end treatment are in acceptable condition

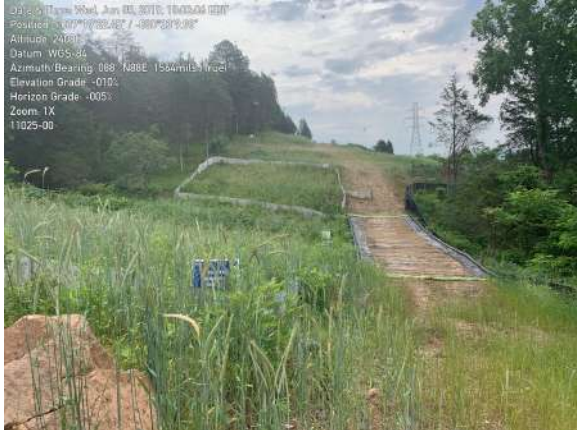
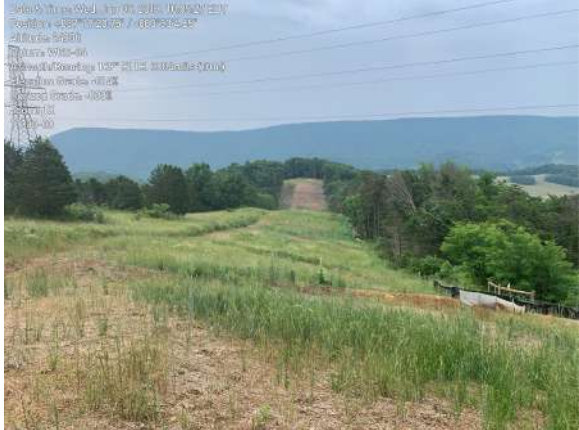
GPS Location	37.32	Field Station#	11025+00	GPS Location	37.32	Field Station#	11030+00
Description	ECD's and ROW conditions			Description	ECD's and ROW conditions

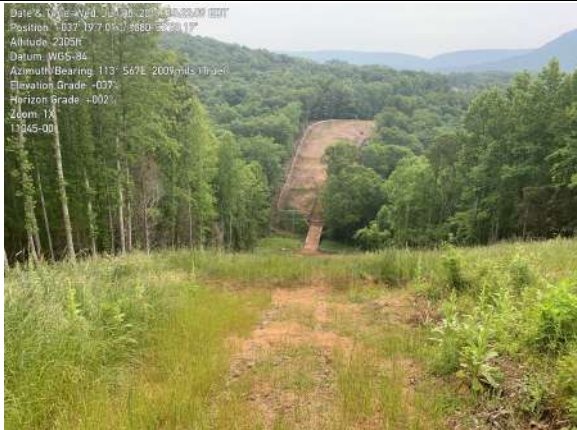
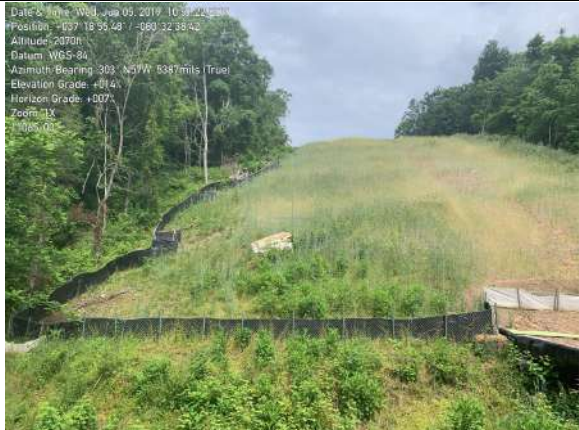
GPS Location	37.32	Field Station#	11045+00	GPS Location	37.32	Field Station#	11065+00
Description	ECD's and ROW conditions			Description	ECD's and ROW conditions

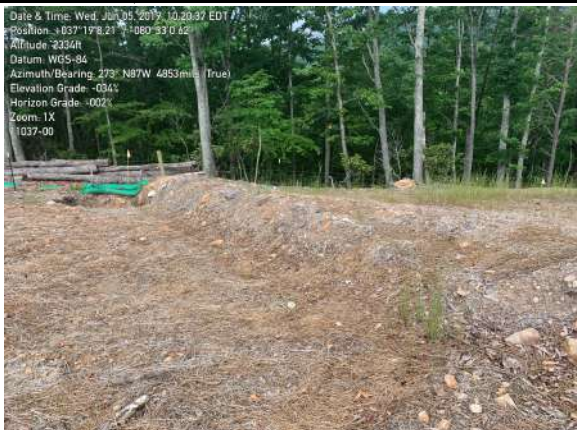
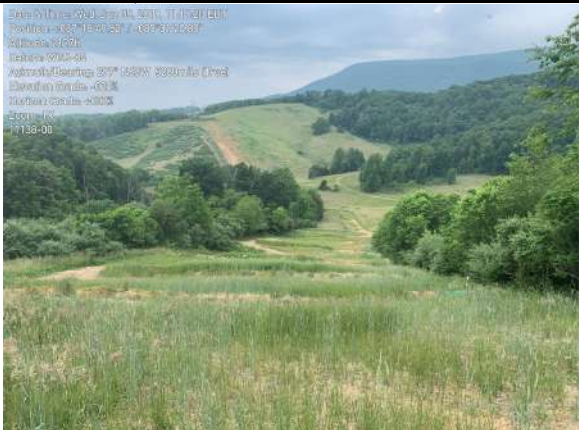
GPS Location	37.32	Field Station#	11037+00	GPS Location	37.32	Field Station#	11138+00
Description	ECD's and ROW conditions			Description	ECD's and ROW conditions

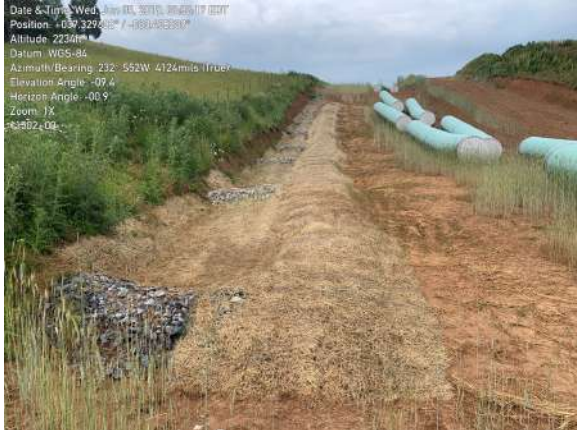
GPS Location	37.31	Field Station#	11502+00	GPS Location	37.31	Field Station#	11496+00
Description	See photo for GPS location. Conveyance channel with rock checks in place.			Description	See photo for GPS location. Rock inlet filled with sediment. Issue communicated to contractor.

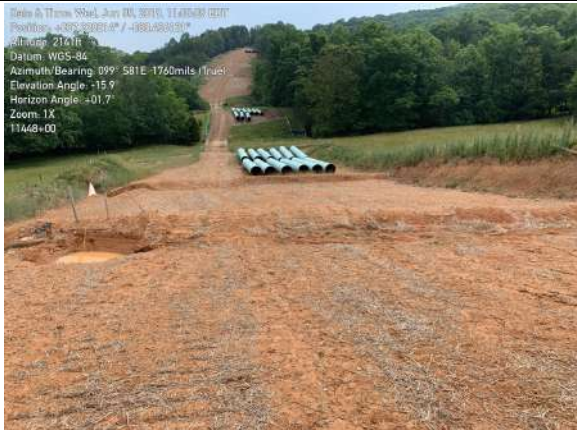
GPS Location	37.31	Field Station#	11448+00	GPS Location	37.31	Field Station#	11433+00
Description	See photo for GPS location. Waterbars and sump pits in place.			Description	See photo for GPS location. Sediment off ROW. PAR wrote.

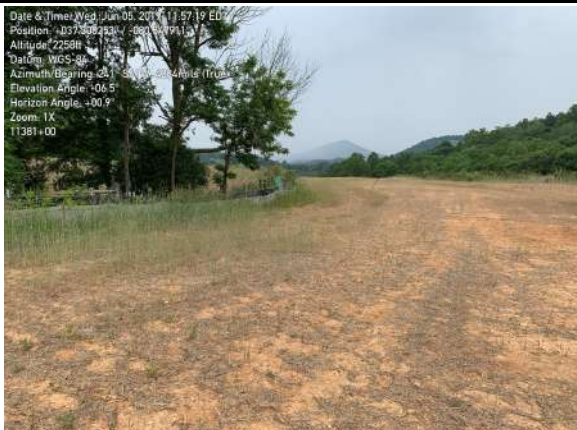
GPS Location	37.31	Field Station#	11381+00	GPS Location	37.31	Field Station#	11372+00
Description	See photo for GPS location. Triple barrier ECDs in place at Karst feature.			Description	See photo for GPS location. Plunge pool in place.

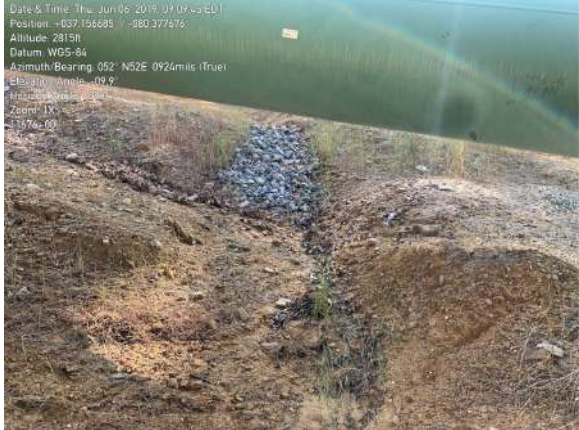
GPS Location	37.18	Field Station#	11670+00	GPS Location	37.18
Description		See photo for GPS location. Waterbars and end treatments in place.		Field Station# 11676+00	
Description		See photo for GPS location. Rock lined channel over two tone in place.

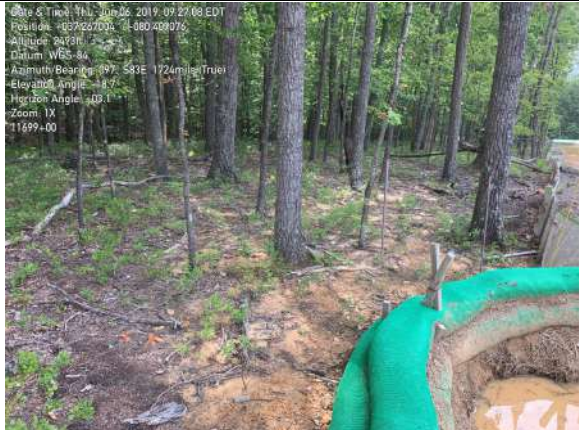
GPS Location	37.18	Field Station#	11687+40	GPS Location	37.18
Description		See photo for GPS location. Sensitive resource buffer in place at stream S-MN21.		Field Station# 11699+00	
Description		See photo for GPS location. Sediment off ROW.

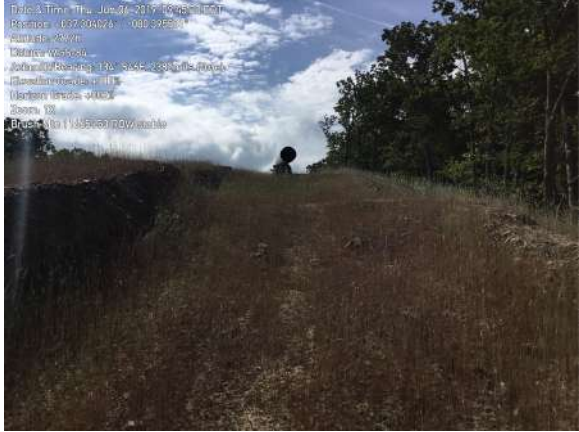
GPS Location	37.31	Field Station#	11667+00	GPS Location	37.31	Field Station#	11665+50
Description	Correct coordinates on photo. End treatments are functional.			Description	Correct coordinates on photo. ROW stable currently. Annual grasses are dying.		
<p>Date & Time: Thu Jun 06, 2019, 10:15:41 EDT Position: +037.307164 / -080.317667 Altitude: 2340ft Datum: WGS-84 Azimuth/Bearing: 340° N20W 604mils (True) Elevation Grade: +001° Horizon Grade: +000° Zoom: 2X Brush Mtn 11653+00 annual grasses browning</p>

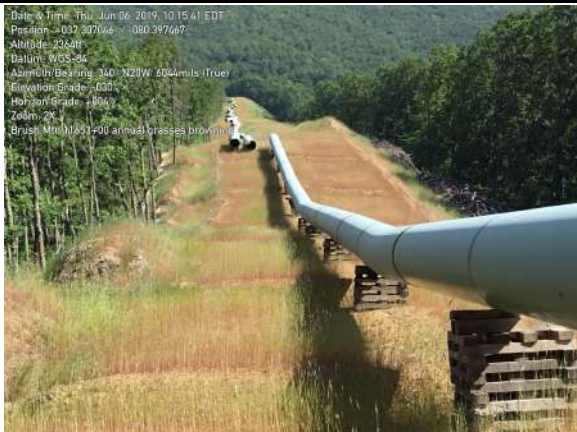
GPS Location	37.31	Field Station#	11653+00	GPS Location	37.31	Field Station#	11643+50
Description	Correct coordinates on photo. ROW currently stable. Annual grasses are dying.			Description	Correct coordinates on photo. Interior ROW stable.		
<p>Date & Time: Thu Jun 06, 2019, 10:42:19 EDT Position: +037.313574 / -080.316040 Altitude: 1778ft Datum: WGS-84 Azimuth/Bearing: 295° N65W 524mils (True) Elevation Grade: +001° Horizon Grade: +012° Zoom: 1X Brush Mtn 11628+00 perimeter controls in place ROW currently stable</p>  		<p>Date & Time: Thu Jun 06, 2019, 10:58:20 EDT Position: +037.314255 / -080.316922 Altitude: 1668ft Datum: WGS-84 Azimuth/Bearing: 293° N67W 520mils (True) Elevation Grade: +001° Horizon Grade: +001° Zoom: 1X Brush Mtn 11619+00 perimeter controls in place</p>  					
GPS Location	37.31	Field Station#	11628+00	GPS Location	37.31	Field Station#	11619+50
Description	Correct coordinates on photo. Perimeter controls are in place and functional.			Description	Correct coordinates on photo. Perimeter controls are in place.

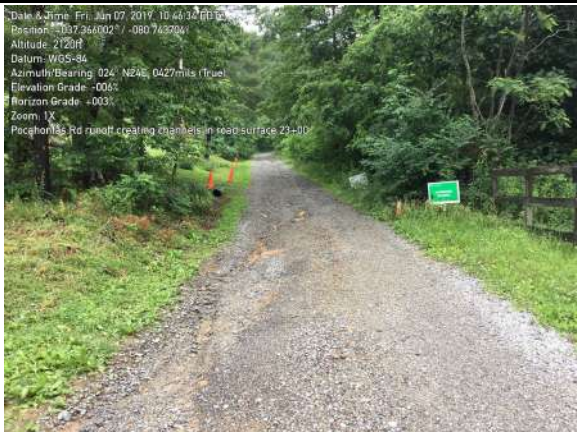
GPS Location	37.31	Field Station#	39+75	GPS Location	37.31	Field Station#	27+50
Description	Correct coordinates on photo. Channeling of runoff on road surface apparent.			Description	Correct coordinates on photo. Channeling of runoff on road surface apparent.		
<p>Date & Time: Fri Jun 07, 2019 10:41:10 EDT Position: -037.360002 / -080.743204 Altitude: 2120ft Datum: WGS-84 Azimuth/Bearing: 024° N24E 0427mils (True) Elevation Grade: -003% Horizon Grade: -003% Zoom: 1X Pocahontas Rd runoff creating channels in road surface 23+00</p>

GPS Location	37.31	Field Station#	23+00	GPS Location	37.31	Field Station#	21+00
Description	Correct coordinates on photo. Channeling of runoff on road surface apparent.			Description	Correct coordinates on photo. Channeling of runoff on road surface apparent.		
<p>Date & Time: Fri Jun 07, 2019 10:49:20 EDT Position: -037.364241 / -080.745977 Altitude: 2107ft Datum: WGS-84 Azimuth/Bearing: 146° S31E 300mils (True) Elevation Grade: -013% Horizon Grade: -002% Zoom: 1X Pocahontas Rd runoff creating channels in road surface 18+75</p>

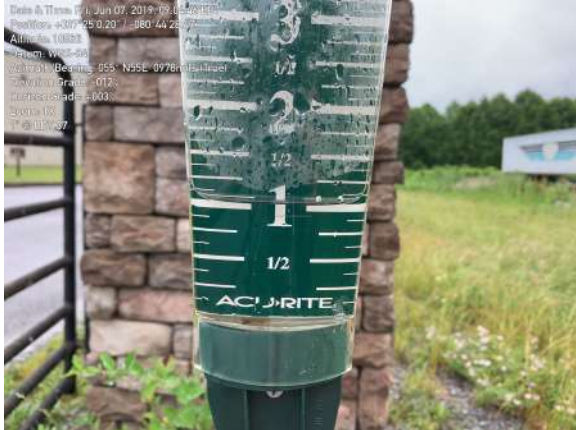
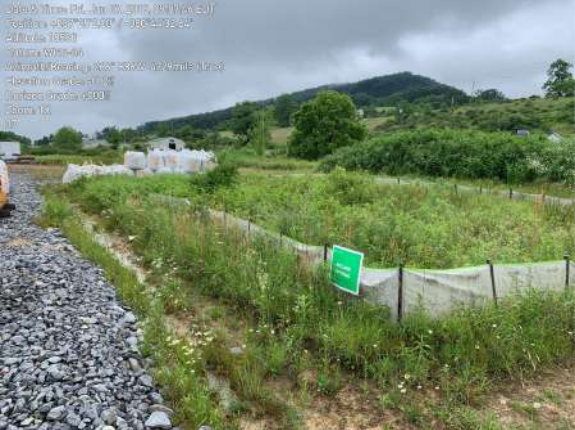
GPS Location	37.24	Field Station#	+37	GPS Location	37.24	Field Station#	+37
Description	1" @ LDY 37			Description	ECD's and ROW conditions

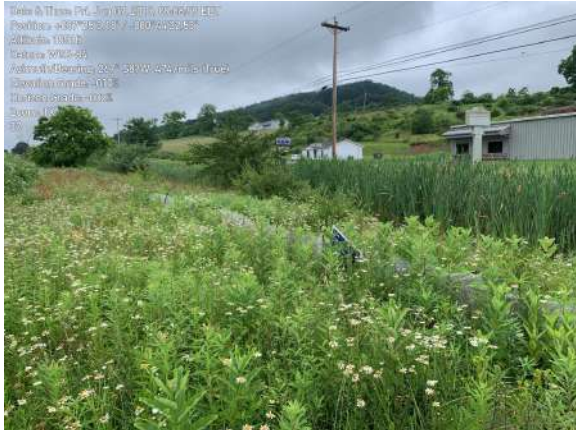
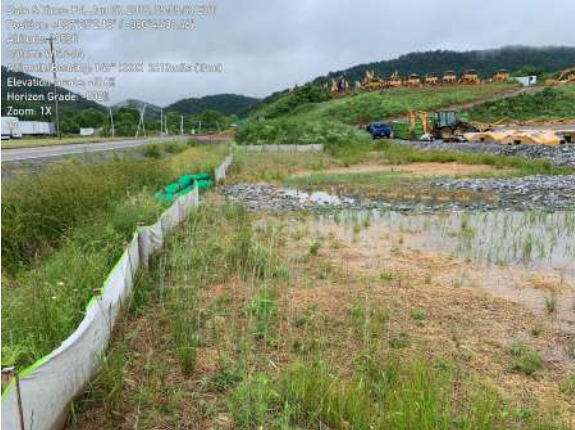
GPS Location	37.24	Field Station#	+37	GPS Location	37.24	Field Station#	+37
Description	ECD's and ROW conditions			Description	ECD's and ROW conditions

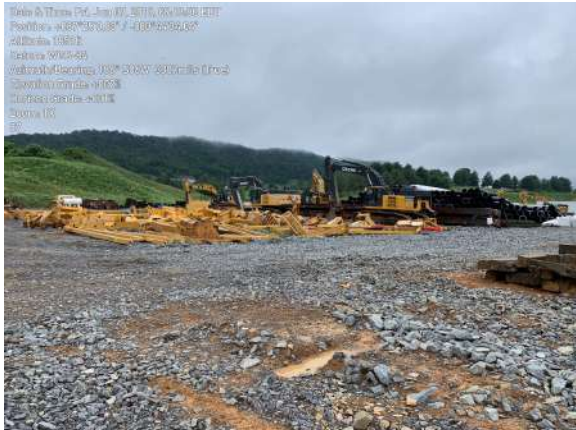
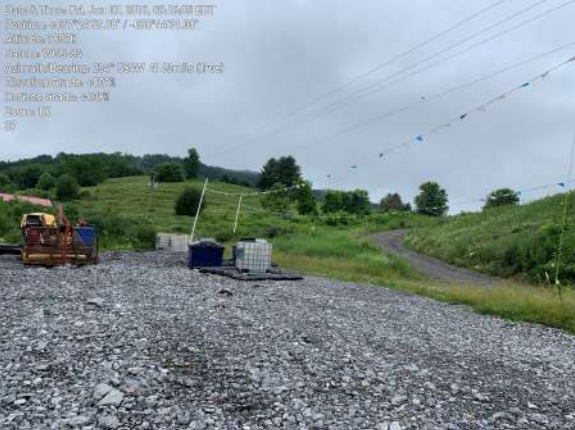
GPS Location	37.24	Field Station#	+37	GPS Location	37.24	Field Station#	+37
Description	ECD's and ROW conditions			Description	ECD's and ROW conditions

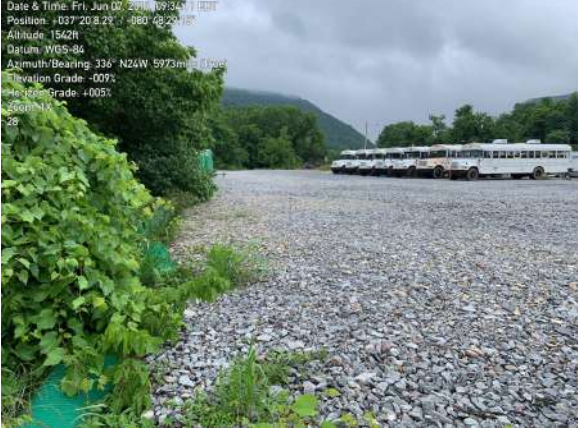
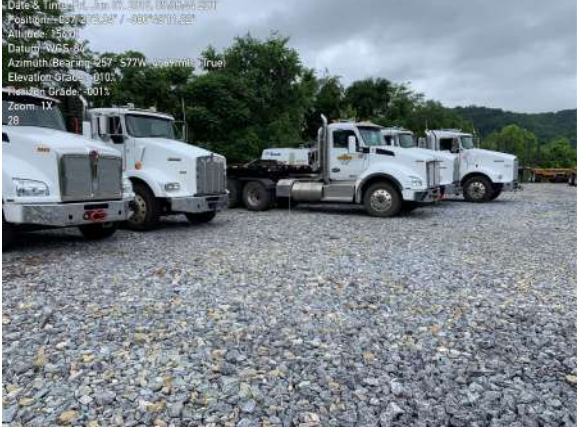
GPS Location	37.24	Field Station#	+28	GPS Location	37.24
Description	ECD's and ROW conditions		Description	ECD's and ROW conditions	
<p>Date & Time: Fri, Jun 07, 2019 11:12:40 (GMT) Position: +037° 18' 20.29" / -080° 22' 21.15" Altitude: 2154ft Datum: WGS-84 Azimuth/Bearing: 263° S23W 3609mils (True) Elevation Grade: -004% Horizon Grade: -004% Zoom: 1X m</p>

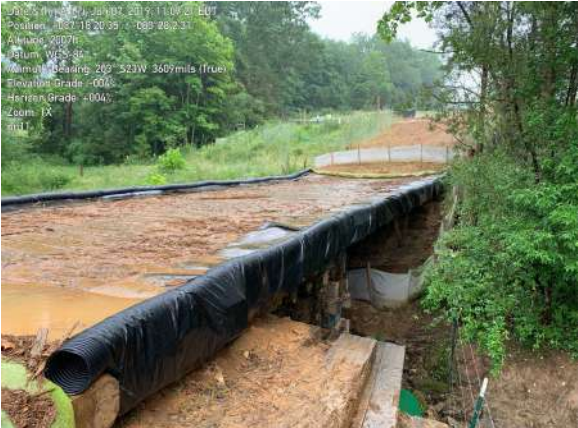
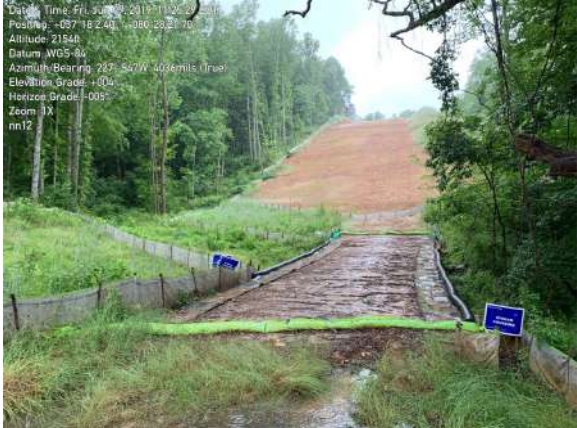
GPS Location	37.24	Field Station#	11352+97	GPS Location	37.24
Description	ECD's and ROW conditions SNN11		Description	ECD's and ROW conditions SNN11	
<p>Date & Time: Fri, Jun 07, 2019 11:14:50 (GMT) Position: +037° 18' 13.42" / -080° 26' 8.05" Altitude: 2179ft Datum: WGS-84 Azimuth/Bearing: 011° N11E 0124mils (True) Elevation Grade: -033% Horizon Grade: +001% Zoom: 1X m</p>

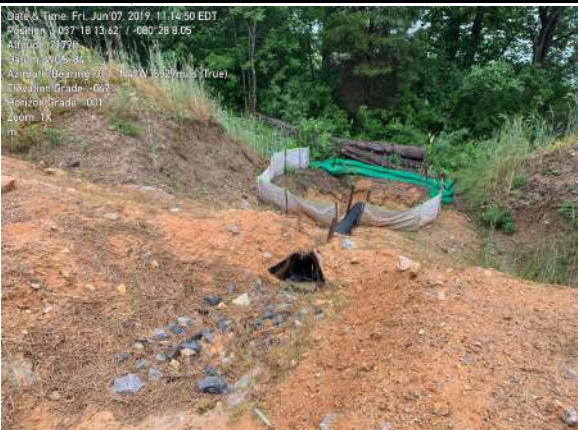
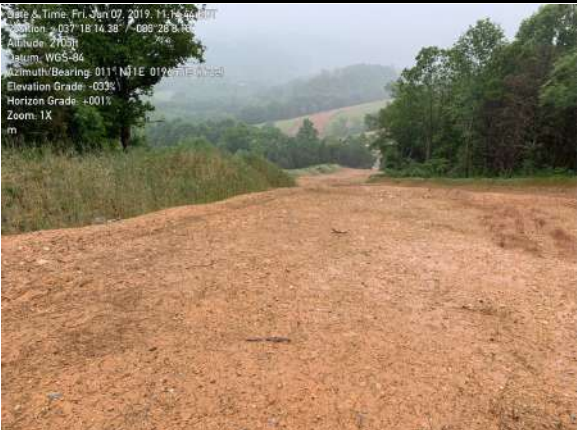
GPS Location	37.24	Field Station#	11340+00	GPS Location	37.24
Description	ECD's and ROW conditions		Description	ECD's and ROW conditions

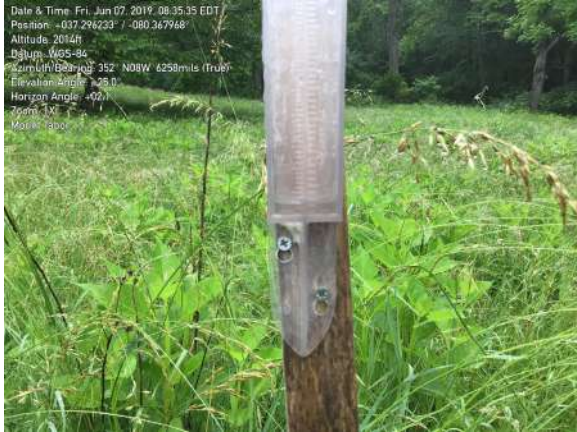
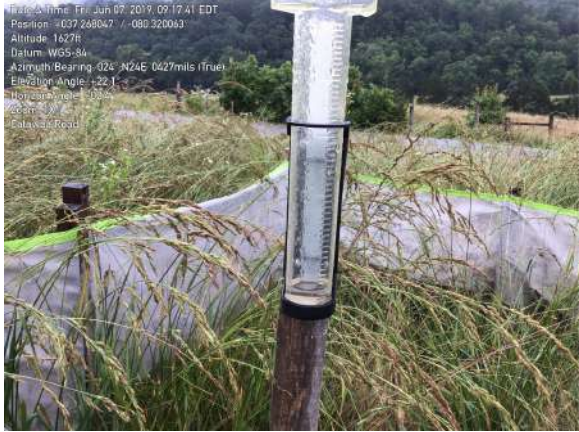
GPS Location	37.18	Field Station#	11676+00	GPS Location	37.18
Description	See photo for GPS location. Rain gauge at Mount Tabor Road reads .3 inches.

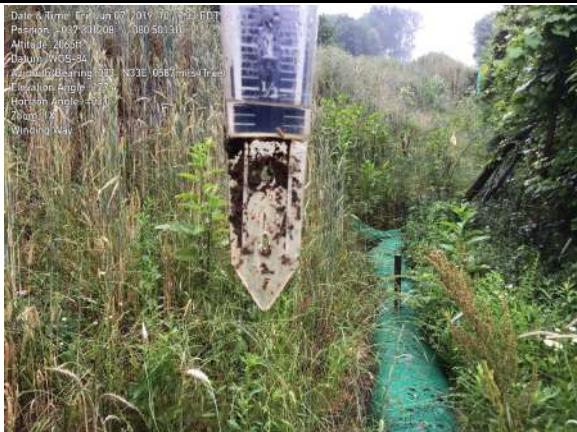
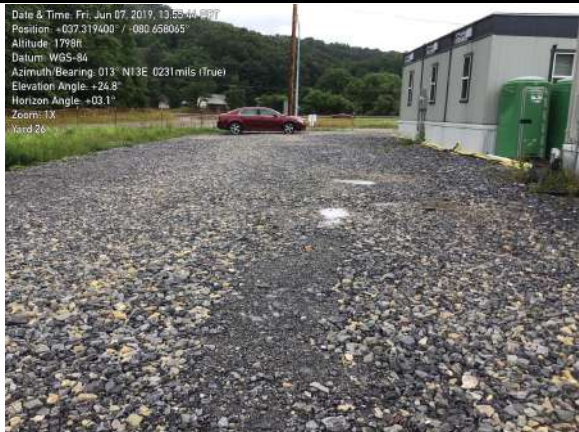
GPS Location	37.18	Field Station#	11125+00	GPS Location	37.18
Description	See photo for GPS location. Rain gauge at MLV 25 reads .3 inches.

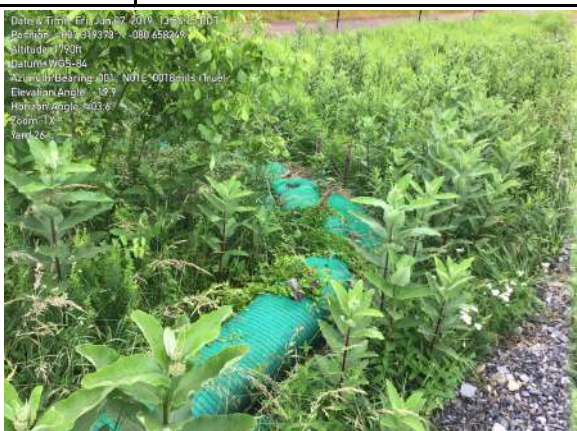
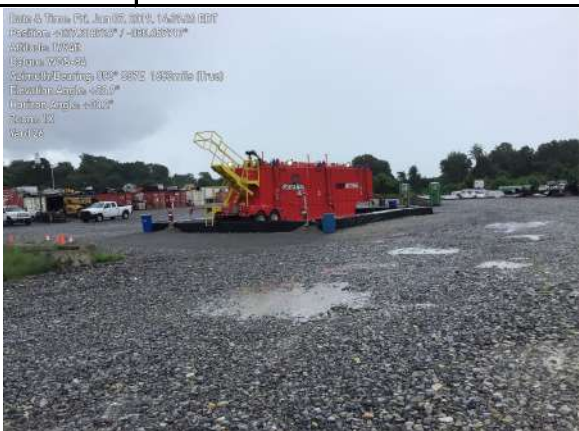
GPS Location	37.18	Field Station#	12005+00	GPS Location	37.18
Description	See photo for GPS location. Triple stack compost filter sock in place.				
GPS Location	37.18	Field Station#	12005+00	GPS Location	37.18
Description	See photo for GPS location. Containment in place around fuel cell.
