Visual Site Inspection Report

| Project Name | H-600 Pipeline Spread G | AFE | 124300137 | Spread | H-600 Pipeline Spread G |
| Inspector | Len Kruizenga | | | Date/Time | 6/10/2019 7:39 AM |

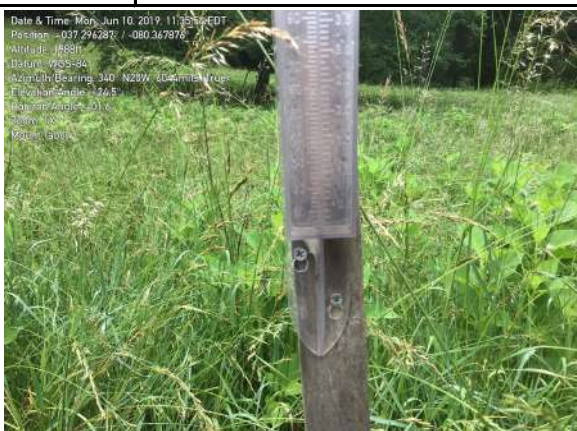
| <p>Date & Time: Mon, Jun 10, 2019, 11:05:55 EDT Position: +037.296287° / -080.367876° Altitude: 1858ft Datum: WGS-84 Azimuth/Bearing: 340° N28W 5813mils (True) Elevation Angle: +26.5° Horizon Angle: +04.6° Zoom: 1X Mount Tabor</p> | | | <p>Date & Time: Mon, Jun 10, 2019, 11:05:55 EDT Position: +037.296287° / -080.320049° Altitude: 1679ft Datum: WGS-84 Azimuth/Bearing: 022° N22E 6391mils (True) Elevation Angle: +22.7° Horizon Angle: +01.0° Zoom: 1X Catawba</p> | | | | |
| Description | See photo for GPS location. Rain gauge at Mount Tabor Road reads 0.1 inches. | | | Description | See photo for GPS location. Rain gauge at Catawba Road reads 0.2 inches. | | |

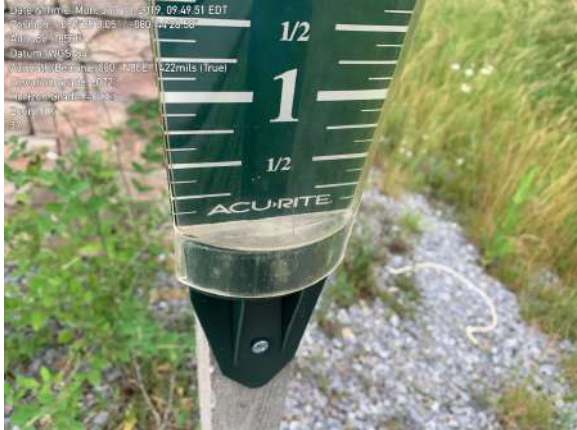
| Description | No rain recorded @ LDY 37 | | | Description | ECD's and row conditions | | |

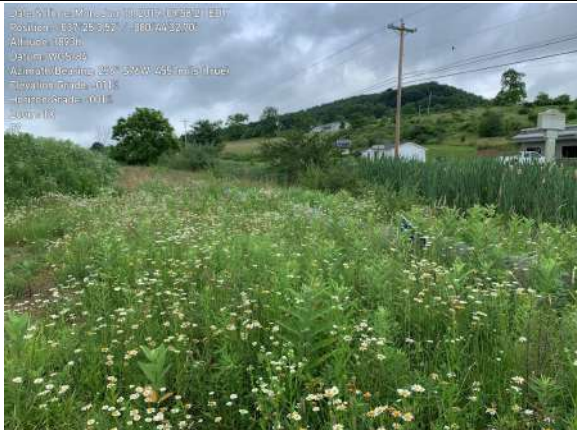
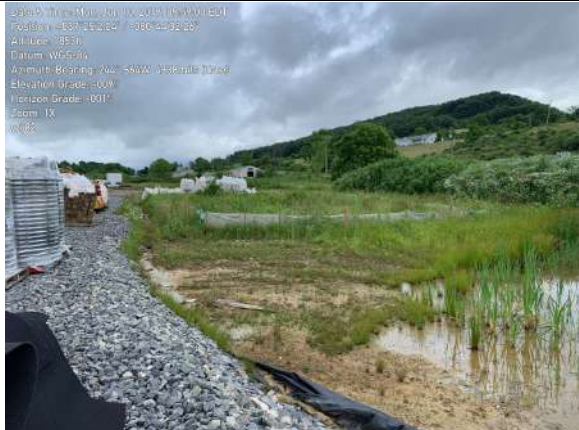
| Description | ECD's and row conditions | | | Description | ECD's and row conditions | | |

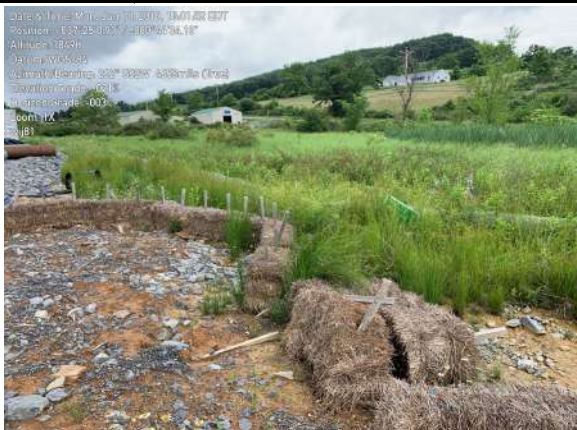
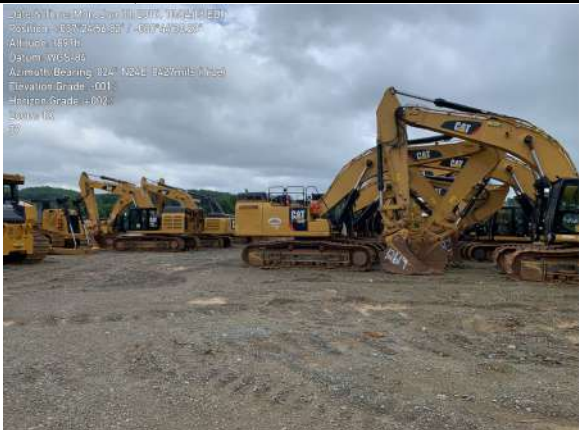
| Description | ECD's and row conditions | | | Description | ECD's and row conditions | | |

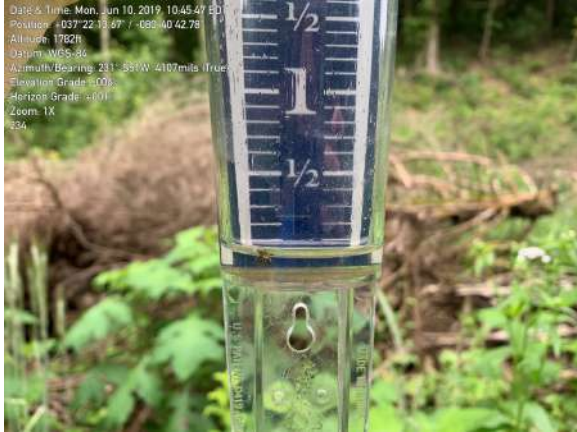
| Description | .1" of rain recorded | | | Description | AR 234 | | |

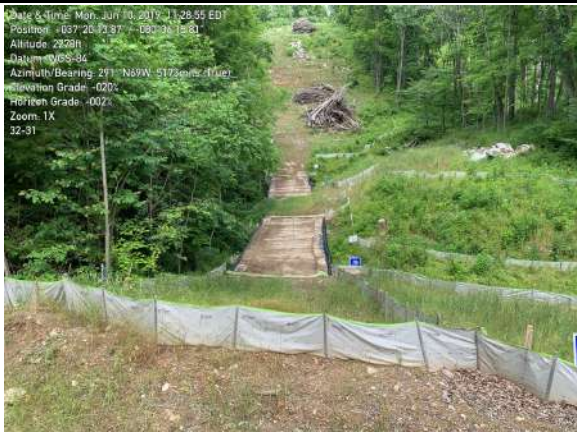
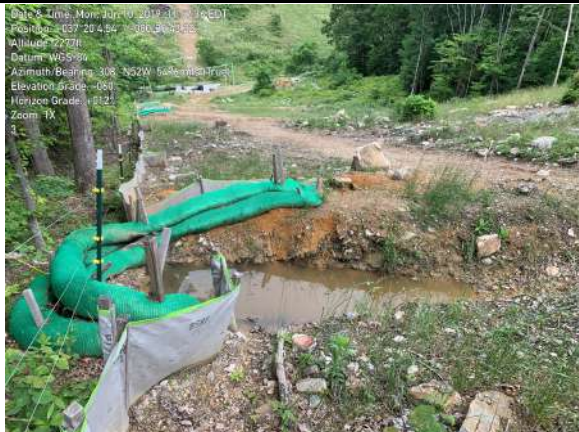
| Description | ECD's and row conditions | | | Description | ECD's and row conditions | | |

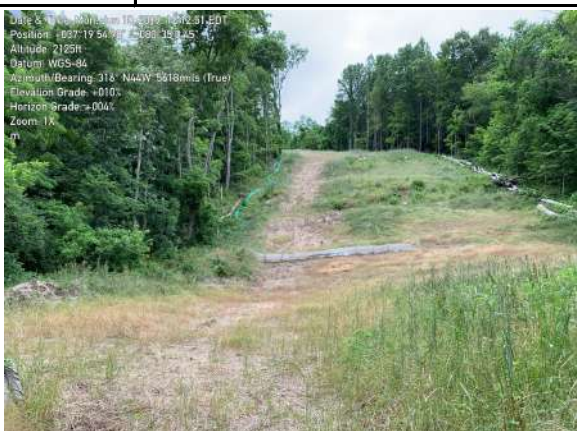
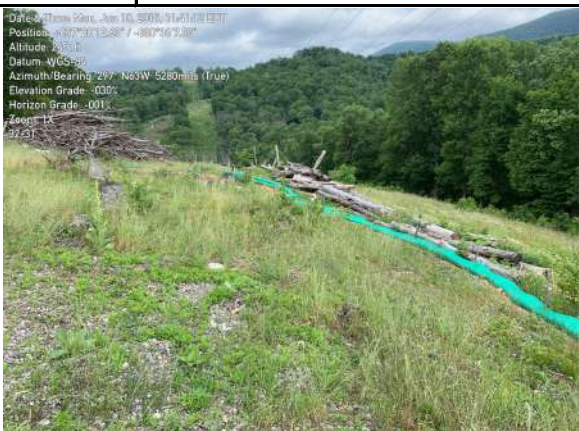
| Description | ECD's and row conditions | | | Description | ECD's and row conditions | | |

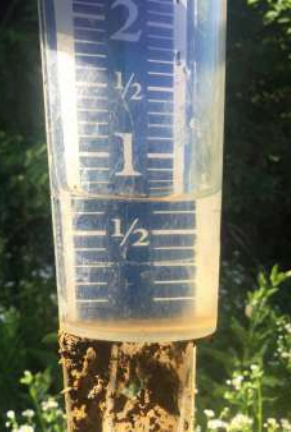
| Description | Winding Way rain gauge reading- 0.70" | | | Description | Sensitive resource area, drainage feature ECD's, signage & Equipment bridge are in acceptable condition | | |

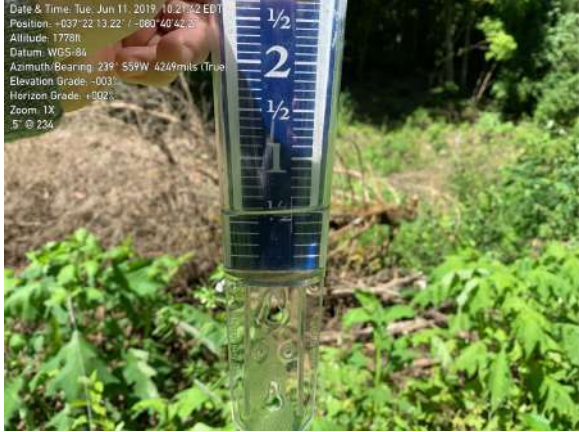
| Description | .5" @ Buff | | Description | .5" @ 234 | |

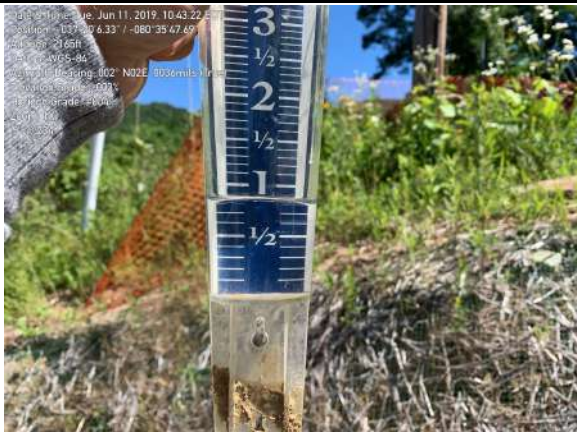
| Description | .8 @ Kow Camp | | Description | .8" @ 244 | |

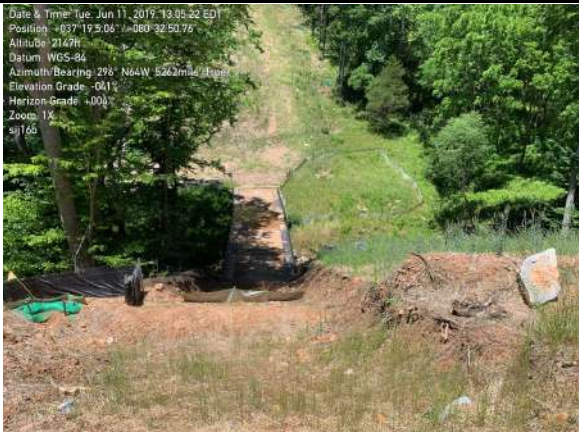
| Description | ECD's and row conditions | | Description | ECD's and row conditions | |

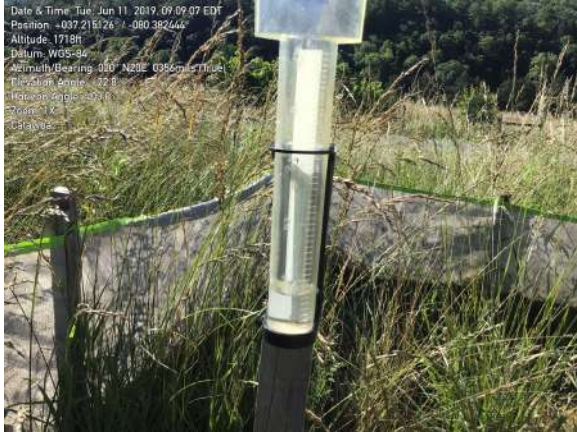
| Description | See photo for GPS location. Rain gauge at Catawba Road reads .8 inches. | | | Description | See photo for GPS location. Sediment retrieval completed along AR 266. | | |

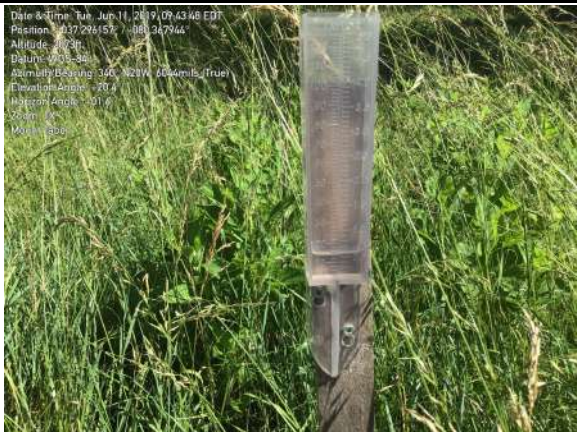
| Description | See photo for GPS location. Rain gauge at Mount Tabor Road reads .5 inches. | | | Description | See photo for GPS location. Rain gauge at Steele Acres reads .6 inches. | | |

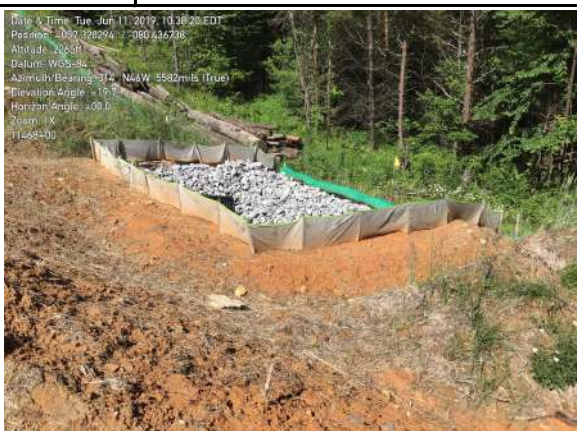
| Description | See photo for GPS location. Plunge pool in place. | | | Description | See photo for GPS location. Waterbar end treatment undermined. | | |

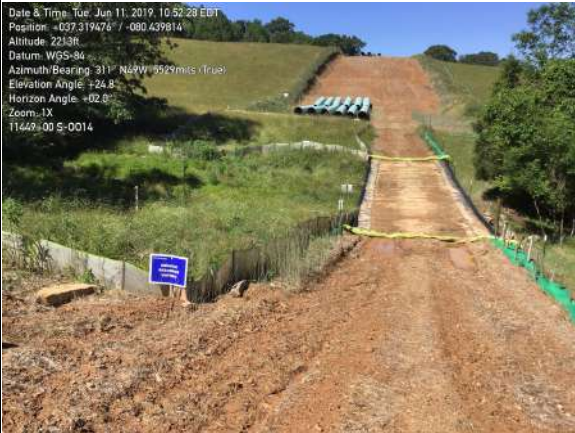
| Description | See photo for GPS location. Sensitive resource buffer in place at stream S-0014. | | | Description | See photo for GPS location. Priority one silt fence end treatment in place. | | |

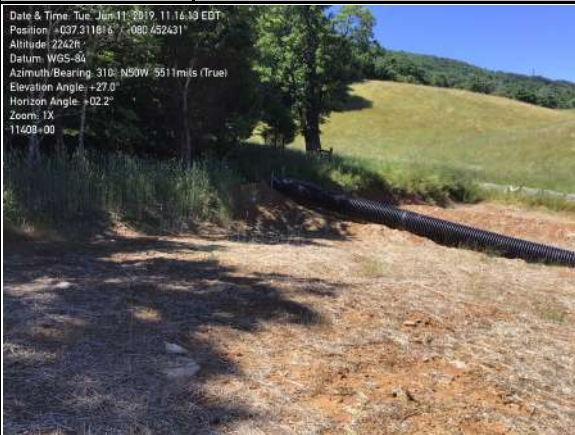
| Description | See photo for GPS location. Clean water diversion berm and pipe. | | | Description | See photo for GPS location. Rock inlet at slope drain. | | |

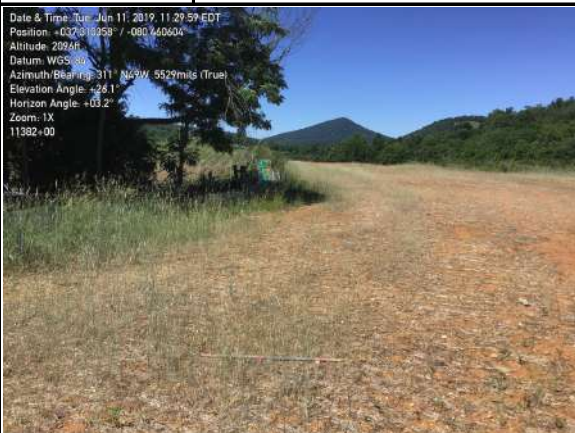
| Description | See photo for GPS location. Triple barrier ECDs in place at off ROW karst feature. | | | Description | See photo for GPS location. RCE in place at Old Furnace Road. | | |

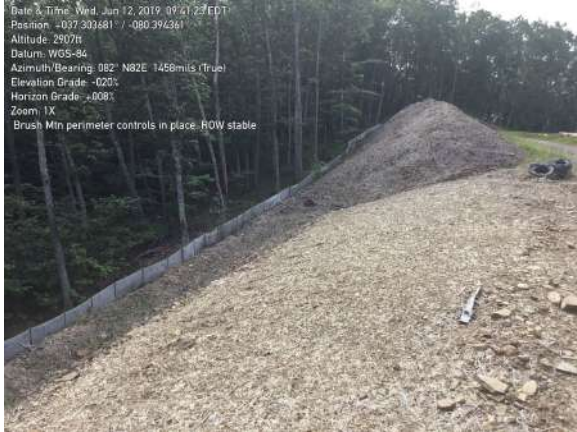
| Description | Correct coordinates on photo. Area void of grass but remains stable. | | | Description | Correct coordinates on photo. ROW ECDs functional. | | |

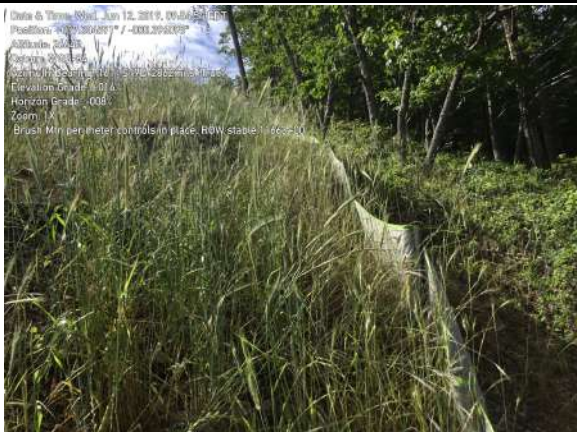
| Description | Correct coordinates on photo. Grasses and perimeter controls have contained sediment. | | | Description | Correct coordinates on photo. Perimeter controls are in place where needed. | | |

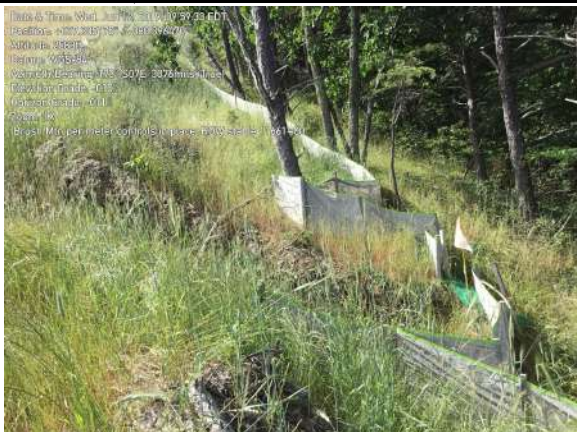
| Description | Correct coordinates on photo. ROW stable with ECDs in place. | | | Description | Correct coordinates on photo. Annual grasses have begun to brown. | | |

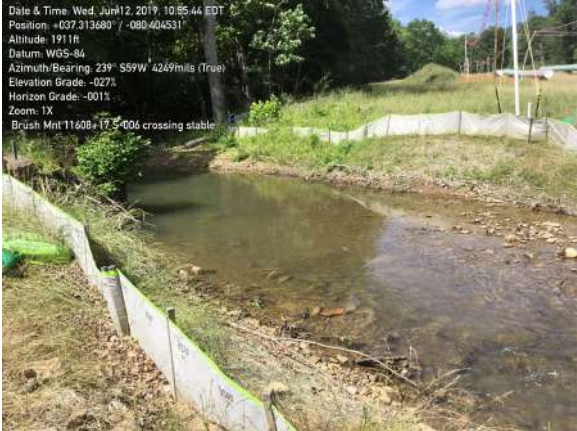
| Description | Correct coordinates on photo. S-006 crossing stable. | | Description | | |

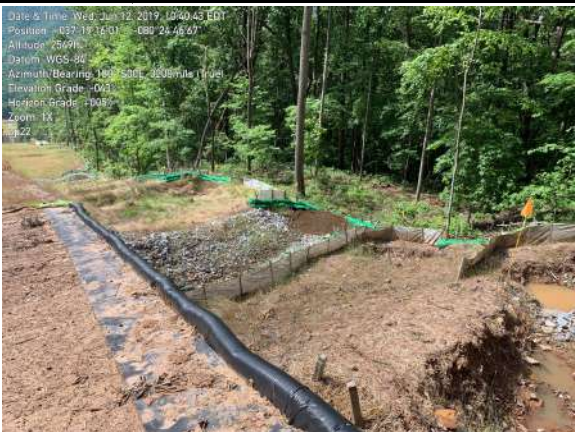
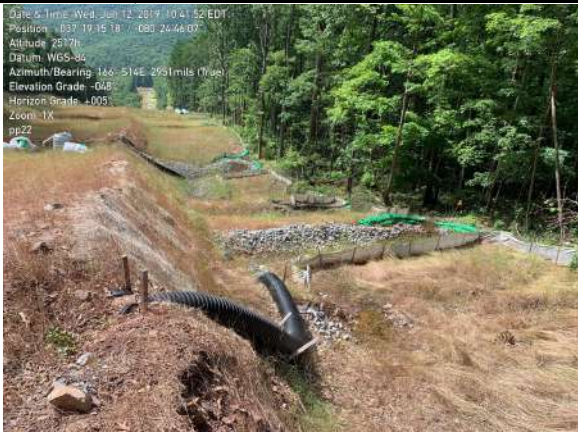
| Description | ECD's and Row conditions @ S PP22 | | | Description | ECD's and Row conditions @ S PP22 | | |

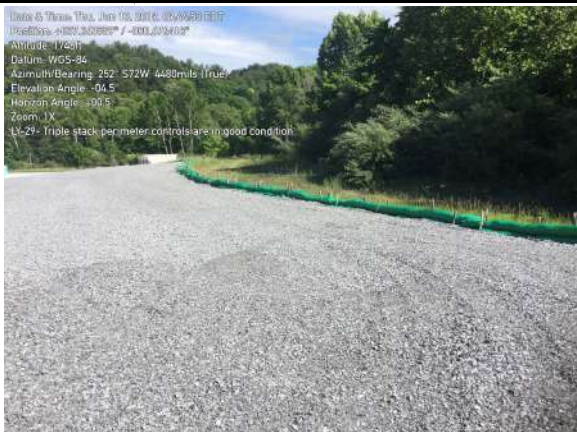
| Description | LY-29- Triple stack CFS perimeter controls are in acceptable condition. | | | Description | LY-29- House keeping is acceptable. | | |

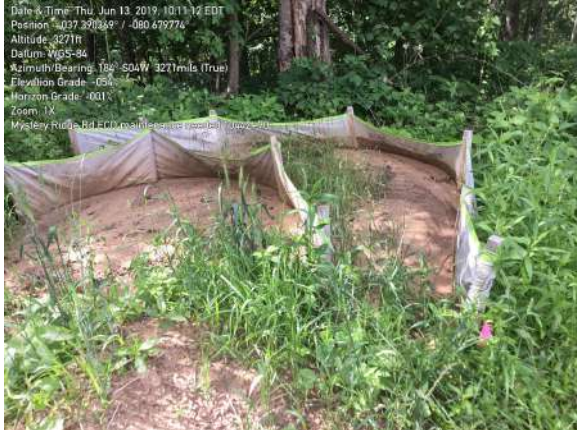
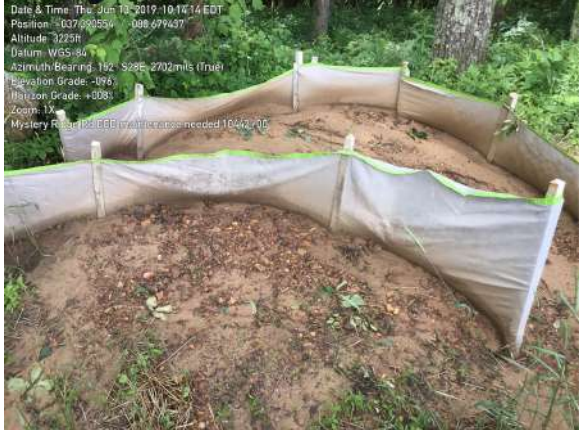
| GPS Location | 37.31 | Field Station# | 10442+70 | GPS Location | 37.31 | Field Station# | 10442+00 |

| Date & Time: Thu Jun 13, 2019, 10:11:12 EDT Position: 4037.391369° / -080.679776° Altitude: 3271ft Datum: WGS-84 Azimuth/Bearing: 194° S28E 2702mils (True) Elevation Grade: -096° Horizon Grade: +003° Zoom: 1X Mystery Ridge Rd ECD maintenance needed 10442+70 | | Date & Time: Thu Jun 13, 2019, 10:16:14 EDT Position: 4037.390554° / -080.679437° Altitude: 3225ft Datum: WGS-84 Azimuth/Bearing: 194° S28E 2702mils (True) Elevation Grade: -096° Horizon Grade: +003° Zoom: 1X Mystery Ridge Rd ECD maintenance needed 10442+00 | | | | | |
| Description | Correct coordinates on photo. Mystery Ridge Road ECDs in need of maintenance. | | | Description | Correct coordinates on photo. Mystery Ridge Road ECDs in need of maintenance. | | |

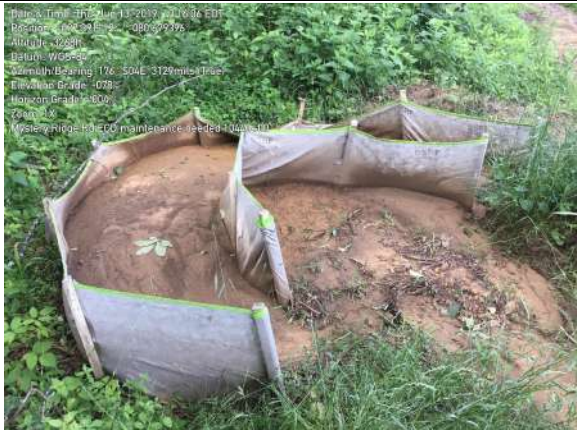
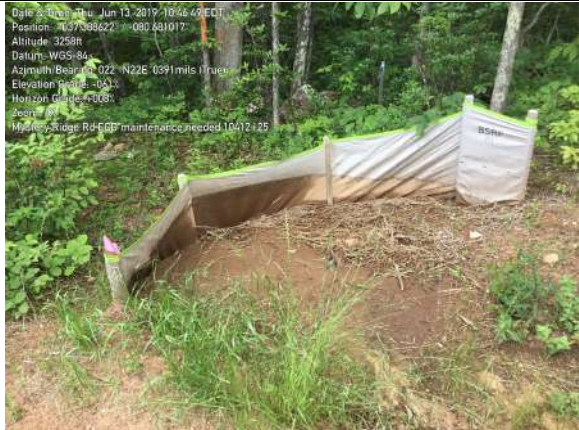
| GPS Location | 37.31 | Field Station# | 10440+00 | GPS Location | 37.31 | Field Station# | 10412+25 |

| Date & Time: Thu Jun 13, 2019, 10:16:42 EDT Position: 4037.390422° / -080.681017° Altitude: 3258ft Datum: WGS-84 Azimuth/Bearing: 176° S04E 3129mils (True) Elevation Grade: -079° Horizon Grade: +002° Zoom: 1X Mystery Ridge Rd ECD maintenance needed 10440+00 | | Date & Time: Thu Jun 13, 2019, 10:46:42 EDT Position: 4037.390422° / -080.681017° Altitude: 3258ft Datum: WGS-84 Azimuth/Bearing: 022° N22E 0391mils (True) Elevation Grade: -051° Horizon Grade: +003° Zoom: 1X Mystery Ridge Rd ECD maintenance needed 10412+25 | | | | | |

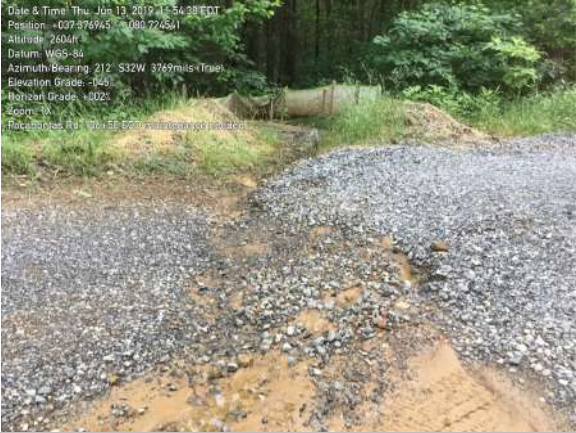
| GPS Location | 37.31 | Field Station# | 106+50 | GPS Location | |

| Description | Correct coordinates on photo. ECDs on Pocahontas Road in need of maintenance. | | Description | | |

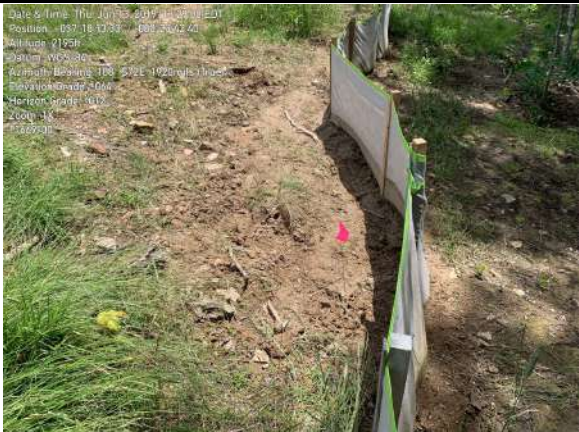
| Description | ECD's and row conditions LDY 28 | | | Description | Crews repaired P1SF undermined | | |

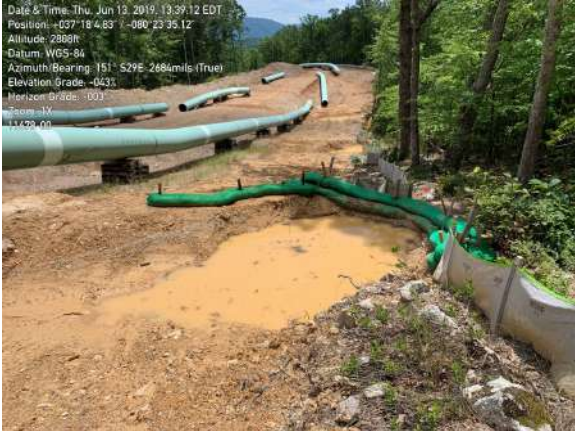
| Description | ECD's and ROW conditions | | | Description | Punchlist item | | |

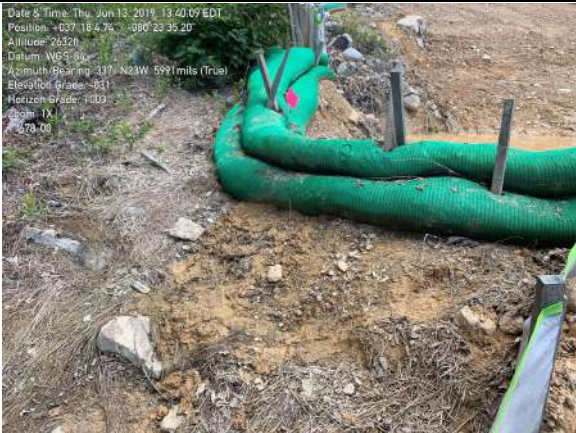
| Description | Punchlist repairs | | | Description | ECD's and row conditions | | |

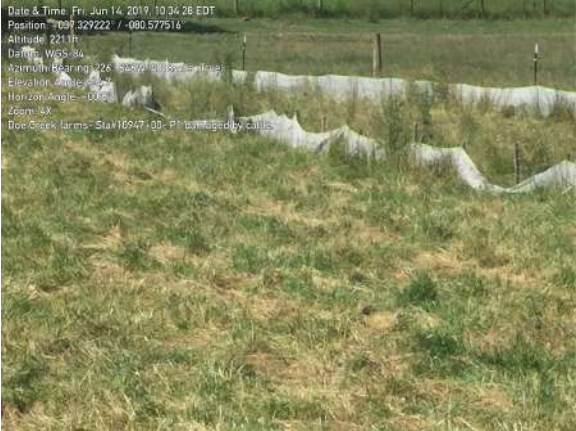
| GPS Location | 37.32 | Field Station# | 10947+00 | GPS Location | |

| <small> Date & Time: Fri Jun 14, 2019 10:34:28 EDT Position: 10947.529222 / -000.577516 Altitude: 221 ft Datum: WGS84 Azimuth Bearing: 226.5550 Elevation Angle: 0.00 Horizon Angle: 0.00 Zoom: 6X Doe Creek Farms- Sta110947+00- P1 Damaged by Cattle </small> | | <div>Insert image here</div> | | | |
| Description | Doe Creek Farms- P1 at drainage feature damage by cattle grazing row. | | Description | | |

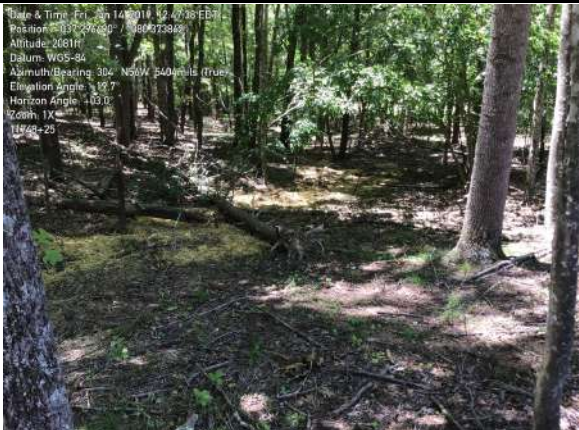
| Description | See photo for GPS location. Waterbar and end treatment in place. | | | Description | See photo for GPS location. Retrieved sediment from outside the LOD. | | |
