Visual Site Inspection Report

Project Name	H-600 Pipeline Spread G	AFE	124300137	Spread	H-600 Pipeline Spread G
Contractor	Precision			Report #	18758
Inspector	Len Kruizenga			Date/Time	6/17/2019 8:57 AM
Permit #	TBD	Inspection Type	VA SWPP	Station Begin	11254+88
State	VA	Inspection Area	Full	Station End	11161+00
County	Giles	Ground	Damp	Temperature (°F)	68.00
Municipality	N/A	Weather	Cloudy	Rain Gauge (in)	0.02
				Rain Accumulation Time (days)	3.00

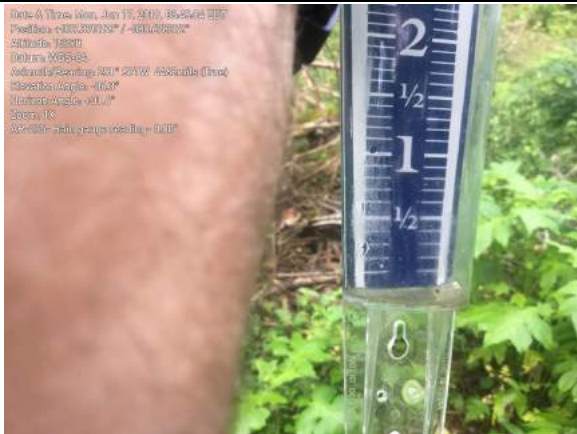
GPS Location	37.34	Field Station#	12005+00	GPS Location	37.34
				Field Station#	10677+00
Description	AR-235- rain gauge reading- 0.00"			Description	Buffalo Anklets rain gauge reading- 0.00"

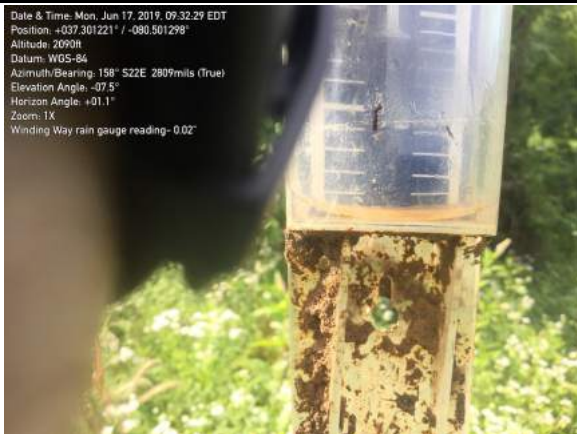
GPS Location	37.30	Field Station#	11227+00	GPS Location	37.30
				Field Station#	11192+00
Description	Winding Way rain gauge reading-0.02"			Description	Sensitive resource controls are in acceptable condition.

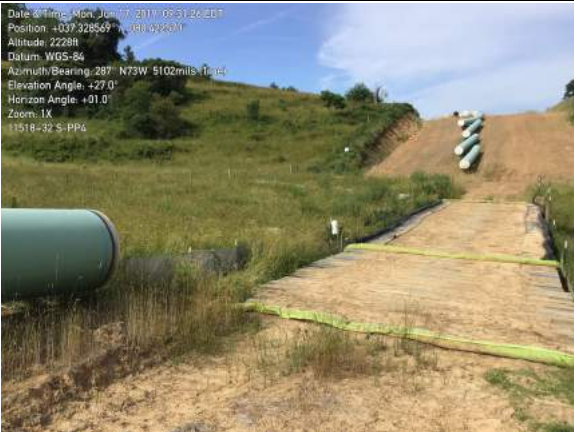
GPS Location	37.18	Field Station#	11518+32	GPS Location	37.18	Field Station#	11504+00
Description	See photo for GPS location. Sensitive resource buffer in place at stream S-PP4.			Description	See photo for GPS location. Plunge pool in place.

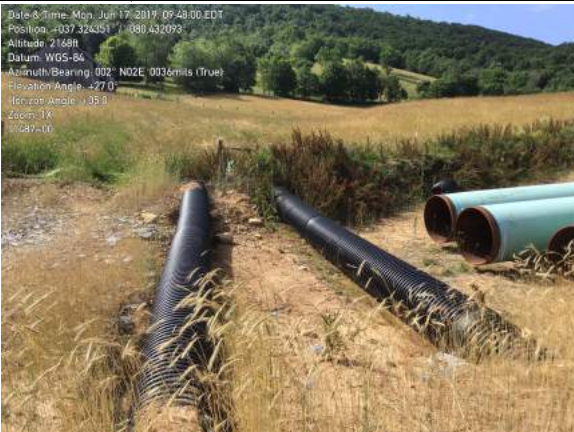
GPS Location	37.18	Field Station#	11487+00	GPS Location	37.18	Field Station#	11381+00
Description	See photo for GPS location. Clean water diversion pipe and berm in place.			Description	See photo for GPS location. Triple barrier ECDs in place at off ROW karst feature.

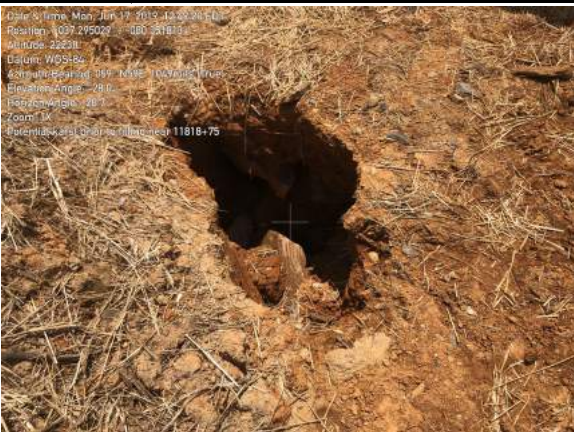
GPS Location	37.32	Field Station#	11818+75	GPS Location	37.32	Field Station#	11818+75
Description	Potential karst prior to filling.			Description	Potential karst after cap.

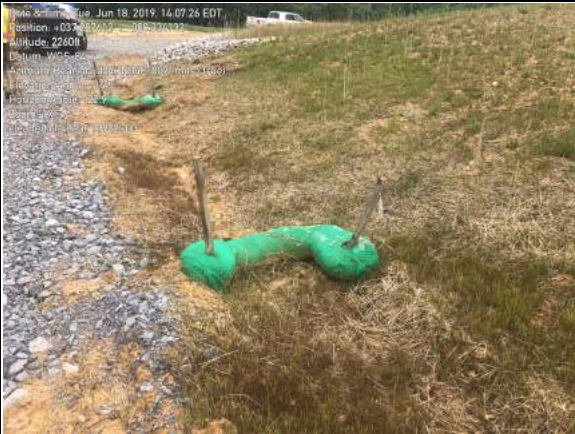
GPS Location	37.26	Field Station#	12001+00	GPS Location	37.13
Description	Wetland P1 is under cut in multiple areas, wooden stake snapped off.				
<div><div>Date & Time: Tue, Jun 18, 2019, 14:07:26 EDT Position: +037.193442° / -080.327122° Altitude: 2260ft Datum: WGS-84 Azimuth/Bearing: 100° N100E 1000mils (True) Elevation Angle: -24.4° Horizon Angle: -24.4° Zoom: 1X Gully (150'x10') near 11902+00</div>

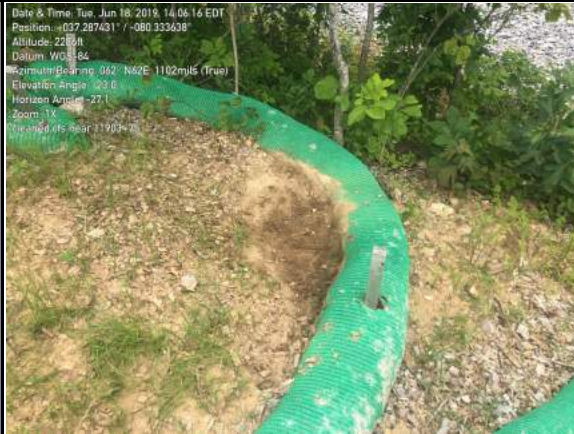
</div>			<div><div>Date & Time: Tue, Jun 18, 2019, 14:06:16 EDT Position: +037.287431° / -080.333638° Altitude: 2270ft Datum: WGS-84 Azimuth/Bearing: 062° N62E 1102mils (True) Elevation Angle: -03.6° Horizon Angle: -27.1° Zoom: 1X Gully (45'x10') near 11903+75</div>

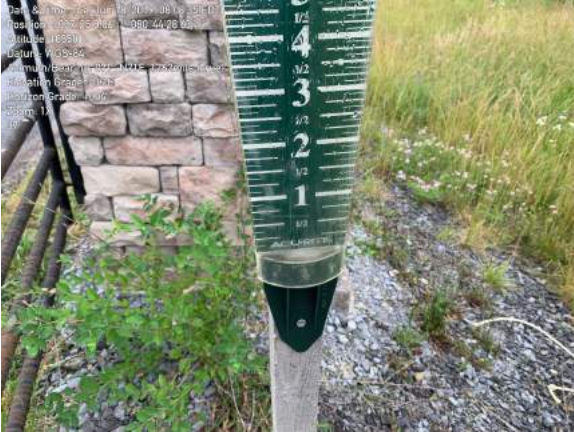
GPS Location	37.24	Field Station#	+37	GPS Location	37.24	Field Station#	11530+00
Description	No rain collected			Description	Slope drain and end treatment

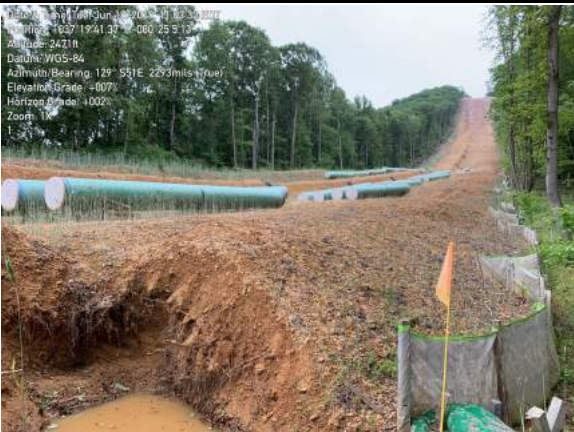
GPS Location	37.24	Field Station#	11540+00	GPS Location	37.24	Field Station#	11550+00
Description	ECD's and row conditions			Description	ECD's and row conditions

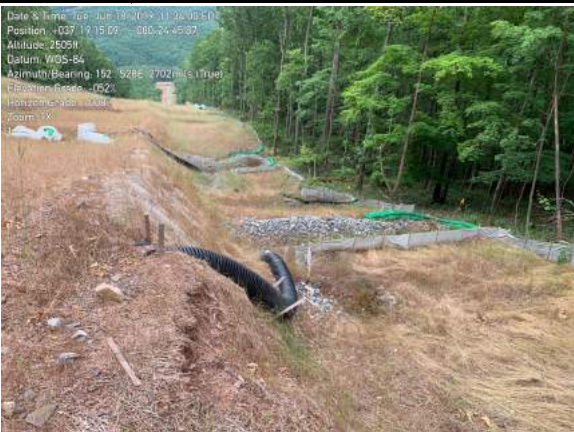
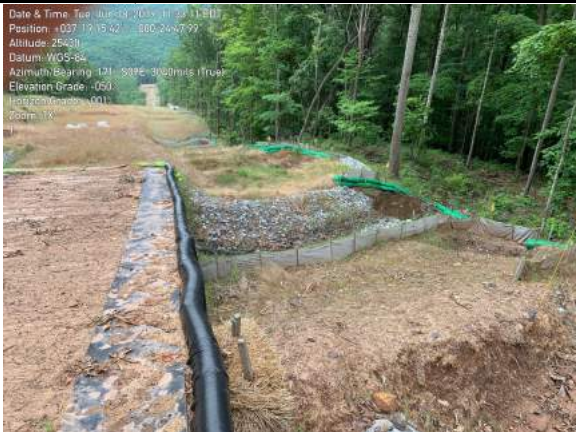
GPS Location	37.24	Field Station#	11570+00	GPS Location	37.24	Field Station#	11570+00
Description	Spp22			Description	Spp22

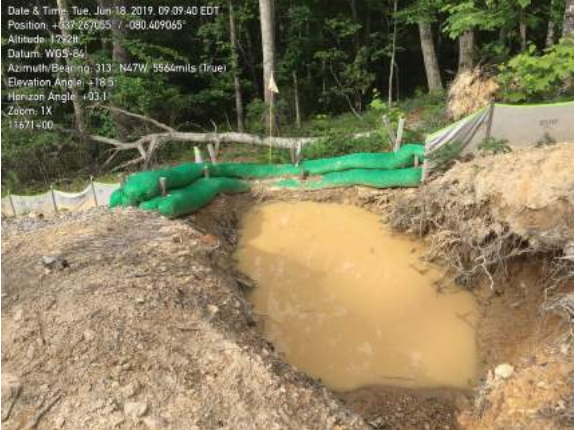
GPS Location	37.18	Field Station#	11671+00	GPS Location	37.18	Field Station#	11673+00
Description	See photo for GPS location. Sump pit and water bar end treatment in place.			Description	See photo for GPS location. Rock lined channel in place over two tone.		
<p>Date & Time: Tue, Jun 18, 2019, 09:21:08 EDT Position: +037.295689° / -080.391277° Altitude: 2474ft Datum: WGS-84 Azimuth/Bearing: 324° N36W 5760mils (True) Elevation Angle: +21.3° Horizon Angle: +04.5° Zoom: 1X 11687+00 S-MN21</p>

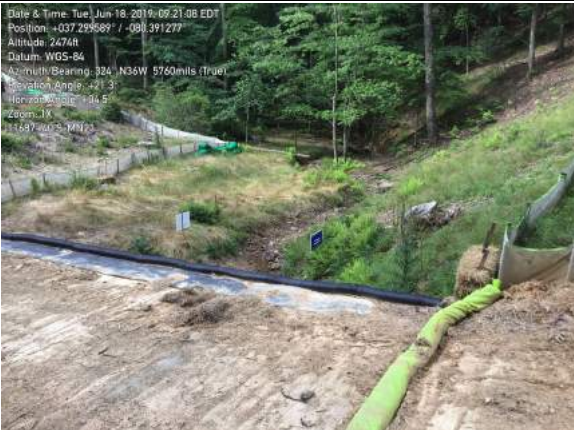
GPS Location	37.18	Field Station#	11687+40	GPS Location	37.18	Field Station#	11743+97
Description	See photo for GPS location. Stream bed with stream bank ECDs in place at S-MN21.			Description	See photo for GPS location. Sensitive resource buffer in place at stream S-EF65.		
<p>Date & Time: Tue, Jun 18, 2019, 10:06:56 EDT Position: +037.296197° / -080.367635° Altitude: 1990ft Datum: WGS-84 Azimuth/Bearing: 022° N22E 0391mils (True) Elevation Angle: +20.4° Horizon Angle: +03.4° Zoom: 1X 11767+00</p>

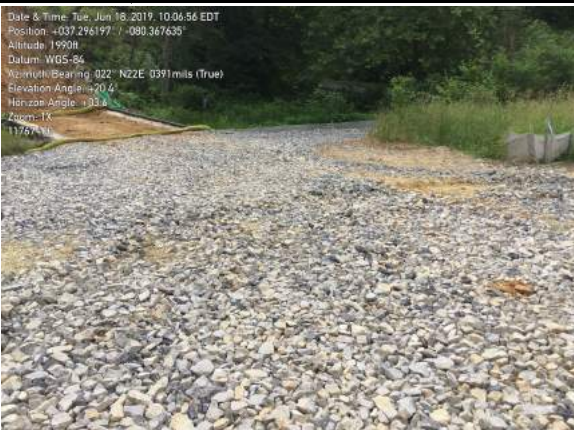
GPS Location	37.18	Field Station#	11767+00	GPS Location	37.18	Field Station#	11776+00
Description	See photo for GPS location. RCE in place at Main Line Valve 26.			Description	See photo for GPS location. Clean water diversion pipe and plunge pool in place.

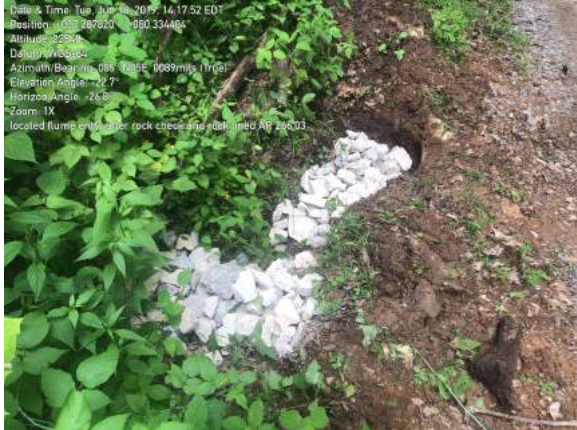
A/E	124300137	Date/Time	6/18/2019 5:00 PM	Report #	18874		
Pictures							
<div><div><div>Date & Time: Tue, Jun 18, 2019, 14:17:52 EDT Position: +037.287622° / +080.334484° Altitude: 2189ft Datum: WGS-84 Azimuth/Bearing: 042° N42E 1102mils (True) Elevation Angle: -22.7° Horizon Angle: -26.8° Zoom: 1X located flume on top of rock check and rock lined AR 266.03</div>

</div></div>				
GPS Location	37.32	Field Station#	11900+00	GPS Location	37.32	Field Station#	11903+75
Description	Previously unknown flume on AR 266.03 after exposing and installing a rock check and lining inlet with stone.			Description	Sediment removed from CFS.

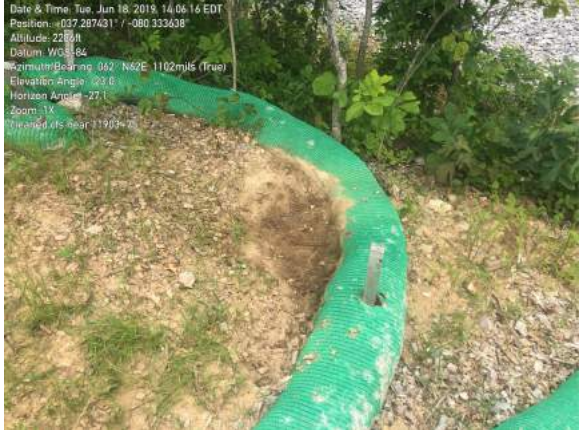
</div></div>			<div><div><div>Date & Time: Tue, Jun 18, 2019, 14:06:16 EDT Position: +037.287431° / +080.333638° Altitude: 2189ft Datum: WGS-84 Azimuth/Bearing: 042° N42E 1102mils (True) Elevation Angle: -23.8° Horizon Angle: -27.1° Zoom: 1X located CFS near 11903+75</div>

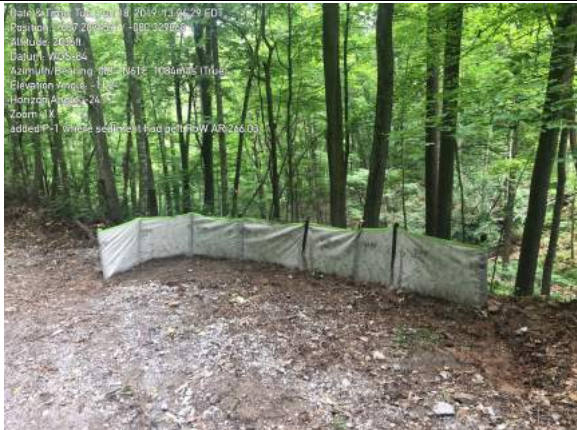
<div><div><div>Date & Time: Tue, Jun 18, 2019, 13:56:29 EDT Position: +037.286622° / +080.334422° Altitude: 2189ft Datum: WGS-84 Azimuth/Bearing: 042° N42E 1102mils (True) Elevation Angle: -11.5° Horizon Angle: -24.8° Zoom: 1X added P-1 where sediment had been on AR 266.03</div>

</div></div>				
GPS Location	37.32	Field Station#	11900+00	GPS Location	37.32	Field Station#	11892+00
Description	P-1 installed on AR 266.03 where sediment was washed off access RoW on VA-MO-5530.			Description	Vegetation lacking in travel lane.		
<div><div><div>Date & Time: Tue, Jun 18, 2019, 10:42:23 EDT Position: +037.285622° / +080.344221° Altitude: 2189ft Datum: WGS-84 Azimuth/Bearing: 028° N28E 0498mils (True) Elevation Angle: -08.4° Horizon Angle: -23.0° Zoom: 1X P-KL-2 11863+60</div>

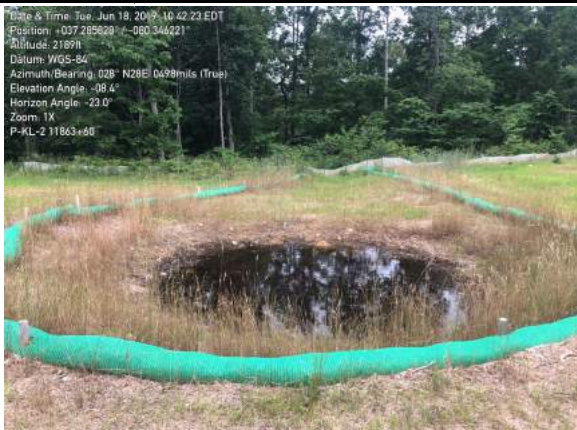
GPS Location	37.32	Field Station#	11863+60	GPS Location	37.32	Field Station#	11792+40
Description	P-KL-2.			Description	Section of RoW where un-used wash station was removed and the RoW restored.

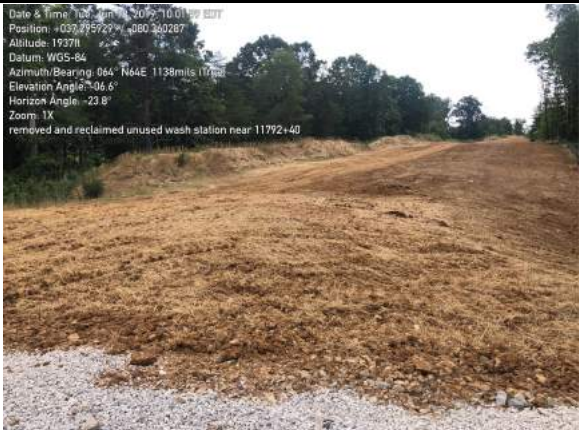
</div></div>			<div><div><div>Date & Time: Tue, Jun 18, 2019, 10:01:59 EDT Position: +037.275722° / +080.360287° Altitude: 1937ft Datum: WGS-84 Azimuth/Bearing: 064° N46E 1138mils (True) Elevation Angle: -06.6° Horizon Angle: -23.8° Zoom: 1X removed and reclaimed unused wash station near 11792+40</div>

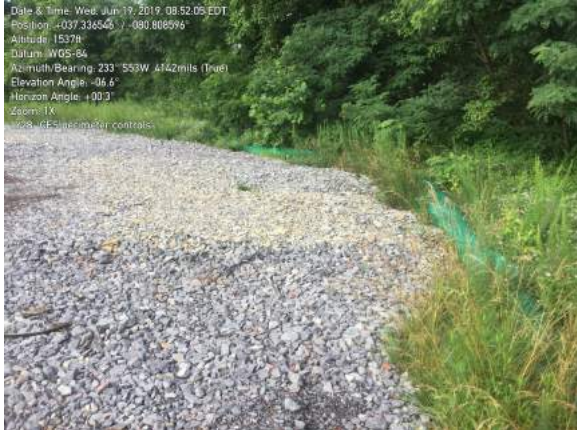
A/E	124300137	Date/Time	6/19/2019 7:43 AM	Report #	18900		
Pictures							
<div><div><div>Date & Time: Wed, Jun 19, 2019, 08:52:05 EDT Position: +037.33655 / -080.806596 Altitude: 1537ft Datum: WGS-84 Azimuth/Bearing: 233° 53'W 4142mils (True) Elevation Angle: -06.6° Horizon Angle: +00.3° Zoom: 1X LY-28- CFS perimeter controls</div>

</div></div>				
GPS Location	37.33	Field Station#	12005+00	GPS Location	37.33	Field Station#	12005+00
Description	LY28- Northern portion of the yard - CFS perimeter controls			Description	LY-28- Northern portion of the yard- RCE is maintained in acceptable condition.		
<div><div><div>Date & Time: Wed, Jun 19, 2019, 09:13:01 EDT Position: +037.336103 / -080.806334 Altitude: 1539ft Datum: WGS-84 Azimuth/Bearing: 233° 53'W 4142mils (True) Elevation Angle: -06.6° Horizon Angle: +01.6° Zoom: 1X LY-28- Northern portion of the yard- Precision personnel carrier buses, four of seven buses have secondary containment units under motors.</div> </div></div>			<div><div><div>Date & Time: Wed, Jun 19, 2019, 09:13:01 EDT Position: +037.336103 / -080.806334 Altitude: 1539ft Datum: WGS-84 Azimuth/Bearing: 233° 53'W 4142mils (True) Elevation Angle: -06.6° Horizon Angle: +00.3° Zoom: 1X LY-28- Southern portion of the yard- CFS controls bordering the forklift road along goal posts are maintained</div>

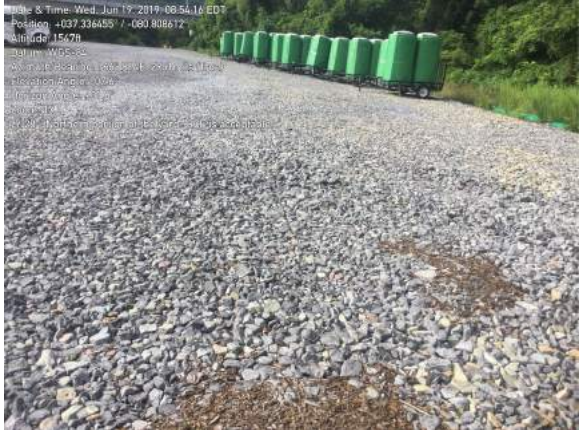
</div></div>			<div><div><div>Date & Time: Wed, Jun 19, 2019, 08:54:16 EDT Position: +037.33655 / -080.806612 Altitude: 1537ft Datum: WGS-84 Azimuth/Bearing: 233° 53'W 4142mils (True) Elevation Angle: -06.6° Horizon Angle: +00.3° Zoom: 1X LY-28- CFS perimeter controls</div>

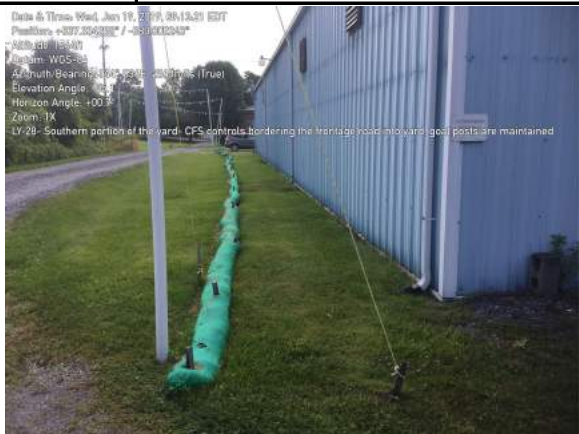
GPS Location	37.33	Field Station#	12005+00	GPS Location	37.33	Field Station#	12005+00
Description	LY-28-Northern portion of the yard-Personnel carriers, four of seven buses have secondary containment units under motors.			Description	LY-28-Southern portion of the yard- CFS bordering access road- goal posts are maintained in acceptable condition.		
<div><div><div>Date & Time: Wed, Jun 19, 2019, 09:13:01 EDT Position: +037.334204 / -080.806334 Altitude: 1539ft Datum: WGS-84 Azimuth/Bearing: 286° 10'W 4150mils (True) Elevation Angle: -06.6° Horizon Angle: +00.4° Zoom: 1X LY-28- Southern portion of the yard- Pipe fitting storage- Did not observe fluid leaks at time of inspection.</div>

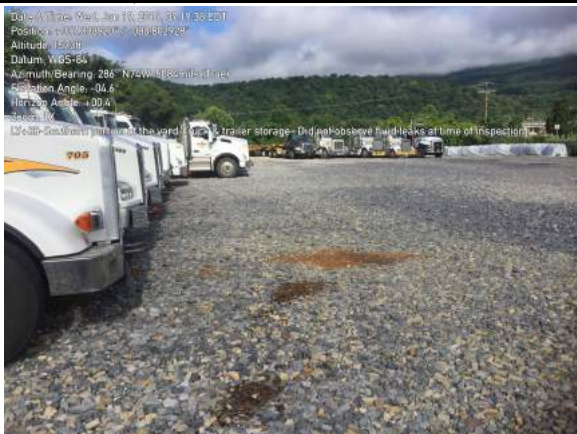
GPS Location	37.33	Field Station#	12005+00	GPS Location	37.33	Field Station#	12005+00
Description	LY-28- Southern portion of the yard- Truck & trailer storage- No fluid leaks observed at the time of inspection.			Description	LY-28- Pipe fittings have been covered to protect coating.

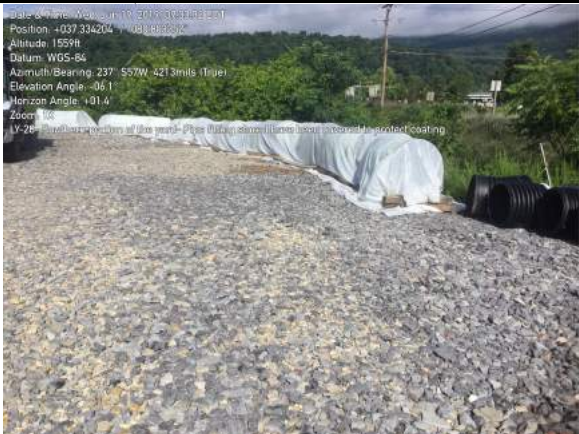
</div></div>			<div><div><div>Date & Time: Wed, Jun 19, 2019, 09:13:01 EDT Position: +037.334204 / -080.806334 Altitude: 1539ft Datum: WGS-84 Azimuth/Bearing: 237° 55'W 4213mils (True) Elevation Angle: -06.1° Horizon Angle: +01.4° Zoom: 1X LY-28- Southern portion of the yard- Pipe fittings have been covered to protect coating</div>

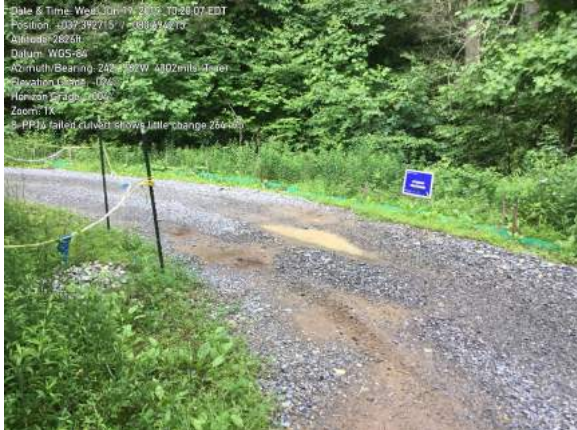
<p>Date & Time: Wed, Jun 19, 2019, 10:24:07 EDT Position: 43°37'39.215" N / 76°03'41.17" W Altitude: 2686ft Datum: WGS-84 Azimuth/Bearing: 248° 15' 31" W 4302mils (True) Elevation Grade: 105° Horizontal Grade: 100° Zoom: 1X Pocahontas Rd ECD crossing shows little change 264+60</p>

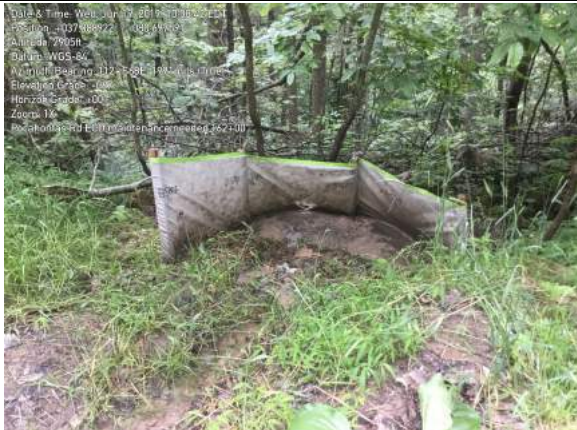
<p>Date & Time: Wed, Jun 19, 2019, 10:22:00 EDT Position: 43°37'39.215" N / 76°03'41.17" W Altitude: 2686ft Datum: WGS-84 Azimuth/Bearing: 248° 15' 31" W 4302mils (True) Elevation Grade: 105° Horizontal Grade: 100° Zoom: 1X Pocahontas Rd ECD crossing shows little change 264+60</p>					
GPS Location	37.31	Field Station#	264+75	GPS Location	37.31	Field Station#	253+60
Description	No change at site of failed culvert on Pocahontas Road S-PP14 crossing.			Description	Waterbars and end treatments in need of maintenance. Awaiting Forest Service approval.

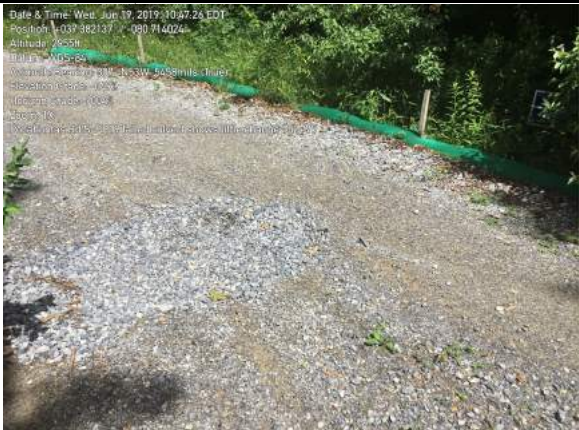
<p>Date & Time: Wed, Jun 19, 2019, 10:47:26 EDT Position: 43°37'38.1565" N / 76°03'41.1535" W Altitude: 2607ft Datum: WGS-84 Azimuth/Bearing: 217° 50' 58" E 311mils (True) Elevation Grade: 104° Horizontal Grade: 100° Zoom: 1X Pocahontas Rd ECD maintenance needed 161+50</p>

GPS Location	37.31	Field Station#	161+50	GPS Location	37.31	Field Station#	152+75
Description	End treatment worn.			Description	Failed culvert at the S-PP19 crossing shows no change.

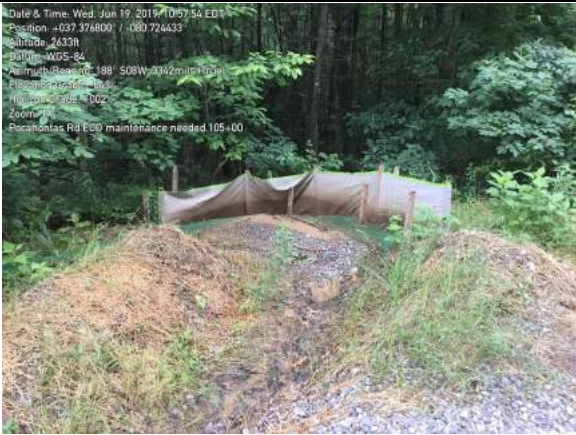
GPS Location	37.31	Field Station#	145+00	GPS Location	37.31
Description	Runoff channeling on road surface in several areas.		Description	Sediment deposits at worn end treatment.	
<small>Date & Time: Wed, Jun 19, 2019, 10:57:54 EDT Position: +037.374800° / -080.724433° Altitude: 2433ft Datum: WGS-84 Azimuth/Bearing: 198° 50'8W 4392m (True) Elevation Grade: +004% Horizon Grade: +102% Zoom: 1X Pocahontas Rd ECD maintenance needed 105+00</small>

GPS Location	37.38	Field Station#	105+00	GPS Location	
Description	Sediment and rock deposits in end treatment.		Description		
Insert image here			Insert image here		
GPS Location		Field Station#		GPS Location	
Description			Description

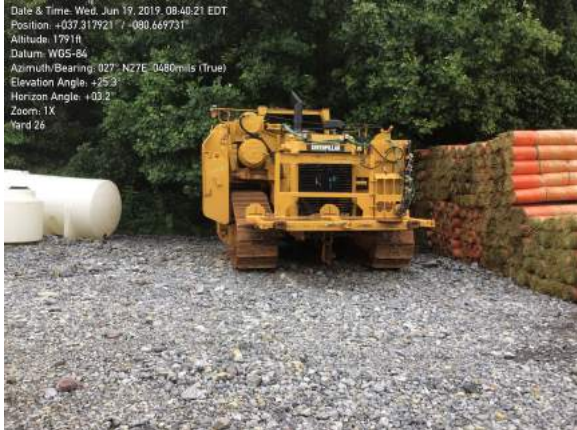
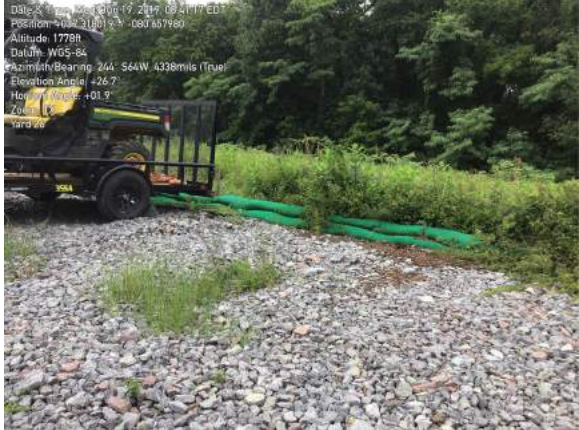
Date & Time: Wed, Jun 19, 2019, 08:40:21 EDT Position: +037.317921° / -080.669731° Altitude: 1797ft Datum: WGS-84 Azimuth/Bearing: 027° N27E 0480mils (True) Elevation Angle: +25.3° Horizon Angle: +03.2° Zoom: 1X Yard 26		Date & Time: Wed, Jun 19, 2019, 08:41:17 EDT Position: +037.318011° / -080.657980° Altitude: 1778ft Datum: WGS-84 Azimuth/Bearing: 264° S64W 4330mils (True) Elevation Angle: +26.7° Horizon Angle: +01.9° Zoom: 1X Yard 26					
GPS Location	37.18	Field Station#	12005+00	GPS Location	37.18	Field Station#	12005+00
Description	See photo for GPS location. No leaks observed around equipment.			Description	See photo for GPS location. Triple stack 12 inch compost filter sock in place.

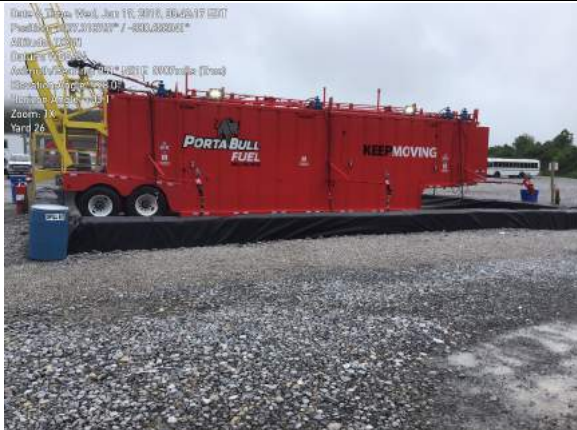
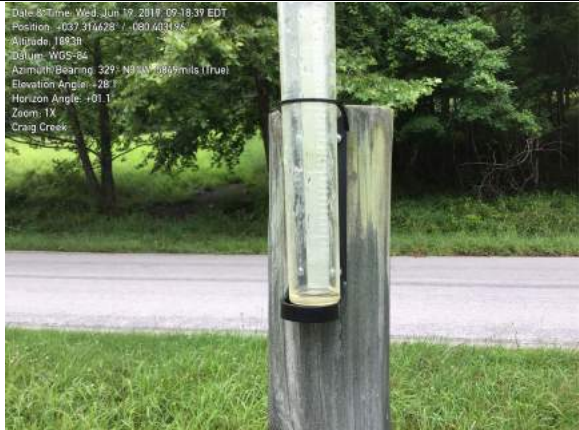
Date & Time: Wed, Jun 19, 2019, 09:04:17 EDT Position: +037.316202° / -080.668961° Altitude: 1630ft Datum: WGS-84 Azimuth/Bearing: 329° N29W 8899mils (True) Elevation Angle: +28.1° Horizon Angle: +01.1° Zoom: 1X Yard 26		Date & Time: Wed, Jun 19, 2019, 09:18:39 EDT Position: +037.314428° / -080.403195° Altitude: 1683ft Datum: WGS-84 Azimuth/Bearing: 329° N29W 8899mils (True) Elevation Angle: +28.1° Horizon Angle: +01.1° Zoom: 1X Craig Creek

GPS Location	37.18	Field Station#	12005+00	GPS Location	37.18	Field Station#	11613+00
Description	See photo for GPS location. Secondary containment in place at fuel cell.			Description	See photo for GPS location. Rain gauge at Craig Creek Road.

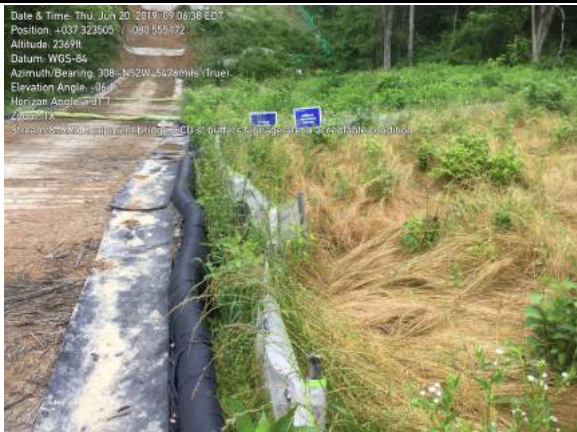
A/E	124300137	Date/Time	6/20/2019 7:37 AM	Report #	18950		
Pictures							
<p>Date & Time: Thu, Jun 20, 2019, 08:37:37 EDT Position: +037.317165 / -089.553850 Altitude: 1862ft Datum: WGS-84 Azimuth/Bearing: 291° N69W 517mils (true) Elevation Angle: -04.6° Horizon Angle: +02.3° Zoom: 1X AR-244 rain gauge reading: 0.20</p>  		<p>Date & Time: Thu, Jun 20, 2019, 08:53:49 EDT Position: +037.321620 / -089.552937 Altitude: 2330ft Datum: WGS-84 Azimuth/Bearing: 321° N39W 5707mils (true) Elevation Angle: -06.4° Horizon Angle: +01.6° Zoom: 1X Stream S-IJ18- Equipment bridge, ECD's, signage are in acceptable condition.</p>  					
GPS Location	37.32	Field Station#	11022+00	GPS Location	37.32	Field Station#	11022+00
Description	AR-244- Rain gauge reading-0.20"			Description	Stream S-IJ18- Equipment bridge, ECD's, signage are in acceptable condition.		
<p>Date & Time: Thu, Jun 20, 2019, 09:09:38 EDT Position: +037.323605 / -089.555172 Altitude: 2369ft Datum: WGS-84 Azimuth/Bearing: 308° N52W 5476mils (true) Elevation Angle: -05.6° Horizon Angle: +01.7° Zoom: 1X Stream S-RR5- Equipment bridge, ECD's, buffers, signage are in acceptable condition.</p>

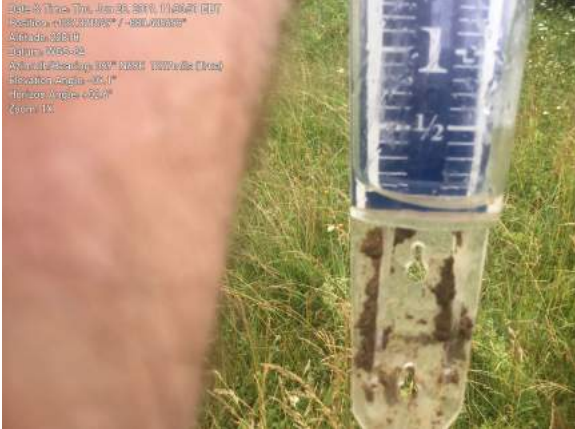
GPS Location	37.32	Field Station#	10947+00	GPS Location	37.32
Description	Contractor replaced damaged P1, caused by landowner grazing row.		Description	Steel Acres rain gauge reading- 0.10"	
Insert image here			Insert image here		
GPS Location		Field Station#		GPS Location

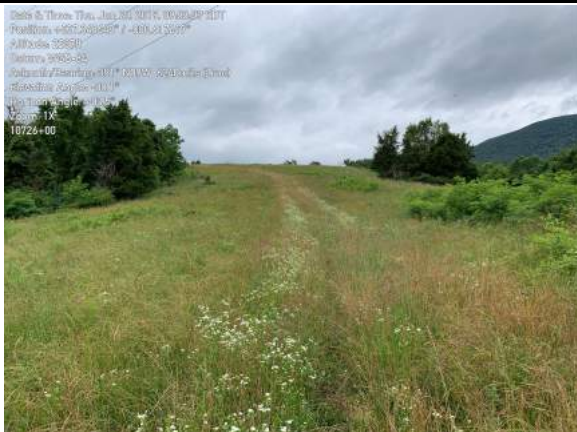
GPS Location	37.31	Field Station#	10726+00	GPS Location	37.31	Field Station#	10696+00
Description	See photo for GPS location. ROW stabilized with natural vegetation.			Description	See photo for GPS location. RCE in place at Buffalo Anklets Road.

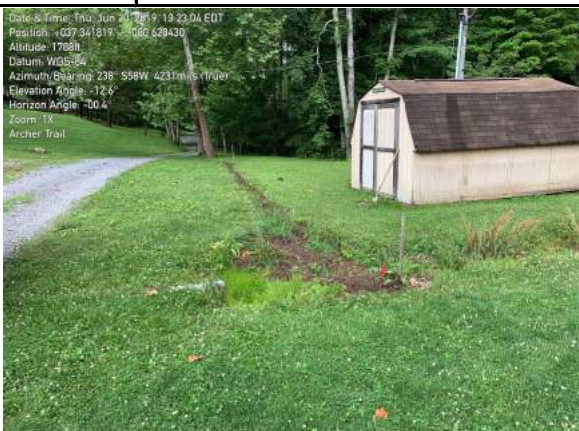
Date & Time: Thu, Jun 20, 2019 10:53:24 EDT Position: +037.347085°W -080.552789°W Altitude: 2067ft Datum: WGS84 Azimuth/Bearing: 145° W 321mils (true) Elevation Angle: -10.4° Horizon Angle: -10.4° Zoom: 1X 10696+00			Date & Time: Thu, Jun 20, 2019 10:53:04 EDT Position: +037.341819°W -080.528430°W Altitude: 1763ft Datum: WGS84 Azimuth/Bearing: 238° 558W 4231mils (true) Elevation Angle: -12.4° Horizon Angle: -00.4° Zoom: 1X Archer Trail				
GPS Location	37.31	Field Station#	10696+00	GPS Location	37.31	Field Station#	10832+00
Description	See photo for GPS location. Rain gauge at Buffalo Anklets Road reads 1 inch.			Description	See photo for GPS location. CFS removed.

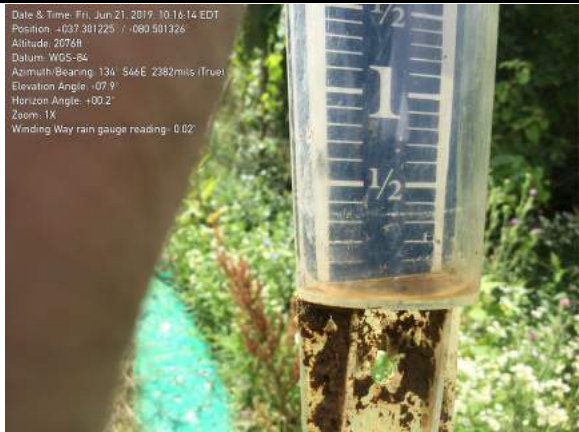
GPS Location	37.32	Field Station#	11475+00	GPS Location	37.30
Description	Slope drains & two tone side slope are stable, inlet stone on slope drains need to be refreshed		Description	Winding Way rain gauge reading- 0.02"

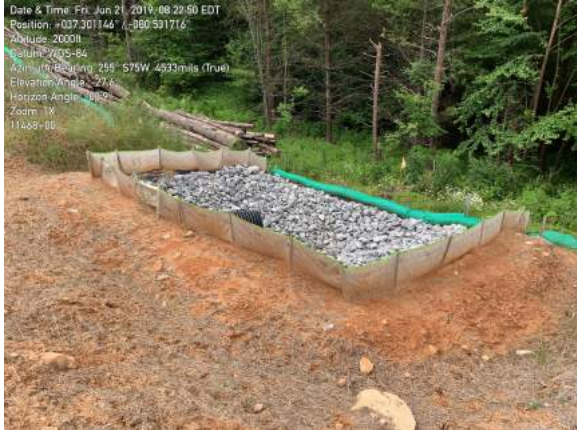
GPS Location	37.18	Field Station#	11468+00	GPS Location	37.18	Field Station#	11465+00
Description	See photo for GPS location. Plunge pool in place.			Description	See photo for GPS location. Slope drain in place over fill slope. Priority one silt fence end treatment in place.		
<p>Date & Time: Fri, Jun 21, 2019, 08:25:30 EDT Position: +037.319797° / -080.531248° Altitude: 1777ft Datum: WGS-84 Azimuth/Bearing: 224° S44W 3982mils (True) Elevation Angle: -11.8° Horizon Angle: -02.3° Zoom: 1X 11451+00 S-0012 & S-0013</p>

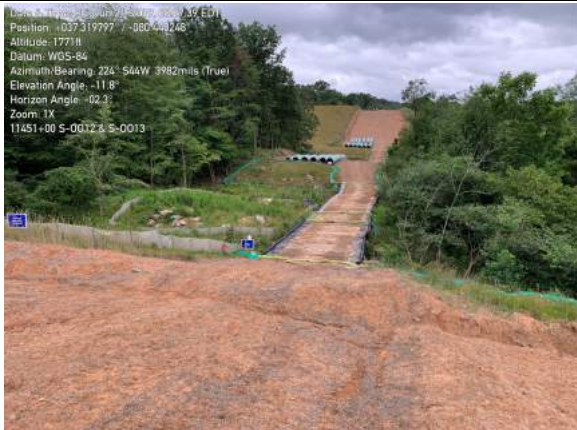
GPS Location	37.18	Field Station#	11451+00	GPS Location	37.18	Field Station#	11432+00
Description	See photo for GPS location. Sensitive resource buffer in place at streams S-0012 & S-0013.			Description	See photo for GPS location. Waterbar in place.		
<p>Date & Time: Fri, Jun 21, 2019, 08:44:58 EDT Position: +037.310633° / -080.453704° Altitude: 1746ft Datum: WGS-84 Azimuth/Bearing: 323° N37W 5742mils (True) Elevation Angle: -29.0° Horizon Angle: +03.6° Zoom: 1X 11401+00</p>

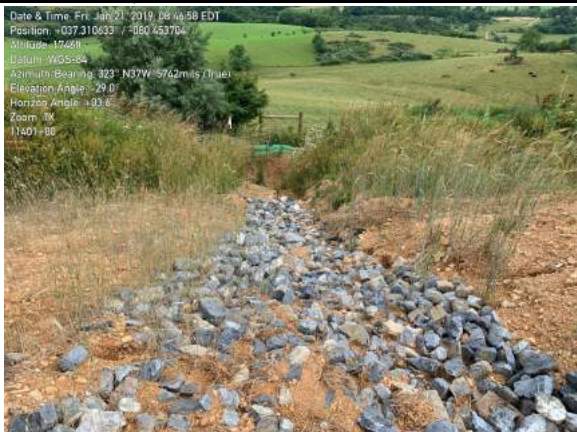
GPS Location	37.18	Field Station#	11401+00	GPS Location	37.18	Field Station#	11381+00
Description	See photo for GPS location. Rock lined channel in place over fill slope.			Description	See photo for GPS location. Triple barrier ECDs in place at off ROW karst feature.

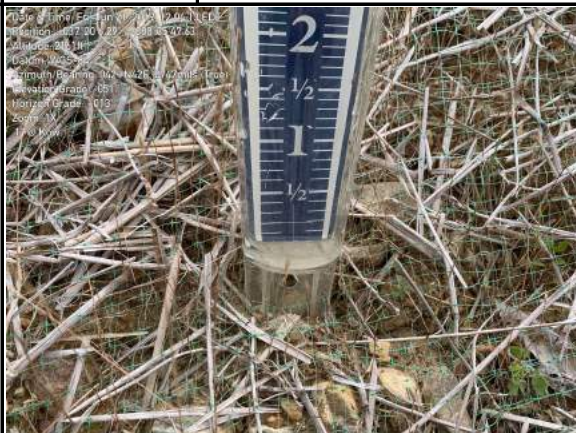
</div>			
GPS Location		37.24	Field Station#		11143+00		
Description		ECD's and row conditions					
GPS Location		37.24	Field Station#		2+40		
Description		.05" of rain collected
