Visual Site Inspection Report

Project Name	H-600 Pipeline Spread G	AFE	124300137	Spread	H-600 Pipeline Spread G
Contractor	Precision			Report #	20284
Inspector	Len Kruizenga			Date/Time	7/15/2019 9:20 AM
Permit #	TBD	Inspection Type	VA SWPP	Station Begin	11161+00
State	VA	Inspection Area	Full	Station End	11354+00
County	Giles	Ground	Damp	Temperature (°F)	85.00
Municipality	N/A	Weather	Cloudy	Rain Gauge (in)	0.00
				Rain Accumulation Time (days)	4.00

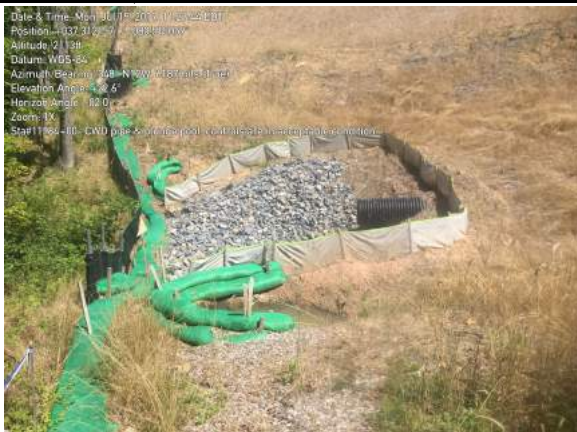
<p>Date & Time: Mon, Jul 15, 2019, 11:37:38 EDT Position: +037 309235 / -090 515205 Altitude: 1699ft Datum: WGS-84 Azimuth/Bearing: 026° N26W 526/mid-Midst Elevation Angle: +13° Horizon Angle: -92° Zoom: 1X Sta#1117270- Slope drain, CFS checks, end treatment are in acceptable condition.</p>

GPS Location	37.30	Field Station#	11184+00	GPS Location	37.30	Field Station#	1117270-
Pic 5 Description	CWD pipe & plunge pool, controls are in acceptable condition			Pic 6 Description	Slope drain, CFS checks, end treatment are in good condition.

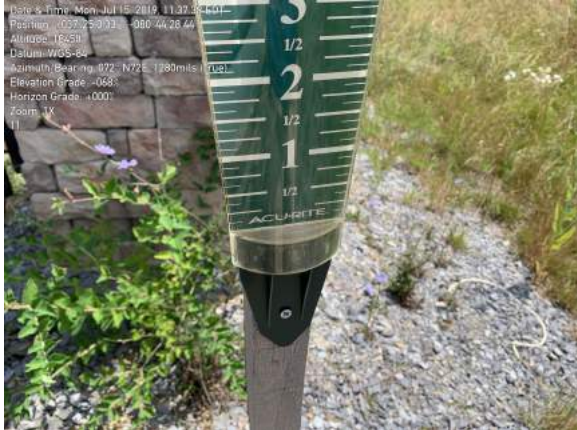
GPS Location	37.24	Field Station#	+37	GPS Location	37.24	Field Station#	+37
Pic 1 Description	No rain recorded			Pic 2 Description	ECD's and row conditions

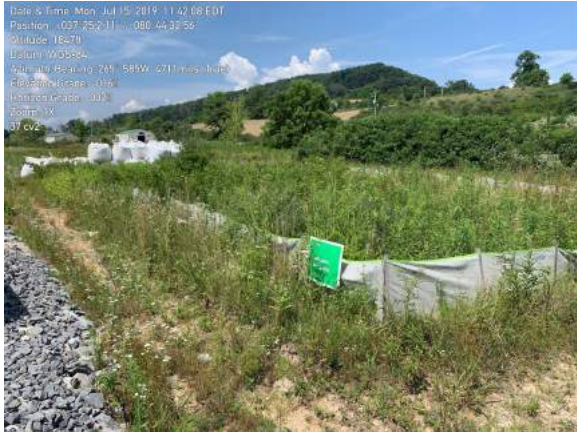
GPS Location	37.24	Field Station#	+37	GPS Location	37.24	Field Station#	+37
Pic 3 Description	ECD's and row conditions			Pic 4 Description	ECD's and row conditions

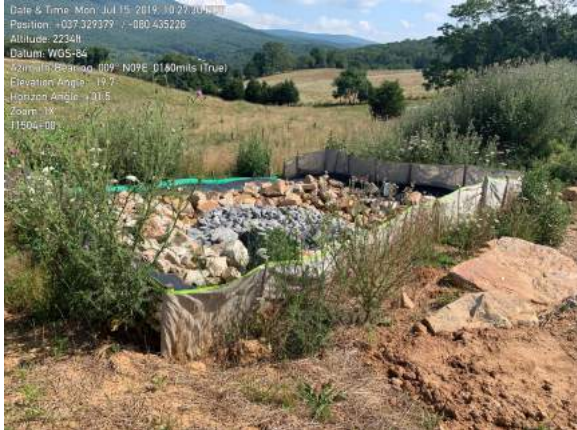
<p>Date & Time: Mon Jul 15, 2019, 10:27:00 EDT Position: +037.329379 / -080.435226 Altitude: 2234ft Datum: WGS-84 Azimuth/Bearing: 402° N09E 0180mils (True) Elevation Angle: -19.7 Horizon Angle: -01.5 Zoom: 1X 11504+00</p>

<p>Date & Time: Mon Jul 15, 2019, 10:27:00 EDT Position: +037.325720 / -080.427476 Altitude: 2227ft Datum: WGS-84 Azimuth/Bearing: 062° N62E 1102mils (True) Elevation Angle: -23.5 Horizon Angle: -02.8 Zoom: 1X 11501+00</p>				
GPS Location	37.18	Field Station#	11504+00	GPS Location	37.18	Field Station#	11501+00
Pic 1 Description	See photo for GPS location. Plunge pool in place.			Pic 2 Description	See photo for GPS location. Conveyance channel with rock checks in place.

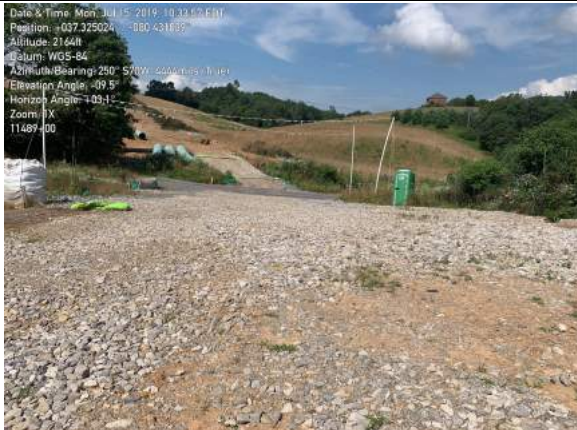
<p>Date & Time: Mon Jul 15, 2019, 10:33:00 EDT Position: +037.325024 / -080.431137 Altitude: 2164ft Datum: WGS-84 Azimuth/Bearing: 250° S70W 244mils (True) Elevation Angle: -09.5 Horizon Angle: -03.1 Zoom: 1X 11489+00</p>

GPS Location	37.18	Field Station#	11489+00	GPS Location	37.18	Field Station#	11476+00
Pic 3 Description	See photo for GPS location. RCE in place at Stevers Gap Road.			Pic 4 Description	See photo for GPS location. Slope drain with rock outlet in place over two tone.

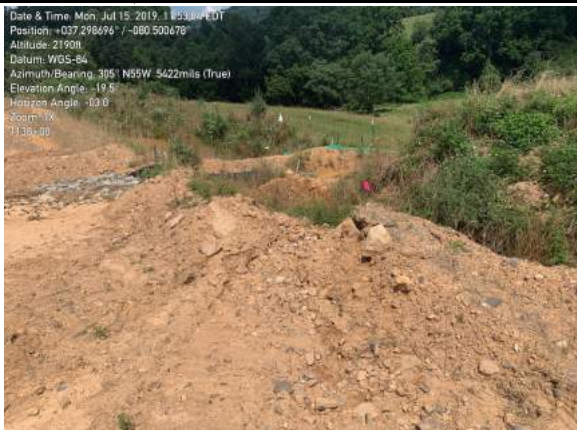
<p>Date & Time: Mon Jul 15, 2019, 11:33:00 EDT Position: +037.298699 / -080.500676 Altitude: 2190ft Datum: WGS-84 Azimuth/Bearing: 305° N55W 5422mils (True) Elevation Angle: -19.5 Horizon Angle: -03.0 Zoom: 1X 11382+00</p>

<p>Date & Time: Mon Jul 15, 2019, 12:02:06 EDT Position: +037.309231 / -080.466636 Altitude: 1988ft Datum: WGS-84 Azimuth/Bearing: 256° S74W 4551mils (True) Elevation Angle: -17.1 Horizon Angle: -15.0 Zoom: 1X 11363+00</p>				
GPS Location	37.18	Field Station#	11382+00	GPS Location	37.18	Field Station#	11363+00
Pic 5 Description	See photo for GPS location. Earthen berm breached. Item added to punchlist.			Pic 6 Description	See photo for GPS location. CFS overtopped with sediment resulting in sediment off ROW.

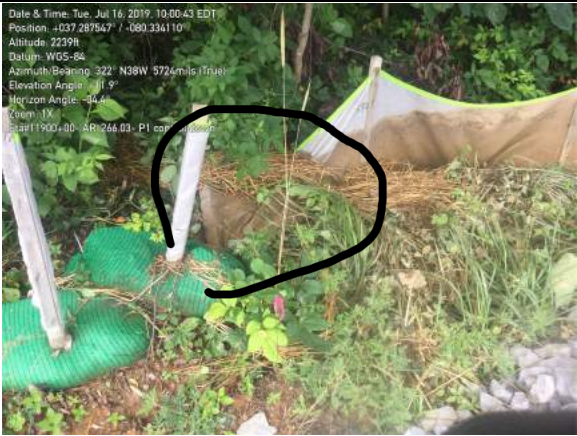
GPS Location	37.26	Field Station#	11989+00	GPS Location	37.28	Field Station#	11900+00
Pic 1 Description	Catawba rain gauge reading-2.20"			Pic 2 Description	P1 controls is down.		
<p>Date & Time: Tue, Jul 16, 2019, 10:13:13 EDT Position: +037.287901° / -090.334092° Altitude: 2242ft Datum: WGS-84 Azimuth/Bearing: 336° N38E 0440mils (True) Elevation Angle: -11.5° Horizon Angle: -02.7° Zoom: 1X AR-266.03 - Sediment over top of water bar outlet protection, sediment off row.</p>

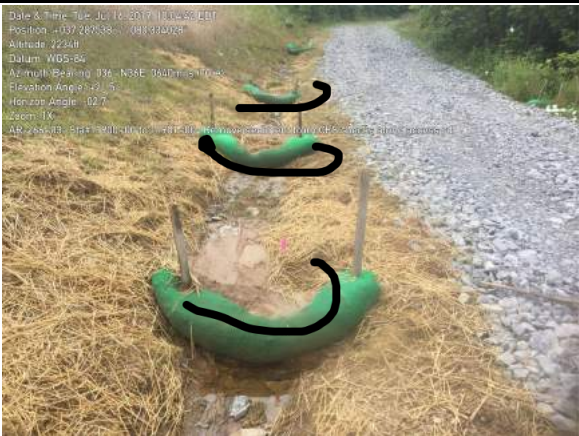
<p>Date & Time: Tue, Jul 16, 2019, 10:13:13 EDT Position: +037.287901° / -090.334092° Altitude: 2242ft Datum: WGS-84 Azimuth/Bearing: 336° N38E 0440mils (True) Elevation Angle: -11.5° Horizon Angle: -02.7° Zoom: 1X AR-266.03 - Sediment over top of water bar outlet protection, sediment off row.</p>

GPS Location	37.28	Field Station#	11900+50	GPS Location	37.28	Field Station#	11901+00
Pic 3 Description	AR- 266.03 - Remove sediment from CFS checks beside access rd.			Pic 4 Description	Sediment over top of water bar out protection, sediment off row.		
<p>Date & Time: Tue, Jul 16, 2019, 10:17:05 EDT Position: +037.287955° / -090.334090° Altitude: 2245ft Datum: WGS-84 Azimuth/Bearing: 341° N34W 5329mils (True) Elevation Angle: -02.5° Horizon Angle: -02.6° Zoom: 1X Sediment over top of water bar outlet protection, sediment off row.</p>

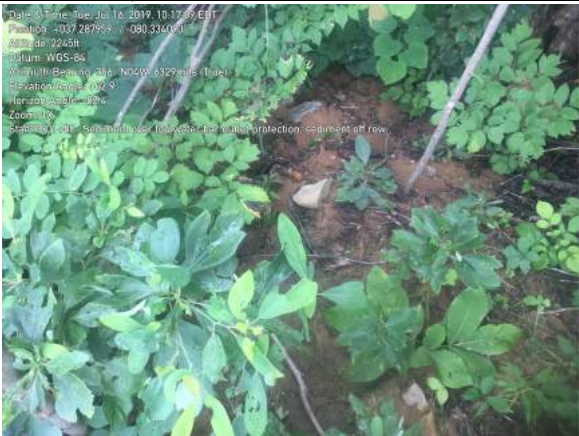
Pic 5 Description	Sediment off row, over top of water bar outlet protection.			Pic 6 Description	Sta#11900+00 to 11904+00- Remove sediment from all CFS perimeter controls & sock crossing row.

<p>Date & Time: Tue, Jul 16, 2019, 10:39:12 EDT Position: +037.287297° / -090.333281° Altitude: 2780ft Datum: WGS-84 Azimuth/Bearing: 330° N30W 5867mils (True) Elevation Angle: -07.6° Horizon Angle: -02.0° Zoom: 1X Sta#11904+00 to 11900+00 - Remove sediment from all CFS perimeter controls & sock crossing row.</p>

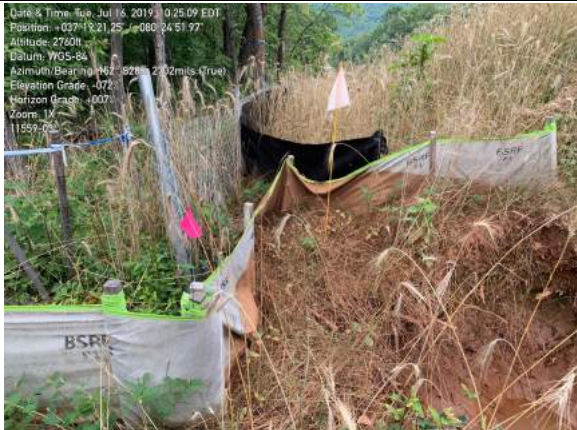
GPS Location	37.24	Field Station#	11559+03	GPS Location	37.24	Field Station#	11568+00
Pic 3 Description	ECD's and row conditions			Pic 4 Description	ECD's and row conditions PP22		
<div><div>Date & Time: Tue, Jul 16, 2019 11:05:29 EDT</div><div>Position: 037.195644, 36.0243456</div><div>Altitude: 1215ft</div><div>Datum: WGS-84</div><div>Azimuth/Bearing: 167.826W, 2302mils (True)</div><div>Elevation Grade: -098</div><div>Horizon Grade: -009</div><div>Zoom: 1X</div><div>11582+50</div></div>

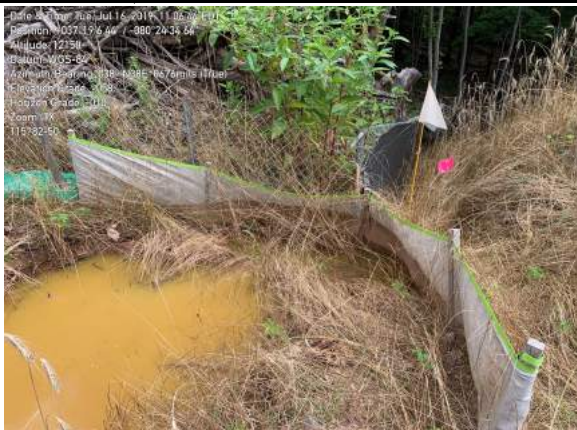
Pic 5 Description	ECD's and row conditions			Pic 6 Description	Crew unloading straw bales

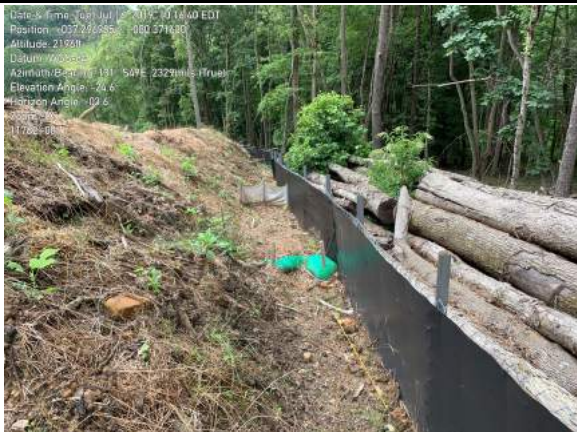
GPS Location	37.18	Field Station#	11778+00	GPS Location	37.18	Field Station#	11687+40
Pic 5 Description	See photo for GPS location. Plunge pool in place.			Pic 6 Description	See photo for GPS location. Sensitive resource buffer in place at stream S-MN21.

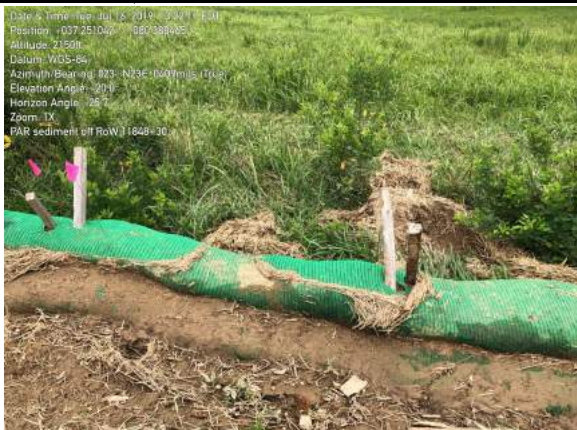
GPS Location	37.32	Field Station#	11848+30	GPS Location	37.32	Field Station#	11869+60
Pic 5 Description	Overtopped triple stack CFS with sediment off RoW.			Pic 6 Description	Overtopped triple stack CFS with sediment off RoW.

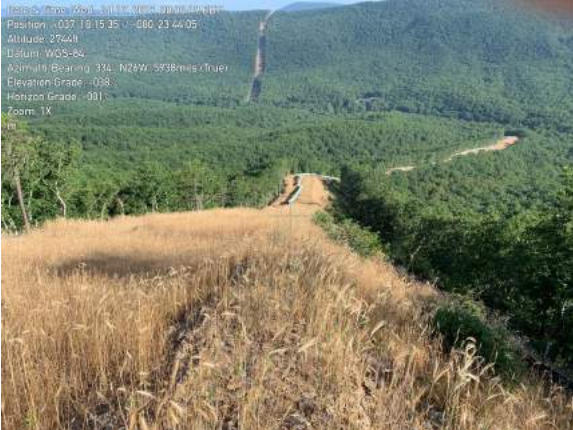
<p>Date & Time: Wed Jul 17 2019 08:02:14 EDT Position: 037.18 15.35 - 080.23 44.05 Altitude: 2764 ft Datum: WGS84 Azimuth Bearing: 334 N24W 5938mils (True) Elevation Grade: -038 Horizon Grade: -031 Zoom: 1X Pic 1</p>

<p>Date & Time: Wed Jul 17 2019 08:02:14 EDT Position: 037.18 50.07 - 080.20 54.57 Altitude: 1120 ft Datum: WGS84 Azimuth Bearing: 190 N30W 3350mils (True) Elevation Grade: -011 Horizon Grade: -003 Zoom: 1X Pic 2</p>					
GPS Location	37.24	Field Station#	11680+00	GPS Location	37.24	Field Station#	11625+00
Pic 1 Description	ECD's and row conditions			Pic 2 Description	ECD's and row conditions HH-18

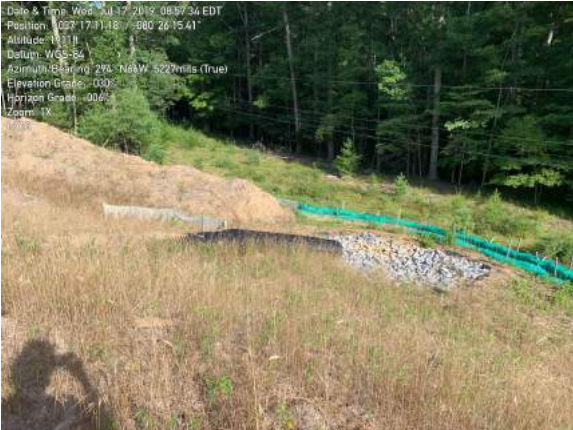
<p>Date & Time: Wed Jul 17 2019 08:07:34 EDT Position: 037.17 11.18 - 080.26 15.41 Altitude: 1511 ft Datum: WGS84 Azimuth Bearing: 294 N44W 5220mils (True) Elevation Grade: -030 Horizon Grade: -026 Zoom: 1X Pic 3</p>

GPS Location	37.24	Field Station#	11620+00	GPS Location	37.24	Field Station#	11617+95
Pic 3 Description	ECD's and row conditions			Pic 4 Description	P1SF undermined

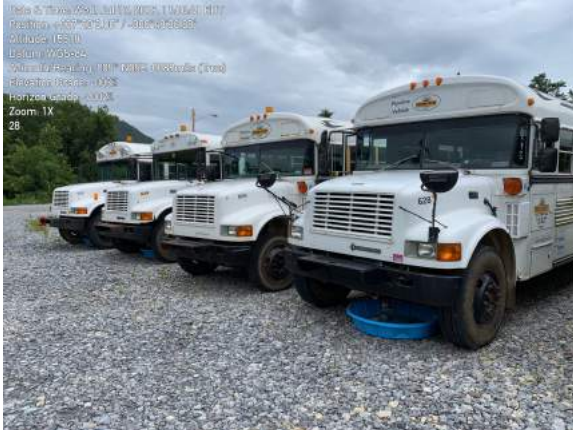
<p>Date & Time: Wed Jul 17 2019 11:20:51 EDT Position: 037.16 52.51 - 080.48 12.12 Altitude: 1830 ft Datum: WGS84 Azimuth Bearing: 111 N44E 16340mils (True) Elevation Grade: -002 Horizon Grade: -002 Zoom: 1X Pic 6</p>					
GPS Location	37.24	Field Station#	+28	GPS Location	37.24	Field Station#	+28
Pic 5 Description	ECD's and row conditions			Pic 6 Description	ECD's and row conditions

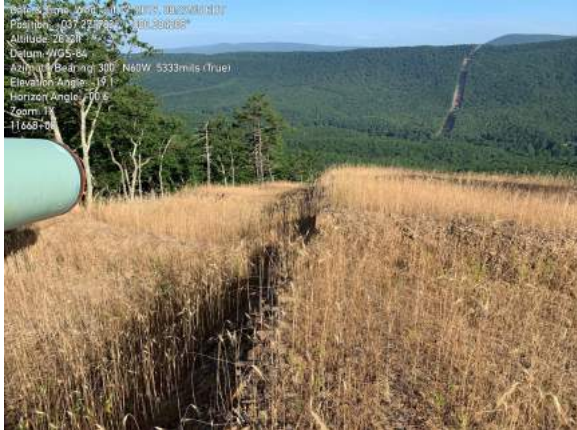
GPS Location	37.18	Field Station#	11668+00	GPS Location	37.18	Field Station#	11654+00
Pic 1 Description	See photo for GPS location. ROW temporarily stabilized.			Pic 2 Description	See photo for GPS location. CFS in place.

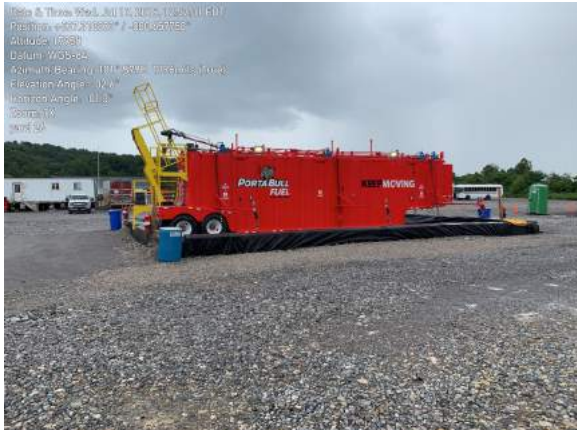
GPS Location	37.18	Field Station#	12005+00	GPS Location	37.18	Field Station#	12005+00
Pic 5 Description	See photo for GPS location. Secondary containment in place around fuel cell.			Pic 6 Description	See photo for GPS location. RCE in place at lay down yard 26.

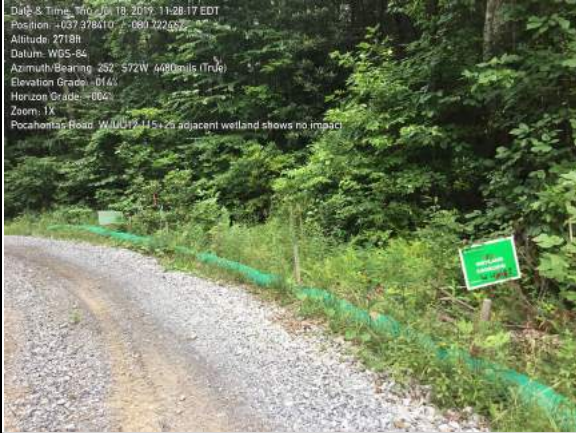
<p> <small> Date & Time: Thu, Jul 18, 2019, 11:28:17 EDT Position: +037.378410, -080.722512 Altitude: 2218ft Datum: WGS-84 Azimuth/Bearing: 252° 57' 2W 490mils (True) Elevation Grade: +014% Horizon Grade: +004% Zoom: 1X Pocahontas Road, WJ0017 H5+25 adjacent wetland shows no impact </small> </p>		
GPS Location 37.31		Field Station# +44		GPS Location 37.31	
Field Station# 115+25					
Pic 7 Description		Wetlands adjacent to the road show no impact.		Pic 8 Description	
				Wetlands adjacent to the road show no signs of impact.

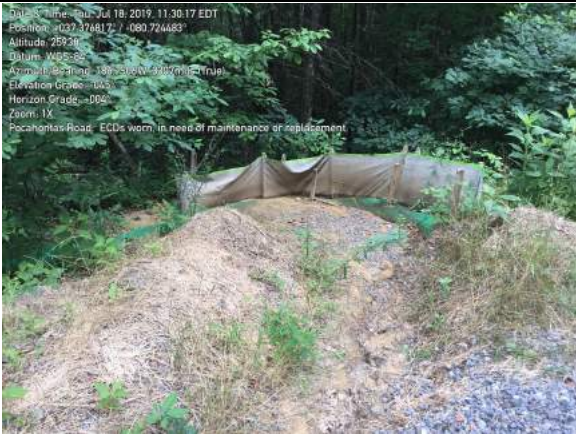
<p> <small> Date & Time: Thu, Jul 18, 2019, 11:30:17 EDT Position: +037.374817, -080.724483 Altitude: 2293ft Datum: WGS-84 Azimuth/Bearing: 189° 53' 16W 500mils (True) Elevation Grade: +04% Horizon Grade: +00% Zoom: 1X Pocahontas Road, ECDs worn in need of maintenance or replacement </small> </p>			Insert image here		
GPS Location 37.31		Field Station# +55		GPS Location	
Field Station#				Field Station#	
Pic 9 Description		ECDs are worn and in need of repair or replacement.		Pic 10 Description	
Insert image here			Insert image here		
GPS Location		Field Station#		GPS Location	
				Field Station#	
Pic 11 Description				Pic 12 Description

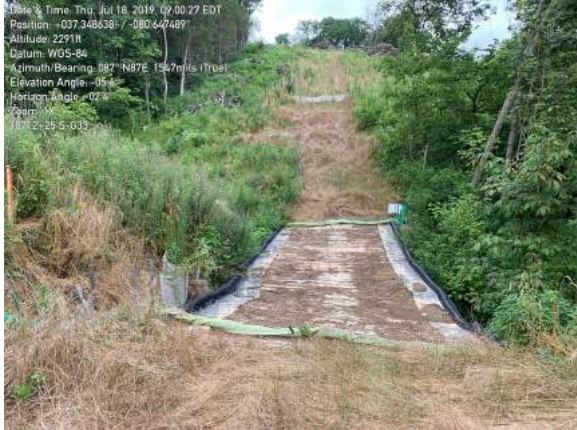
<p>Date & Time: Thu, Jul 18, 2019, 09:00:27 EDT Position: +037.348638° / -080.647489° Altitude: 2221ft Datum: WGS-84 Azimuth/Bearing: 88.7° N87E 1347mils (True) Elevation Angle: -02.6° Horizon Angle: -02.6° Zoom: 1X 10712+00</p>

<p>Date & Time: Thu, Jul 18, 2019, 09:04:54 EDT Position: +037.348638° / -080.647489° Altitude: 2221ft Datum: WGS-84 Azimuth/Bearing: 88.7° N87E 1347mils (True) Elevation Angle: -02.6° Horizon Angle: -02.6° Zoom: 1X 10711+00</p>				
GPS Location	37.18	Field Station#	10712+25	GPS Location	37.18	Field Station#	10711+00
Pic 1 Description	See photo for GPS location. Sensitive resource buffer in place at stream S-G33.			Pic 2 Description	See photo for GPS location. ROW stabilized with natural vegetation.

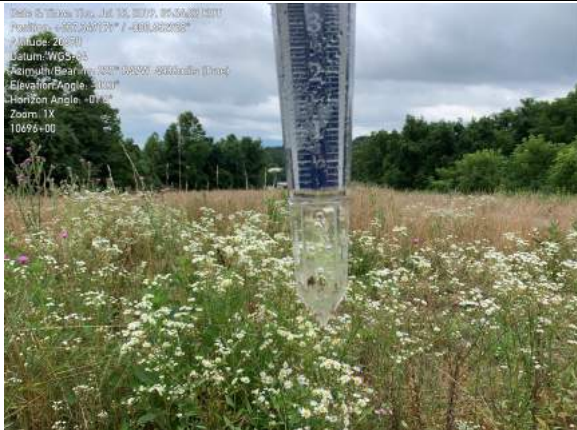
<p>Date & Time: Thu, Jul 18, 2019, 09:04:54 EDT Position: +037.348638° / -080.647489° Altitude: 2069ft Datum: WGS-84 Azimuth/Bearing: 88.7° N87E 1347mils (True) Elevation Angle: -02.6° Horizon Angle: -02.6° Zoom: 1X 10696+00</p>

GPS Location	37.18	Field Station#	10696+00	GPS Location	37.18	Field Station#	10696+00
Pic 3 Description	See photo for GPS location. Rain gauge at Buffalo Anklets Road reads .1 inches.			Pic 4 Description	See photo for GPS location. RCE in place at Buffalo Anklets Road.

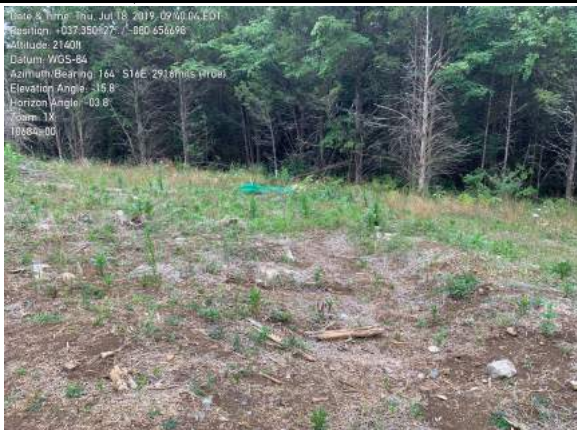
<p>Date & Time: Thu, Jul 18, 2019, 09:00:06 EDT Position: +037.350072° / -080.656696° Altitude: 2160ft Datum: WGS-84 Azimuth/Bearing: 164° S14E 2910mils (True) Elevation Angle: -03.8° Horizon Angle: -03.8° Zoom: 1X 10684+00</p>

<p>Date & Time: Thu, Jul 18, 2019, 09:32:51 EDT Position: +037.350072° / -080.652055° Altitude: 2160ft Datum: WGS-84 Azimuth/Bearing: 263° S63° 58W 4676mils (True) Elevation Angle: -14.5° Horizon Angle: -06.0° Zoom: 1X 10698+00</p>				
GPS Location	37.18	Field Station#	10684+00	GPS Location	37.18	Field Station#	10698+00
Pic 5 Description	See photo for GPS location. Waterbar with triple stack CFS as end treatment.			Pic 6 Description	See photo for GPS location. Triple stack CFS along stream bank.

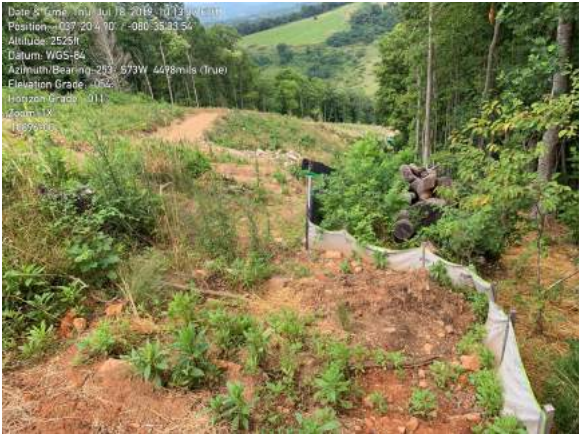
</div></div>					
GPS Location	37.24	Field Station#	10855+00	GPS Location	37.24	Field Station#	1087+55
Pic 1 Description	ECD's and row conditions			Pic 2 Description	ECD's and row conditions		
<div><div><div>Date & Time: Thu, Jul 18, 2019, 10:45:08 EDT Position: +037° 22' 24.60" / -080° 35' 47.6" Altitude: 2163ft Datum: WGS-84 Azimuth/Bearing: 033° 54'E 3052mils (True) Elevation Grade: +00% Horizon Grade: -007 Zoom: 1X 10987</div>

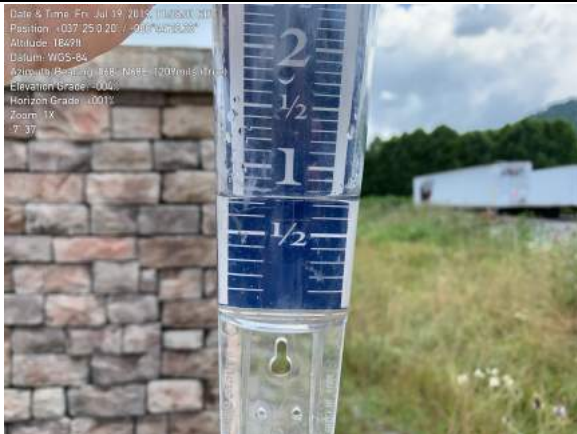
GPS Location	37.24	Field Station#	+37	GPS Location	37.24	Field Station#	11025+00
Pic 1 Description	.7" @ LDY 37			Pic 2 Description	ECD's and row conditions

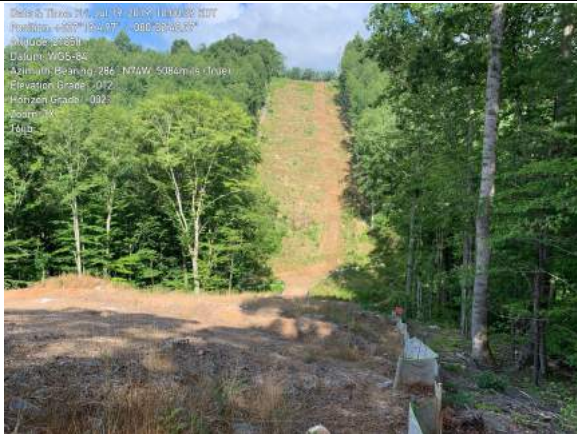
GPS Location	37.24	Field Station#	11049+00	GPS Location	37.24	Field Station#	11053+00
Pic 3 Description	ECD's and row conditions			Pic 4 Description	ECD's and row conditions

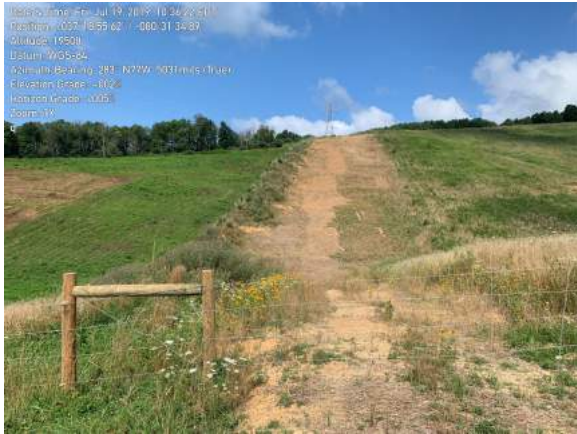
GPS Location	37.24	Field Station#	11146+00	GPS Location	37.24	Field Station#	11155+00
Pic 5 Description	ECD's and row conditions			Pic 6 Description	ECD's and row conditions

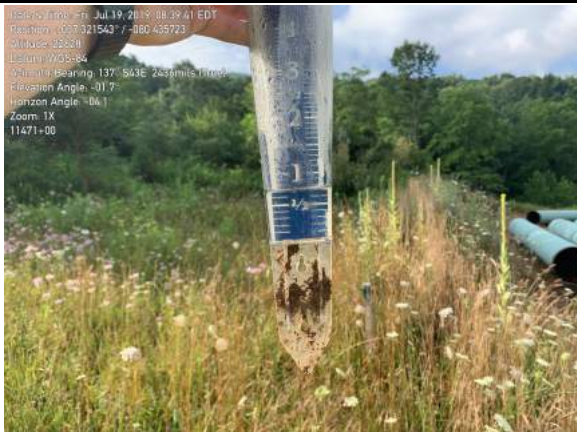
GPS Location	37.18	Field Station#	11471+00	GPS Location	37.18	Field Station#	11442+00
Pic 3 Description	See photo for GPS location. Rain gauge at Steele Acres reads .7 inches.			Pic 4 Description	See photo for GPS location. Rock in, style at slope drain needs refreshed.

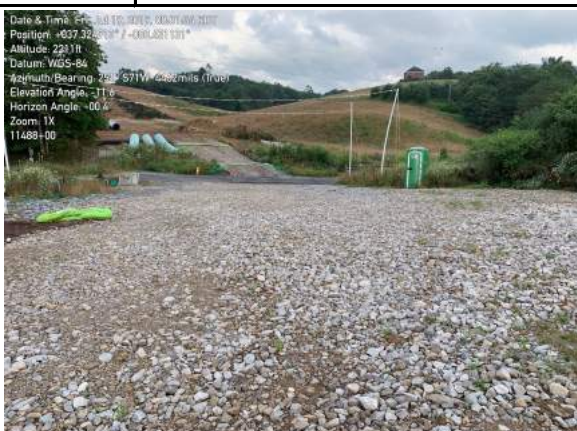
GPS Location	37.18	Field Station#	11489+00	GPS Location	37.18	Field Station#	11375+00
Pic 5 Description	See photo for GPS location. RCE in place at Stevers Gap Road.			Pic 6 Description	See photo for GPS location. Clean water diversion pipe and diversion berm in place.
