Visual Site Inspection Report

Project Name	H-600 Pipeline Spread G	AFE	124300137	Spread	H-600 Pipeline Spread G
Contractor	Precision			Report #	6
Inspector	Len Kruizenga			Date/Time	7/29/2019 8:42 AM
Permit #	TBD	Inspection Type	VA SWPP	Station Begin	12005+00
State	VA	Inspection Area	Full	Station End	12005+00
County	Giles	Ground	Dry	Temperature (°F)	85.00
Municipality	N/A	Weather	Sunny	Rain Gauge (in)	0.00
				Rain Accumulation Time (days)	1.00

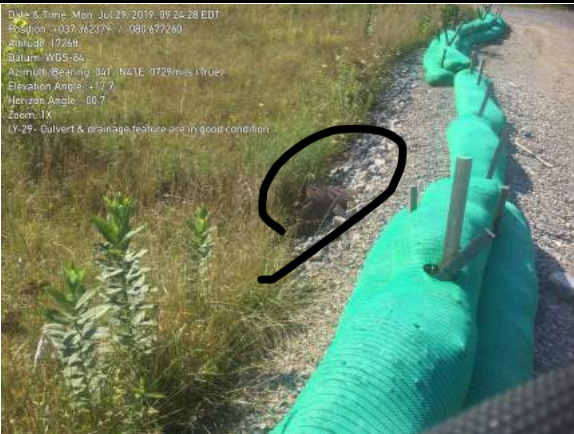
GPS Location	See photo GPS		GPS Location	See photo GPS	
Field Station#	12005+00		Field Station#	12005+00	
Pic 5 Desc.	LY-29- Culvert & drainage feature are in good condition		Pic 6 Desc.	AR-238.00- Access road has rill erosion on slopes going into the yard

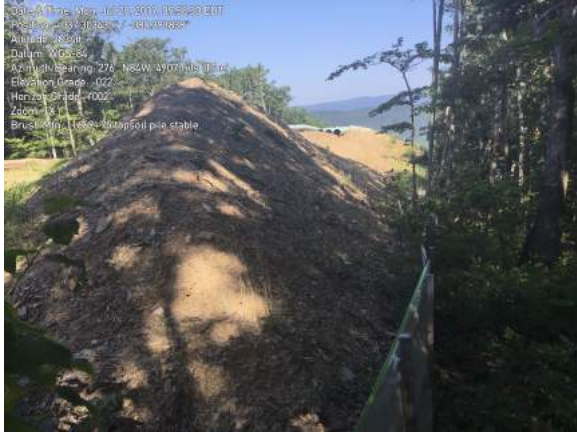
A/E	124300137	Date/Time	7/29/2019 3:17 PM	Report #	18
Pictures					
<p>Date & Time: Mon, Jul 29, 2019, 10:53:58 EDT Position: +037.304233 / -080.31663 Altitude: 2725ft Datum: WGS-84 Azimuth/Bearing: 321° N49W 51.07mils (True) Elevation Grade: +002 Horizon Grade: +010 Zoom: 1X Brush Min. 11669+75 topsoil pile stable</p>

GPS Location	1	GPS Location	1		
Field Station#	11669+75	Field Station#	11664+00		
Pic 1 Desc.	Topsoil pile stable. Was seeded several times.	Pic 2 Desc.	Perimeter controls are in place where needed.		
<p>Date & Time: Mon, Jul 29, 2019, 10:13:05 EDT Position: +037.305028 / -080.396396 Altitude: 2613ft Datum: WGS-84 Azimuth/Bearing: 320° N49W 56.89mils (True) Elevation Grade: +042 Horizon Grade: +011 Zoom: 1X Brush Min. Slope breakers functional 11651+00</p>

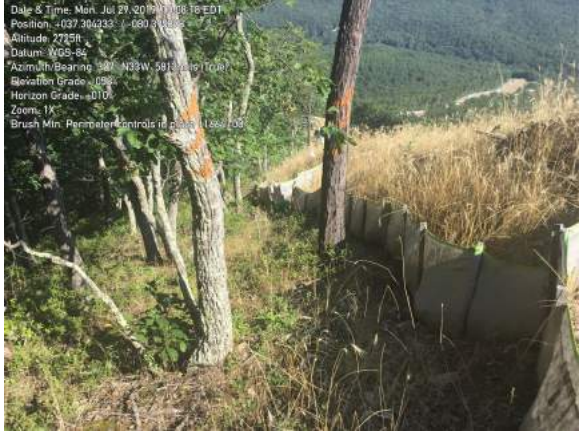
<p>Date & Time: Mon, Jul 29, 2019, 10:16:18 EDT Position: +037.304233 / -080.31663 Altitude: 2725ft Datum: WGS-84 Azimuth/Bearing: 321° N49W 51.07mils (True) Elevation Grade: +002 Horizon Grade: +010 Zoom: 1X Brush Min. Perimeter controls in place 11664+00</p>

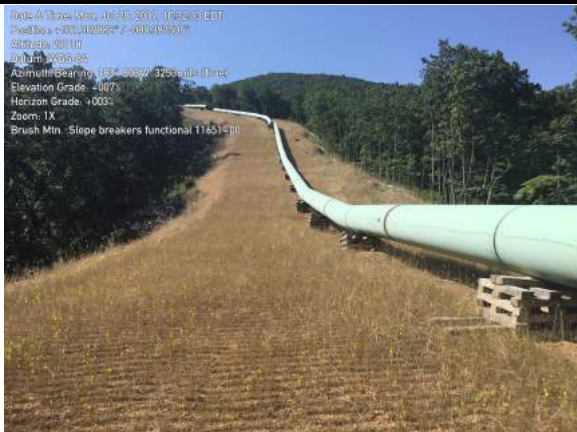
GPS Location	1	GPS Location	1		
Field Station#	11651+00	Field Station#	11661+00		
Pic 3 Desc.	Slope breakers functional. ROW stable.	Pic 4 Desc.	Perimeter controls are in place and functioning		
<p>Date & Time: Mon, Jul 29, 2019, 10:12:11 EDT Position: +037.316271 / -080.402134 Altitude: 1908ft Datum: WGS-84 Azimuth/Bearing: 327° N41E 24.71mils (True) Elevation Grade: +003 Horizon Grade: +007 Zoom: 1X Brush Min. S-HH18 crossing stable 11626+04</p>

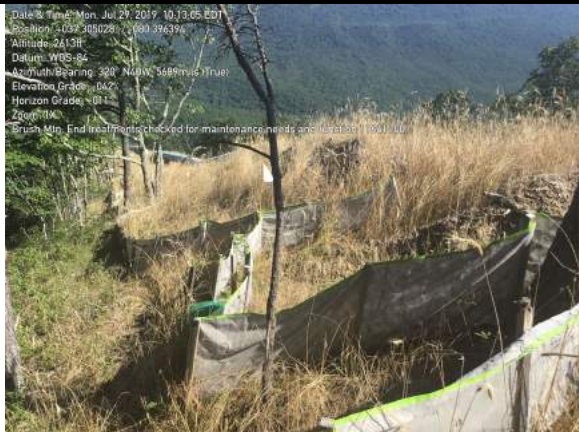
<p>Date & Time: Mon, Jul 29, 2019, 10:13:05 EDT Position: +037.305028 / -080.396396 Altitude: 2613ft Datum: WGS-84 Azimuth/Bearing: 320° N49W 56.89mils (True) Elevation Grade: +042 Horizon Grade: +011 Zoom: 1X Brush Min. End treatments checked for maintenance needs and location 11651+00</p>

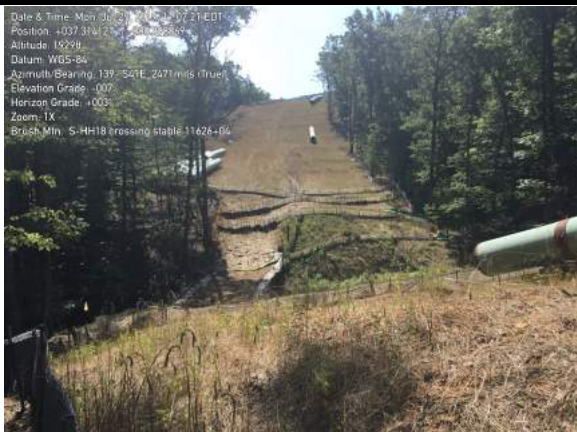
GPS Location	1	GPS Location	1		
Field Station#	11626+04	Field Station#	11615+20		
Pic 5 Desc.	S-HH18 crossing is stable.	Pic 6 Desc.	End treatments upslope of the S-RR14 crossing are functional

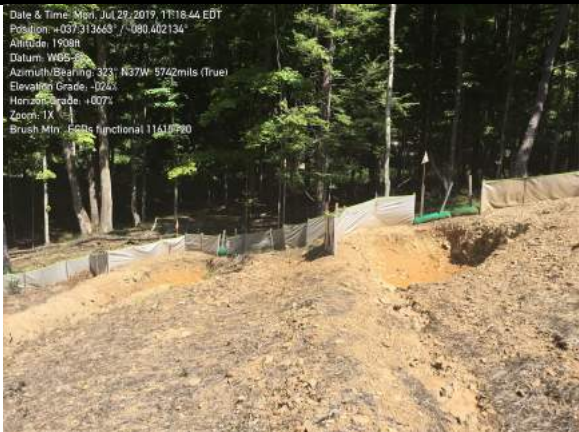
<p>Date & Time: Mon, Jul 29, 2019, 10:18:44 EDT Position: +037.313663 / -080.402134 Altitude: 1908ft Datum: WGS-84 Azimuth/Bearing: 323° N37W 57.42mils (True) Elevation Grade: +024 Horizon Grade: +007 Zoom: 1X Brush Min. S-HH18 crossing functional 11615+20</p>

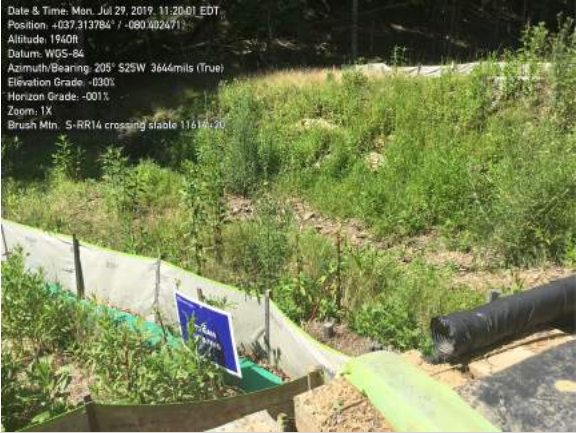
AFE	124300137	Date/Time	7/29/2019 3:17 PM	Report #	18
Pictures					
<p>Date & Time: Mon Jul 29, 2019, 11:20:01 EDT Position: -037.312784 / -080.002471 Altitude: 1960ft Datum: WGS-84 Azimuth/Bearing: 205° S25W 3666mils (True) Elevation Grade: -030% Horizon Grade: -001% Zoom: 1X Brush Min: S-RR14 crossing stable 11614+20</p>

GPS Location	1	GPS Location	1		
Field Station#	11614+20	Field Station#	11613+69		
Pic 7 Desc.	S-RR14 crossing stable.	Pic 8 Desc.	S-RR13 crossing is stable.		
<p>Date & Time: Mon Jul 29, 2019, 11:30:29 EDT Position: -037.313652 / -080.004466 Altitude: 1931ft Datum: WGS-84 Azimuth/Bearing: 121° S39E 2507mils (True) Elevation Grade: -02% Horizon Grade: -002% Zoom: 1X Brush Min: S-006 crossing stable 11607+81</p>

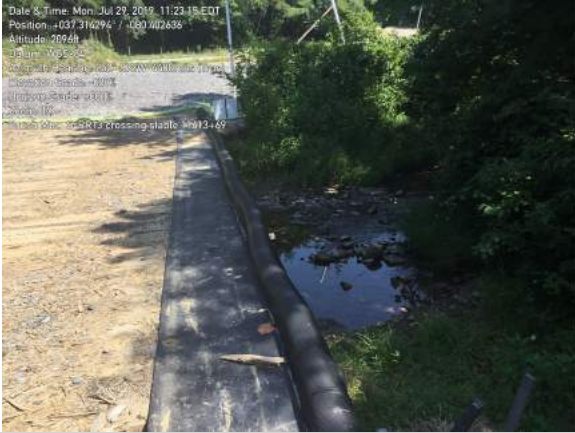
<p>Date & Time: Mon Jul 29, 2019, 11:23:15 EDT Position: -037.312896 / -080.002636 Altitude: 2064ft Datum: WGS-84 Azimuth/Bearing: 205° S25W 3666mils (True) Elevation Grade: -030% Horizon Grade: -001% Zoom: 1X Brush Min: S-RR13 crossing stable 11613+69</p>

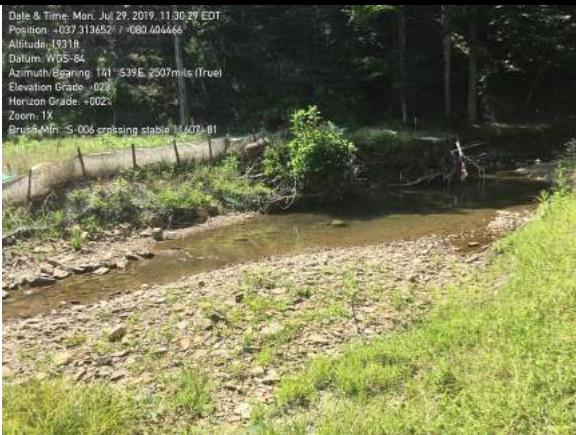
GPS Location	1	GPS Location			
Field Station#	11607+81	Field Station#			
Pic 9 Desc.	S-006 crossing is stable.	Pic 10 Desc.			
<p style="text-align: center;">Insert image here</p>		<p style="text-align: center;">Insert image here</p>			
GPS Location		GPS Location			
Field Station#		Field Station#			
Pic 11 Desc.		Pic 12 Desc.

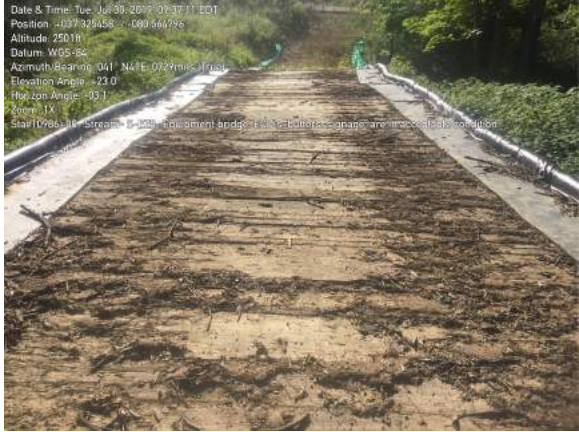
<p>Date & Time: Tue Jul 30, 2019 09:57:11 EDT Position: +037.321558 / -089.566796 Altitude: 2501ft Datum: WGS-84 Azimuth Bearing: 041° N41E 022mils (True) Elevation Angle: +23.0° Horizon Angle: -03.1° Zoom: 1X Stream S-E25- Equipment bridge, ECD's, buffers, signage are in acceptable condition</p>

GPS Location	N/A	GPS Location	N/A		
Field Station#	11022+00	Field Station#	10986+00		
Pic 1 Desc.	AR-244 at bridge, Stream S-IJ18- P1 damaged!	Pic 2 Desc.	Stream S-E25- Bridge, ECD's, buffers, signage		
<p>Date & Time: Tue Jul 30, 2019 09:56:40 EDT Position: +037.325597 / -089.560196 Altitude: 2627ft Datum: WGS-84 Azimuth Bearing: 344° N44W 616mils (True) Elevation Angle: +05.9° Horizon Angle: -02.5° Zoom: 1X Stream S-E24 Equipment bridge, ECD's, buffers, signage are in acceptable condition.</p>

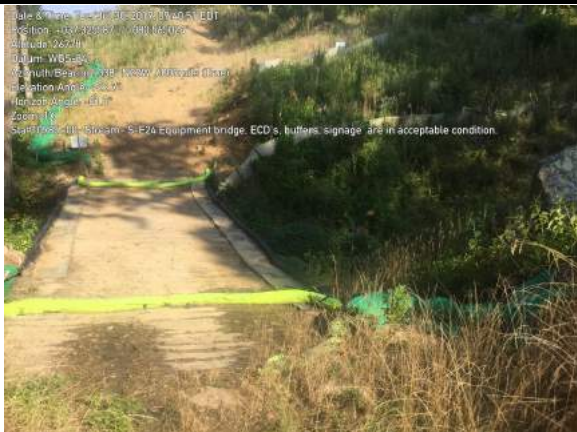
<p>Date & Time: Tue Jul 30, 2019 09:56:40 EDT Position: +037.325597 / -089.560196 Altitude: 2627ft Datum: WGS-84 Azimuth Bearing: 344° N44W 616mils (True) Elevation Angle: +05.9° Horizon Angle: -02.5° Zoom: 1X Stream S-E24 Equipment bridge, ECD's, buffers, signage are in acceptable condition.</p>

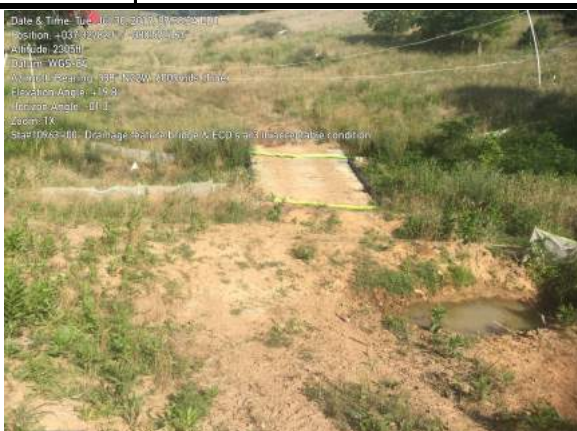
GPS Location	N/A	GPS Location	N/A		
Field Station#	10985+00	Field Station#	10965+00		
Pic 3 Desc.	Stream-S-E24- Bridge,ECD's,buffers, signage	Pic 4 Desc.	Karst ECD's& signage are in acceptable condition		
<p>Date & Time: Tue Jul 30, 2019 10:02:00 EDT Position: +037.330475 / -089.581003 Altitude: 2229ft Datum: WGS-84 Azimuth Bearing: 347° N13W 616mils (True) Elevation Angle: +12.2° Horizon Angle: +04.5° Zoom: 1X Stream S-E24- Drainage feature bridge & ECD's are in acceptable condition.</p>

GPS Location	N/A	GPS Location	N/A		
Field Station#	10963+00	Field Station#	10930+00		
Pic 5 Desc.	Drainage feature bridge & ECD's - good.	Pic 6 Desc.	Doe Creek RCE is in good condition.

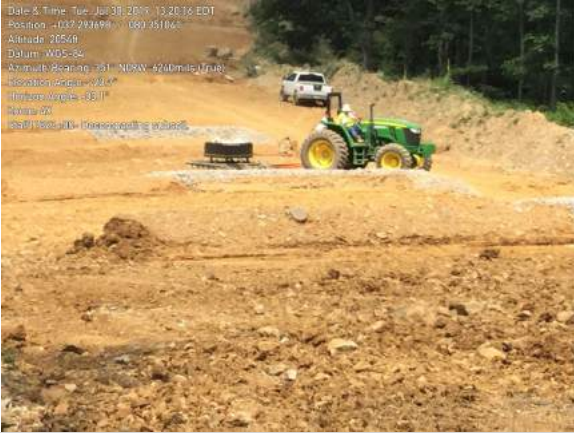
GPS Location	N/A	GPS Location	N/A		
Field Station#	11823+00	Field Station#	11838+00		
Pic 7 Desc.	Deco packing subsoil.	Pic 8 Desc.	Area that contractor is retrieving sediment.		
Insert image here		Insert image here			
GPS Location		GPS Location			
Field Station#		Field Station#			
Pic 9 Desc.		Pic 10 Desc.			
Insert image here		Insert image here			
GPS Location		GPS Location			
Field Station#		Field Station#			
Pic 11 Desc.		Pic 12 Desc.

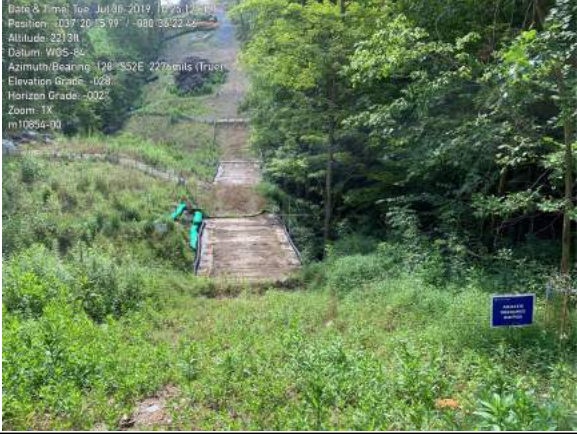
GPS Location	See picture for GPS coordinates	GPS Location	See picture for GPS coordinates		
Field Station#	10856+00	Field Station#	10854+00		
Pic 1 Desc.	End treatment undermined	Pic 2 Desc.	ECD's and row conditions

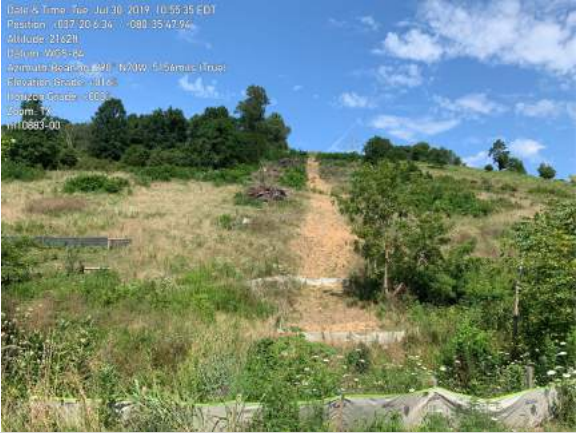
AFE	124300137	Date/Time	7/30/2019 2:18 PM	Report #	62
Pictures					
<p>Date & Time: Tue Jul 30, 2019 10:29:39 EDT Position: 43° 20' 4.34" N - 080° 35' 47.92" W Altitude: 2162ft Datum: WGS-84 Azimuth/Bearing: 191° N82W 15.58mils (True) Elevation Grade: +015% Horizon Grade: +005% Zoom: 1X 10883+00</p>

GPS Location	See picture for GPS coordinates		GPS Location	See picture for GPS coordinates	
Field Station#	10880+00		Field Station#	10900+00	
Pic 7 Desc.	ECD's and row conditions		Pic 8 Desc.	ECD's and row conditions	
<p>Date & Time: Tue Jul 30, 2019 10:57:56 EDT Position: 43° 20' 5.86" N - 080° 35' 47.42" W Altitude: 2110ft Datum: WGS-84 Azimuth/Bearing: 191° N82W 3407mils (True) Elevation Grade: +05% Horizon Grade: +008% Zoom: 1X 10883+00</p>

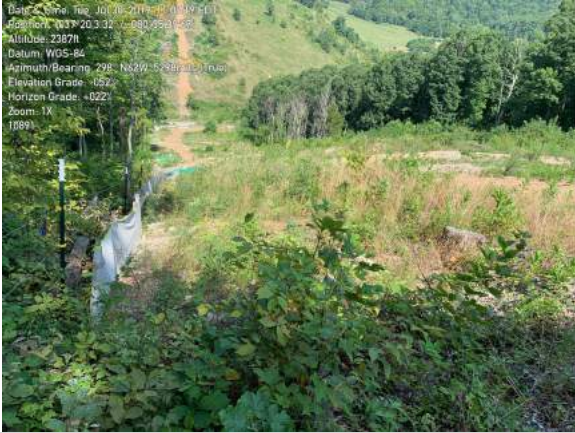
<p>Date & Time: Tue Jul 30, 2019 10:39:10 EDT Position: 43° 20' 3.32" N - 080° 35' 41.55" W Altitude: 2287ft Datum: WGS-84 Azimuth/Bearing: 238° N82W 5.38mils (True) Elevation Grade: +022% Horizon Grade: +022% Zoom: 1X 10891</p>

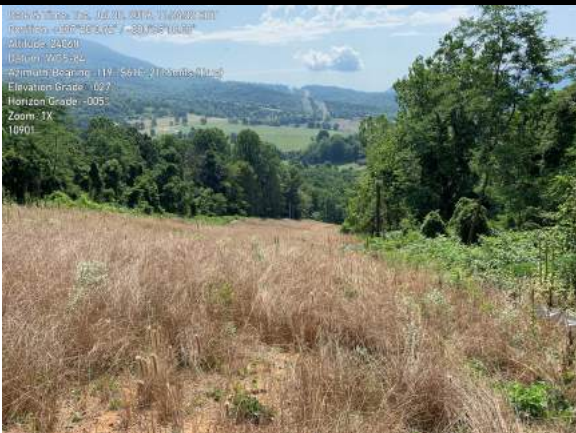
GPS Location	See picture for GPS coordinates		GPS Location	See picture for GPS coordinates	
Field Station#	10883+00		Field Station#	10890+00	
Pic 9 Desc.	End treatment		Pic 10 Desc.	End treatment	
<p>Date & Time: Tue Jul 30, 2019 12:01:41 EDT Position: 43° 19' 52.16" N - 80° 35' 16.83" W Altitude: 2450ft Datum: WGS-84 Azimuth/Bearing: 119° S41E 2100mils (True) Elevation Grade: +027% Horizon Grade: +005% Zoom: 1X 10901</p>

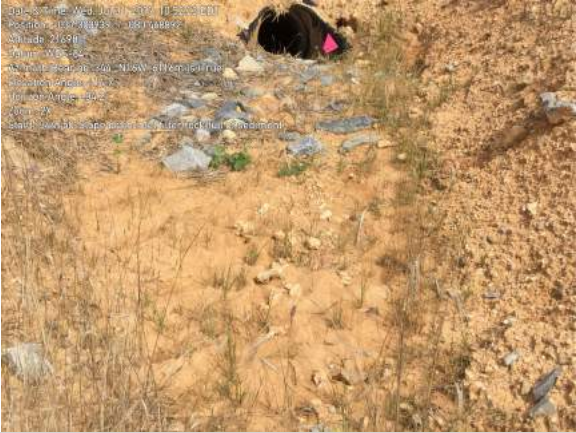
AFE	124300137	Date/Time	7/31/2019 7:29 AM	Report #	109
Pictures					
  <p>Date & Time: Wed Jul 31, 2019 18:59:12 EDT Position: +037.305513 / +080.487513 Altitude: 2025ft Datum: WGS-84 Azimuth/Bearing: 024° N24E 0427mis (1.1) Elevation Angle: +13.8° Horizon Angle: -04.0° Zoom: 1X Sta#11351+00- P1 controls damaged above stream</p>		  <p>Date & Time: Wed Jul 31, 2019 18:59:12 EDT Position: +037.305513 / +080.487513 Altitude: 2025ft Datum: WGS-84 Azimuth/Bearing: 024° N24E 0427mis (1.1) Elevation Angle: +13.8° Horizon Angle: -04.0° Zoom: 1X Sta#11351+00- P1 controls damaged above stream</p>

Field Station#	11344+50	Field Station#	11351+00	Field Station#	11351+00
Pic 7 Desc.	Slope drain inlet filter rock full of sediment.	Pic 8 Desc.	P1 controls damaged above stream.	Pic 8 Desc.	P1 controls damaged above stream.
  <p>Date & Time: Wed Jul 31, 2019 18:59:12 EDT Position: +037.305513 / +080.487513 Altitude: 2025ft Datum: WGS-84 Azimuth/Bearing: 024° N24E 0427mis (1.1) Elevation Angle: +13.8° Horizon Angle: -04.0° Zoom: 1X Sta#11351+00- P1 controls damaged above stream</p>		  <p>Date & Time: Wed Jul 31, 2019 18:59:12 EDT Position: +037.305513 / +080.487513 Altitude: 2025ft Datum: WGS-84 Azimuth/Bearing: 024° N24E 0427mis (1.1) Elevation Angle: +13.8° Horizon Angle: -04.0° Zoom: 1X Sta#11351+00- P1 controls damaged above stream</p>		  <p>Date & Time: Wed Jul 31, 2019 18:59:12 EDT Position: +037.305513 / +080.487513 Altitude: 2025ft Datum: WGS-84 Azimuth/Bearing: 024° N24E 0427mis (1.1) Elevation Angle: +13.8° Horizon Angle: -04.0° Zoom: 1X Sta#11351+00- P1 controls damaged above stream</p>

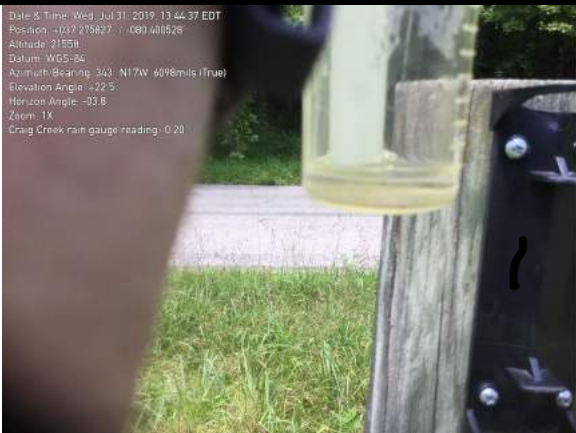
<p>Date & Time: Wed Jul 31, 2019 13:44:37 EDT Position: +037.275827 / +080.480528 Altitude: 2155ft Datum: WGS-84 Azimuth/Bearing: 343° N17W 6098mis (True) Elevation Angle: +22.5° Horizon Angle: -03.8° Zoom: 1X Craig Creek rain gauge reading: 0.20"</p>		  <p>Date & Time: Wed Jul 31, 2019 13:44:37 EDT Position: +037.275827 / +080.480528 Altitude: 2155ft Datum: WGS-84 Azimuth/Bearing: 343° N17W 6098mis (True) Elevation Angle: +22.5° Horizon Angle: -03.8° Zoom: 1X Craig Creek rain gauge reading: 0.20"</p>		  <p>Date & Time: Wed Jul 31, 2019 13:44:37 EDT Position: +037.275827 / +080.480528 Altitude: 2155ft Datum: WGS-84 Azimuth/Bearing: 343° N17W 6098mis (True) Elevation Angle: +22.5° Horizon Angle: -03.8° Zoom: 1X Craig Creek rain gauge reading: 0.20"</p>

GPS Location	See photo GPS	GPS Location		GPS Location	
Field Station#	11670+00	Field Station#		Field Station#	
Pic 11 Desc.	Craig Creek rain gauge reading 0.20"	Pic 12 Desc.		Pic 12 Desc.

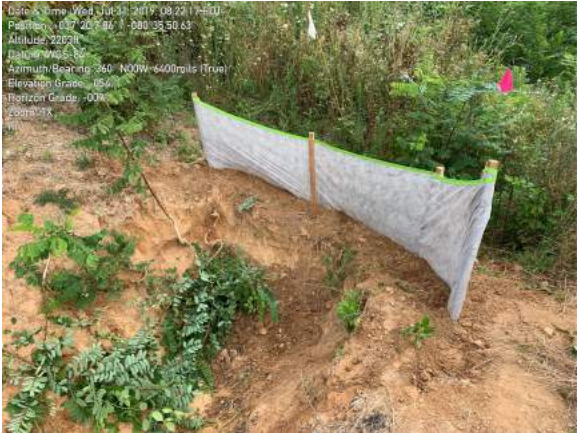
<p><small>Date & Time: Wed Jul 31, 2019, 08:23:17-00 Position: 037.20.6.38 -080.35.47.63 Altitude: 2200 Datum: WGS-84 Azimuth/Bearing: 340° N00W-6400mils (True) Elevation Grade: -004% Horizon Grade: -004% Zoom: 1X 11025-00</small></p>	
GPS Location	037.20.6.38-080.35.47.63	GPS Location	037.20.7.86-080.35.50.63		
Field Station#	10927+00	Field Station#	10920+00		
Pic 1 Desc.	No rain collected	Pic 2 Desc.	Punch list item repaired

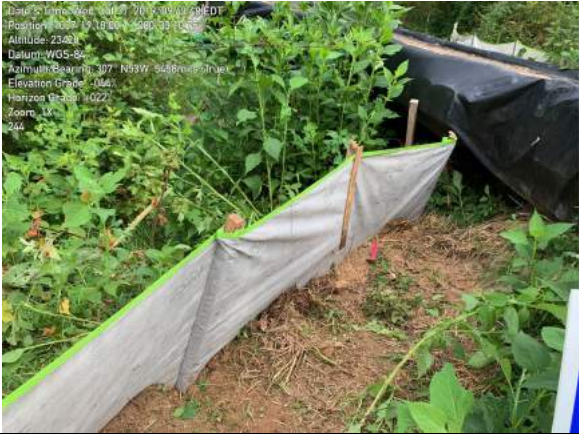
<p><small>Date & Time: Wed Jul 31, 2019, 09:06:00-0000 Position: 037.19.22.80 -080.33.9.71 Altitude: 2403ft Datum: WGS-84 Azimuth/Bearing: 091° S89E-1618mils (True) Elevation Grade: -004% Horizon Grade: -002% Zoom: 1X 11025-00</small></p>	
GPS Location	037.19.18.00-080.33.10.75	GPS Location	037.19.22.00-080.33.9.71		
Field Station#	2+34	Field Station#	11025+00		
Pic 3 Desc.	Punchlist item repaired	Pic 4 Desc.	ECD's and row conditions

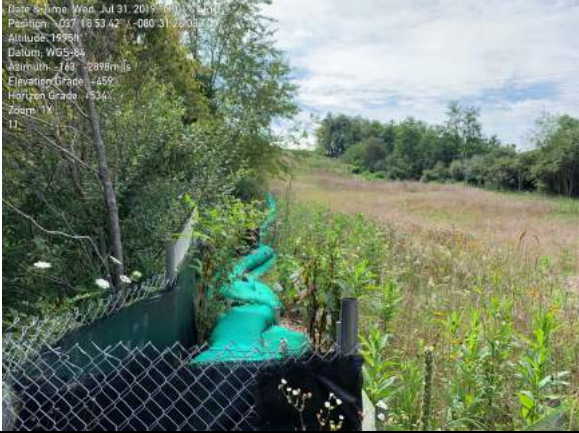
<p><small>Date & Time: Wed Jul 31, 2019, 1:40:17-0000 Position: 037.18.53.42 -080.31.26.08 Altitude: 1998ft Datum: WGS-84 Azimuth/Bearing: 149° S32W-3342mils (True) Elevation Grade: -030% Horizon Grade: -033% Zoom: 1X 234</small></p>	
GPS Location	037.18.53.42-080.31.26.08	GPS Location	037.22.27.38—080.40.47.51		
Field Station#	11140+00	Field Station#	2+34		
Pic 5 Desc.	ECD's and row conditions	Pic 6 Desc.	New staking for AR 234

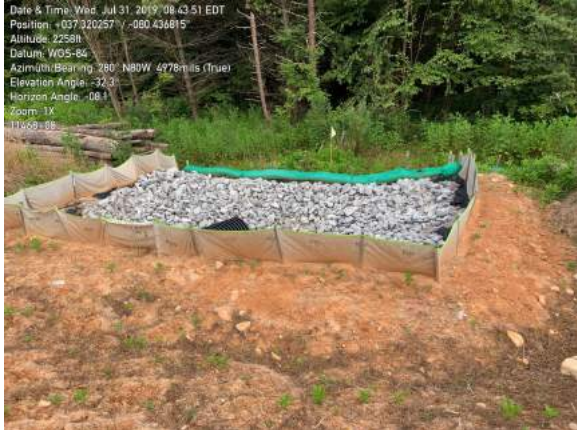
GPS Location	See photo	GPS Location	See photo		
Field Station#	11468+00	Field Station#	11451+00		
Pic 1 Desc.	Plunge pool in place.	Pic 2 Desc.	Sensitive resource buffer in place.		
<p>Date & Time: Wed, Jul 31, 2019, 09:02:17 EDT Position: +037.330157° / -080.439677° Altitude: 2159ft Datum: WGS-84 Azimuth/Bearing: 326° N36W 5760mils (True) Elevation Angle: -25.6° Horizon Angle: -03.3° Zoom: 1X 11428+00</p>

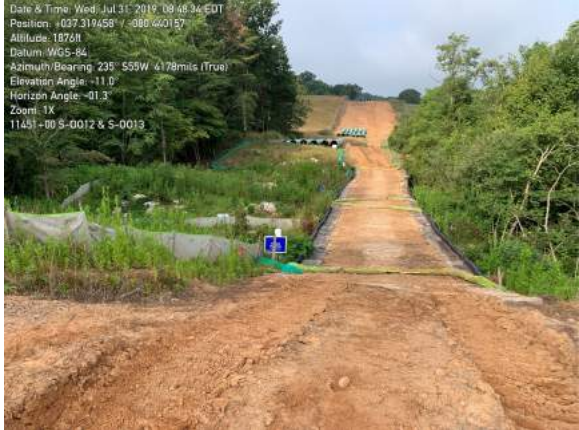
<p>Date & Time: Wed, Jul 31, 2019, 08:48:34 EDT Position: +037.319458° / -080.420157° Altitude: 1876ft Datum: WGS-84 Azimuth/Bearing: 235° S55W 4178mils (True) Elevation Angle: -11.0° Horizon Angle: -01.3° Zoom: 1X 11451+00 S-0012 & S-0013</p>

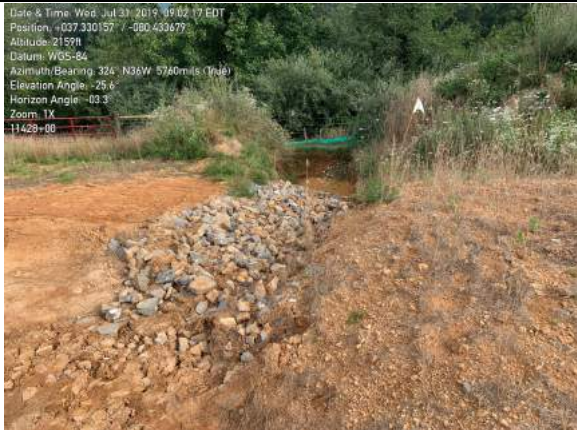
GPS Location	See photo	GPS Location	See photo		
Field Station#	11428+00	Field Station#	11366+00		
Pic 3 Desc.	Rock lined channel in place.	Pic 4 Desc.	Environmental crew mulching ROW.		
<p>Date & Time: Wed, Jul 31, 2019, 09:14:14 EDT Position: +037.306079° / -080.467045° Altitude: 2018ft Datum: WGS-84 Azimuth/Bearing: 103° S13W 3609mils (True) Elevation Angle: -01.0° Horizon Angle: -01.1° Zoom: 1X 11364+00</p>

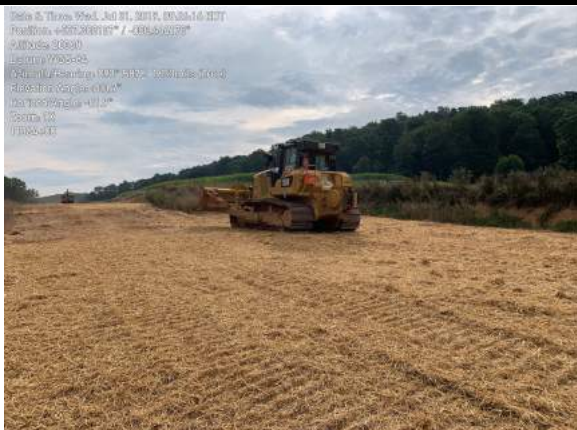
GPS Location	See photo	GPS Location	See photo		
Field Station#	11364+00	Field Station#	11351+00		
Pic 5 Desc.	Mulch being crimped in.	Pic 6 Desc.	RCE in place at Old Furnace Road.

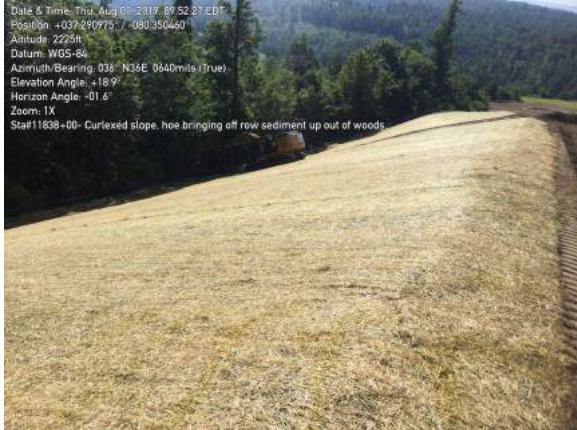
GPS Location	See photo GPS		GPS Location	See photo GPS	
Field Station#	11838+00		Field Station#	11836+00	
Pic 1 Desc.	Curlexed slope, hoe transferring off row sediment up hill.		Pic 2 Desc.	Dozer & hoe grading, final restoration in progress.

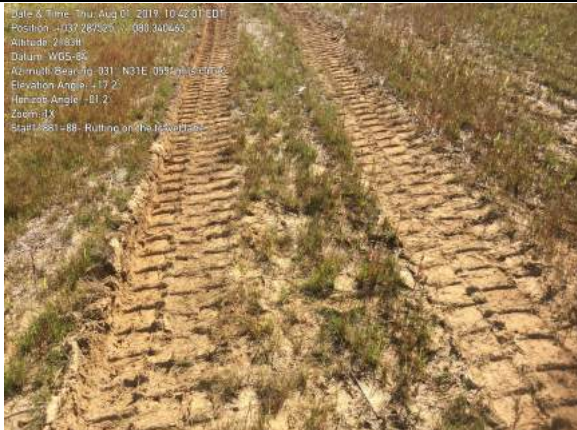
GPS Location	See photo GPS		GPS Location	See photo GPS	
Field Station#	11881+88		Field Station#	11949+00	
Pic 3 Desc.	Travel lane rutted in final restoration area.		Pic 4 Desc.	Sink hole has not changed from last inspection

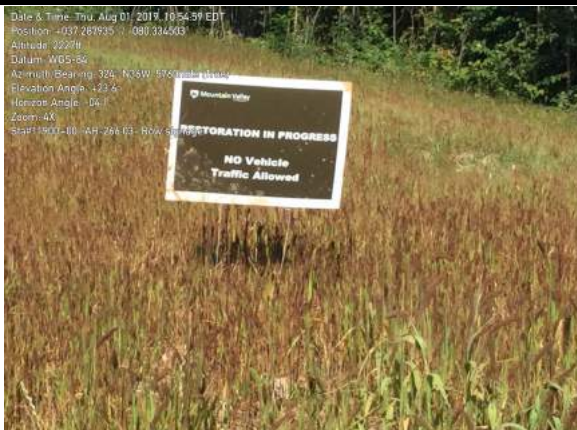
GPS Location	See photo GPS		GPS Location	See photo GPS	
Field Station#	11900+00		Field Station#	12001+00	
Pic 5 Desc.	Row signage.		Pic 6 Desc.	P1 in wetland is under cut & installed wrong.

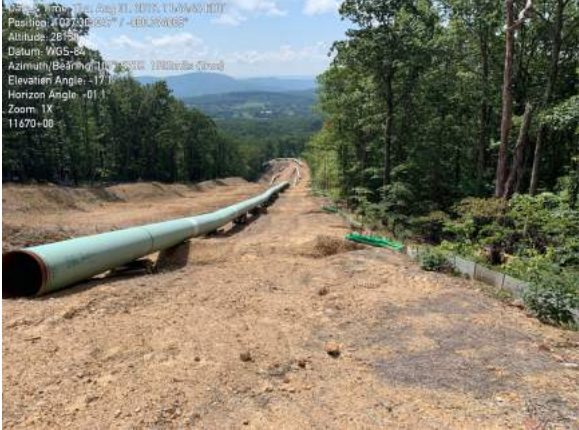
GPS Location	See photo.	GPS Location	See photo.		
Field Station#	11670+00	Field Station#	11686+81		
Pic 1 Desc.	Waterbars and end treatments in place.	Pic 2 Desc.	Sump pit and end treatment in place.

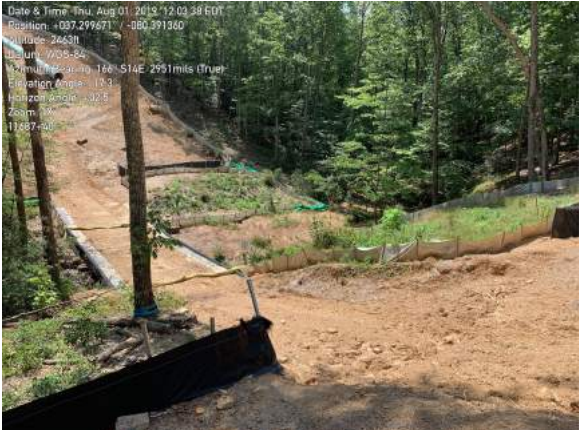
GPS Location	See photo.	GPS Location	See photo.		
Field Station#	11687+40	Field Station#	11733+00		
Pic 3 Desc.	Sensitive resource buffer in place at stream.	Pic 4 Desc.	Waterbar in place.

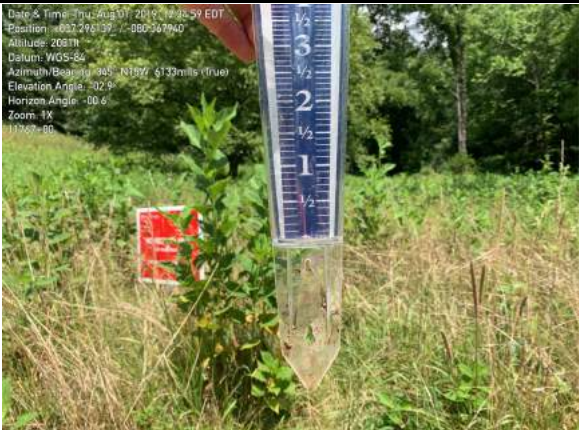
GPS Location	See photo.	GPS Location	See photo.		
Field Station#	11767+00	Field Station#	11767+00		
Pic 5 Desc.	Trace amount of rain at Mount Tabor Road.	Pic 6 Desc.	RCE in place at Mount Tabor Road.

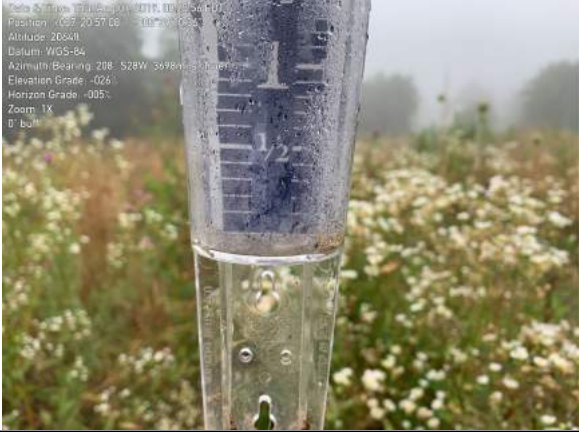
GPS Location	See picture above for GPS coordinates	GPS Location	See picture above for GPS coordinates		
Field Station#	2+34	Field Station#	11530+00		
Pic 1 Desc.	No rain recorded	Pic 2 Desc.	ECD's and row conditions

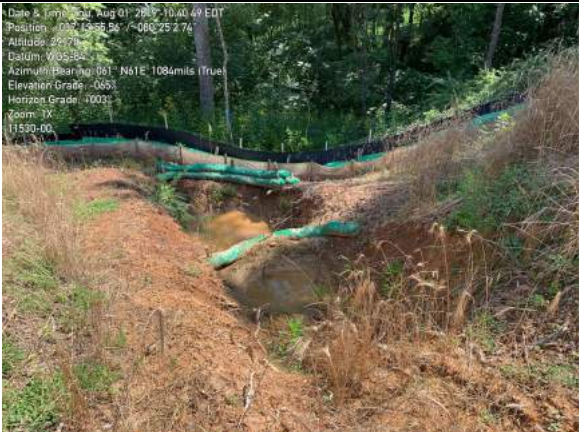
GPS Location	See picture above for GPS coordinates	GPS Location	See picture above for GPS coordinates		
Field Station#	11532+00	Field Station#	11562+00		
Pic 3 Desc.	ECD's and row conditions	Pic 4 Desc.	ECD's and row conditions

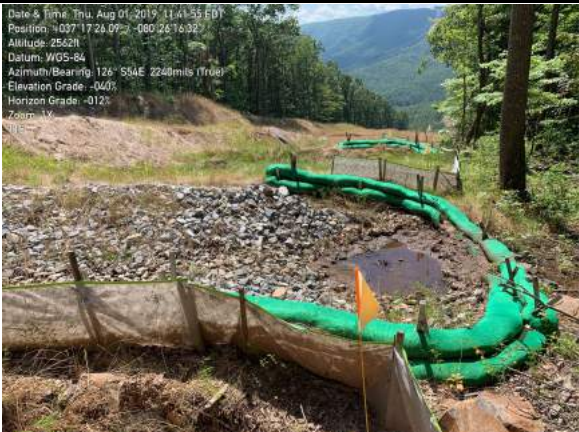
GPS Location	See picture above for GPS coordinates	GPS Location	See picture above for GPS coordinates		
Field Station#	11587+00	Field Station#	11573+00		
Pic 5 Desc.	ECD's and row conditions	Pic 6 Desc.	Punchlist repair

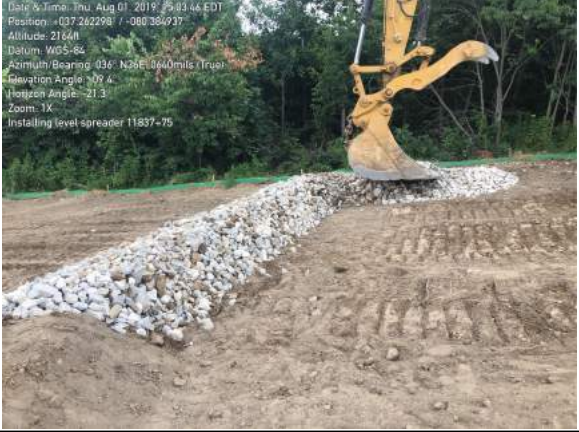
GPS Location	1	GPS Location	2		
Field Station#	118737+75	Field Station#	11837+75		
Pic 1 Desc.	Re-installed permanent water bar and Level spreader	Pic 2 Desc.	Re-stalling level spreader.		
<p>Date & Time: Thu, Aug 01, 2019, 12:34:24 EDT Position: +037.262298 / -080.384937 Altitude: 2196 ft Datum: WGS-84 Azimuth Bearing: 072° N72E 1316mils (True) Elevation Angle: 10.6° Horizon Angle: -25.2° Zoom: 1X Permanent water bar 11837+75</p>

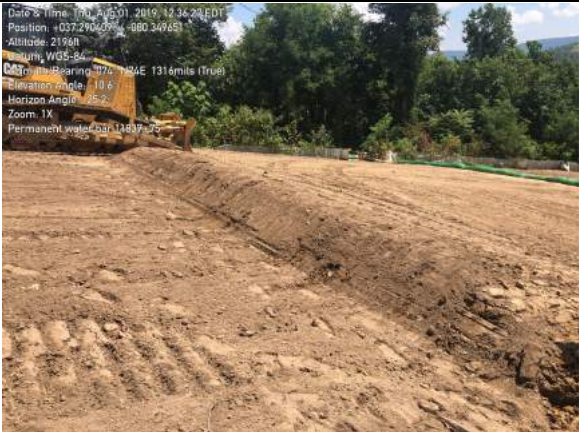
<p>Date & Time: Thu, Aug 01, 2019, 12:34:24 EDT Position: +037.262298 / -080.384937 Altitude: 2196 ft Datum: WGS-84 Azimuth Bearing: 072° N72E 1316mils (True) Elevation Angle: 10.6° Horizon Angle: -24.2° Zoom: 1X Measuring out level spreader 11837+75</p>

GPS Location	3	GPS Location	4		
Field Station#	11837+75	Field Station#	11837+75		
Pic 3 Desc.	Re-installed permanent water bar.	Pic 4 Desc.	Measuring out level spreader.		
<p>Date & Time: Thu, Aug 01, 2019, 12:34:24 EDT Position: +037.262298 / -080.384937 Altitude: 2196 ft Datum: WGS-84 Azimuth Bearing: 072° N72E 1316mils (True) Elevation Angle: 10.6° Horizon Angle: -20.7° Zoom: 1X Removed water bar and level spreader to be reversed 11837+75</p>

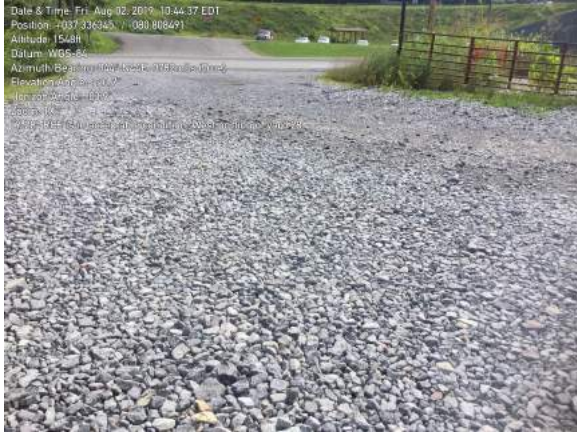
<p>Date & Time: Fri, Aug 02, 2019, 10:47:56 EDT Position: +037.336591 / -080.808617 Altitude: 1550ft Datum: WGS-84 Azimuth Bearing: 317.16°W-566mils (True) Elevation Angle: +19.5° Horizon Angle: -03.1° Zoom: 1X LY-28- West- RCE in acceptable condition.</p>

GPS Location	See photo GPS	GPS Location	See photo GPS		
Field Station#	12005+00	Field Station#	12005+00		
Pic 1 Desc.	LY-28- west- RCE in acceptable condition	Pic 2 Desc.	LY-28-west- 18" CFS perimeter controls.		
<p>Date & Time: Fri, Aug 02, 2019, 10:51:31 EDT Position: +037.335977 / -080.808203 Altitude: 1553ft Datum: WGS-84 Azimuth Bearing: 188.54°E-624mils (True) Elevation Angle: +22.8° Horizon Angle: -02.4° Zoom: 1X LY-28- West- RCE in acceptable condition. Secondary containment. Images of several buses.</p>

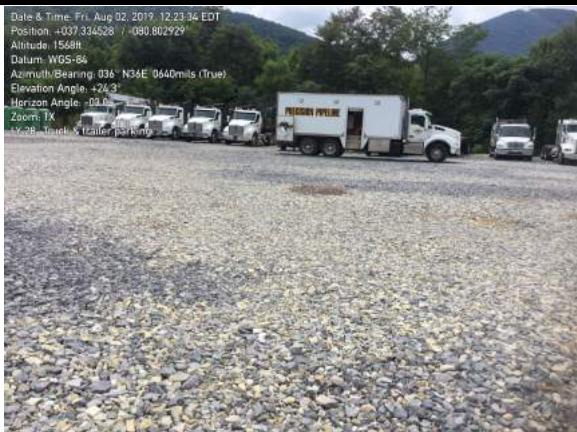
<p>Date & Time: Fri, Aug 02, 2019, 12:25:42 EDT Position: +037.334111 / -080.803428 Altitude: 1569ft Datum: WGS-84 Azimuth Bearing: 317.16°W-566mils (True) Elevation Angle: +22.8° Horizon Angle: -01.7° Zoom: 1X LY-28- Secondary containment unit under motor.</p>

GPS Location	See photo GPS	GPS Location	See photo GPS		
Field Station#	12005+00	Field Station#	12005+00		
Pic 5 Desc.	LY-28-East- Truck and trailer parking	Pic 6 Desc.	Secondary containment unit under motor.

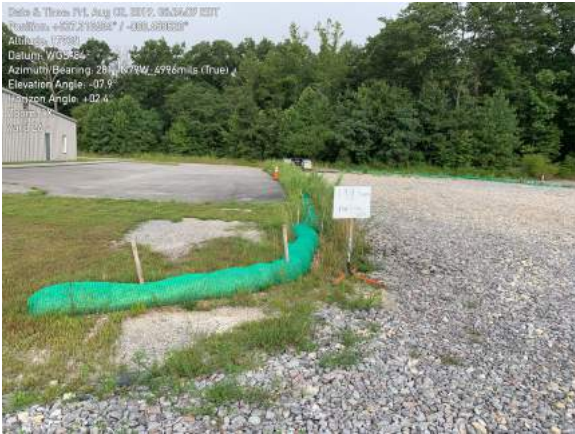
GPS Location	1	GPS Location	2		
Field Station#	12005+00	Field Station#	12005+00		
Pic 1 Desc.	18 inch CFS in place.	Pic 2 Desc.	Secondary containment in place under fuel cell

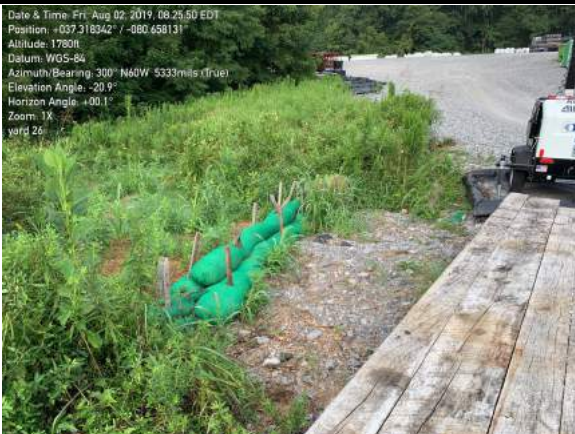
GPS Location	3	GPS Location	4		
Field Station#	12005+00	Field Station#	12005+00		
Pic 3 Desc.	Triple stack CFS in place.	Pic 4 Desc.	RCE in place.

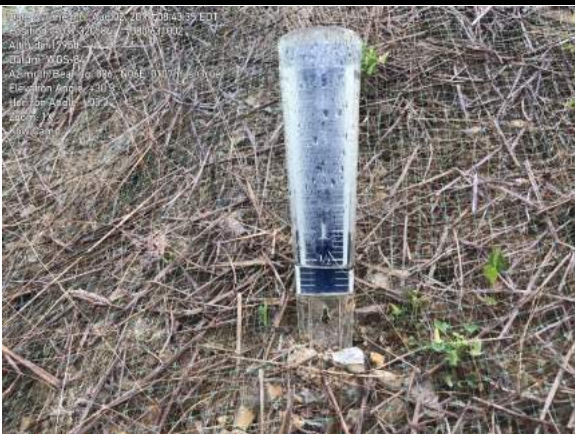
GPS Location	5	GPS Location	6		
Field Station#	10883+50	Field Station#	11024+00		
Pic 5 Desc.	Kow Camp - 0.4 inches.	Pic 6 Desc.	AR 244 - 0.3 inches.
