Visual Site Inspection Report

Project Name	H-600 Pipeline Spread G	AFE	124300137	Spread	H-600 Pipeline Spread
Contractor	Precision			Report #	340
Inspector	Len Kruizenga			Date/Time	8/5/2019 7:24 AM
Permit #	TBD	Inspection Type	VA SWPP	Station Begin	11022+00
State	VA	Inspection Area	Full	Station End	10930+00
County	Giles	Ground	Dry	Temperature (°F)	75.00
Municipality	N/A	Weather	Sunny	Rain Gauge (in)	0.00
				Rain Accumulation Time (days)	2.00

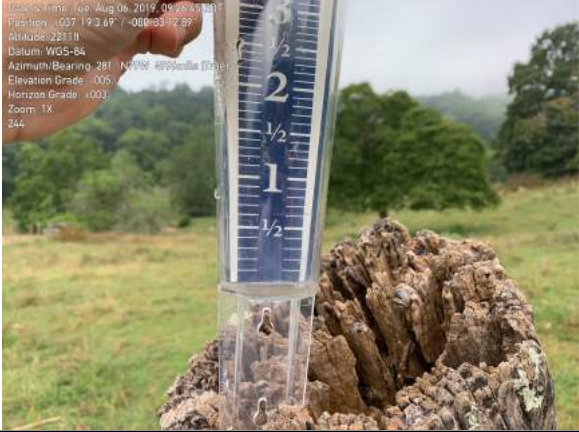
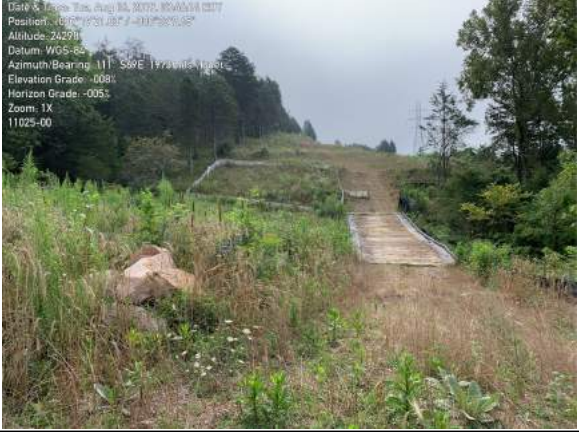
<p>GPS Location See picture above for GPS coordinates</p> <p>Field Station# 2+44</p> <p>Pic 1 Desc. No rain recorded</p>

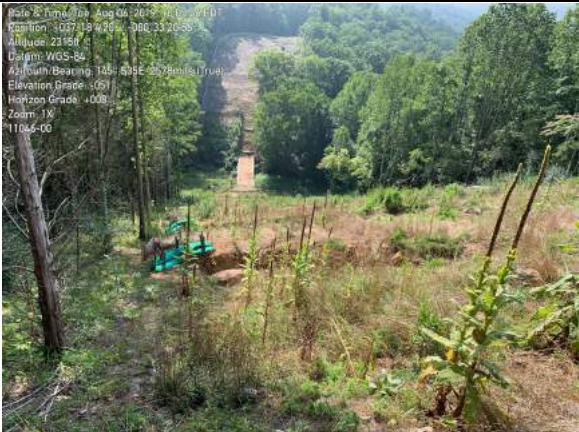
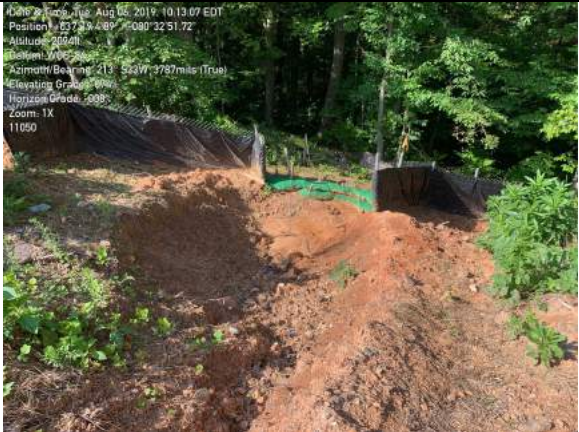
<p>GPS Location See picture above for GPS coordinates</p> <p>Field Station# 11025+00</p> <p>Pic 2 Desc. ECD's and row conditions S-IJ18</p>

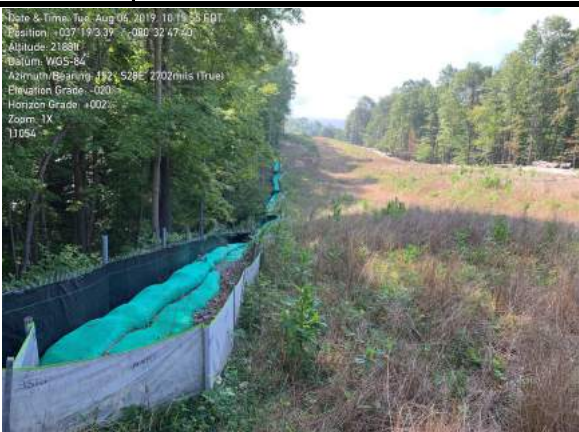
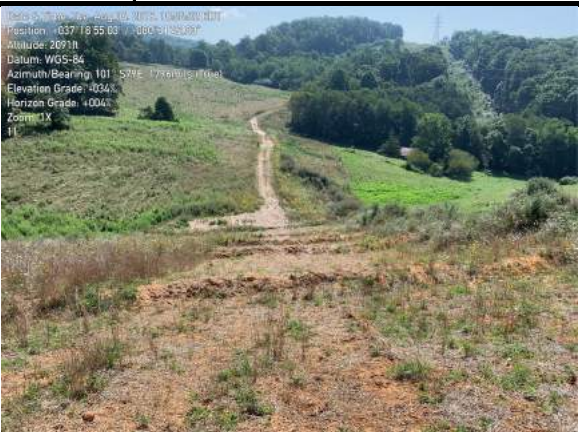
<p>GPS Location See picture above for GPS coordinates</p> <p>Field Station# 11046+00</p> <p>Pic 3 Desc. ECD's and row conditions</p>

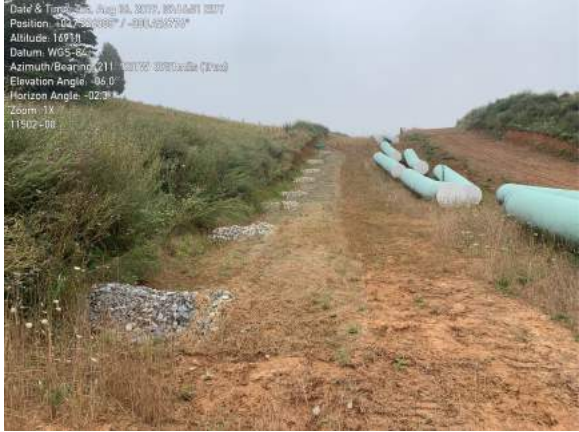
GPS Location	See photo for GPS location.	GPS Location	See photo for GPS location.		
Field Station#	11520+00	Field Station#	11502+00		
Pic 1 Desc.	Sediment built along CFS.	Pic 2 Desc.	Conveyance channel with rock checks.		
<p>Date & Time: Tue, Aug 06, 2019, 07:04:01 EDT Position: +057.29322° / -88.42092° Altitude: 219ft Datum: WGS-84 Azimuth/Bearing: 167° S30W 333mils (true) Elevation Angle: +0.4° Horizon Angle: +0.4° Zoom: 1X 11489+00</p>

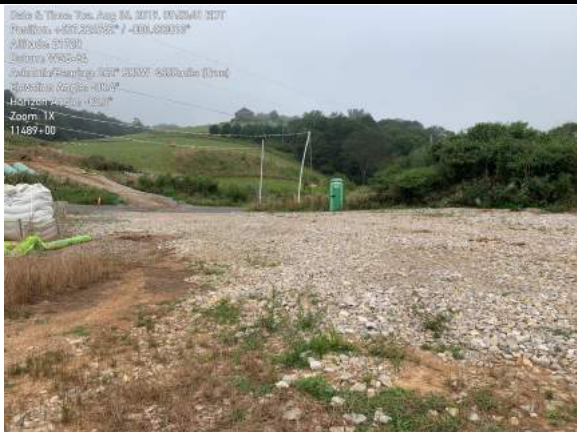
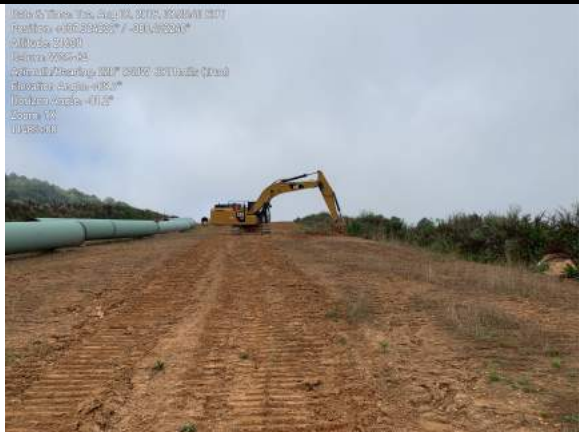
GPS Location	See photo for GPS location.	GPS Location	See photo for GPS location.		
Field Station#	11489+00	Field Station#	11485+00		
Pic 3 Desc.	RCE at Stevers Gap Road.	Pic 4 Desc.	Environmental crew reworking waterbar.		
<p>Date & Time: Tue, Aug 06, 2019, 08:04:11 EDT Position: +057.32937° / -88.43844° Altitude: 224ft Datum: WGS-84 Azimuth/Bearing: 222° S29W 304mils (true) Elevation Angle: +04.3° Horizon Angle: -02.3° Zoom: 1X 11467+00</p>

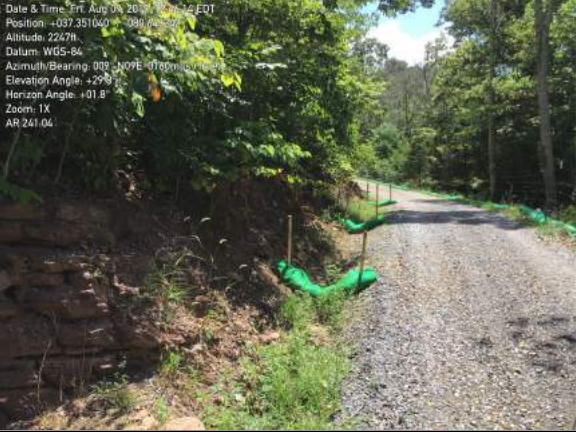
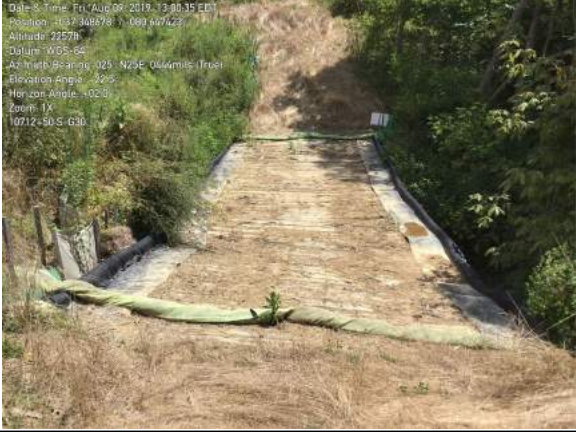
GPS Location	See photo for GPS location.		GPS Location	See photo for GPS location.	
Field Station#	12005+00		Field Station#	10712+50	
Pic 1 Desc.	Sock checks in bar ditch		Pic 2 Desc.	Sensitive resource buffer in place at stream.	
<p>Date & Time: Fri, Aug 09, 2019, 13:01:41 EDT Position: +037.348725° / -089.647768° Altitude: 2309ft Datum: WGS-84 Azimuth/Bearing: 034° N55W 540mils (True) Elevation Angle: +37.2° Horizon Angle: +01.7° Zoom: 1X 10714+00</p>

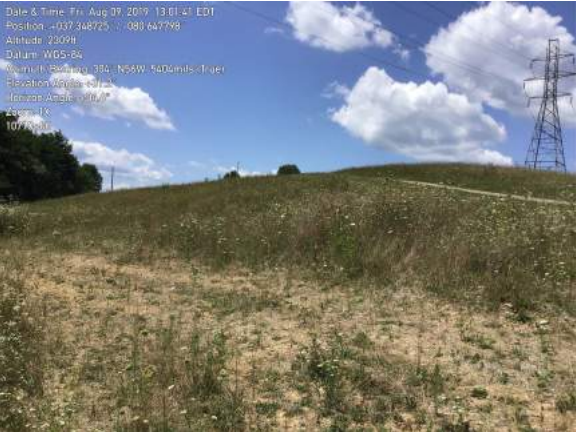
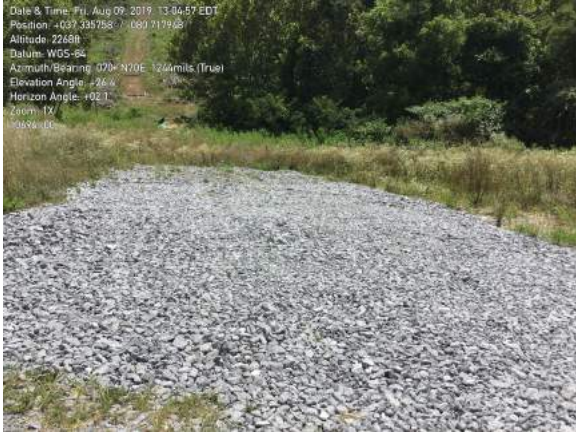
GPS Location	See photo for GPS location.		GPS Location	See photo for GPS location.	
Field Station#	10714+00		Field Station#	10696+00	
Pic 3 Desc.	ROW stabilized with natural vegetation.		Pic 4 Desc.	RCE in place at Buffalo Anklets Road.	
<p>Date & Time: Fri, Aug 09, 2019, 13:08:01 EDT Position: +037.348074° / -089.651927° Altitude: 2072ft Datum: WGS-84 Azimuth/Bearing: 011° N20W 30.0mils (True) Elevation Angle: +30.8° Horizon Angle: +02.8° Zoom: 1X 10698+00 S.G32</p>

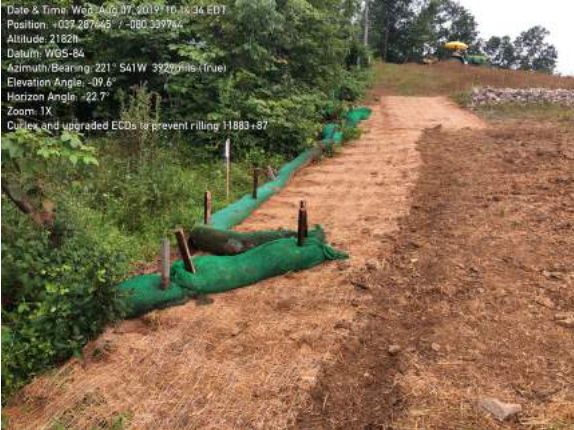
AFE	124300137	Date/Time	8/7/2019 7:15 AM	Report #	451
Pictures					
<p>Date & Time: Wed Aug 07, 2019 10:14:34 EDT Position: +037.267445° / -080.33772° Altitude: 2162ft Datum: WGS-84 Azimuth/Bearing: 221° S41W 3529mils (True) Elevation Angle: -09.6° Horizon Angle: -22.7° Zoom: 1X Curlex and upgraded ECDs to prevent rilling 11883+87</p>

GPS Location	1	GPS Location	2		
Field Station#	11883+87	Field Station#	11889+75		
Pic 1 Desc.	Curlex and CFS energy dissipater to prevent rilling.	Pic 2 Desc.	Curlex and CFS added to prevent rilling.		
<p>Date & Time: Wed Aug 07, 2019 10:14:49 EDT Position: +037.267445° / -080.33772° Altitude: 2178ft Datum: WGS-84 Azimuth/Bearing: 010° N10E 0178mils (True) Elevation Angle: -09.8° Horizon Angle: -23.6° Zoom: 1X Re-graded and upgraded ECDs 11889+00</p>

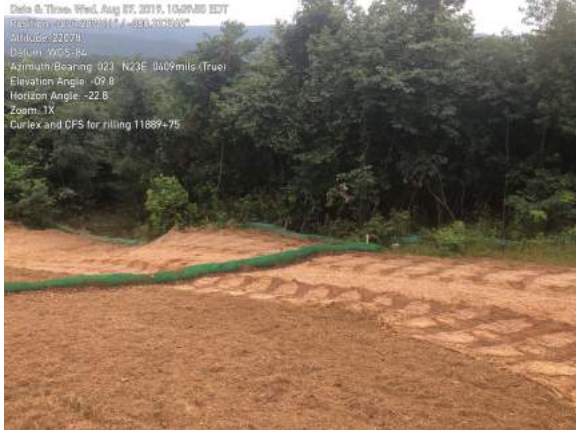
<p>Date & Time: Wed Aug 07, 2019 10:09:05 EDT Position: +037.267445° / -080.33772° Altitude: 2162ft Datum: WGS-84 Azimuth/Bearing: 023° N23E 9409mils (True) Elevation Angle: -09.8° Horizon Angle: -22.8° Zoom: 1X Curlex and CFS for rilling 11889+75</p>

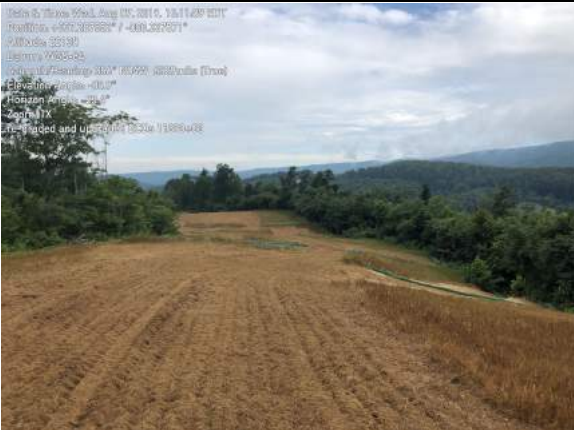
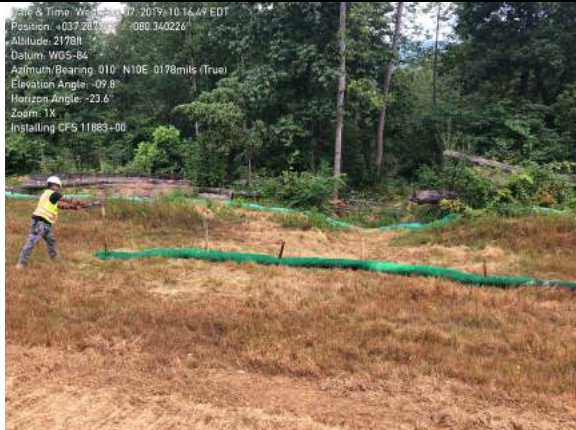
GPS Location	3	GPS Location	4		
Field Station#	11890+00	Field Station#	11883+00		
Pic 3 Desc.	Re-graded section of RoW after discing.	Pic 4 Desc.	Installing CFS.		
<p>Date & Time: Wed Aug 07, 2019 13:25:41 EDT Position: +037.267894° / -080.341235° Altitude: 2162ft Datum: WGS-84 Azimuth/Bearing: 112° S86E 1671mils (True) Elevation Angle: -13.5° Horizon Angle: -23.9° Zoom: 1X ECDs to prevent rilling 11880+00</p>

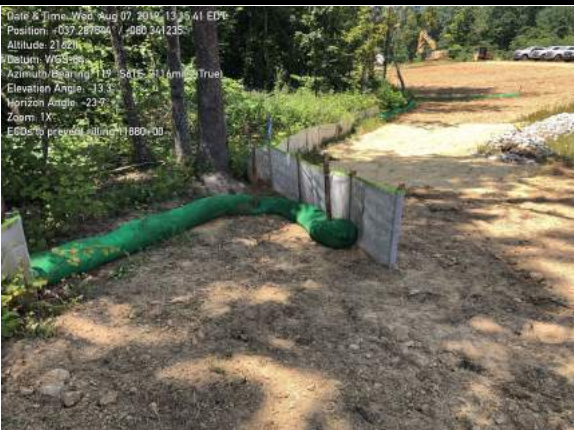
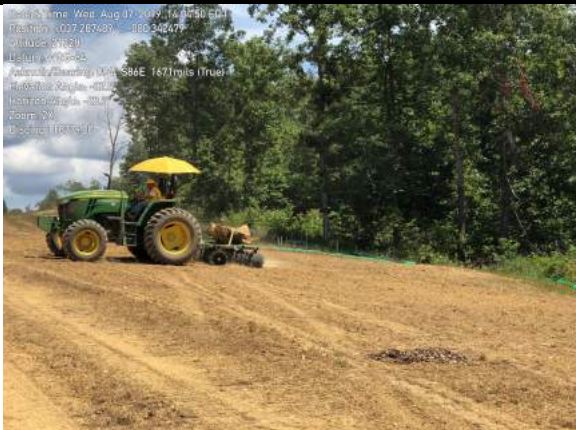
GPS Location	5	GPS Location	6		
Field Station#	11880+00	Field Station#	11877+00		
Pic 5 Desc.	Breaks created to prevent rilling.	Pic 6 Desc.	Discing to create seed bed.

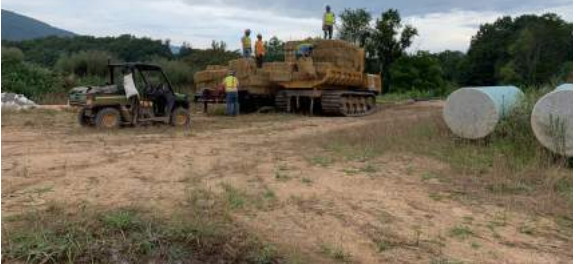
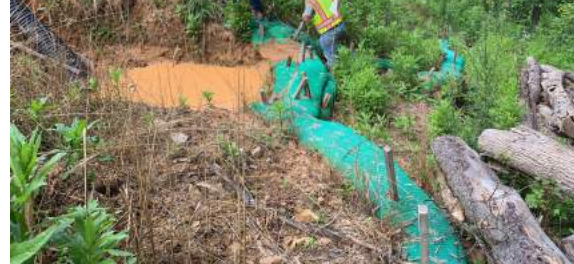
</div></div></div>		GPS Location See picture above for GPS coordinates		GPS Location See picture above for GPS coordinates	
Field Station# 11520+00		Field Station# 11525+00		Field Station# 11525+00			
Pic 1 Desc. Crews preparing for stabilization		Pic 2 Desc. Crews repairing end treatment		Pic 2 Desc. Crews repairing end treatment

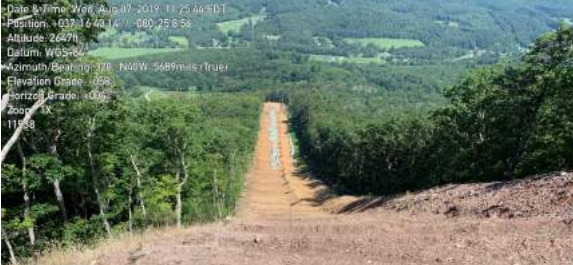
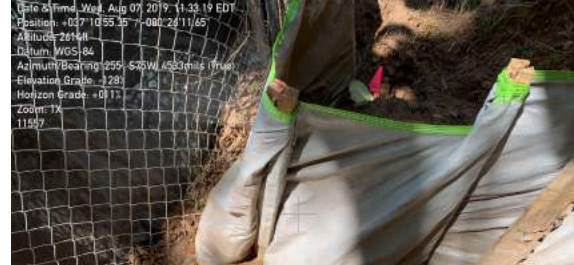
</div></div></div>		GPS Location See picture above for GPS coordinates		GPS Location See picture above for GPS coordinates	
Field Station# 11538+00		Field Station# 11557+00		Field Station# 11557+00			
Pic 3 Desc. ECD's and row conditions		Pic 4 Desc. Undermined end treatment		Pic 4 Desc. Undermined end treatment			
<div><div><div>Date & Time: Wed, Aug 07, 2019 11:41:52 EDT Position: +037°19'21.72" / -080°24'51.23" Altitude: 2750ft Datum: WGS-84 Azimuth/Bearing: 221° S41°W 3928mils (True) Elevation Grade: +231 Horizon Grade: +072 Zoom: 1X 11559-03</div><div>

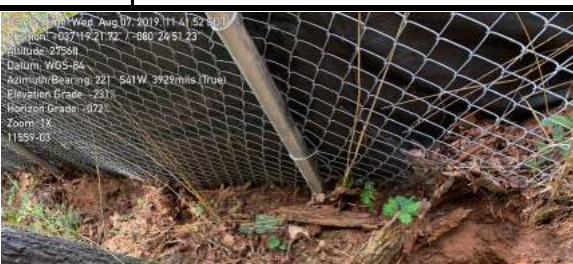
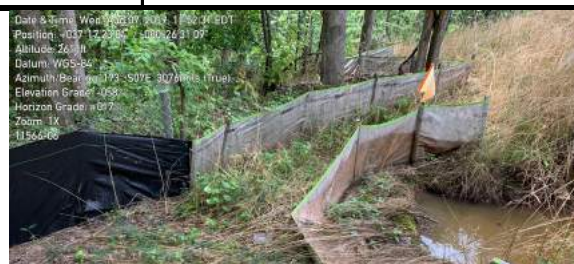
Field Station# 11559+03		Field Station# 11566+06		Field Station# 11566+06			
Pic 5 Desc. Channelizing under SSF		Pic 6 Desc. End treatment damaged		Pic 6 Desc. End treatment damaged

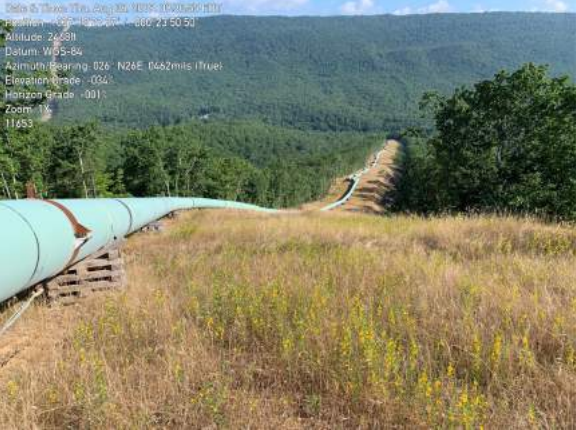
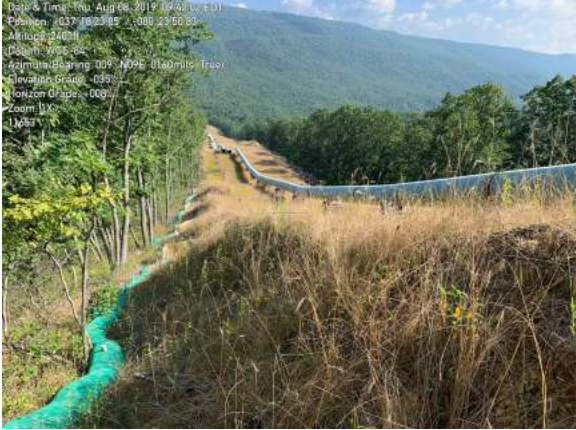
GPS Location	See picture for GPS coordinates		GPS Location	See picture for GPS coordinates	
Field Station#	11653+00		Field Station#	11652+00	
Pic 1 Desc.	ECD's and row conditions		Pic 2 Desc.	ECD's and row conditions

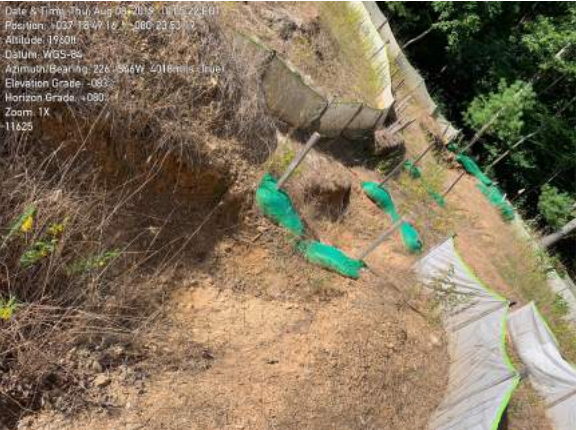
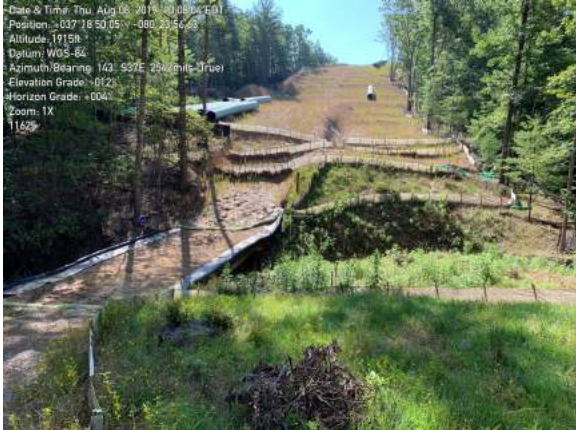
GPS Location	See picture for GPS coordinates		GPS Location	See picture for GPS coordinates	
Field Station#	11625+00		Field Station#	11625+00	
Pic 3 Desc.	ECD's and row conditions		Pic 4 Desc.	ECD's and row conditions

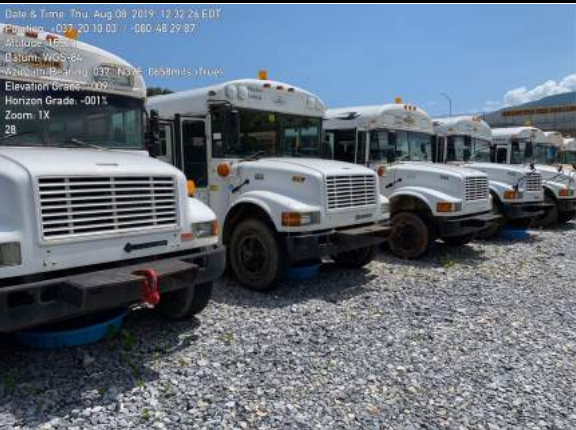
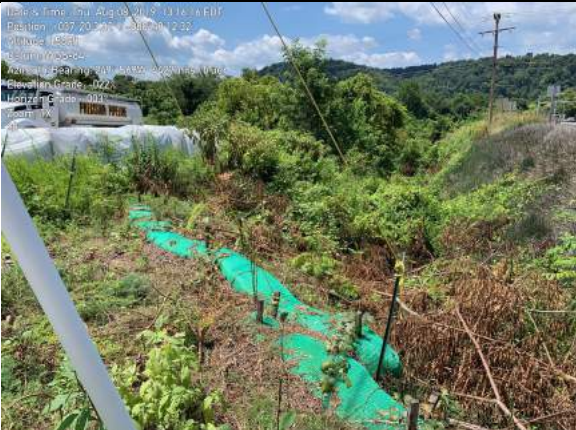
GPS Location	See picture for GPS coordinates		GPS Location	See picture for GPS coordinates	
Field Station#	+28		Field Station#	+28	
Pic 5 Desc.	ECD's and row conditions		Pic 6 Desc.	ECD's and row conditions

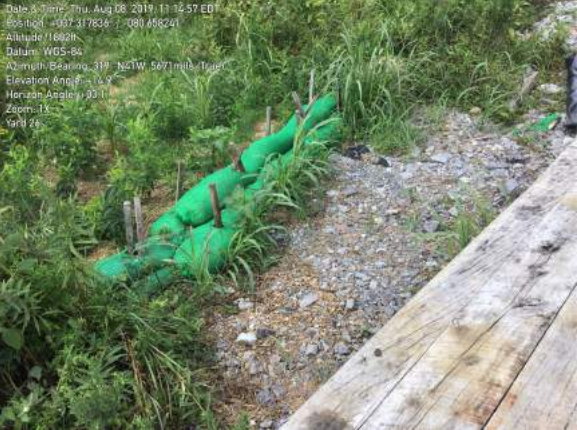
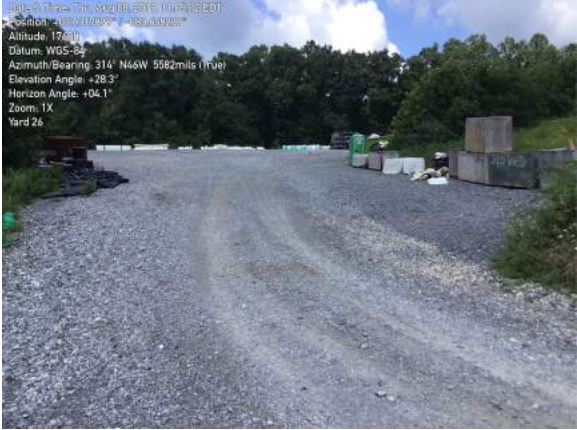
GPS Location	See photo for GPS location.		GPS Location	See photo for GPS location.	
Field Station#	12005+00		Field Station#	12005+00	
Pic 1 Desc.	Triple stack CFS in place.		Pic 2 Desc.	Parking area covered with geotextile and rock.	
<p>Date & Time: Thu, Aug 08, 2019, 11:38:18 EDT Position: +037.318455° / -080.457431° Altitude: 1759ft Datum: WGS-84 Azimuth/Bearing: 327° N62W 5631mils (True) Elevation Angle: +26.3° Horizon Angle: +01.1° Zoom: 1X Yard: 26</p>

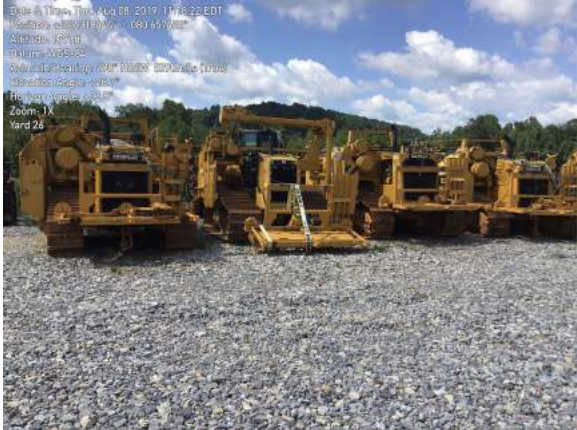
<p>Date & Time: Thu, Aug 08, 2019, 11:38:18 EDT Position: +037.318455° / -080.457431° Altitude: 1759ft Datum: WGS-84 Azimuth/Bearing: 327° N62W 5631mils (True) Elevation Angle: +26.3° Horizon Angle: +01.1° Zoom: 1X Yard: 26</p>

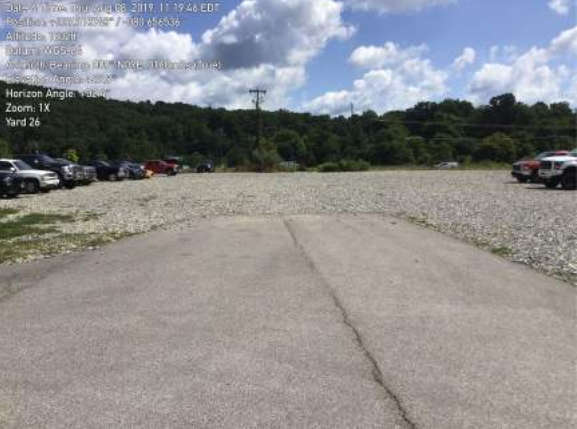
GPS Location	See photo for GPS location.		GPS Location	See photo for GPS location.	
Field Station#	12005+00		Field Station#	12005+00	
Pic 3 Desc.	Secondary containment in place under fuel cell		Pic 4 Desc.	Parked equipment, no leaks observed.	
<p>Date & Time: Thu, Aug 08, 2019, 11:39:44 EDT Position: +037.319242° / -080.456336° Altitude: 1829ft Datum: WGS-84 Azimuth/Bearing: 328° N62W 5631mils (True) Elevation Angle: +26.3° Horizon Angle: +03.3° Zoom: 1X Yard: 26</p>

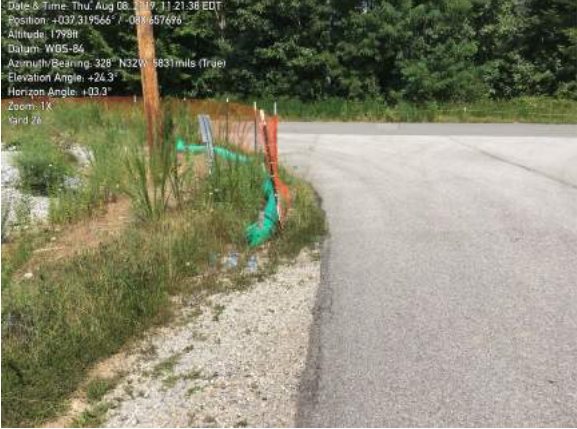
<p>Date & Time: Thu, Aug 08, 2019, 11:41:38 EDT Position: +037.319566° / -080.457696° Altitude: 1799ft Datum: WGS-84 Azimuth/Bearing: 328° N62W 5631mils (True) Elevation Angle: +26.3° Horizon Angle: +03.3° Zoom: 1X Yard: 26</p>

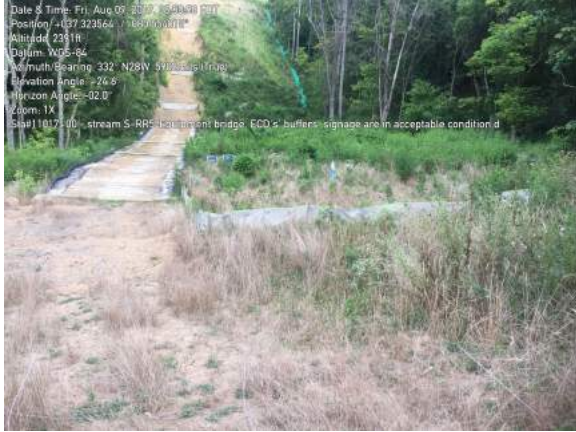
<p>Date & Time: Fri, Aug 09, 2019, 08:43:00 EDT Position: +037.323864° / -090.645908° Altitude: 2311ft Datum: WGS-84 Azimuth/Bearing: 332° N28W 5113mils (True) Elevation Angle: +26.8° Horizon Angle: -02.0° Zoom: 1X Still 11017+00 Stream S-RR5- butiment bridge, ECD's, buffers, signage are in acceptable condition</p>

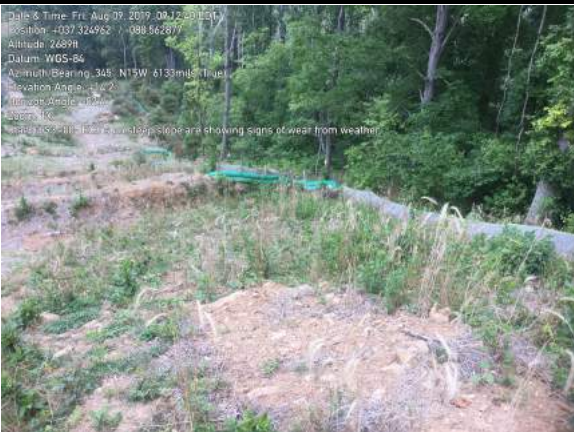
<p>Date & Time: Fri, Aug 09, 2019, 09:12:00 EDT Position: +037.324962° / -090.562877° Altitude: 2689ft Datum: WGS-84 Azimuth/Bearing: 345° N15W 6133mils (True) Elevation Angle: +16.2° Horizon Angle: -03.9° Zoom: 1X Still 10993+00 Steep slope ECD's are showing signs of wear from weather</p>

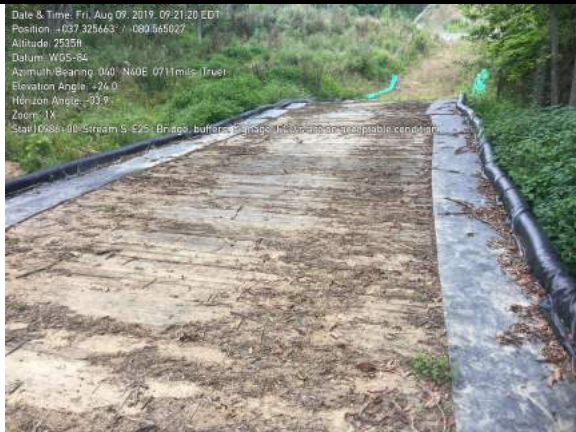
<p>Date & Time: Fri, Aug 09, 2019, 09:21:20 EDT Position: +037.325463° / -090.565027° Altitude: 2535ft Datum: WGS-84 Azimuth/Bearing: 040° N40E 0711mils (True) Elevation Angle: +26.0° Horizon Angle: -03.9° Zoom: 1X Still 10986+00 Stream S-E25- Bridge, buffers, signage are in acceptable condition</p>

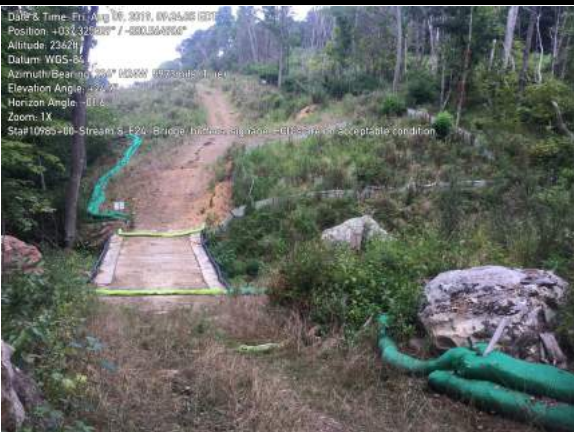
GPS Location	See photo GPS	GPS Location	See photo GPS		
Field Station#	10993+00	Field Station#	10986+00		
Pic 3 Desc.	Steep slope ECD's are in acceptable condition	Pic 4 Desc.	Stream- S-E25- iControls & bridge are good		
<p>Date & Time: Fri, Aug 09, 2019, 09:25:06 EDT Position: +037.325282° / -090.564906° Altitude: 2367ft Datum: WGS-84 Azimuth/Bearing: 334° N28W 4930mils (True) Elevation Angle: +26.0° Horizon Angle: -03.9° Zoom: 1X Still 10985+00 Stream S-E24- Bridge, buffers, signage are in acceptable condition</p>

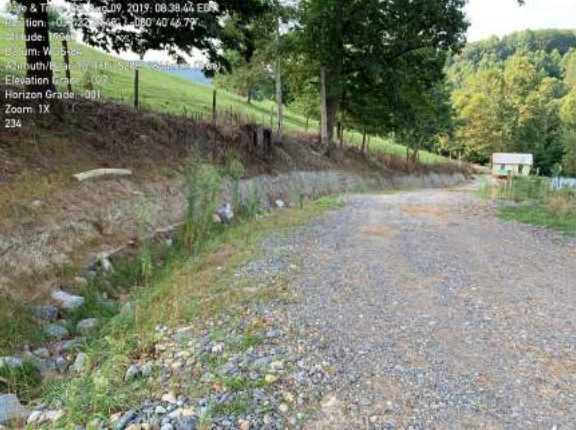
GPS Location	See picture above for GPS coordinates	GPS Location	See picture above for GPS coordinates		
Field Station#	2+34	Field Station#	10832+00		
Pic 1 Desc.	ECD's and row conditions	Pic 2 Desc.	Punchlist item completed

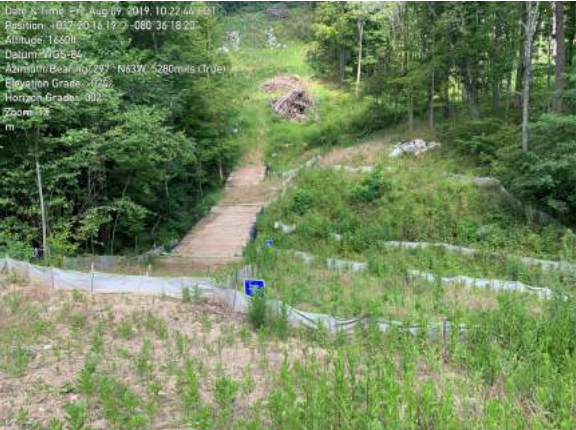
GPS Location	See picture above for GPS coordinates	GPS Location	See picture above for GPS coordinates		
Field Station#	10830+00	Field Station#	10882+00		
Pic 3 Desc.	ECD's and row conditions	Pic 4 Desc.	Rill erosion

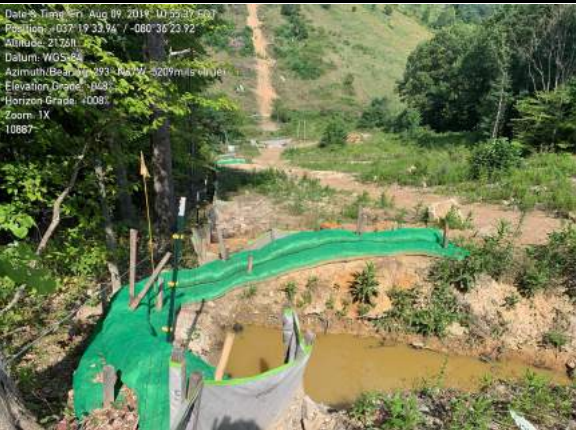
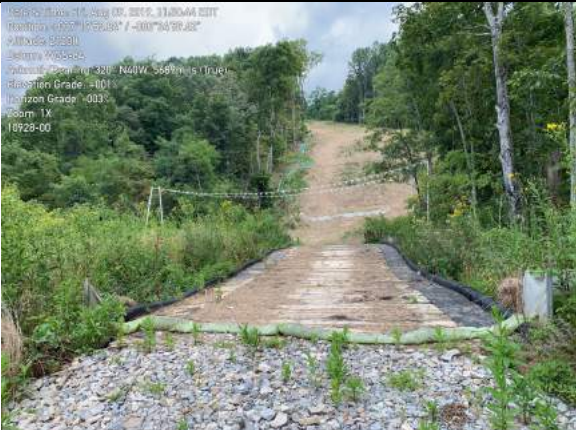
GPS Location	See picture above for GPS coordinates	GPS Location	See picture above for GPS coordinates		
Field Station#	10887+00	Field Station#	1092+98		
Pic 5 Desc.	ECD's and row conditions	Pic 6 Desc.	ECD's and row conditions
