Visual Site Inspection Report

Project Name	H-600 Pipeline Spread G	AFE	124300137	Spread	H-600 Pipeline Spread
Contractor	Precision			Report #	677
Inspector	Len Kruizenga			Date/Time	8/12/2019 7:22 AM
Permit #	TBD	Inspection Type	VA SWPP	Station Begin	11354+00
State	VA	Inspection Area	Full	Station End	11161+00
County	Giles	Ground	Dry	Temperature (°F)	90.00
Municipality	N/A	Weather	Sunny	Rain Gauge (in)	0.00
				Rain Accumulation Time (days)	3.00

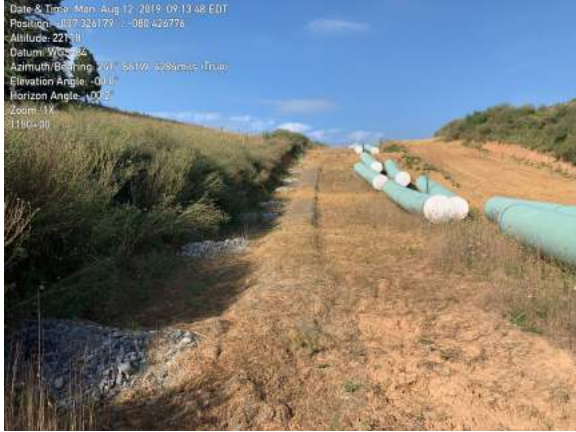
</div>			
GPS Location	see photo.	GPS Location	see photo		
Field Station#	11506+00	Field Station#	11502+00		
Pic 1 Desc.	Plunge pool in place.	Pic 2 Desc.	Conveyance channel with rock checks in place.		
<div><p>Date & Time: Mon Aug 12, 2019 09:26:21 EDT Position: +037.323694 / -080.433667 Altitude: 2105ft Datum: WGS-84 Azimuth/Bearing: 266° S86W 472ft (True) Elevation Angle: +04.2° Horizon Angle: +01.2° Zoom: 1X 11476+00</p>

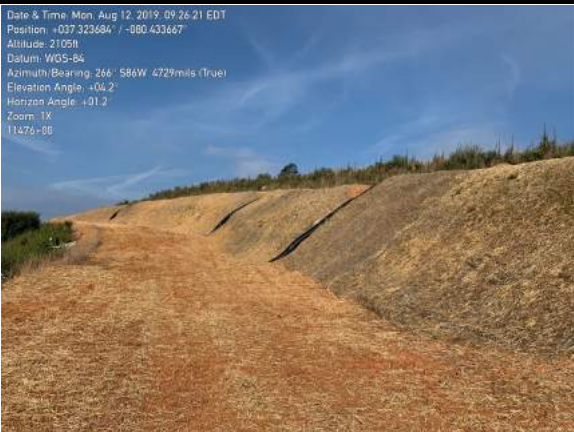
GPS Location	see photo	GPS Location	see photo		
Field Station#	11476+00	Field Station#	11497+00		
Pic 3 Desc.	Two tone with slope drains and ECB.	Pic 4 Desc.	ROW stabilized with seed and mulch.		
<div><p>Date & Time: Mon Aug 12, 2019 09:42:51 EDT Position: +037.315698 / -080.431273 Altitude: 2229ft Datum: WGS-84 Azimuth/Bearing: 231° S81W 419ft (True) Elevation Angle: -08.7° Horizon Angle: -00.2° Zoom: 1X 11451+00 S-0012 & S-0013</p>

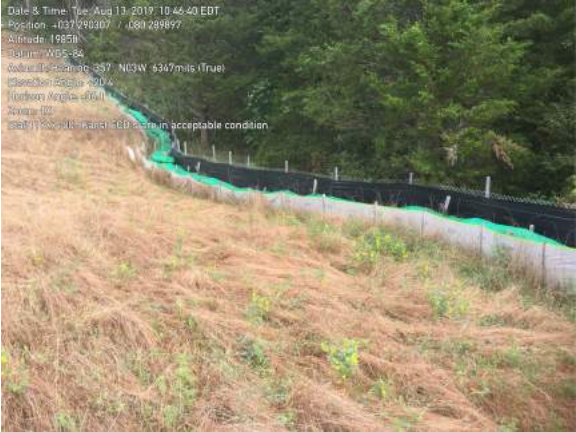
Insert image here			
GPS Location	See photo GPS	GPS Location			
Field Station#	11979+00	Field Station#			
Pic 7 Desc.	Karst ECD's	Pic 8 Desc.			
Insert image here		Insert image here			
GPS Location		GPS Location			
Field Station#		Field Station#			
Pic 9 Desc.		Pic 10 Desc.			
Insert image here		Insert image here			
GPS Location		GPS Location			
Field Station#		Field Station#			
Pic 11 Desc.		Pic 12 Desc.

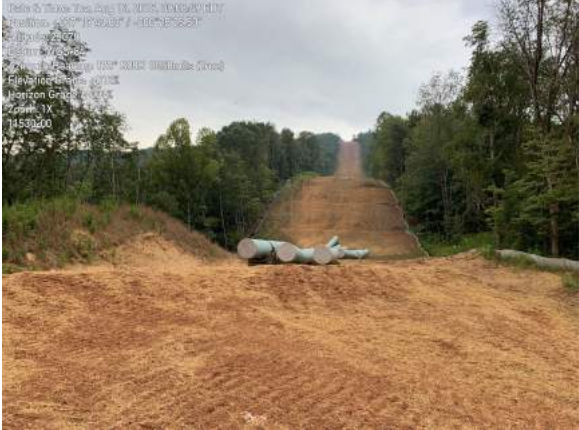
GPS Location	See picture above for GPS coordinates	GPS Location	See picture above for GPS coordinates		
Field Station#	11525+00	Field Station#	11540+00		
Pic 1 Desc.	ECD's and row conditions	Pic 2 Desc.	ECD's and row conditions

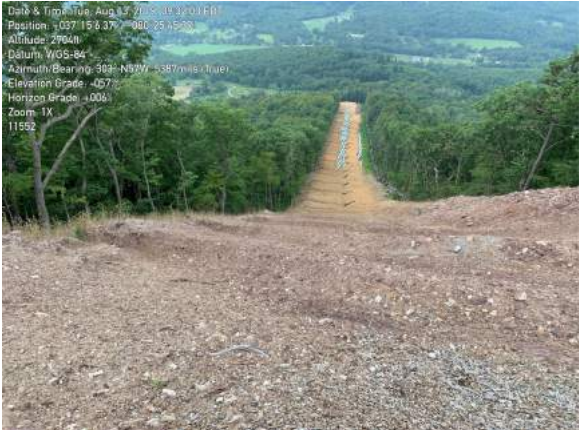
GPS Location	See picture above for GPS coordinates	GPS Location	See picture above for GPS coordinates		
Field Station#	11553+00	Field Station#	11567+00		
Pic 3 Desc.	ECD's and row conditions	Pic 4 Desc.	ECD's and row conditions

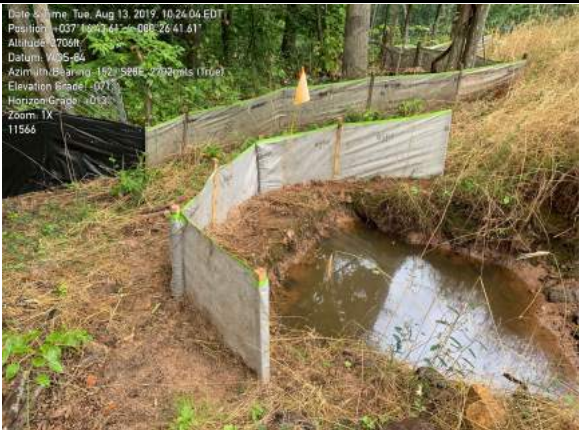
GPS Location	See picture above for GPS coordinates	GPS Location	See picture above for GPS coordinates		
Field Station#	1157+00	Field Station#	11583+00		
Pic 5 Desc.	ECD's and row conditions	Pic 6 Desc.	ECD's and row conditions

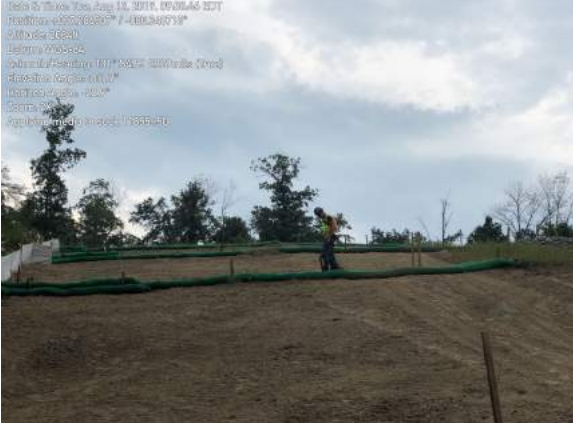
GPS Location	1	GPS Location	2		
Field Station#	11855+50	Field Station#	11855+00		
Pic 1 Desc.	Applying media to CFS.	Pic 2 Desc.	Staking CFS.		
<p>Date & Time: Tue Aug 13, 2019, 10:01:02 EDT Position: +037.242280° / -080.36778° Altitude: 2231ft Datum: WGS-84 Azimuth/Bearing: 84° N49E 027mils (True) Elevation Angle: -04.1° Horizon Angle: -22.0° Zoom: 1X Karst 11829+50</p>

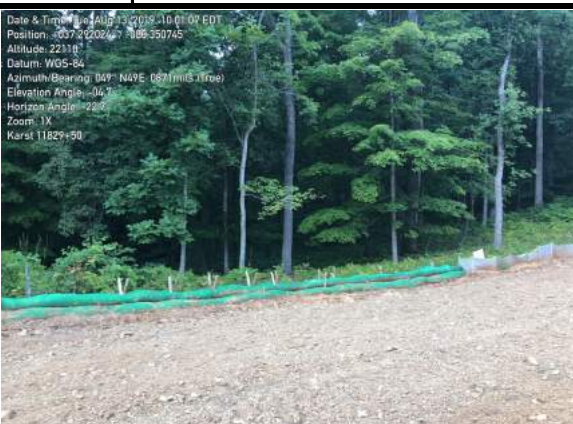
GPS Location	3	GPS Location	4		
Field Station#	11829+50	Field Station#	11833+50		
Pic 3 Desc.	Perimeter controls in good condition near karst	Pic 4 Desc.	Vegetation beginning to pop on curlex Ed section		
<p>Date & Time: Tue Aug 13, 2019, 12:52:09 EDT Position: +037.242280° / -080.36778° Altitude: 2239ft Datum: WGS-84 Azimuth/Bearing: 88° N99E 016mils (True) Elevation Angle: -11.2° Horizon Angle: -23.0° Zoom: 1X Adding stakes to triple stack 11835+00</p>

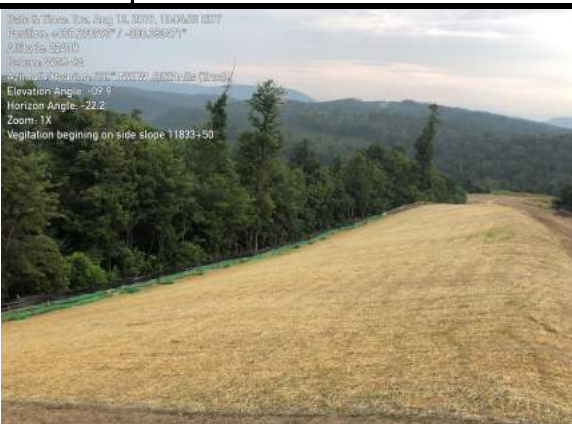
<p>Date & Time: Tue Aug 13, 2019, 10:49:08 EDT Position: +037.242280° / -080.36778° Altitude: 2231ft Datum: WGS-84 Azimuth/Bearing: 84° N49E 027mils (True) Elevation Angle: -04.1° Horizon Angle: -22.2° Zoom: 1X Vegetation beginning on side slope 11833+50</p>

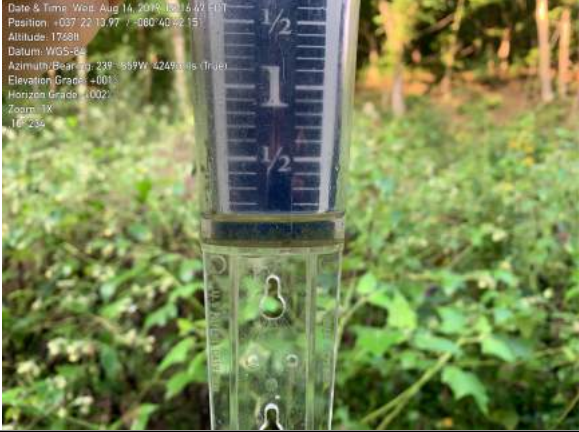
<p>Date & Time: Wed, Aug 14, 2019, 08:16:47 EDT Position: +037 22 13.45 / -080 40 41.95 Altitude: 1774ft Datum: WGS-84 Azimuth/Bearing: 215° N65W 540ft/mis (true) Elevation Grade: +003 Horizon Grade: +001 Zoom: 1X 234</p>		GPS Location See picture above for GPS coordinates	
Field Station# 2+34		Field Station# 2+34		GPS Location See picture above for GPS coordinates	
Pic 1 Desc. .10" recorded @ AR 234		Pic 2 Desc. ECD's and row conditions AR 234		Field Station# 2+34

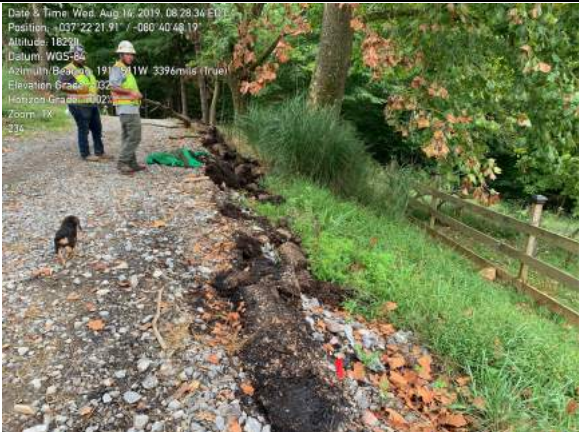
Field Station# 2+34		Field Station# +28		GPS Location See picture above for GPS coordinates	
Pic 3 Desc. Crews removing damaged CFS		Pic 4 Desc. ECD's and row conditions @ LDY 28		Field Station# +28

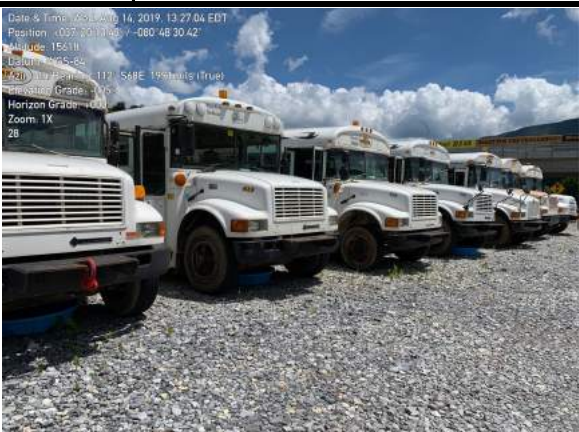
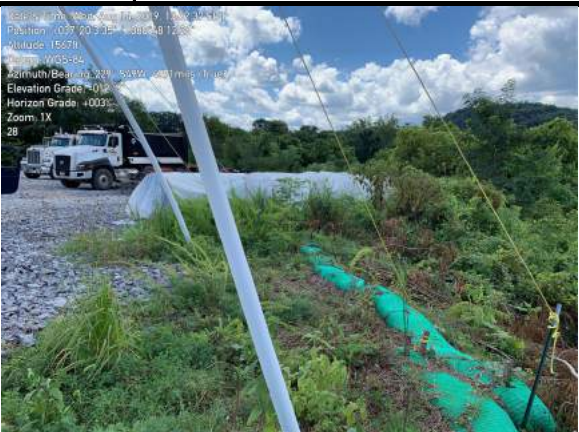
<p>Date & Time: Wed, Aug 14, 2019, 13:27:04 EDT Position: +037 20 53.15 / -080 48 30.42 Altitude: 1561ft Datum: WGS-84 Azimuth/Bearing: 112° S49E 19ft/mis (true) Elevation Grade: +015 Horizon Grade: +001 Zoom: 1X 28</p>		GPS Location See picture above for GPS coordinates	
Field Station# +28		Field Station# +28		GPS Location See picture above for GPS coordinates	
Pic 5 Desc. ECD's and row conditions @ LDY 28		Pic 6 Desc. ECD's and row conditions @ LDY 28		Field Station# +28

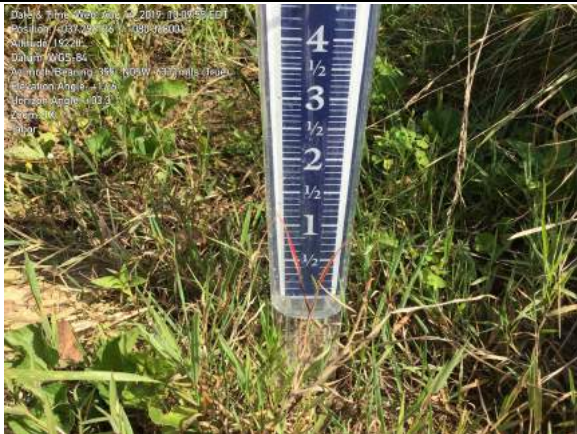
<p>Date & Time: Wed, Aug 14, 2019, 14:35:03 EDT Position: +037.318887°N -080.659841°W Altitude: 1785ft Datum: WGS-84 Azimuth/Bearing: 007° N07E 0024mils (True) Elevation Angle: +20.7° Horizon Angle: +00.1° Zenith: 1° Yard 26</p>			
GPS Location	See photo for GPS location.	GPS Location	See photo for GPS location.		
Field Station#	11767+00	Field Station#	12005+00		
Pic 1 Desc.	Rain gauge at Mount Tabor has a trace amount.	Pic 2 Desc.	Triple stack 12" CFS in place.

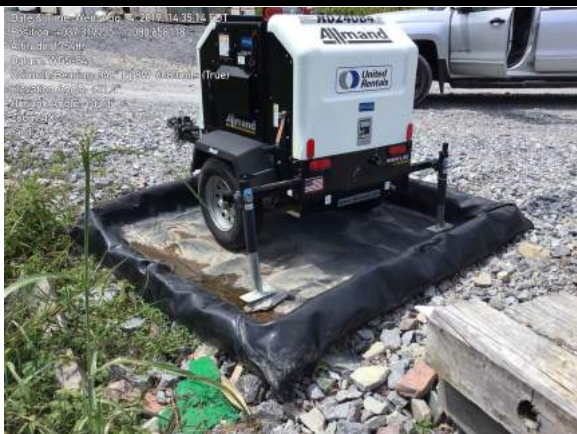
GPS Location	See photo for GPS location.	GPS Location	See photo for GPS location.		
Field Station#	12005+00	Field Station#	12005+00		
Pic 3 Desc.	Secondary containment under light plant.	Pic 4 Desc.	18 inch CFS in place.

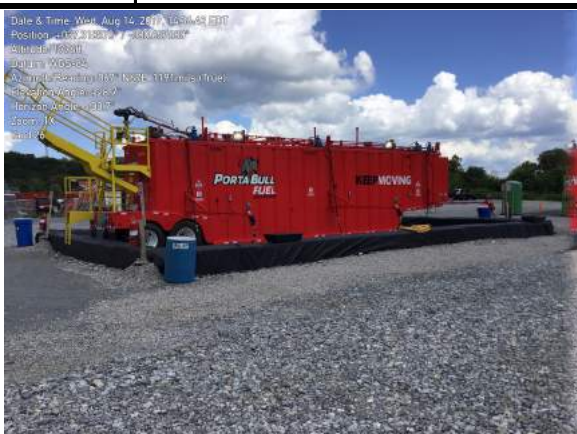
<p>Date & Time: Wed, Aug 14, 2019, 14:35:43 EDT Position: +037.318887°N -080.659841°W Altitude: 1785ft Datum: WGS-84 Azimuth/Bearing: 007° N07E 0024mils (True) Elevation Angle: +20.7° Horizon Angle: +00.1° Zenith: 1° Yard 26</p>			
GPS Location	See photo for GPS location.	GPS Location	See photo for GPS location.		
Field Station#	12005+00	Field Station#	12005+00		
Pic 5 Desc.	Secondary containment under fuel cell.	Pic 6 Desc.	RCE in place.

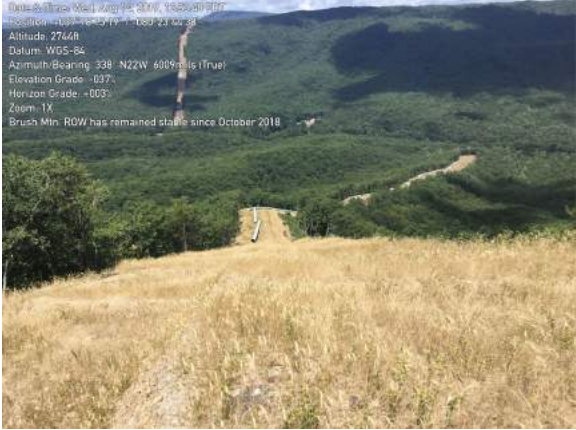
GPS Location	Location on photo		GPS Location	Location on photo	
Field Station#	11669+87		Field Station#	11662+00	
Pic 1 Desc.	All topsoil piles have remained stable regardless of amount of vegetation		Pic 2 Desc.	Vegetation has been adequate for stabilization	
<p>Date & Time: Wed, Aug 14, 2019, 13:15:15 EDT Position: +037 18 12.897 / -080 23 39.93 Altitude: 2784ft Datum: WGS-84 Azimuth/Bearing: 342° N13W 6169mils (True) Elevation Grade: +054% Horizon Grade: +007% Zoom: 1X Brush Mtn. 11662+00 perimeter controls checked for maintenance needs</p>

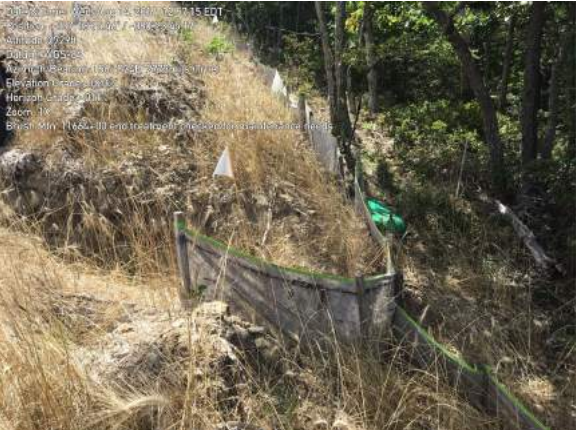
<p>Date & Time: Wed, Aug 14, 2019, 13:02:02 EDT Position: +037 18 18.654 / -080 23 39.93 Altitude: 2404ft Datum: WGS-84 Azimuth/Bearing: 342° N13W 6169mils (True) Elevation Grade: +054% Horizon Grade: +007% Zoom: 1X Brush Mtn. 11661+00 perimeter controls checked for maintenance needs</p>

GPS Location	Location on photo		GPS Location	Location on photo	
Field Station#	11664+00		Field Station#	11661+00	
Pic 3 Desc.	Perimeter controls are in place and functional		Pic 4 Desc.	Perimeter controls are in place and functional	
<p>Date & Time: Wed, Aug 14, 2019, 13:55:22 EDT Position: +037 18 38.177 / -080 18 10.007 Altitude: 2223ft Datum: WGS-84 Azimuth/Bearing: 221° N39W 1570mils (True) Elevation Grade: +114% Horizon Grade: +022% Zoom: 1X Brush Mtn. 11645+00 ROW stable</p>

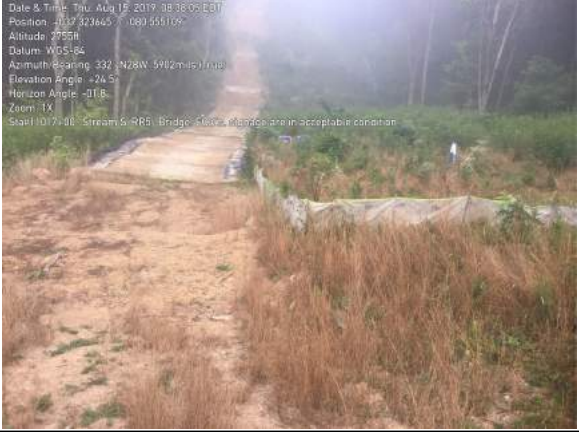
<p>Date & Time: Thu, Aug 15, 2019, 08:38:05 EDT Position: +037.323665 / -080.555109 Altitude: 2355ft Datum: WGS-84 Azimuth Bearing: 332° N28W 5402mils (True) Elevation Angle: +26.5° Horizon Angle: -01.8° Zoom: 1X Stat: 11017+00- Stream S-RR5- Bridge- signage, ECD's, good</p>		GPS Location See photo GPS Field Station# 11022+00 Pic 1 Desc. Stream S-IJ18- ECD's, signage, bridge, good

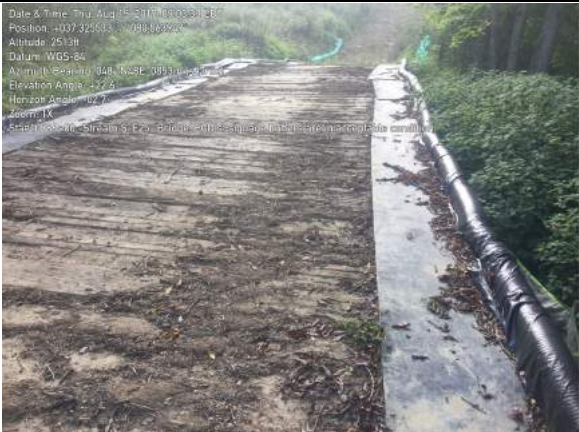
<p>Date & Time: Thu, Aug 15, 2019, 09:04:19 EDT Position: +037.325613 / -080.560327 Altitude: 2513ft Datum: WGS-84 Azimuth Bearing: 348° N48W 633mils (True) Elevation Angle: +27.6° Horizon Angle: -02.7° Zoom: 1X Stat: 10986+00- Stream S-E25- Bridge- buffers, signage, ECD's are in acceptable condition</p>

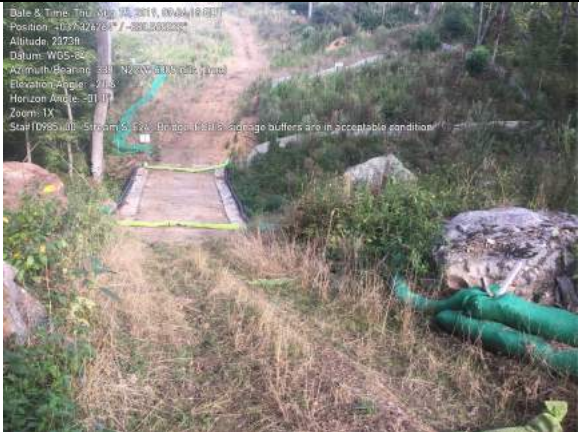
<p>Date & Time: Thu, Aug 15, 2019, 09:04:19 EDT Position: +037.326757 / -080.560327 Altitude: 2373ft Datum: WGS-84 Azimuth Bearing: 331° N29W 613mils (True) Elevation Angle: +21.3° Horizon Angle: -01.0° Zoom: 1X Stat: 10985+00- Stream S-E25- Bridge- buffers, signage, ECD's are in acceptable condition</p>		GPS Location See photo GPS Field Station# 11017+00 Pic 2 Desc. Stream S-RR5- bridge, signage ECD's, good

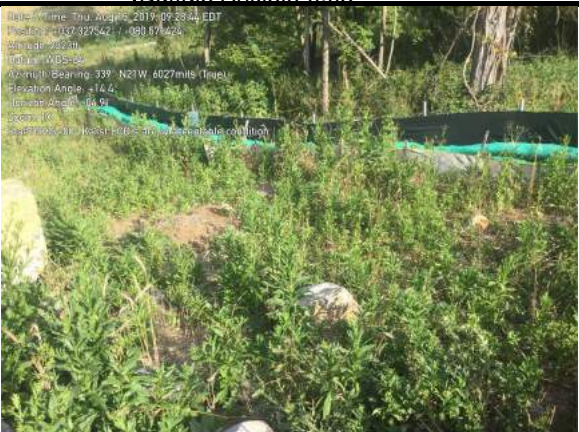
<p>Date & Time: Thu, Aug 15, 2019, 09:29:44 EDT Position: +037.327547 / -080.570267 Altitude: 2397ft Datum: WGS-84 Azimuth Bearing: 331° N21W 6027mils (True) Elevation Angle: +14.4° Horizon Angle: -04.9° Zoom: 1X Stat: 10965+00- Karst ECD's are in acceptable condition</p>		GPS Location See photo GPS Field Station# 10986+00 Pic 3 Desc. Stream S-E25- bridge, buffers, signage, ECD's are in acceptable condition	
GPS Location See photo GPS Field Station# 10969+50 Pic 5 Desc. LO or other has removed top sock on perimeter controls		GPS Location See photo GPS Field Station# 10985+00 Pic 4 Desc. Checked rain gauge's: Buffalo Anklets-0.05"		GPS Location See photo GPS Field Station# 10965+00 Pic 6 Desc. Karst ECD's are in acceptable condition

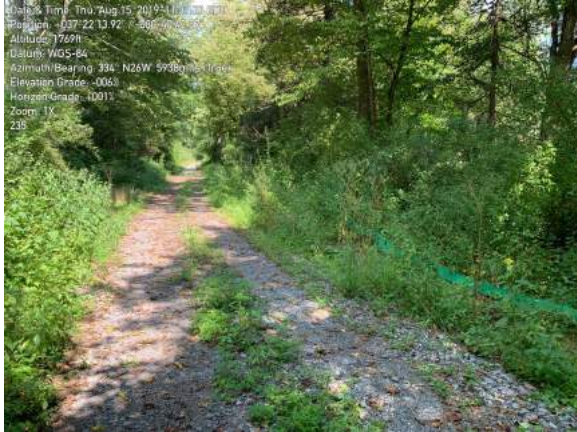
<p>Date & Time: Thu, Aug 15, 2019 11:33:41 EDT Position: -037 22 13.92 / -080 40 43.22 Altitude: 1769ft Datum: WGS-84 Azimuth Bearing: 334° N26W 593mish True Elevation Grade: -003 Horizon Grade: -001 Zoom: 1X 235</p>

<p>Date & Time: Thu, Aug 15, 2019 11:31:34 EDT Position: -037 22 13.12 / -080 40 43.22 Altitude: 1800ft Datum: WGS-84 Azimuth Bearing: 299° N70W 515mish True Elevation Grade: -022 Horizon Grade: -001 Zoom: 1X 234</p>			
GPS Location	See picture above for GPS coordinates		GPS Location	See picture above for GPS coordinates	
Field Station#	2+35		Field Station#	2+34	
Pic 1 Desc.	ECD's and row conditions AR 235		Pic 2 Desc.	ECD's and row conditions AR 234

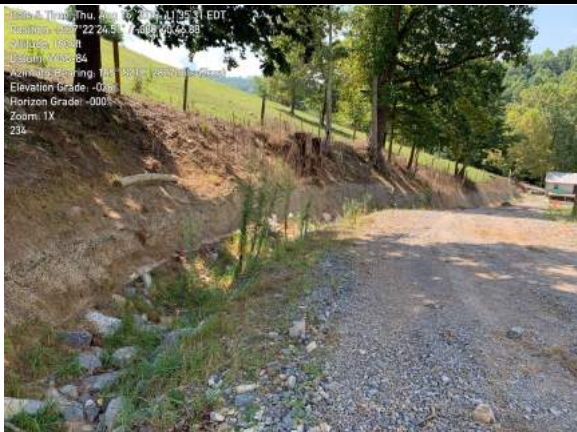
<p>Date & Time: Thu, Aug 15, 2019 12:24:51 EDT Position: -037 22 24.51 / -080 35 43.50 Altitude: 1600ft Datum: WGS-84 Azimuth Bearing: 304° N30W 520mish True Elevation Grade: -003 Horizon Grade: -003 Zoom: 1X 236</p>

GPS Location	See picture above for GPS coordinates		GPS Location	See picture above for GPS coordinates	
Field Station#	2+34		Field Station#	10855+00	
Pic 3 Desc.	ECD's and row conditions AR 234		Pic 4 Desc.	ECD's and row conditions for SA33 & SA34

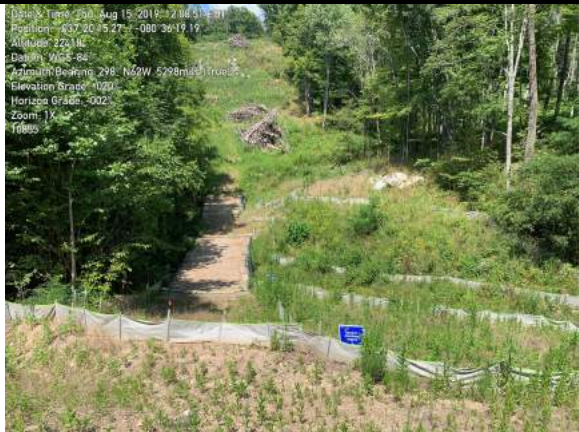
<p>Date & Time: Thu, Aug 15, 2019 12:04:11 EDT Position: -037 20 15.47 / -080 36 19.19 Altitude: 2211ft Datum: WGS-84 Azimuth Bearing: 298° N20W 529mish True Elevation Grade: -020 Horizon Grade: -002 Zoom: 1X 10855</p>

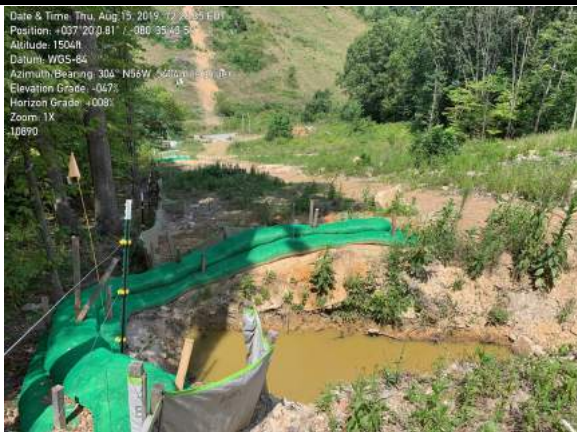
<p>Date & Time: Thu, Aug 15, 2019 12:35:01 EDT Position: -037 20 0.81 / -080 35 43.50 Altitude: 1504ft Datum: WGS-84 Azimuth Bearing: 304° N36W 540mish True Elevation Grade: -047 Horizon Grade: -009 Zoom: 1X 10890</p>

<p>Date & Time: Thu, Aug 15, 2019 12:36:05 EDT Position: -037 19 55.56 / -080 35 43.22 Altitude: 1411ft Datum: WGS-84 Azimuth Bearing: 285° N72W 512mish True Elevation Grade: -041 Horizon Grade: -041 Zoom: 1X 10921</p>			
GPS Location	See picture above for GPS coordinates		GPS Location	See picture above for GPS coordinates	
Field Station#	10890+00		Field Station#	10921+00	
Pic 5 Desc.	ECD's and row conditions		Pic 6 Desc.	ECD's and row conditions

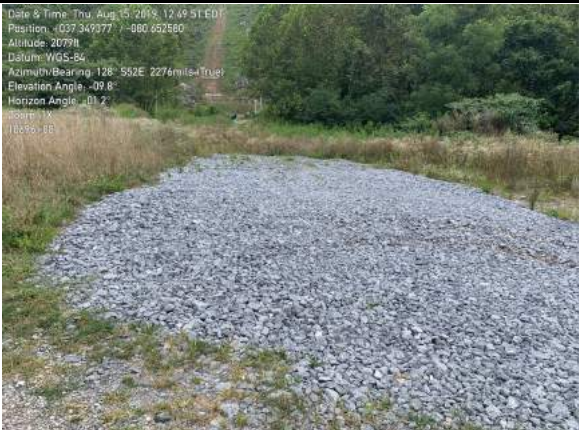
<p>Date & Time: Thu, Aug 15, 2019, 12:50:40 EDT Position: -037.347377 / -080.654639 Altitude: 2059ft Datum: WGS-84 Azimuth/Bearing: 281° W44W 4296ftmils (True) Elevation Angle: -00.1° Horizon Angle: +03.3° Zoom: 1X 10693+00</p>

GPS Location	See photo for GPS location.		GPS Location	See photo for GPS location.	
Field Station#	10696+00		Field Station#	10693+00	
Pic 5 Desc.	RCE in place at Buffalo Anklets Road.		Pic 6 Desc.	Top soil pile stabilized.

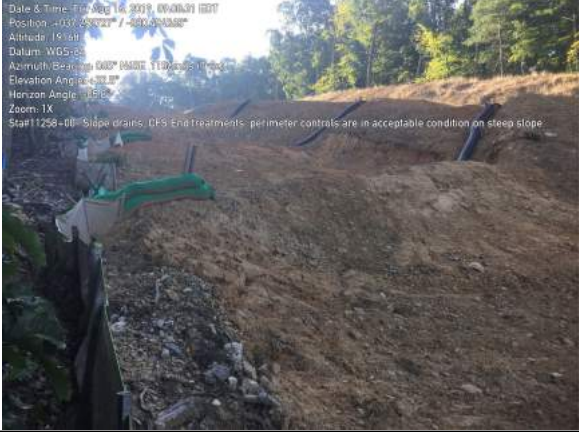
AFE	124300137	Date/Time	8/16/2019 8:07 AM	Report #	938
Pictures					
<p>Date & Time: Fri, Aug 16, 2019, 08:06:31 EDT Position: +037 295727° / -080 486155° Altitude: 1916ft Datum: WGS-84 Azimuth/Bearing: 307° NS3W 5493mils (True) Elevation Angle: +23.3° Horizon Angle: -04.3° Zoom: 1X Sta#11258+00- Slope drains, CFS end treatments- perimeter controls are in acceptable condition on steep slope.</p>

GPS Location	See photo GPS	GPS Location	See photo GPS		
Field Station#	11258+00	Field Station#	11279+00		
Pic 1 Desc.	Steep slope ECD's in acceptable condition.	Pic 2 Desc.	CWD, plunge pool, slope drain are good.

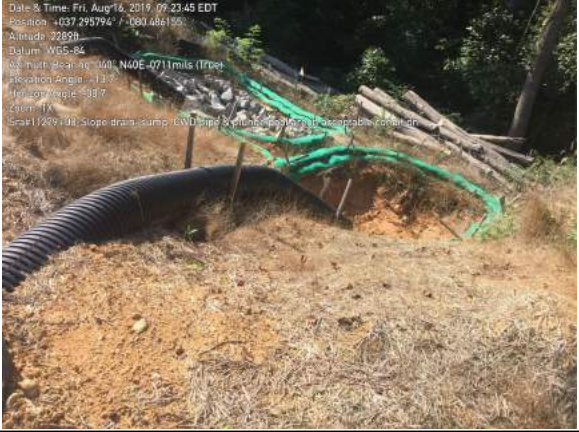
<p>Date & Time: Fri, Aug 16, 2019, 09:23:45 EDT Position: +037 295794° / -080 486155° Altitude: 2282ft Datum: WGS-84 Azimuth/Bearing: 344° N40E 4711mils (True) Elevation Angle: +17° Horizon Angle: -08.7° Zoom: 1X Sta#11279+00- slope drain, sump, CWD pipe & plunge pool are in acceptable condition.</p>

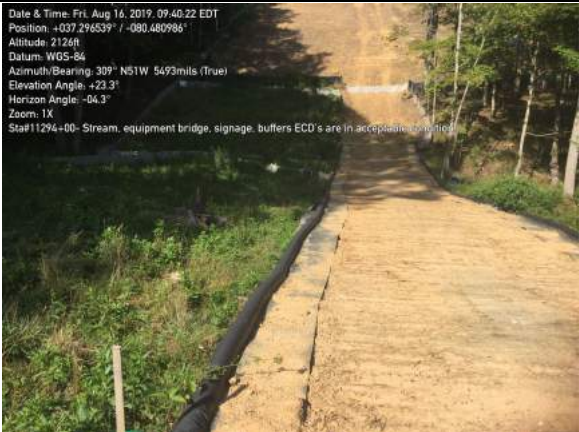
<p>Date & Time: Fri, Aug 16, 2019, 09:40:22 EDT Position: +037 296539° / -080 480986° Altitude: 2126ft Datum: WGS-84 Azimuth/Bearing: 309° NS1W 5493mils (True) Elevation Angle: +23.3° Horizon Angle: -04.3° Zoom: 1X Sta#11294+00- Stream, equipment bridge, signage, buffers ECD's are in acceptable condition.</p>

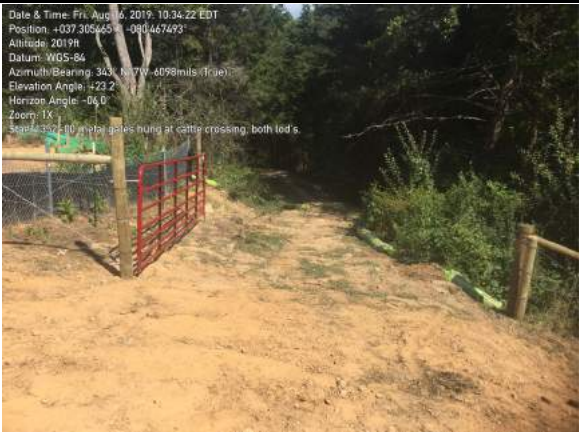
<p>Date & Time: Fri, Aug 16, 2019, 10:04:58 EDT Position: +037 309120° / -080 510386° Altitude: 2347ft Datum: WGS-84 Azimuth/Bearing: 307° NS3W 5458mils (True) Elevation Angle: +26.5° Horizon Angle: -04.7° Zoom: 1X Stream S-NN12- Equipment bridge, signage, buffers, stream controls are in acceptable condition.</p>  			
GPS Location	See photo GPS	GPS Location	See photo GPS		
Field Station#	11294+00	Field Station#	11328+00		
Pic 3 Desc.	Stream controls, buffers, signage, bridge, good	Pic 4 Desc.	Stream S-NN12- Controls are acceptable.		
<p>Date & Time: Fri, Aug 16, 2019, 10:34:22 EDT Position: +037 306465° / -080 467493° Altitude: 2011ft Datum: WGS-84 Azimuth/Bearing: 343° NS1W 4696mils (True) Elevation Angle: +23.2° Horizon Angle: -04.0° Zoom: 1X Sta#11352+00- Metal gates hung at cattle crossing, both led's.</p>

GPS Location	See photo GPS	GPS Location	See photo GPS		
Field Station#	11352+00	Field Station#	11225+00		
Pic 5 Desc.	Metal cattle crossing gates hung, both los's.	Pic 6 Desc.	Slope drain rock swale are in acceptable condition

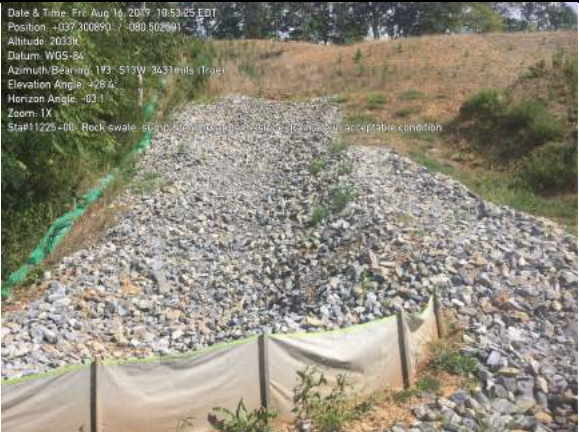
<p>Date & Time: Fri, Aug 16, 2019, 10:53:05 EDT Position: +037 300850° / -080 502691° Altitude: 2053ft Datum: WGS-84 Azimuth/Bearing: 193° S13W 3631mils (True) Elevation Angle: +28.4° Horizon Angle: -03.1° Zoom: 1X Sta#11225+00- Rock swale, sump, sump, sump, sump are in acceptable condition.</p>

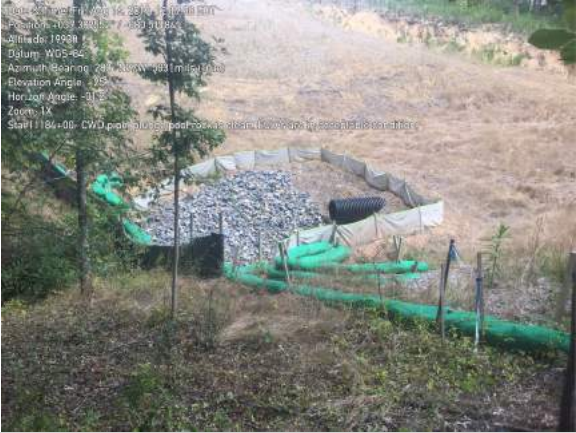
<p>Insert image here</p>			
GPS Location	See photo GPS	GPS Location			
Field Station#	11184+00	Field Station#			
Pic 7 Desc.	CWD. Plunge pool & controls are in acceptable condition	Pic 8 Desc.			
<p>Insert image here</p>		<p>Insert image here</p>			
GPS Location		GPS Location			
Field Station#		Field Station#			
Pic 9 Desc.		Pic 10 Desc.			
<p>Insert image here</p>		<p>Insert image here</p>			
GPS Location		GPS Location			
Field Station#		Field Station#			
Pic 11 Desc.		Pic 12 Desc.

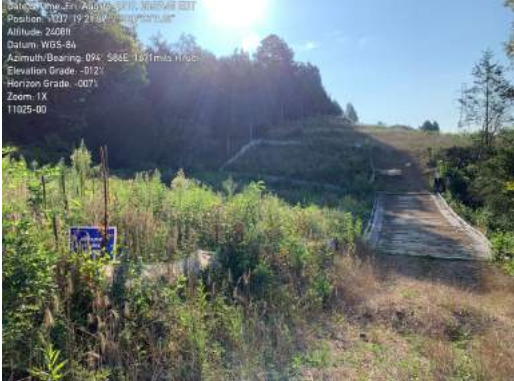
GPS Location	See picture above for GPS coordinates		GPS Location	See picture above for GPS coordinates	
Field Station#	11025+00		Field Station#	11032+00	
Pic 1 Desc.	ECD's and row conditions		Pic 2 Desc.	ECD's and row conditions

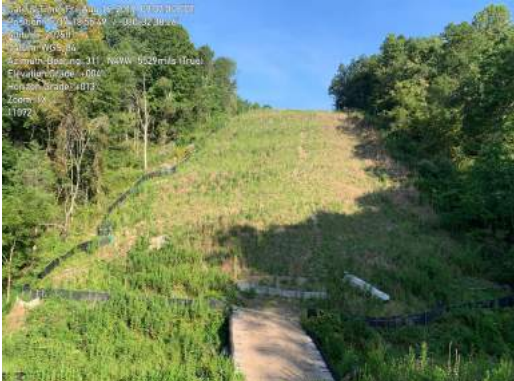
GPS Location	See picture above for GPS coordinates		GPS Location	See picture above for GPS coordinates	
Field Station#	11072+00		Field Station#	11127+00	
Pic 3 Desc.	ECD's and row conditions		Pic 4 Desc.	ECD's and row conditions

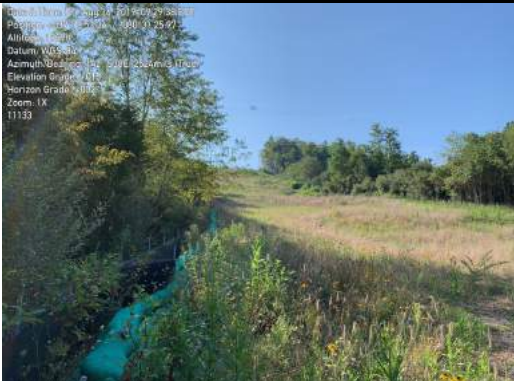
GPS Location	See picture above for GPS coordinates		GPS Location	See picture above for GPS coordinates	
Field Station#	11133+00		Field Station#	11140+00	
Pic 5 Desc.	ECD's and row conditions for Karst		Pic 6 Desc.	ECD's and row conditions
