# Visual Site Inspection Report

<b>Project Name</b>	H-600 Pipeline Spread G	<b>AFE</b>	124300137	<b>Spread</b>	H-600 Pipeline Spread
<b>Contractor</b>	Precision			<b>Report #</b>	1031
<b>Inspector</b>	Len Kruizenga			<b>Date/Time</b>	8/19/2019 8:36 AM
<b>Permit #</b>	TBD	<b>Inspection Type</b>	VA SWPP	<b>Station Begin</b>	11857+00
<b>State</b>	VA	<b>Inspection Area</b>	Full	<b>Station End</b>	12001+00
<b>County</b>	Montgomery	<b>Ground</b>	Damp	<b>Temperature (°F)</b>	90.00
<b>Municipality</b>	N/A	<b>Weather</b>	Sunny	<b>Rain Gauge (in)</b>	0.30
				<b>Rain Accumulation Time (days)</b>	3.00

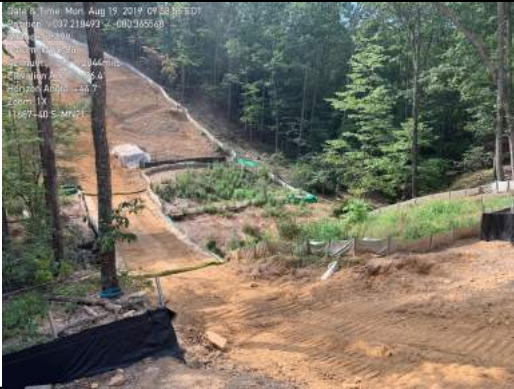
<b>GPS Location</b>	See photo for GPS location.		<b>GPS Location</b>	See photo for GPS location.	
<b>Field Station#</b>	11669+00		<b>Field Station#</b>	11670+00	
<b>Pic 1 Desc.</b>	ECDs upgraded to triple stack compost filter sock and priority one silt fence.		<b>Pic 2 Desc.</b>	Triple stack compost filter sock in place with sump pit.

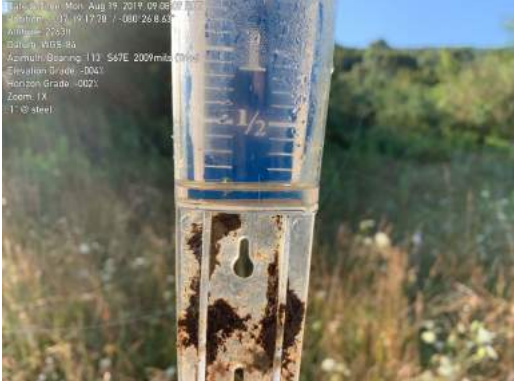
<b>GPS Location</b>	See picture above for GPS coordinates		<b>GPS Location</b>	See picture above for GPS coordinates	
<b>Field Station#</b>	+1		<b>Field Station#</b>	11532+00	
<b>Pic 1 Desc.</b>	.10" of rain recorded @ Steel Acres AR		<b>Pic 2 Desc.</b>	ECD's and row conditions for KARST feature

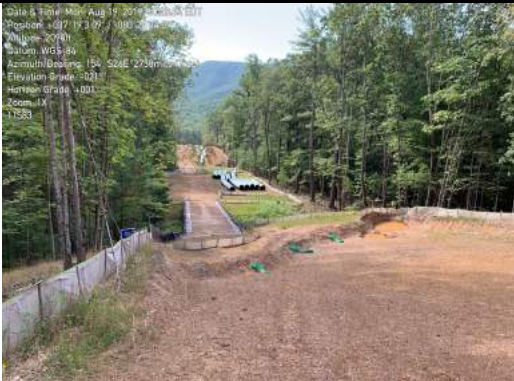
<b>GPS Location</b>	See picture above for GPS coordinates		<b>GPS Location</b>	See picture above for GPS coordinates	
<b>Field Station#</b>	11583+00		<b>Field Station#</b>	11575+00	
<b>Pic 5 Desc.</b>	ECD's and row conditions for S-PP21 & SPP20		<b>Pic 6 Desc.</b>	ECD's and row conditions for S-PP22 and W- CD46

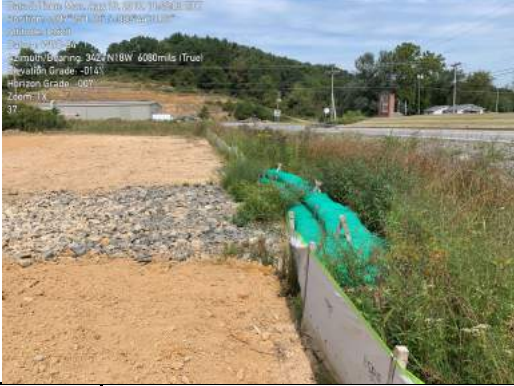
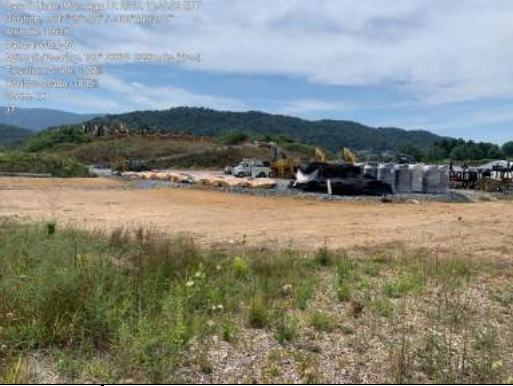
<b>GPS Location</b>	See picture above for GPS coordinates		<b>GPS Location</b>	See picture above for GPS coordinates	
<b>Field Station#</b>	+37		<b>Field Station#</b>	+37	
<b>Pic 1 Desc.</b>	ECD's and row conditions		<b>Pic 2 Desc.</b>	ECD's and row conditions

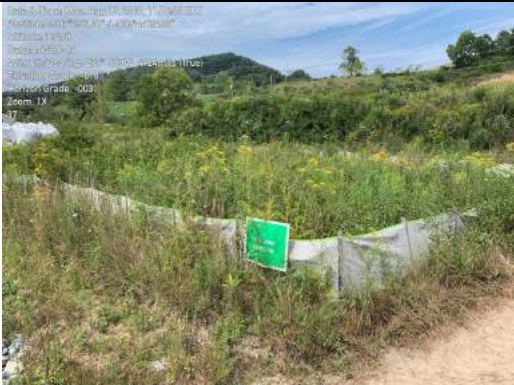
<b>GPS Location</b>	See picture above for GPS coordinates		<b>GPS Location</b>	See picture above for GPS coordinates	
<b>Field Station#</b>	+37		<b>Field Station#</b>	+37	
<b>Pic 3 Desc.</b>	ECD's for W-IJ18		<b>Pic 4 Desc.</b>	Secondary containment

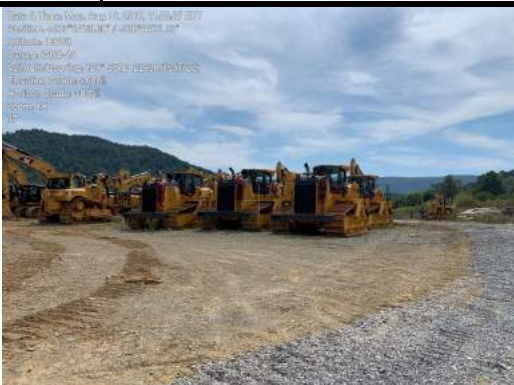
<b>GPS Location</b>	See picture above for GPS coordinates		<b>GPS Location</b>	See picture above for GPS coordinates	
<b>Field Station#</b>	+37		<b>Field Station#</b>	+37	
<b>Pic 5 Desc.</b>	Row conditions		<b>Pic 6 Desc.</b>	ECD's and row conditions

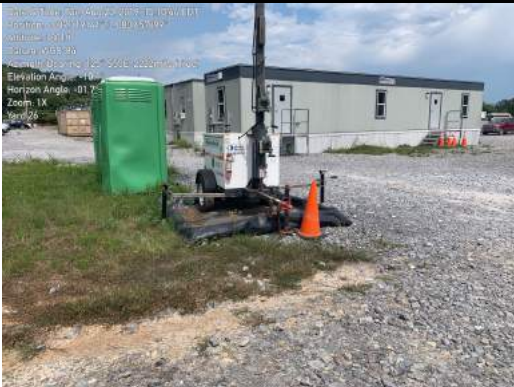
<b>GPS Location</b>	See photo for GPS location.		<b>GPS Location</b>	See photo for GPS location.	
<b>Field Station#</b>	12005+00		<b>Field Station#</b>	12005+00	
<b>Pic 1 Desc.</b>	Light plant in secondary containment.		<b>Pic 2 Desc.</b>	Triple stack CFS in place.

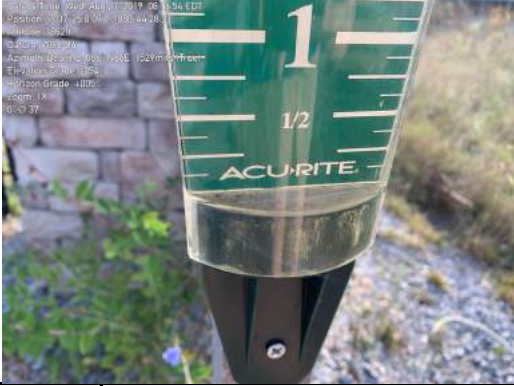
<b>GPS Location</b>	See picture above for GPS coordinates		<b>GPS Location</b>	See picture above for GPS coordinates	
<b>Field Station#</b>	+37		<b>Field Station#</b>	+37	
<b>Pic 1 Desc.</b>	No rain recorded		<b>Pic 2 Desc.</b>	Stickered clean equipment

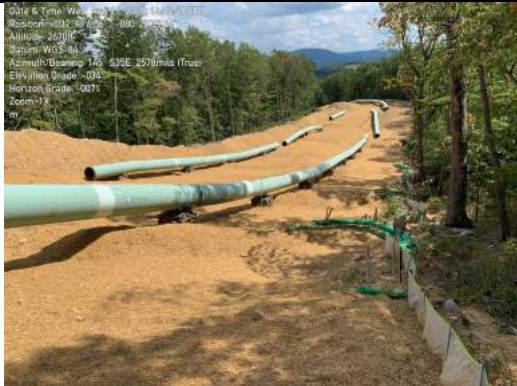
<b>GPS Location</b>	See picture above for GPS coordinates		<b>GPS Location</b>	See picture above for GPS coordinates	
<b>Field Station#</b>	10858+00		<b>Field Station#</b>	11680+00	
<b>Pic 5 Desc.</b>	ECD's and row conditions		<b>Pic 6 Desc.</b>	Crew stabilizing ROW

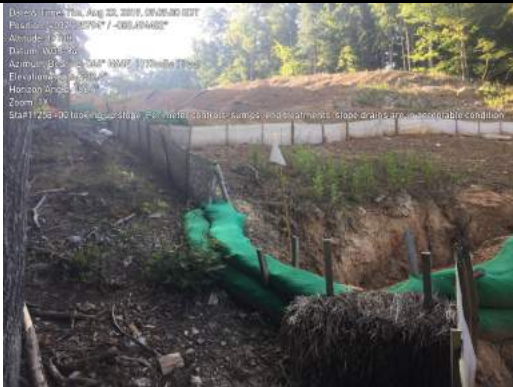
GPS Location	See photo GPS	GPS Location	See photo GPS		
Field Station#	11258+00	Field Station#	11291+00		
Pic 1 Desc.	Looking up slope, Perimeter controls, end treatment's, sump pits, slope drains are in acceptable condition.	Pic 2 Desc.	Steep slope perimeter controls, sumps, end treatment's water bars, stream & stream controls are in acceptable condition.

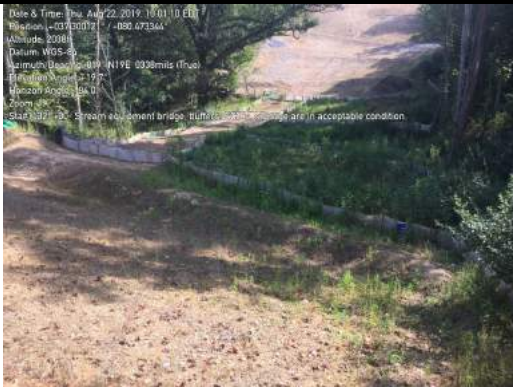
GPS Location	See photo GPS	GPS Location	See photo GPS		
Field Station#	11321+00	Field Station#	11227+00		
Pic 3 Desc.	Stream equipment bridge, buffers, ECD's, signage are in acceptable condition.	Pic 4 Desc.	Contractor working on row stabilization.

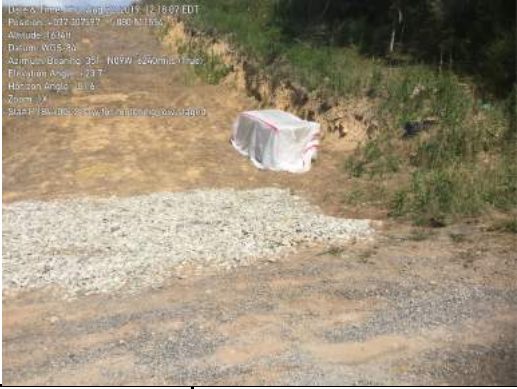
<p>Insert image here</p>			
<b>GPS Location</b>	See photo GPS	<b>GPS Location</b>			
<b>Field Station#</b>	11184+00	<b>Field Station#</b>			
<b>Pic 7 Desc.</b>	Staged straw for row mulching in several locations.	<b>Pic 8 Desc.</b>			
<p>Insert image here</p>		<p>Insert image here</p>			
<b>GPS Location</b>		<b>GPS Location</b>			
<b>Field Station#</b>		<b>Field Station#</b>			
<b>Pic 9 Desc.</b>		<b>Pic 10 Desc.</b>			
<p>Insert image here</p>		<p>Insert image here</p>			
<b>GPS Location</b>		<b>GPS Location</b>			
<b>Field Station#</b>		<b>Field Station#</b>			
<b>Pic 11 Desc.</b>		<b>Pic 12 Desc.</b>

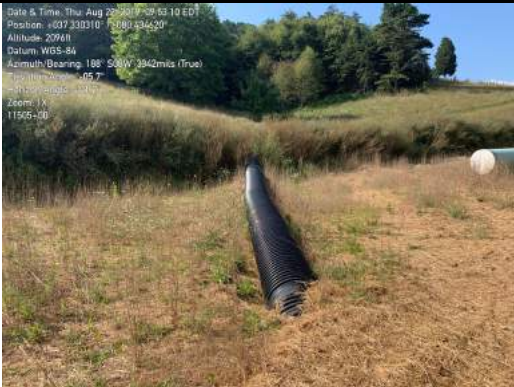
<b>GPS Location</b>	See photo for GPS location.		<b>GPS Location</b>	See photo for GPS location.	
<b>Field Station#</b>	11505+00		<b>Field Station#</b>	11502+00	
<b>Pic 1 Desc.</b>	Clean water diversion pipe and and berm in place.		<b>Pic 2 Desc.</b>	Conveyance channel with rock checks in place.

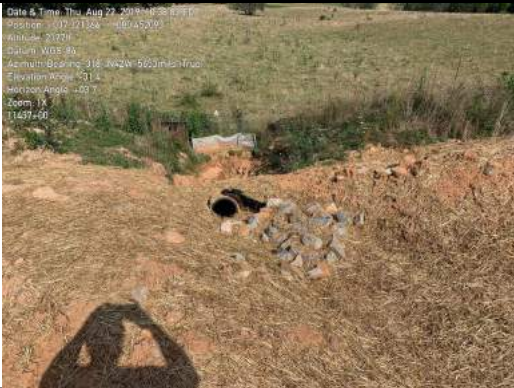
<b>GPS Location</b>	See photo for GPS location.		<b>GPS Location</b>	See photo for GPS location.	
<b>Field Station#</b>	11437+00		<b>Field Station#</b>	11381+00

<b>Pic 5 Desc.</b>	Slope drain over fill slope with rock inlet.		<b>Pic 6 Desc.</b>	Triple barrier ECDs in place at off ROW karst feature.

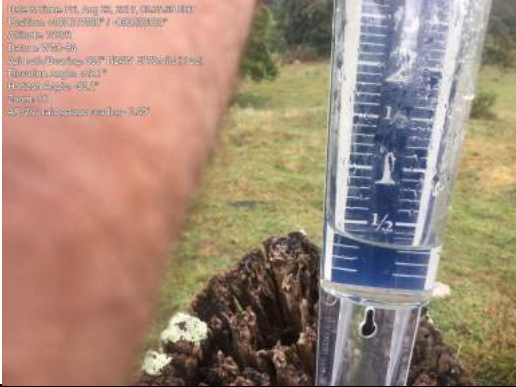
<b>GPS Location</b>	See photo GPS	<b>GPS Location</b>	See photo GPS		
<b>Field Station#</b>	11022+00	<b>Field Station#</b>	11227+00		
<b>Pic 7 Desc.</b>	AR-244- Rain gauge reading- 0.40"	<b>Pic 8 Desc.</b>	Winding Way rain gauge reading- 0.80"		
Insert image here		Insert image here			
<b>GPS Location</b>		<b>GPS Location</b>			
<b>Field Station#</b>		<b>Field Station#</b>			
<b>Pic 9 Desc.</b>		<b>Pic 10 Desc.</b>			
Insert image here		Insert image here			
<b>GPS Location</b>		<b>GPS Location</b>			
<b>Field Station#</b>		<b>Field Station#</b>			
<b>Pic 11 Desc.</b>		<b>Pic 12 Desc.</b>

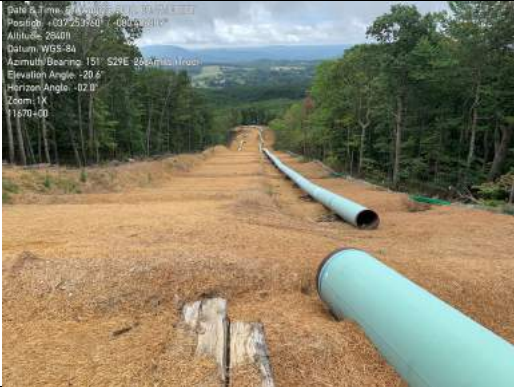
<b>GPS Location</b>	See photo for GPS location.		<b>GPS Location</b>	See photo for GPS location.	
<b>Field Station#</b>	11670+00		<b>Field Station#</b>	11776+00	
<b>Pic 1 Desc.</b>	ROW has been stabilized using seed and mulch. Waterbars, end treatments, and sump pits in place.		<b>Pic 2 Desc.</b>	Clean water diversion pipe in place.

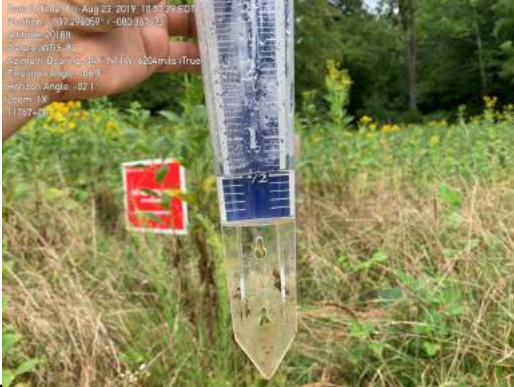
<b>GPS Location</b>	See photo for GPS location.		<b>GPS Location</b>	See photo for GPS location.	
<b>Field Station#</b>	11767+00		<b>Field Station#</b>	10883+50	
<b>Pic 3 Desc.</b>	Rain gauge at Mount Tabor Road reads 0.6 inches.		<b>Pic 4 Desc.</b>	Rain gauge at Kow Camp Road reads 0.4 inches

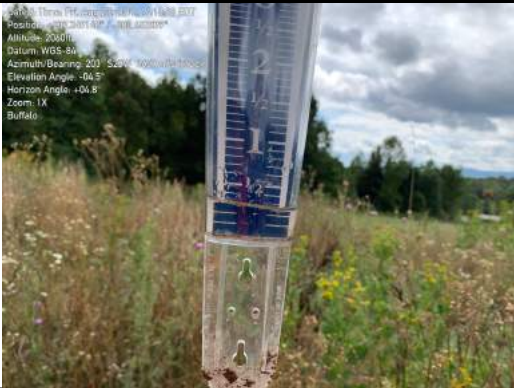
<b>Pic 5 Desc.</b>	Rain gauge at Buffalo Anklets Road reads 0.3 inches.		<b>Pic 6 Desc.</b>	Rain gauge at AR 234 reads 0.6 inches.

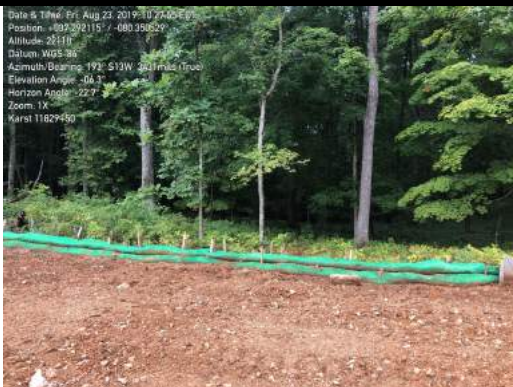
GPS Location	3	GPS Location	4		
Field Station#	11829+50	Field Station#	11833+00		
Pic 3 Desc.	Functional ECDs on off RoW karst area.	Pic 4 Desc.	Section of restored RoW.
