COMPLAINT INSPECTION REPORT

Project Name:	Mountain Valley Pipeline	Inspector:	Marshall Willis
Inspection Date:	Monday, October 28, 2019	Project Contact:	Brian Clauto
Spread H: Montgomery County	STA 12175+00 – 12200+00 ATWS 703, ATWS 704A, ATWS 1446 & ATWS 1375 MVP-MN-275/274	Weather (Wet/Dry/Rain):	Wet

FIELD INSPECTION PHOTO LOG

Project Name: Mountain Valley Pipeline

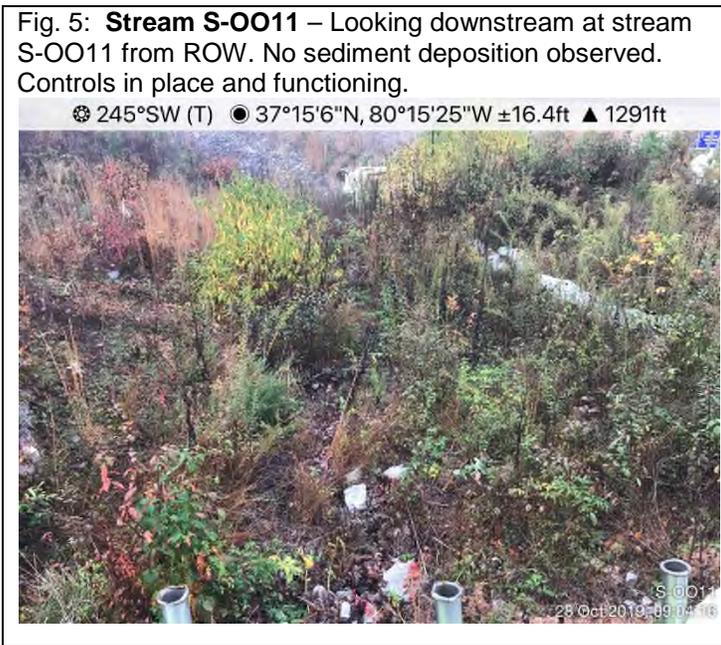
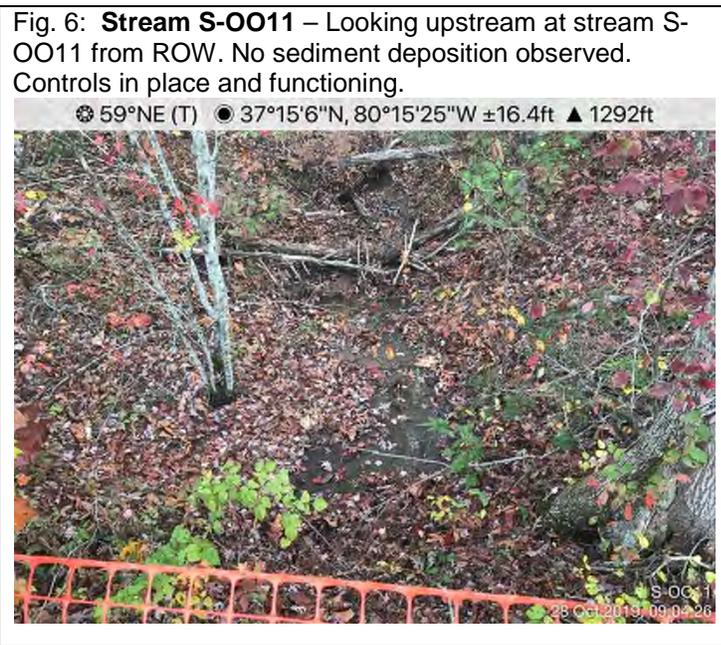
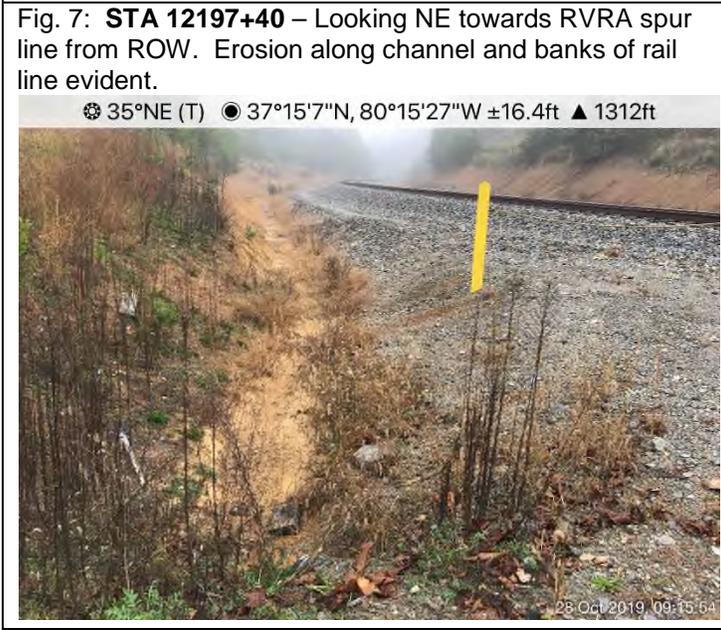
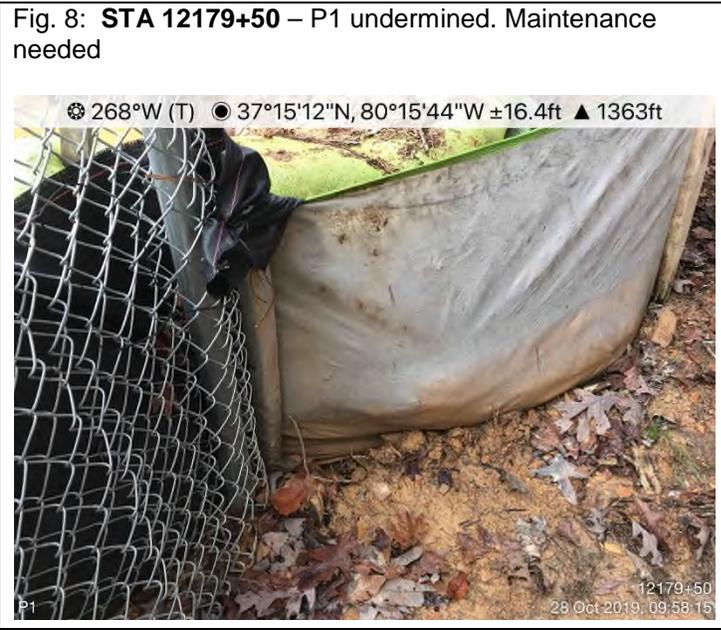
1. At the time of inspection, there was no evidence of sediment discharge from MVP ROW onto Bradshaw Road or into Bradshaw Creek. See Figures 2, 3, 4, 5 & 6.
2. ECDs within the MVP LOD and along the resources were installed per the approved plans and appeared to be functioning as designed. See Note #3.
3. One maintenance item was found at STA 12179+50 (see Figure 8). P1 Silt Fence was undermined at that location, however no sediment was discharged off ROW as a result.
4. There was no evidence of high turbidity upstream or downstream of the MVP crossing of Bradshaw Creek (S-C21). See Figures 3 & 4.
5. Erosion occurring along the Roanoke Valley Resource Authority (RVRA) spur line was documented during the inspection. Discharge from these channels flows through the MVP ROW and into S-OO11. See Figure 7.

Recommended Corrective Action: Maintain and install all controls per the approved plans and PSS&S.
