# Visual Site Inspection Report

<b>Project Name</b>	H-600 Pipeline Spread G	<b>AFE</b>	124300137	<b>Spread</b>	H-600 Pipeline Spread
<b>Contractor</b>	Precision			<b>Report #</b>	4668
<b>Inspector</b>	Chris Burns			<b>Date/Time</b>	10/14/2019 6:59 AM
<b>Permit #</b>	TBD	<b>Inspection Type</b>	VA SWPP	<b>Station Begin</b>	11255+00
<b>State</b>	VA	<b>Inspection Area</b>	Partial	<b>Station End</b>	11354+00
<b>County</b>	Giles	<b>Ground</b>	Wet	<b>Temperature (°F)</b>	71.00
<b>Municipality</b>	N/A	<b>Weather</b>	Sunny	<b>Rain Gauge (in)</b>	0.00
				<b>Rain Accumulation Time (days)</b>	3.00

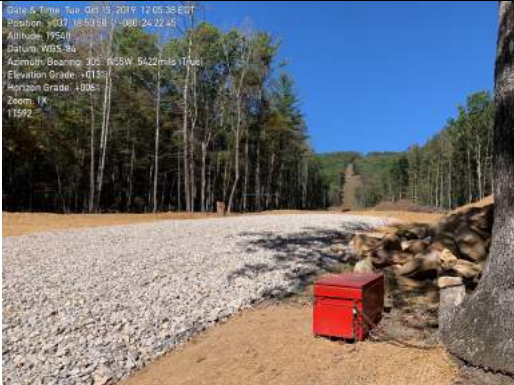
<p>Date &amp; Time: Tue Oct 15, 2019 12:05:36 EDT Position: +011 16 59.51 N -086 24 22.42 W Altitude: 1950 ft Datum: WGS 84 Azimuth Bearing: 300.655W 54.22mils (True) Elevation Grade: +0115 Horizon Grade: +1006 Zoom: 1X 11592</p>			
<b>GPS Location</b>	See picture above for GPS coordinates		<b>GPS Location</b>	See picture above for GPS coordinates	
<b>Field Station#</b>	11603+00		<b>Field Station#</b>	11590+00	
<b>Pic 1 Desc.</b>	ECD's and row conditions		<b>Pic 2 Desc.</b>	ECD's and row conditions

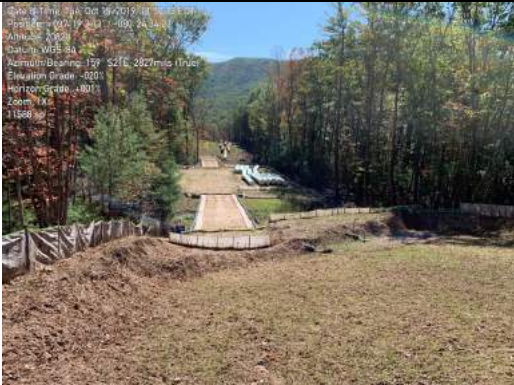
<b>GPS Location</b>	See picture above for GPS coordinates		<b>GPS Location</b>	See picture above for GPS coordinates	
<b>Field Station#</b>	11588+00		<b>Field Station#</b>	11585+00	
<b>Pic 3 Desc.</b>	ECD's and row conditions		<b>Pic 4 Desc.</b>	ECD's and row conditions

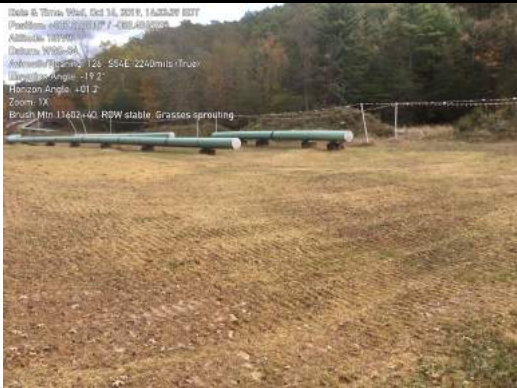
<p>Date &amp; Time: Wed, Oct 16, 2019, 14:28:29 EDT Position: -037 313717N / -080 02523W Altitude: 1899ft Datum: WGS-84 Azimuth/Bearing: 124° S54E 2240mils (True) Elevation Angle: -19.2° Horizon Angle: +01.2° Zoom: 1X Brush Mtn 11602+40 RW crossing stable. Grasses sprouting</p>			
<b>GPS Location</b>	On photo	<b>GPS Location</b>	On photo		
<b>Field Station#</b>	11606+53	<b>Field Station#</b>	11602+40		
<b>Pic 9 Desc.</b>	RCE in good condition at access road 259.03	<b>Pic 10 Desc.</b>	Grasses sprouting on private tract		
  <p>Date &amp; Time: Wed, Oct 16, 2019, 14:14:05 EDT Position: -037 313436N / -080 02036W Altitude: 1909ft Datum: WGS-84 Azimuth/Bearing: 229° S49W 4071mils (True) Elevation Angle: -18.4° Horizon Angle: +02.3° Zoom: 1X Brush Mtn 11607+81 S-006 crossing stable</p>		<div style="text-align: center; height: 150px;">Insert image here</div>
