Visual Site Inspection Report

Project Name	H-600 Pipeline Spread G	AFE	124300137	Spread	H-600 Pipeline Spread
Contractor	Precision			Report #	4969
Inspector	Len Kruizenga			Date/Time	10/21/2019 7:03 AM
Permit #	TBD	Inspection Type	VA SWPP	Station Begin	11788+00
State	VA	Inspection Area	Full	Station End	12000+00
County	Giles	Ground	Muddy	Temperature (°F)	62.00
Municipality	N/A	Weather	Cloudy	Rain Gauge (in)	2.50
				Rain Accumulation Time (days)	1.00

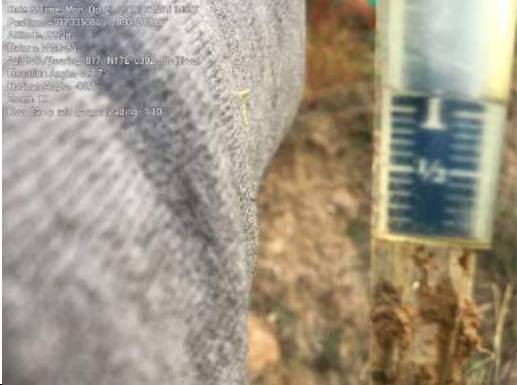
GPS Location	See photo GPS		GPS Location	See photo GPS	
Field Station#	10883+00		Field Station#	11022+00	
Pic 7 Desc.	Kow Camp rain gauge reading- 1.10"		Pic 8 Desc.	AR-244 rain gauge reading- 1.50"	
Insert image here			Insert image here		
GPS Location			GPS Location		
Field Station#			Field Station#		
Pic 9 Desc.			Pic 10 Desc.		
Insert image here			Insert image here		
GPS Location			GPS Location		
Field Station#			Field Station#		
Pic 11 Desc.			Pic 12 Desc.

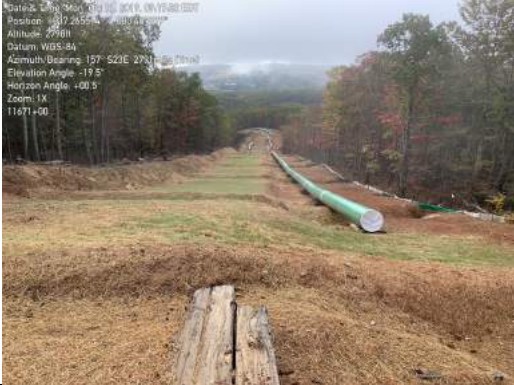
GPS Location	See photo for GPS location.		GPS Location	See photo for GPS location.	
Field Station#	11671+00		Field Station#	11678+00	
Pic 1 Desc.	ROW stabilized with seed and mulch and minor vegetation growth.		Pic 2 Desc.	Waterbar, sump pit, and end treatment in place.

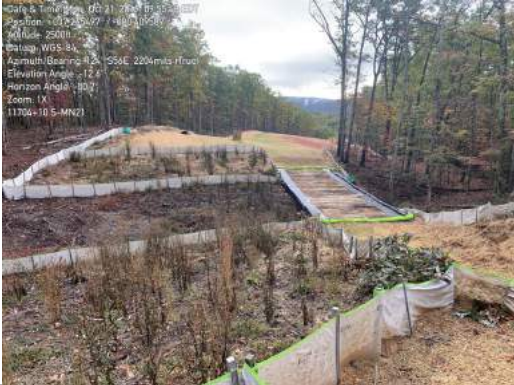
GPS Location	See photo for GPS location.		GPS Location	See photo for GPS location.	
Field Station#	11704+10		Field Station#	11711+00	
Pic 3 Desc.	Sensitive resource buffer in place at stream S-MN22.		Pic 4 Desc.	Priority one silt fence end treatment undermined.

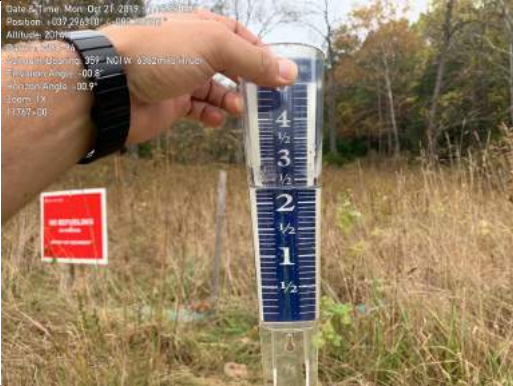
GPS Location	See photo for GPS location.		GPS Location	See photo for GPS location.	
Field Station#	11711+00		Field Station#	11767+00	
Pic 5 Desc.	Priority one silt fence end treatment replaced and retrenched.		Pic 6 Desc.	Rain gauge at Mount Tabor reads 2.4 inches.

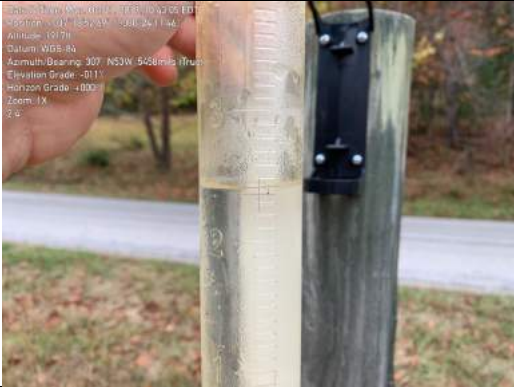
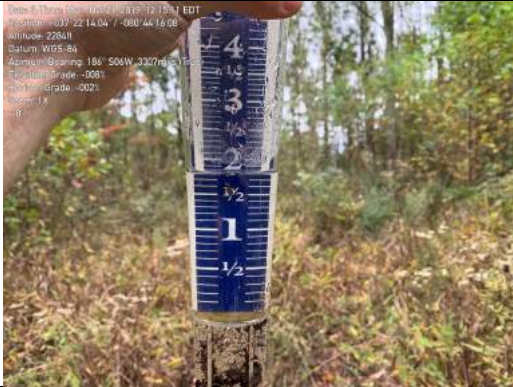
GPS Location	See picture above for GPS coordinates		GPS Location	See picture above for GPS coordinates	
Field Station#	+1		Field Station#	+2	
Pic 1 Desc.	2.4" of rain recorded @ Craig's Creek		Pic 2 Desc.	1.8" of rain recorded @ Pocahontas AR

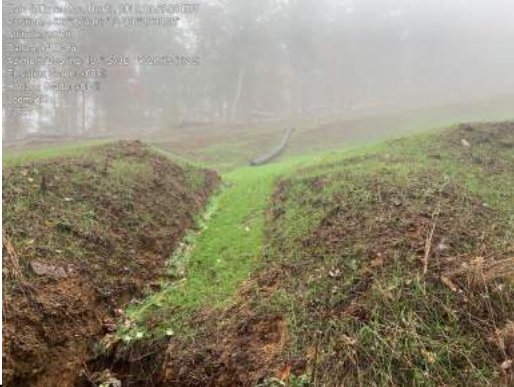
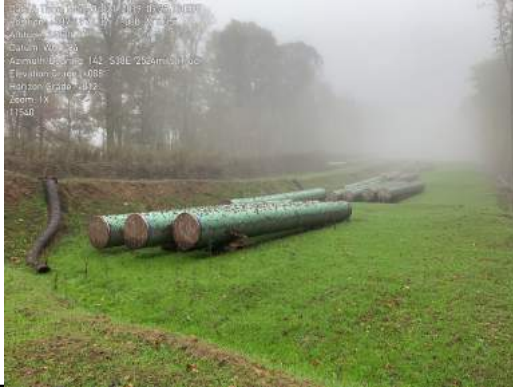
GPS Location	See picture above for GPS coordinates		GPS Location	See picture above for GPS coordinates	
Field Station#	11551+00		Field Station#	11540+00	
Pic 3 Desc.	ECD's and row conditions		Pic 4 Desc.	ECD's and row conditions

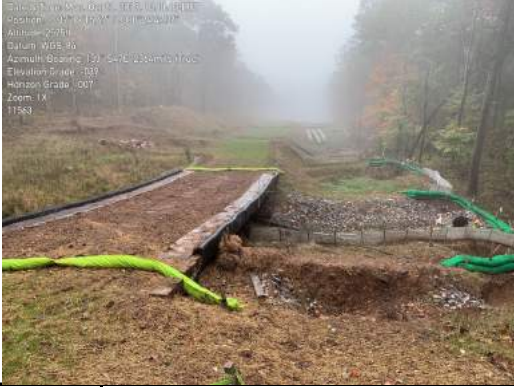
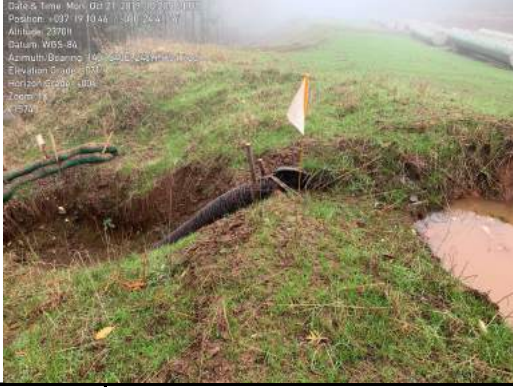
GPS Location	See picture above for GPS coordinates		GPS Location	See picture above for GPS coordinates	
Field Station#	11563+00		Field Station#	11574+00	
Pic 5 Desc.	ECD's and row conditions Spp22		Pic 6 Desc.	ECD's and row conditions

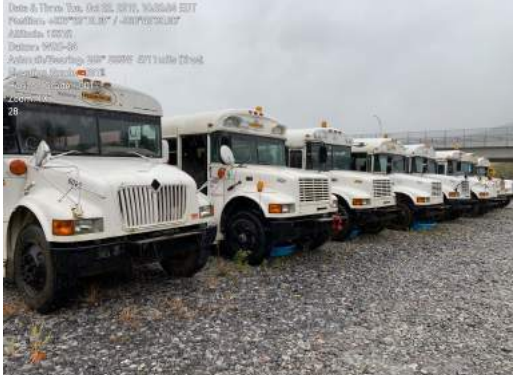
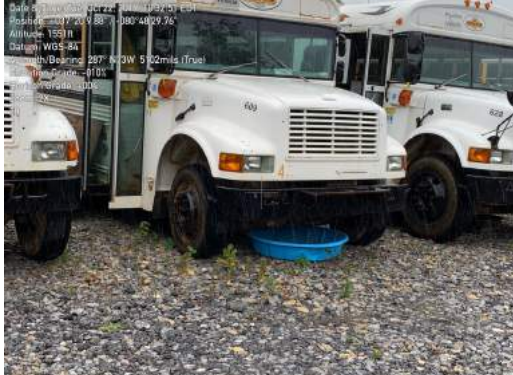
GPS Location	See picture above for GPS coordinates		GPS Location	See picture above for GPS coordinates	
Field Station#	+28		Field Station#	+28	
Pic 1 Desc.	ECD's and row conditions		Pic 2 Desc.	ECD's and row conditions

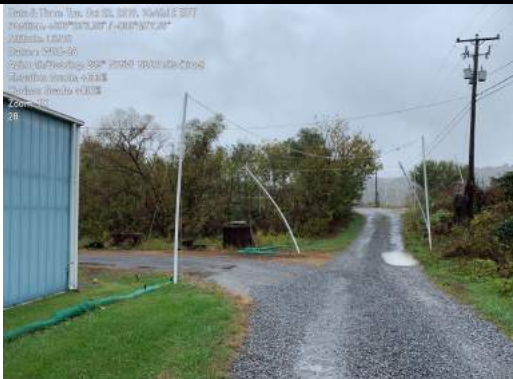
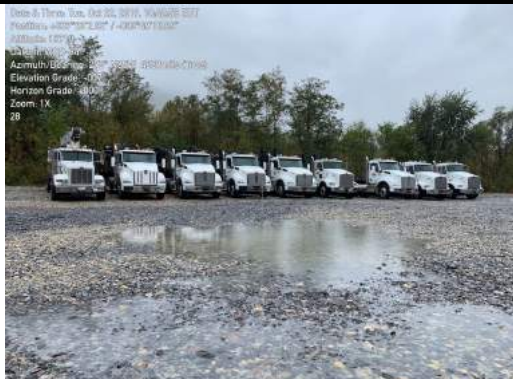
GPS Location	See picture above for GPS coordinates		GPS Location	See picture above for GPS coordinates	
Field Station#	+28		Field Station#	+28	
Pic 3 Desc.	ECD's and row conditions		Pic 4 Desc.	ECD's and row conditions

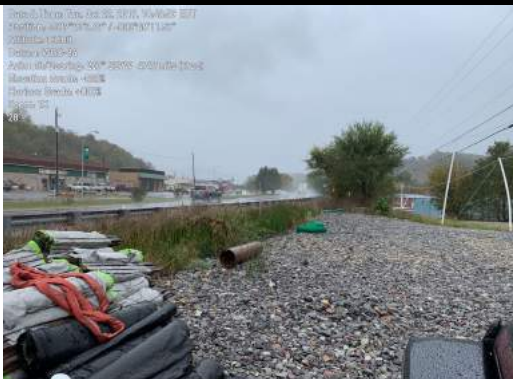
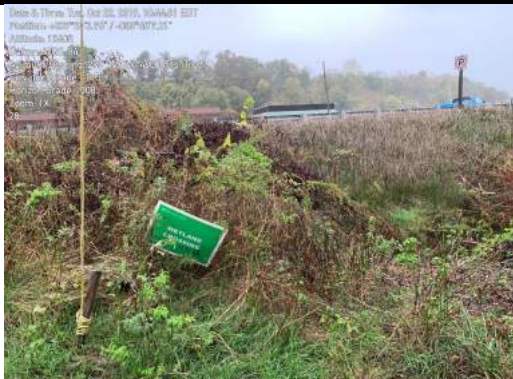
GPS Location	See picture above for GPS coordinates		GPS Location	See picture above for GPS coordinates	
Field Station#	+28		Field Station#	+28	
Pic 5 Desc.	ECD's and row conditions		Pic 6 Desc.	ECD's and row conditions

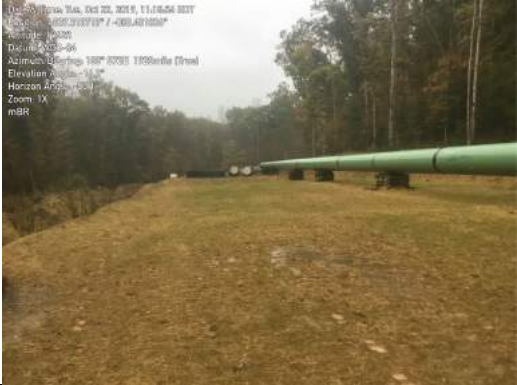
GPS Location	On photo	GPS Location	On photo		
Field Station#	11616+00	Field Station#	11615+00		
Pic 7 Desc.	Private tract stable. Grasses sprouting.	Pic 8 Desc.	End treatments in place and functional

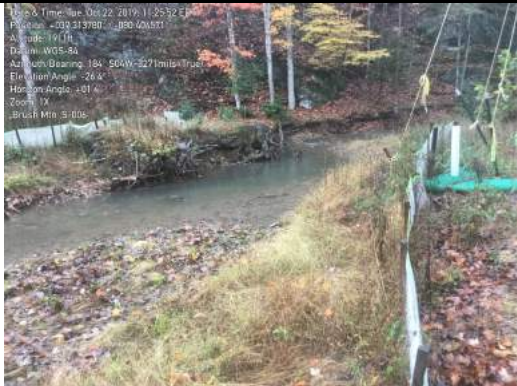
GPS Location	On photo	GPS Location	On photo		
Field Station#	11607+81	Field Station#	11606+50		
Pic 9 Desc.	S006 buffer stable. Controls in place. No impact apparent	Pic 10 Desc.	Private tract stable with controls in place and grasses growing		
<p>Insert image here</p>		<p>Insert image here</p>			
GPS Location		GPS Location			
Field Station#		Field Station#			
Pic 11 Desc.		Pic 12 Desc.

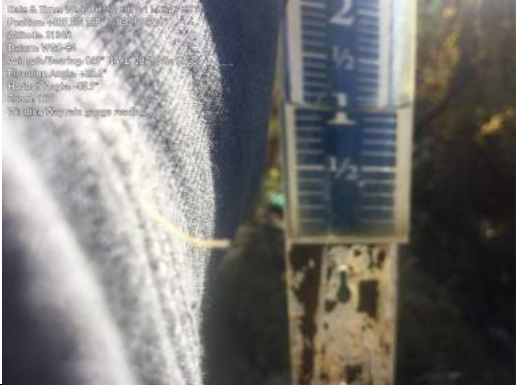
GPS Location	See photo GPS		GPS Location	See photo GPS	
Field Station#	11227+00		Field Station#	11471+00	
Pic 7 Desc.	Winding Way rain gauge reading-1.00"		Pic 8 Desc.	Steel Acres rain gauge reading- 0.90"	
Insert image here			Insert image here		
GPS Location			GPS Location		
Field Station#			Field Station#		
Pic 9 Desc.			Pic 10 Desc.		
Insert image here			Insert image here		
GPS Location			GPS Location		
Field Station#			Field Station#		
Pic 11 Desc.			Pic 12 Desc.

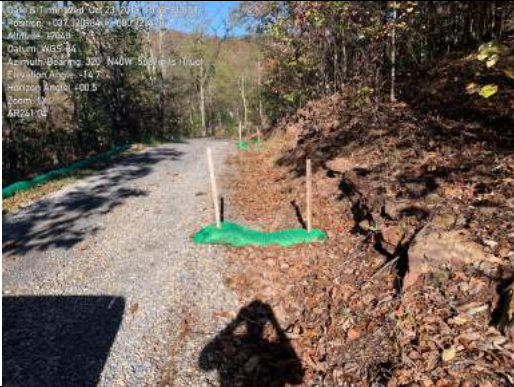
GPS Location	See photo for GPS location.		GPS Location	See photo for GPS location.	
Field Station#	12005+00		Field Station#	10712+50	
Pic 1 Desc.	Compost filter sock checks in place along access road 241.04 in bar ditch.		Pic 2 Desc.	Sensitive resource buffer in place at stream S-G33.

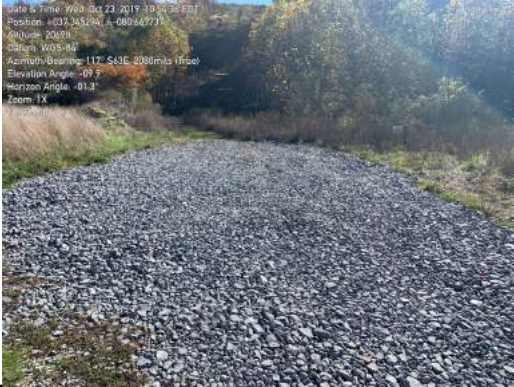
GPS Location	See photo for GPS location.		GPS Location	See photo for GPS location.	
Field Station#	10696+00		Field Station#	11767+00	
Pic 3 Desc.	RCE in place at buffalo anklets to assist in the prevention of track out.		Pic 4 Desc.	Rain gauge at Mount Tabor read 0.7 inches of rain fall.

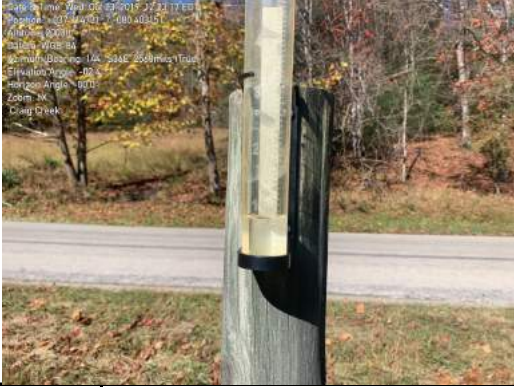
GPS Location	See photo for GPS location.		GPS Location	See photo for GPS location.	
Field Station#	11613+00		Field Station#	11990+00	
Pic 5 Desc.	Rain gauge at Craigs Creek Road reads 0.8 inches of rain fall.		Pic 6 Desc.	Rain gauge at Catawba Road reads 0.8 inches of rain fall.

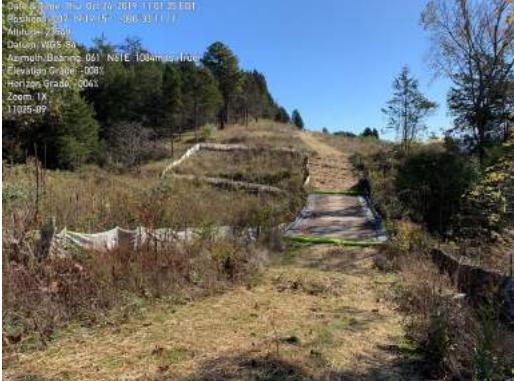
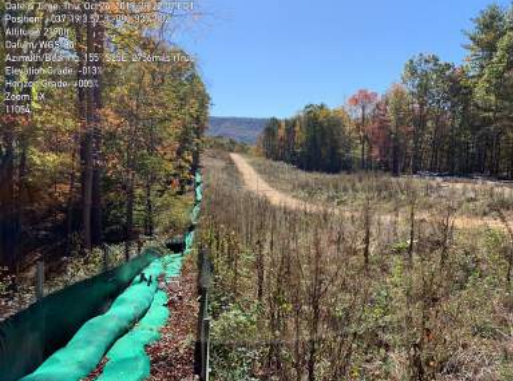
GPS Location	See picture above for GPS coordinates		GPS Location	See picture above for GPS coordinates	
Field Station#	11025+00		Field Station#	11054+00	
Pic 1 Desc.	ECD's and row conditions		Pic 2 Desc.	ECD's and row conditions

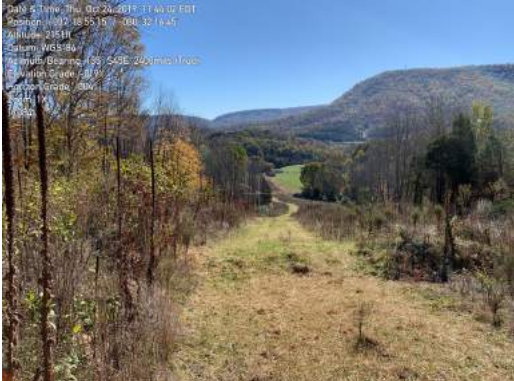
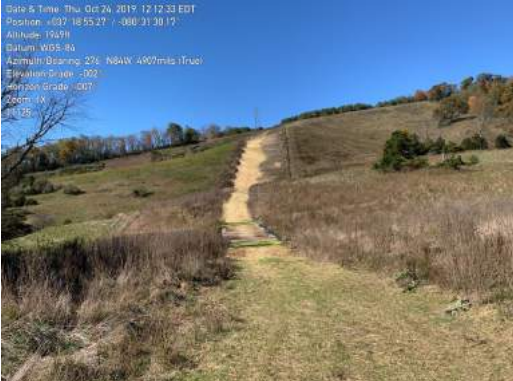
GPS Location	See picture above for GPS coordinates		GPS Location	See picture above for GPS coordinates	
Field Station#	11084+00		Field Station#	11125+00	
Pic 3 Desc.	ECD's and row conditions		Pic 4 Desc.	ECD's and row conditions

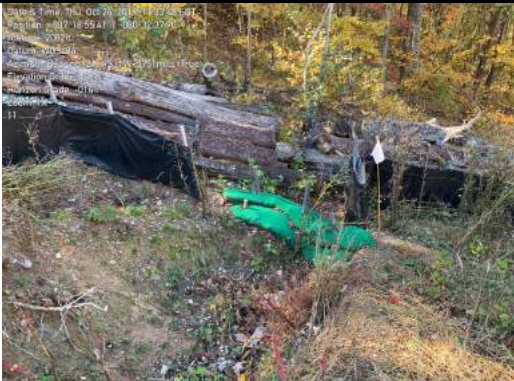
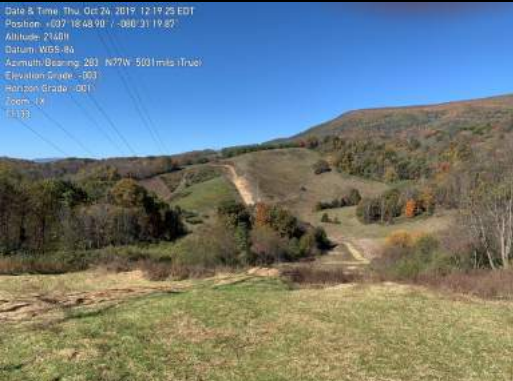
GPS Location	See picture above for GPS coordinates		GPS Location	See picture above for GPS coordinates	
Field Station#	11130+00		Field Station#	11133+00	
Pic 5 Desc.	ECD's and row conditions		Pic 6 Desc.	ECD's and row conditions

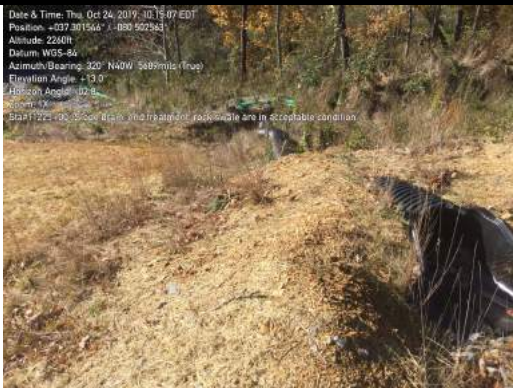
GPS Location	See photo GPS	GPS Location	See photo GPS		
Field Station#	11225+00	Field Station#	11172+70		
Pic 5 Desc.	Slope drain pipe, end treatment, rock swale are in acceptable condition.	Pic 6 Desc.	Slope drain, CFC checks & end treatment are in acceptable condition.

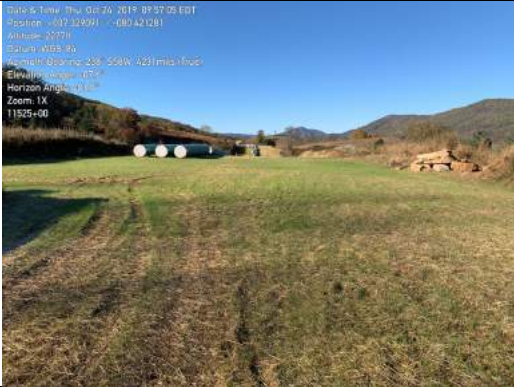
GPS Location	See photo for GPS location.		GPS Location	See photo for GPS location.	
Field Station#	11525+00		Field Station#	11505+00	
Pic 1 Desc.	ROW is stabilized with seed, mulch and minor vegetation growth.		Pic 2 Desc.	Plunge pool and clean water diversion pipe in place.

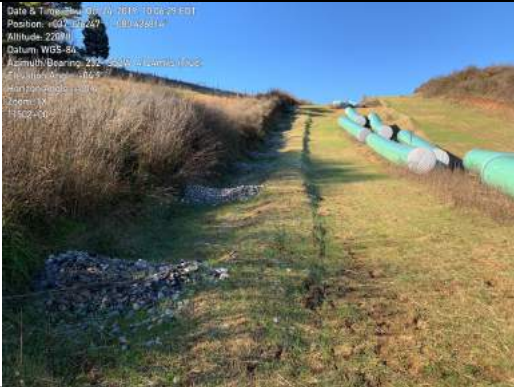
GPS Location	See photo for GPS location.		GPS Location	See photo for GPS location.	
Field Station#	11502+00		Field Station#	11489+00	
Pic 3 Desc.	Conveyance channel with rock checks in place at double cut section of the ROW.		Pic 4 Desc.	RCE in place at Stevers Gap Road to assist with the prevention of track out.

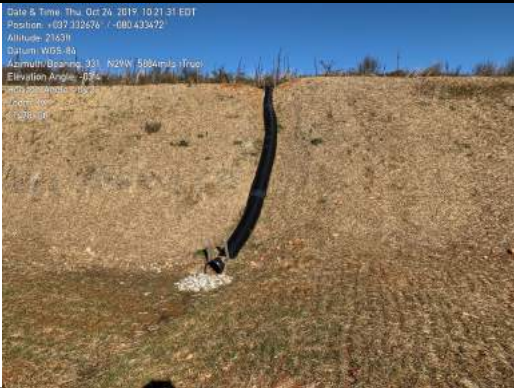
GPS Location	See photo for GPS location.		GPS Location	See photo for GPS location.	
Field Station#	11478+00		Field Station#	11402+00	
Pic 5 Desc.	Slope drain pipe with rock inlet and outlet in place over two-tone. Two-tone is stabilized with ECB.		Pic 6 Desc.	Rock lined channel in place over fill slope.

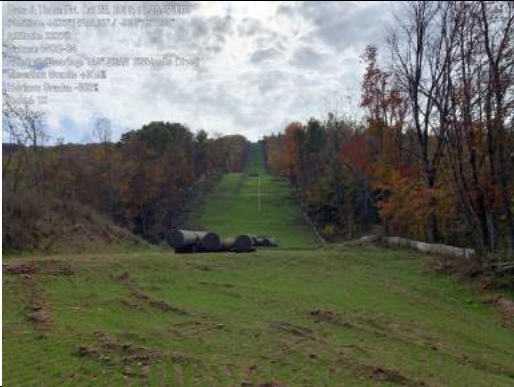
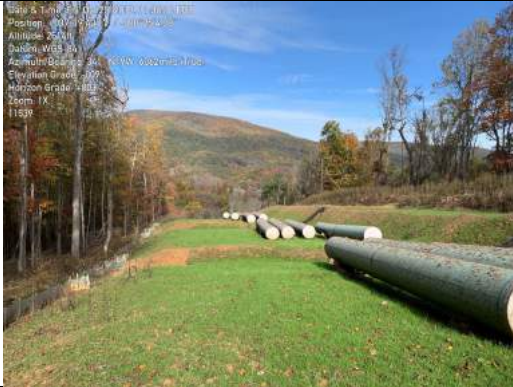
GPS Location	See picture above for GPS coordinates		GPS Location	See picture above for GPS coordinates	
Field Station#	11525+00		Field Station#	11545+00	
Pic 1 Desc.	ECD's and row conditions		Pic 2 Desc.	ECD's and row conditions

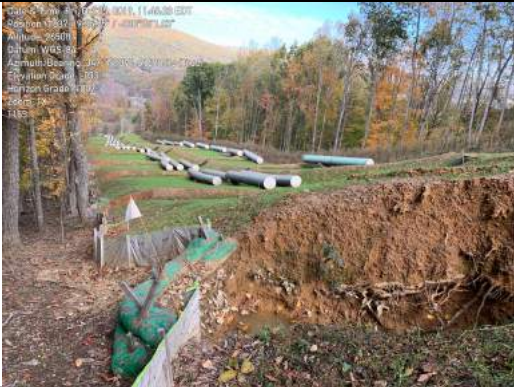
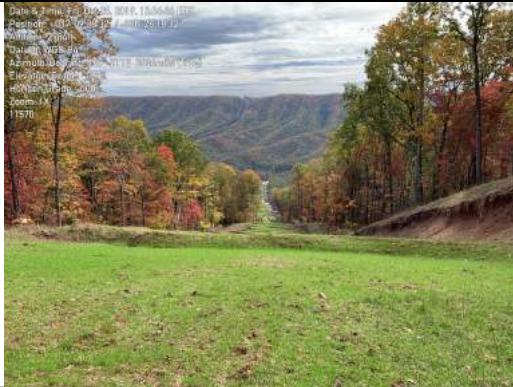
GPS Location	See picture above for GPS coordinates		GPS Location	See picture above for GPS coordinates	
Field Station#	11551+00		Field Station#	11570+00	
Pic 3 Desc.	ECD's and row conditions		Pic 4 Desc.	ECD's and row conditions

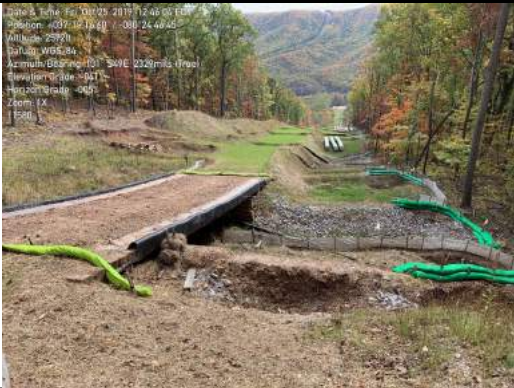
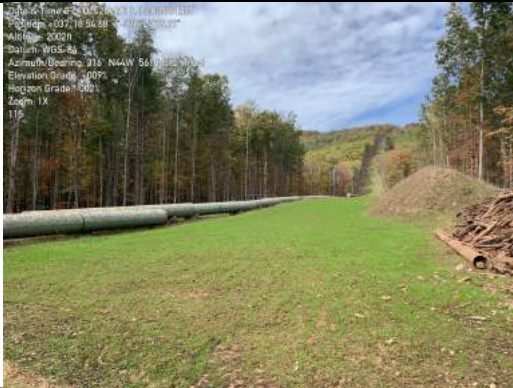
GPS Location	See picture above for GPS coordinates		GPS Location	See picture above for GPS coordinates	
Field Station#	11580+00		Field Station#	11620+00	
Pic 5 Desc.	ECD's and row conditions		Pic 6 Desc.	ECD's and row conditions

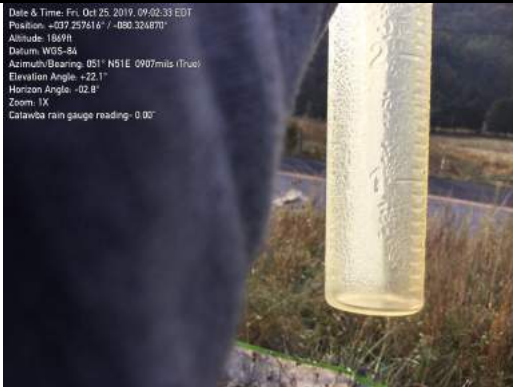
<p>Date & Time: Fri, Oct 25, 2019, 09:02:33 EDT Position: -037.257616° / -080.324870° Altitude: 1854ft Datum: WGS-84 Azimuth/Bearing: 051° N51E 0907mils (True) Elevation Angle: +22.1° Horizon Angle: -02.8° Zoom: 1X Catawba rain gauge reading- 0.00"</p>

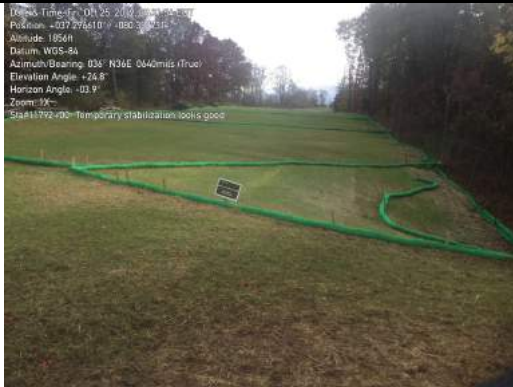
<p>Date & Time: Fri, Oct 25, 2019, 09:03:21 EDT Position: -037.277610° / -080.324870° Altitude: 1854ft Datum: WGS-84 Azimuth/Bearing: 036° N36E 0840mils (True) Elevation Angle: +26.8° Horizon Angle: -03.9° Zoom: 1X Stake 1792+00- Temporary stabilization looks good</p>			
GPS Location	See photo GPS		GPS Location	See photo GPS	
Field Station#	11989+00		Field Station#	11792+00	
Pic 1 Desc.	Catawba rain gauge reading- 0.00"		Pic 2 Desc.	Temporary stabilization looks good.

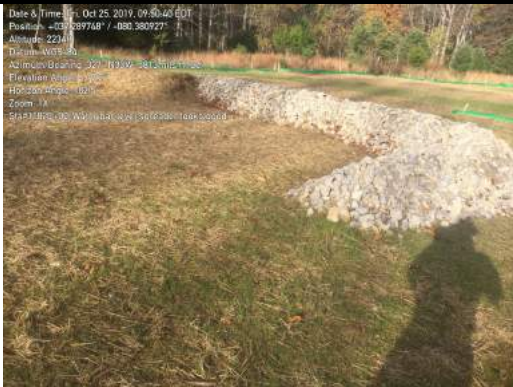
<p>Date & Time: Fri, Oct 25, 2019, 09:50:40 EDT Position: -037.289748° / -080.380927° Altitude: 2234ft Datum: WGS-84 Azimuth/Bearing: 323° N32W 3430mils (True) Elevation Angle: +19.0° Horizon Angle: -03.0° Zoom: 1X Water bar level spreader looks good</p>

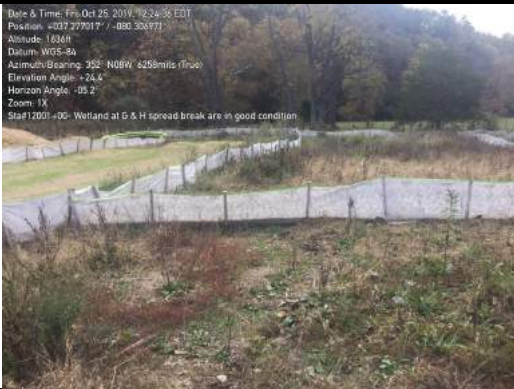
GPS Location		See photo GPS						GPS Location		See photo GPS	
Field Station#		11837+75						Field Station#		12001+00	
Pic 7 Desc.		P1 silt fence perimeter controls, wooden stake snapped off.						Pic 8 Desc.		Wetland ECD's at spread G & H spread break are in acceptable condition.	
Insert image here						Insert image here					
GPS Location								GPS Location			
Field Station#								Field Station#			
Pic 9 Desc.								Pic 10 Desc.			
Insert image here						Insert image here					
GPS Location								GPS Location			
Field Station#								Field Station#			
Pic 11 Desc.								Pic 12 Desc.

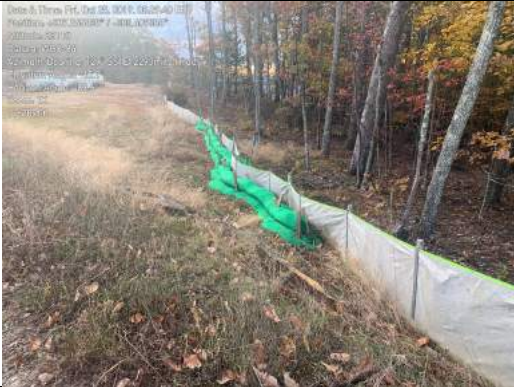
GPS Location	See photo for GPS location.		GPS Location	See photo for GPS location.	
Field Station#	11670+00		Field Station#	11673+00	
Pic 1 Desc.	Triple stack compost filter sock in place with priority one silt fence as a back up control.		Pic 2 Desc.	Waterbar, sump pit, and triple stack compost filter sock end treatment in place.

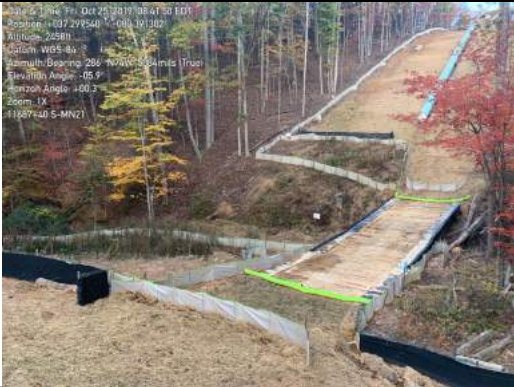
GPS Location	See photo for GPS location.		GPS Location	See photo for GPS location.	
Field Station#	11687+40		Field Station#	11760+00	
Pic 3 Desc.	Sensitive resource buffer in place at stream S-MN21.		Pic 4 Desc.	Reinforced super silt fence in place along LOD.

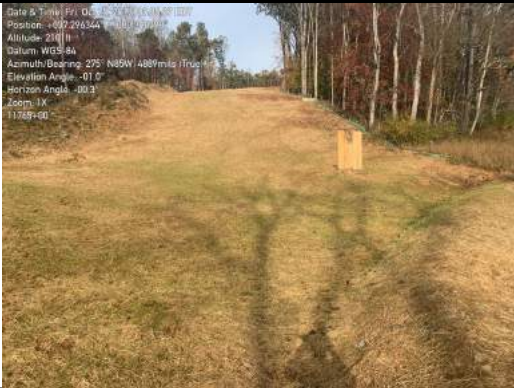
GPS Location	See photo for GPS location.		GPS Location	See photo for GPS location.	
Field Station#	11765+00		Field Station#	11767+00	
Pic 5 Desc.	Waterbar in place. ROW is stabilized with Seed, mulch and minor vegetation growth.		Pic 6 Desc.	RCE in place at main line valve 26 access point to assist with the prevention of track out onto Mount Tabor Road.
