## Visual Site Inspection Report

<b>Project Name</b>	H-600 Pipeline Spread G	<b>AFE</b>	124300137	<b>Spread</b>	H-600 Pipeline Spread G
<b>Contractor</b>	Precision			<b>Report #</b>	5251
<b>Inspector</b>	Len Kruizenga			<b>Date/Time</b>	10/28/2019 8:13 AM
<b>Permit #</b>	TBD	<b>Inspection Type</b>	VA SWPP	<b>Station Begin</b>	12005+00
<b>State</b>	VA	<b>Inspection Area</b>	Full	<b>Station End</b>	12005+00
<b>County</b>	Giles	<b>Ground</b>	Wet	<b>Temperature (°F)</b>	62.00
<b>Municipality</b>	N/A	<b>Weather</b>	Cloudy	<b>Rain Gauge (in)</b>	0.60
				<b>Rain Accumulation Time (days)</b>	2.00

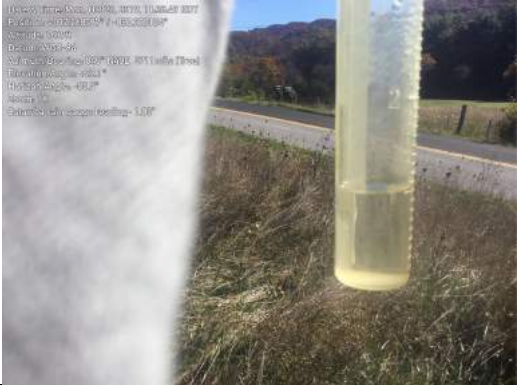
<p>Insert image here</p>			
<b>GPS Location</b>	See photo GPS	<b>GPS Location</b>			
<b>Field Station#</b>	11989+00	<b>Field Station#</b>			
<b>Pic 13 Desc.</b>	Catawba rain gauge reading- 1.00"	<b>Pic 14 Desc.</b>			
<p>Insert image here</p>		<p>Insert image here</p>			
<b>GPS Location</b>		<b>GPS Location</b>			
<b>Field Station#</b>		<b>Field Station#</b>			
<b>Pic 15 Desc.</b>		<b>Pic 16 Desc.</b>			
<p>Insert image here</p>		<p>Insert image here</p>			
<b>GPS Location</b>		<b>GPS Location</b>			
<b>Field Station#</b>		<b>Field Station#</b>			
<b>Pic 17 Desc.</b>		<b>Pic 18 Desc.</b>

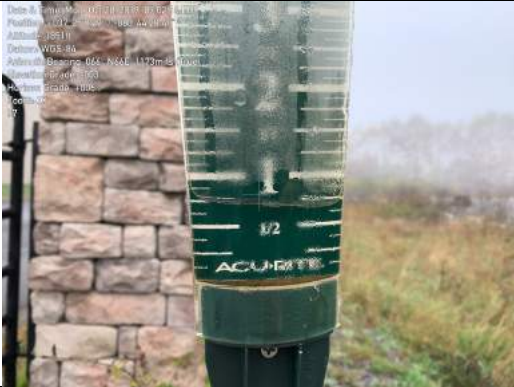
<p>Date &amp; Time: Mon Oct 28 2019 13:13:17 EDT Position: 40°12'22.14"N / -80°44'16.99"W Altitude: 2291 ft Datum: WGS 84 Azimuth Bearing: 184.50W 327.100155 Elevation Grade: +0025 Horizon Grade: +0025 Zoom: 1X T-Space</p>			
<b>GPS Location</b>	See picture above for GPS coordinates		<b>GPS Location</b>	See picture above for GPS coordinates	
<b>Field Station#</b>	+37		<b>Field Station#</b>	+3	
<b>Pic 1 Desc.</b>	.7" of rain recorded @ LDY 37		<b>Pic 2 Desc.</b>	.7" @ AR Pocahontas

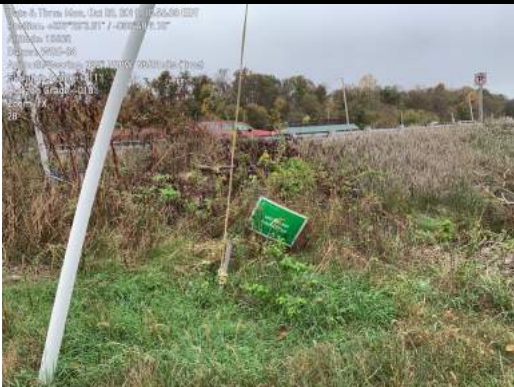
<b>GPS Location</b>	See picture above for GPS coordinates		<b>GPS Location</b>	See picture above for GPS coordinates	
<b>Field Station#</b>	+28		<b>Field Station#</b>	+28	
<b>Pic 3 Desc.</b>	ECD's and row conditions		<b>Pic 4 Desc.</b>	ECD's and row conditions

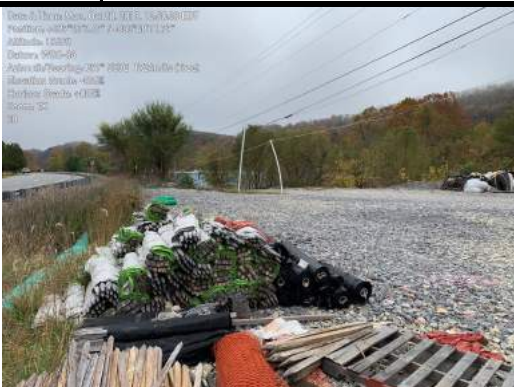
<p>Date &amp; Time: Mon Oct 28 2019 13:13:17 EDT Position: 40°12'22.14"N / -80°44'16.99"W Altitude: 2291 ft Datum: WGS 84 Azimuth Bearing: 184.50W 327.100155 Elevation Grade: +0025 Horizon Grade: +0025 Zoom: 1X T-Space</p>			
<b>GPS Location</b>	See picture above for GPS coordinates		<b>GPS Location</b>	See picture above for GPS coordinates	
<b>Field Station#</b>	+28		<b>Field Station#</b>	+28	
<b>Pic 5 Desc.</b>	ECD's and row conditions		<b>Pic 6 Desc.</b>	ECD's and row conditions

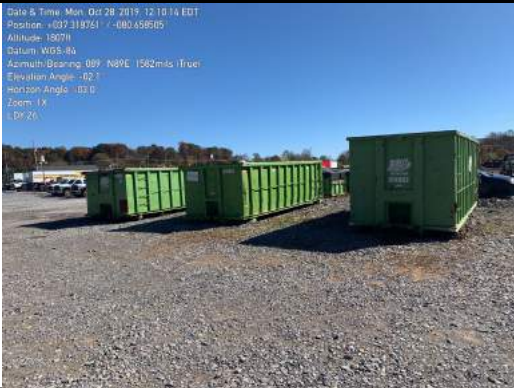
<b>Pic 5 Desc.</b>	Trash dumpster being utilized to ensure site cleanliness.		<b>Pic 6 Desc.</b>	Triple stack compost filter sock in place at LOD of LDY 26.

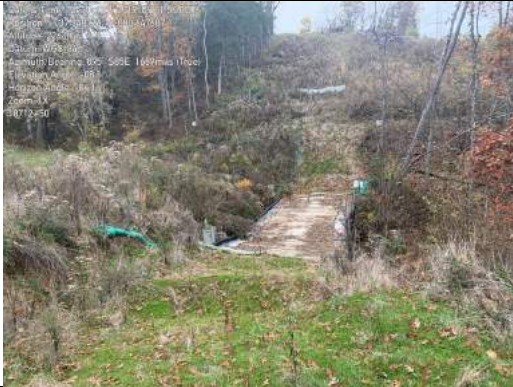
<b>GPS Location</b>	See photo for GPS location.		<b>GPS Location</b>	See photo for GPS location.	
<b>Field Station#</b>	12005+00		<b>Field Station#</b>	10712+50	
<b>Pic 1 Desc.</b>	CFS sock check in place along AR 241.01.		<b>Pic 2 Desc.</b>	Sensitive resource buffer in place at stream S-G33.

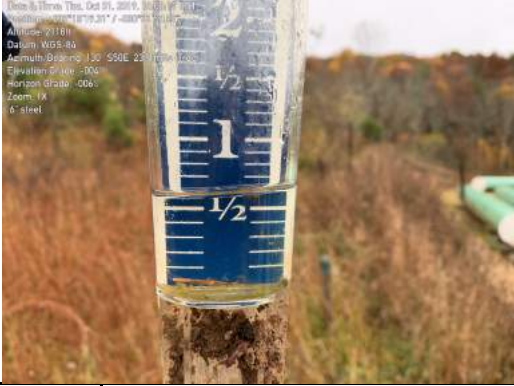
<b>GPS Location</b>	See picture above for GPS coordinates		<b>GPS Location</b>	See picture above for GPS coordinates	
<b>Field Station#</b>	+1		<b>Field Station#</b>	+1	
<b>Pic 1 Desc.</b>	.6" @ Steel Acres		<b>Pic 2 Desc.</b>	.5 " @ Winding

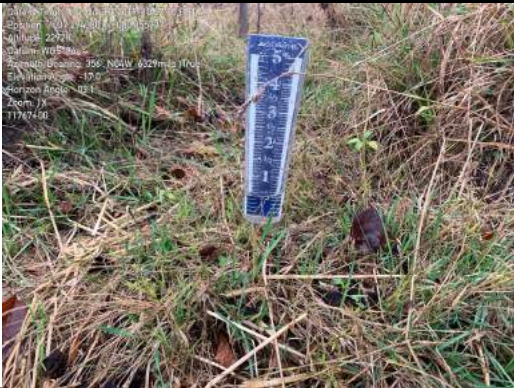
<b>Field Station#</b>	11767+00		<b>Field Station#</b>	11990+00	
<b>Pic 5 Desc.</b>	Rain gauge at Mount Tabor Road reads 0.6 inches.		<b>Pic 6 Desc.</b>	Rain gauge at Catawba Road read 0.6 inches.

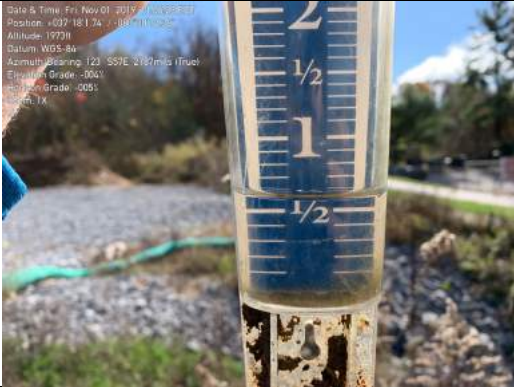
<b>GPS Location</b>	See picture above for GPS coordinates		<b>GPS Location</b>	See picture above for GPS coordinates	
<b>Field Station#</b>	+1		<b>Field Station#</b>	+28	
<b>Pic 1 Desc.</b>	.6" of rain recorded @ Winding Way		<b>Pic 2 Desc.</b>	ECD's and row conditions
