# Visual Site Inspection Report

<b>Project Name</b>	H-600 Pipeline Spread G	<b>AFE</b>	124300137	<b>Spread</b>	H-600 Pipeline Spread
<b>Contractor</b>	Precision			<b>Report #</b>	101989
<b>Inspector</b>	Garrett Barclay			<b>Date/Time</b>	10/7/2019 7:56 AM
<b>Permit #</b>	TBD	<b>Inspection Type</b>	VA SWPP	<b>Station Begin</b>	10840+00
<b>State</b>	VA	<b>Inspection Area</b>	Partial	<b>Station End</b>	10930+00
<b>County</b>	Giles	<b>Ground</b>	Dry	<b>Temperature (°F)</b>	62.00
<b>Municipality</b>	N/A	<b>Weather</b>	Sunny	<b>Rain Gauge (in)</b>	0.00
				<b>Rain Accumulation Time (days)</b>	1.00

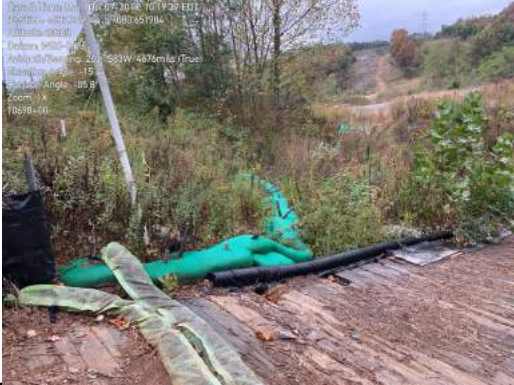
<b>GPS Location</b>	See photo for GPS location.		<b>GPS Location</b>	See photo for GPS location.	
<b>Field Station#</b>	10698+00		<b>Field Station#</b>	10696+00	
<b>Pic 3 Desc.</b>	Triple stack 18 inch compost filter sock in place at stream bank S-G32.		<b>Pic 4 Desc.</b>	RCE in place at Buffalo Anklets Road to assist with track out prevention.

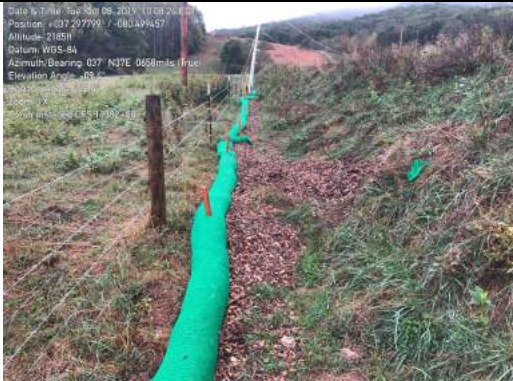
GPS Location	3	GPS Location	4		
Field Station#	11302+00	Field Station#	11323+00		
Pic 3 Desc.	Newly installed CFS.	Pic 4 Desc.	Temporary stabilization.

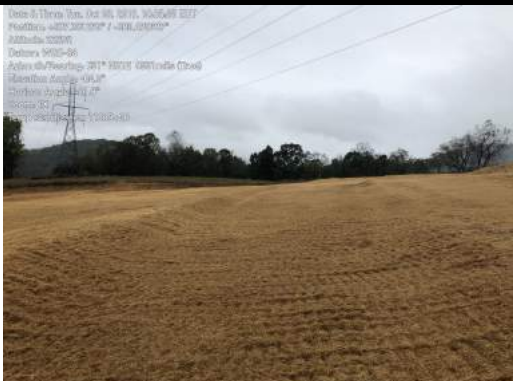
GPS Location	5	GPS Location	6		
Field Station#	11335+00	Field Station#	11348+00		
Pic 5 Desc.	Temporary stabilization.	Pic 6 Desc.	Temporary stabilization.

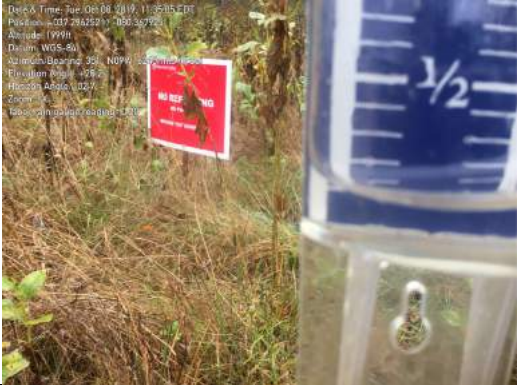
<p> <small>             Date/Time: Tue Oct 08 2019 11:55:05 EDT              Picture: 0124300137_1153231002              Altitude: 1999ft              Datum: WGS-84              Azimuth/Bearing: 358 (NWP) 358 (NWP) 358              Horizontal Angle: 2.00°              Horizontal Angle: 116.2°              Zoom: 1.0              Tabor rain gauge reading: 0.20           </small> </p>			
<b>GPS Location</b>	See photo GPS	<b>GPS Location</b>	See photo GPS

<b>Field Station#</b>	11988+00	<b>Field Station#</b>	11767+00		
<b>Pic 7 Desc.</b>	Catawba rain gauge reading- 0.03"	<b>Pic 8 Desc.</b>	Tabor rain gauge reading- 0.20".		
Insert image here		Insert image here			
<b>GPS Location</b>		<b>GPS Location</b>			
<b>Field Station#</b>		<b>Field Station#</b>			
<b>Pic 9 Desc.</b>		<b>Pic 10 Desc.</b>			
Insert image here		Insert image here			
<b>GPS Location</b>		<b>GPS Location</b>			
<b>Field Station#</b>		<b>Field Station#</b>			
<b>Pic 11 Desc.</b>		<b>Pic 12 Desc.</b>

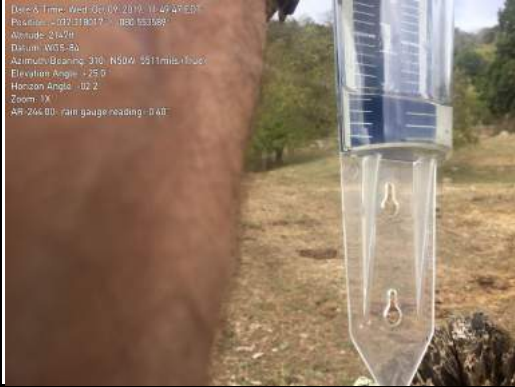
<p>             Date &amp; Time: Wed Oct 09 2019 11:49:47 EDT              Position: -017.118019, -80.051359              Altitude: 214.7m              Datum: WGS-84              Azimuth Bearing: 310, Heading: 5511mishus              Elevation Angle: 25.5              Horizon Angle: 12.2              Zoom: 1X              AR-244.00: rain gauge reading: 0.40"           </p>			
<b>GPS Location</b>	See photo GPS	<b>GPS Location</b>	See photo GPS

<b>Field Station#</b>	11227+00	<b>Field Station#</b>	11022+00		
<b>Pic 7 Desc.</b>	Winding Way rain gauge reading- 0.50"	<b>Pic 8 Desc.</b>	AR-244.00- 0.40"

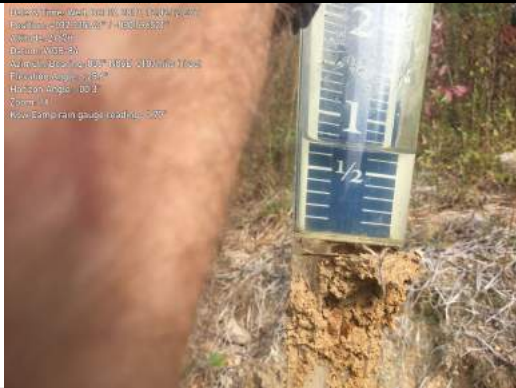
<p>             Date &amp; Time: Wed Oct 09 2019 11:49:47 EDT              Position: -017.118019, -80.051359              Altitude: 214.7m              Datum: WGS-84              Azimuth Bearing: 310, Heading: 5511mishus              Elevation Angle: 25.5              Horizon Angle: 12.2              Zoom: 1X              Kow Camp rain gauge reading: 0.70"           </p>		<p style="text-align: center;">Insert image here</p>			
<b>GPS Location</b>	See photo GPS	<b>GPS Location</b>			
<b>Field Station#</b>	10888+00	<b>Field Station#</b>			
<b>Pic 9 Desc.</b>	Kow Camp rain gauge reading- 0.70"	<b>Pic 10 Desc.</b>			
<p style="text-align: center;">Insert image here</p>		<p style="text-align: center;">Insert image here</p>			
<b>GPS Location</b>		<b>GPS Location</b>

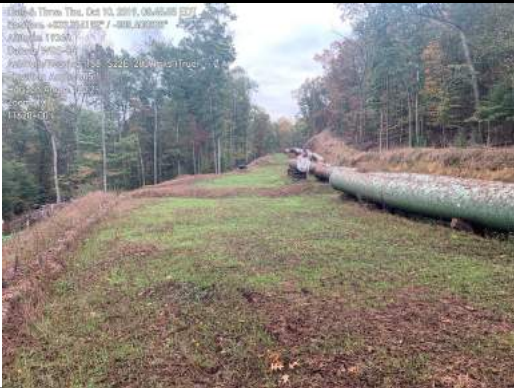
<b>Pic 5 Desc.</b>	Vegetation growth present since recent hydro mulching.		<b>Pic 6 Desc.</b>	Clean water diversion pipe and plunge pool in place.

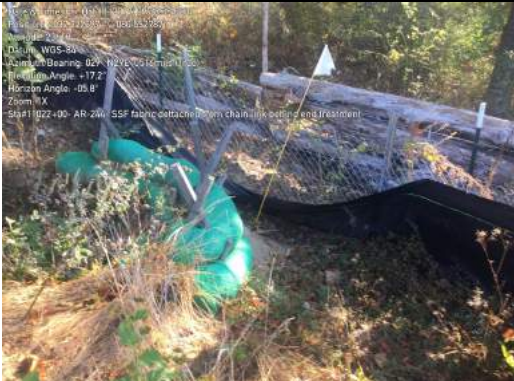
<p>Date &amp; Time: Fri, Oct 11, 2019, 09:04:21 EDT Position: +09.2223297, -080.5311842 Altitude: 2266ft Datum: WGS-84 Azimuth/Bearing: 029° N21W 0340mils (True) Elevation Angle: +17.2° Horizon Angle: -05.8° Zoom: 1X Sta#11022+00- AR-244- SSF fabric detached from chain link ending end treatment.</p>

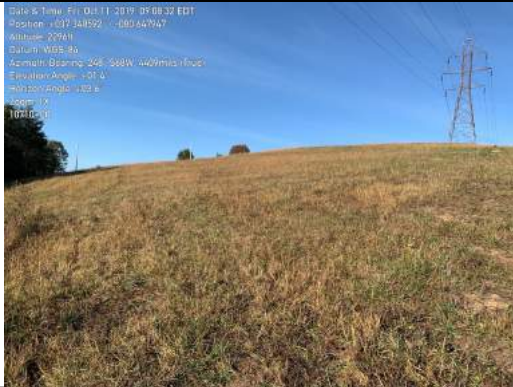
<b>GPS Location</b>	See photo for GPS location.		<b>GPS Location</b>	See photo for GPS location.	
<b>Field Station#</b>	10711+50		<b>Field Station#</b>	10710+00	
<b>Pic 3 Desc.</b>	Waterbar across travel lane with end treatment in place.		<b>Pic 4 Desc.</b>	ROW is stabilized with natural vegetation.

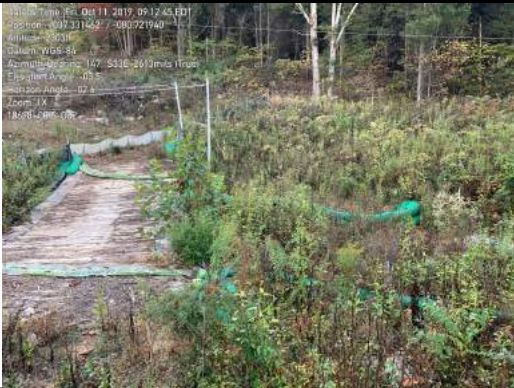
<b>Pic 5 Desc.</b>	Sensitive resource buffer in place at stream S-G32.		<b>Pic 6 Desc.</b>	RCE in place at Buffalo Anklets Road to assist with the prevention of track out.
