Visual Site Inspection Report

| Project Name | H-600 Pipeline Spread G | AFE | 124300137 | Spread | H-600 Pipeline Spread G |

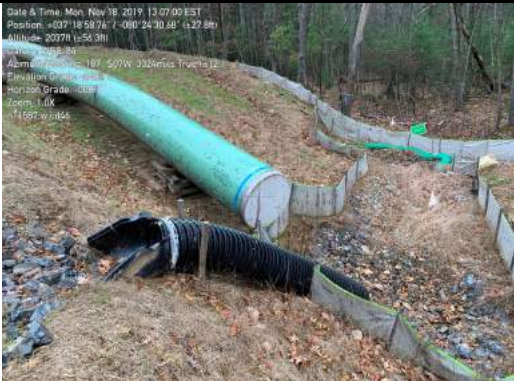
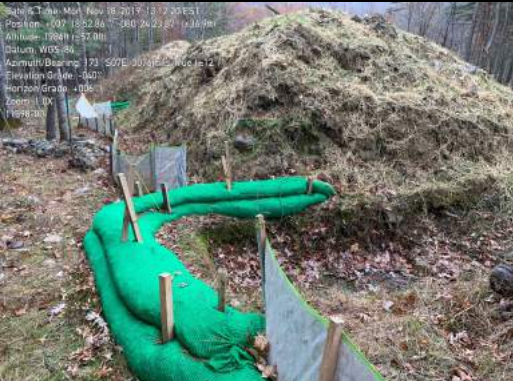
| Field Station# | 11587+00 | | Field Station# | 11598+00 | |

| Pic 5 Desc. | ECD's and row conditions | | Pic 6 Desc. | ECD's and row conditions | |

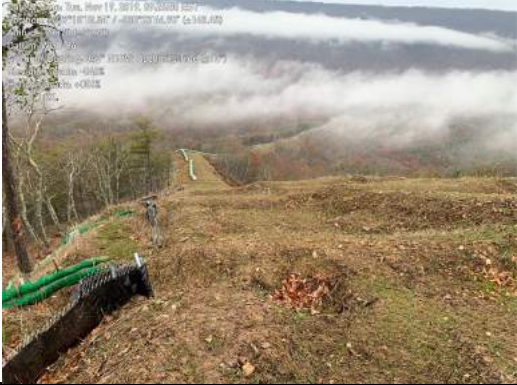
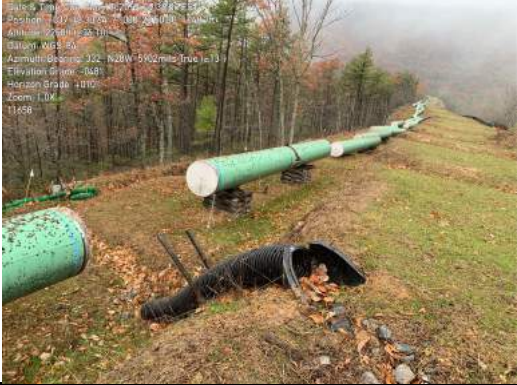
| Field Station# | 11664+00 | | Field Station# | 11658+00 | |

| Pic 7 Desc. | ECD's and row conditions | | Pic 8 Desc. | ECD's and row conditions | |

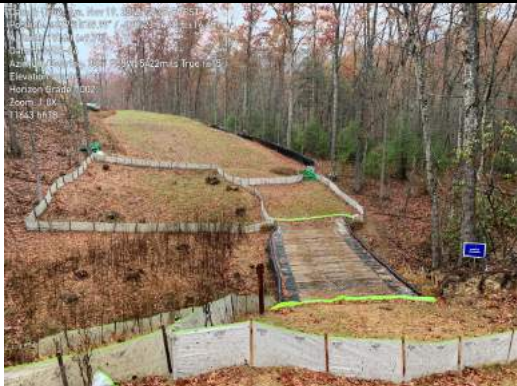
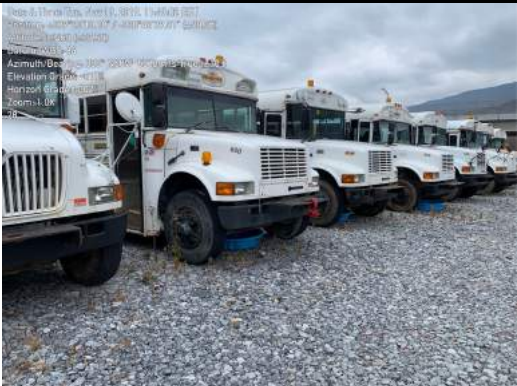
| Field Station# | 11643+00 | | Field Station# | +28 | |

| Pic 9 Desc. | ECD's and row conditions | | Pic 10 Desc. | ECD's and row conditions LDY 28 | |

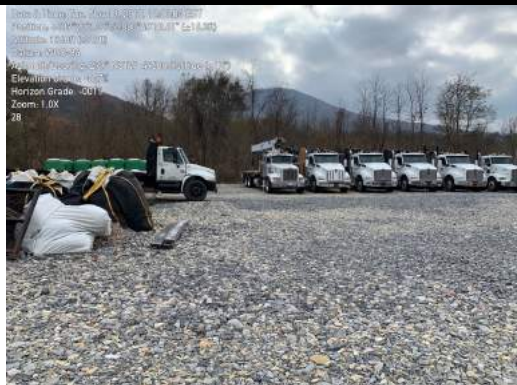
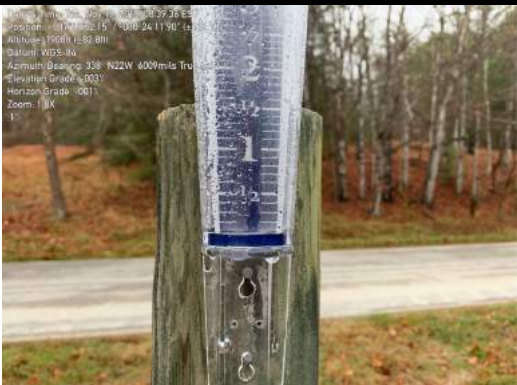
| Field Station# | +28 | | Field Station# | +28 | |

| Pic 11 Desc. | ECD's and row conditions LDY 28 | | Pic 12 Desc. | .1" of rain recorded @ Craig's creek | |

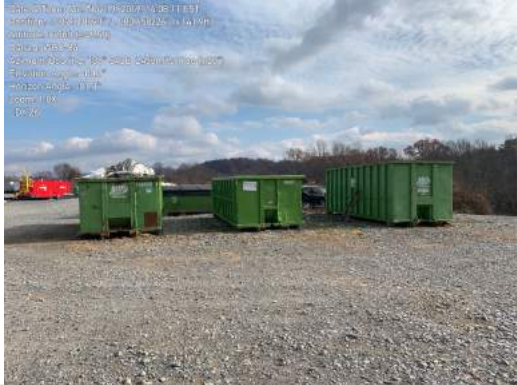
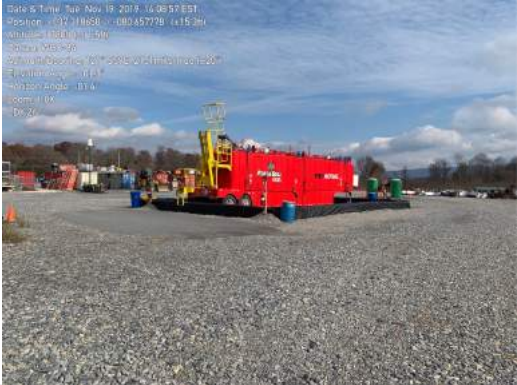
| Field Station# | 12005+00 | Field Station# | 12005+00 | | |

| Pic 9 Desc. | Dumpsters located at LDY 26 for waste management. | Pic 10 Desc. | Secondary containment in place under fuel cell. | | |

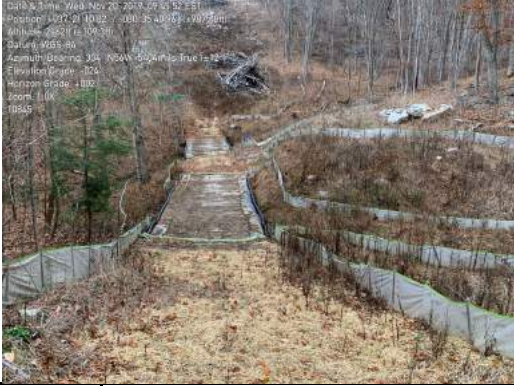
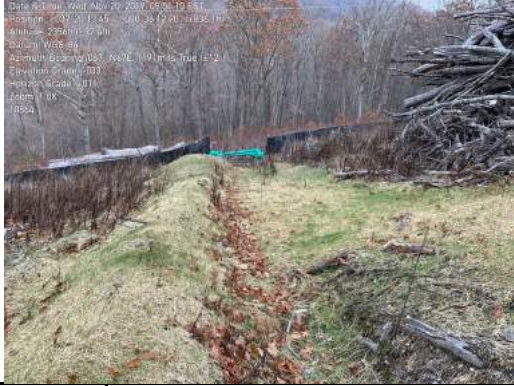
| Field Station# | 10845+00 | | Field Station# | 10864+00 | |

| Pic 1 Desc. | ECD's and row conditions | | Pic 2 Desc. | ECD's and row conditions | |

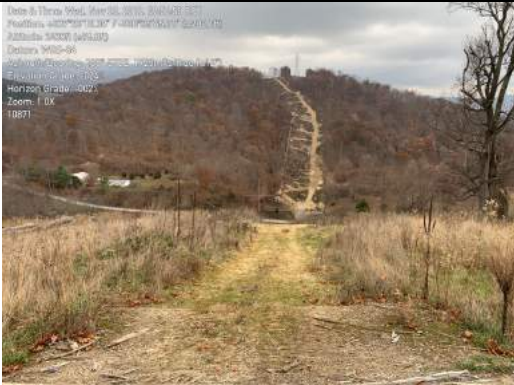
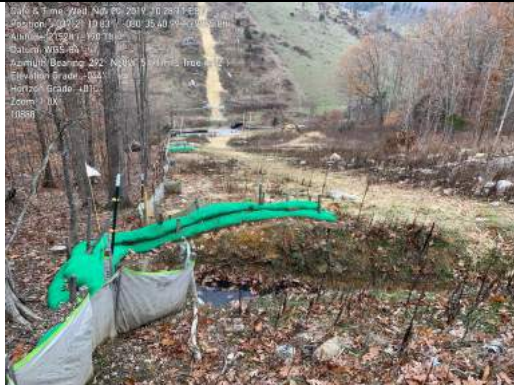
| Field Station# | 10871+00 | | Field Station# | 10888+00 | |

| Pic 3 Desc. | ECD's and row conditions | | Pic 4 Desc. | ECD's and row conditions | |

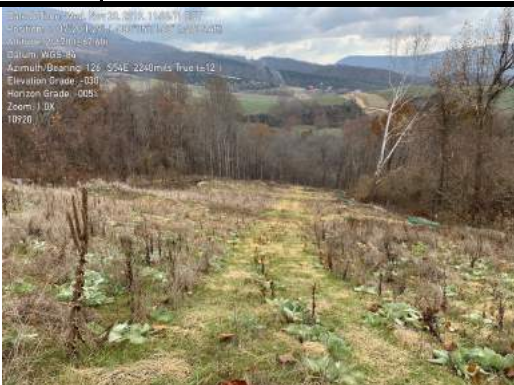
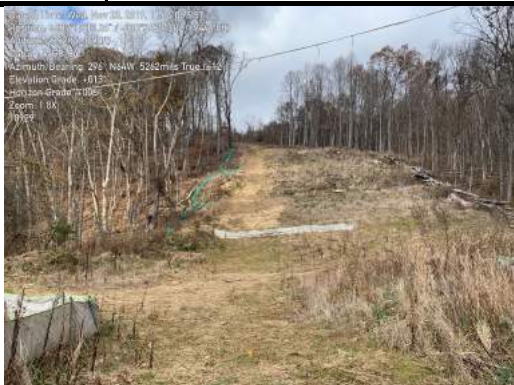
| Field Station# | 10920+00 | | Field Station# | 10929+00 | |

| Pic 5 Desc. | ECD's and row conditions | | Pic 6 Desc. | ECD's and row conditions | |

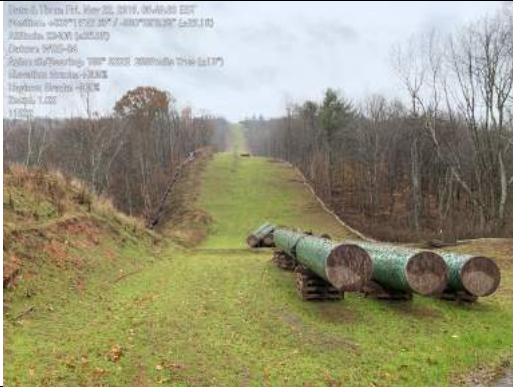
| Field Station# | 11520+00 | | Field Station# | 11532+00 | |

| Pic 1 Desc. | ECD's and row conditions | | Pic 2 Desc. | ECD's and row conditions | |

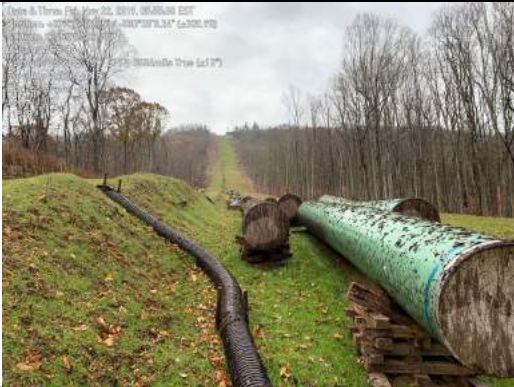
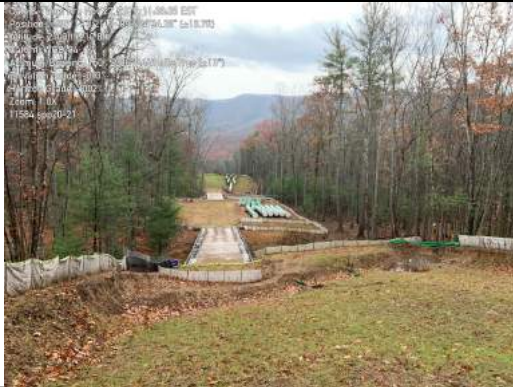
| Field Station# | 11548+00 | | Field Station# | 11584+00 | |

| Pic 3 Desc. | ECD's and row conditions | | Pic 4 Desc. | ECD's and row conditions | |
