Visual Site Inspection Report

Project Name	H-600 Pipeline Spread G	AFE	124300137	Spread	H-600 Pipeline Spread G
Contractor	Precision			Report #	5568
Inspector	Len Kruizenga			Date/Time	11/4/2019 7:20 AM
Permit #	TBD	Inspection Type	VA SWPP	Station Begin	11022+00
State	VA	Inspection Area	Full	Station End	10930+00
County	Giles	Ground	Wet	Temperature (°F)	35.00
Municipality	N/A	Weather	Sunny	Rain Gauge (in)	0.00
				Rain Accumulation Time (days)	3.00

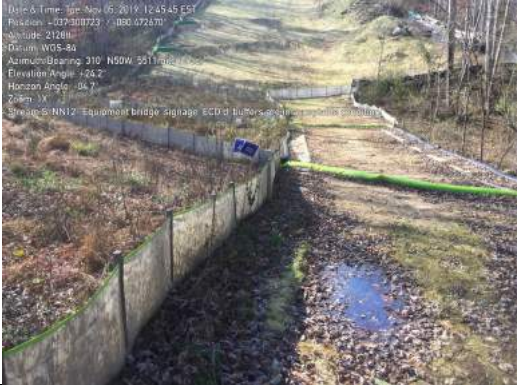
<p> <small> Date/Time: 11/05/2019 12:45:45 EST Position: 43°30'07.23" N 100°07'26.70" W Elevation: 2126 ft Datum: WGS-84 Azimuth/Bearing: 310° NSW, 551.1 m Deviation/Angle: 78.2° Heading/Angle: 184.7° Altitude: 11.1 m Stream S-NN12- Equipment bridge, ECD's, sensitive resource signage, buffers are in acceptable condition. </small> </p>					
GPS Location	See photo GPS	GPS Location			
Field Station#	11328+00	Field Station#			
Pic 7 Desc.	Stream S-NN12- Equipment bridge, ECD's, sensitive resource signage, buffers are in acceptable condition.	Pic 8 Desc.			
Insert image here		Insert image here			
GPS Location		GPS Location			
Field Station#		Field Station#			
Pic 9 Desc.		Pic 10 Desc.			
Insert image here		Insert image here			
GPS Location		GPS Location			
Field Station#		Field Station#			
Pic 11 Desc.		Pic 12 Desc.

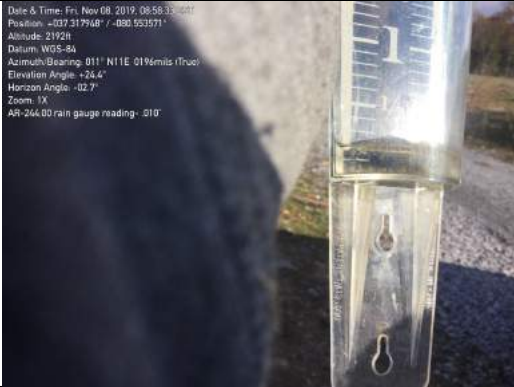
<p>Date & Time: Fri, Nov 08, 2019, 08:58:33 -05 Position: -037.317948 / -080.953571 Altitude: 2192ft Datum: WGS-84 Azimuth/Bearing: 011° N11E 019mils (True) Elevation Angle: +24.4° Horizon Angle: -02.7° Zoom: IX AR-244.00 rain gauge reading- .010"</p>
