Visual Site Inspection Report

Project Name	H-600 Pipeline Spread G	AFE	124300137	Spread	H-600 Pipeline Spread
Contractor	Precision			Report #	100003
Inspector	Garrett Barclay			Date/Time	9/19/2019 3:28 PM
Permit #	TBD	Inspection Type	VA SWPP	Station Begin	10840+00
State	VA	Inspection Area	Partial	Station End	10920+00
County	Giles	Ground	Dry	Temperature (°F)	63.00
Municipality	N/A	Weather	Sunny	Rain Gauge (in)	0.00
				Rain Accumulation Time (days)	1.00

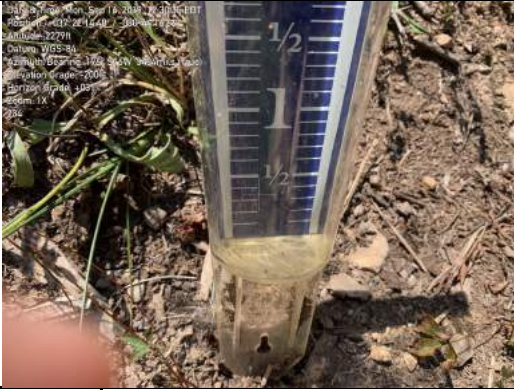
GPS Location	See picture above for GPS coordinates		GPS Location	See picture above for GPS coordinates	
Field Station#	2+34		Field Station#	11025+00	
Pic 1 Desc.	No rain recorded		Pic 2 Desc.	ECD's and row conditions

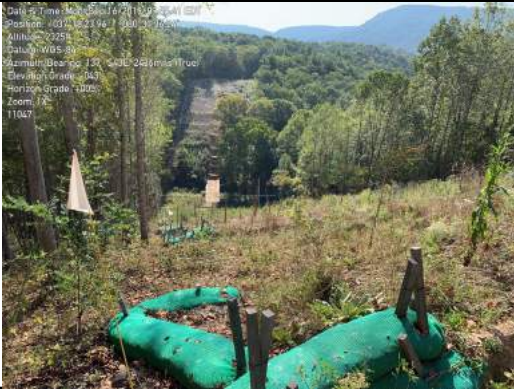
GPS Location	See picture above for GPS coordinates		GPS Location	See picture above for GPS coordinates	
Field Station#	11047+00		Field Station#	11054+00	
Pic 3 Desc.	ECD's and row conditions		Pic 4 Desc.	ECD's and row conditions

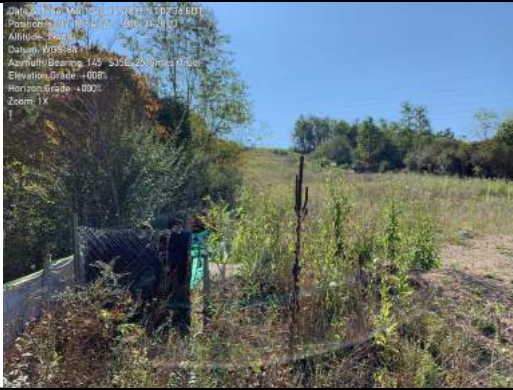
GPS Location	See picture above for GPS coordinates		GPS Location	See picture above for GPS coordinates	
Field Station#	11123+00		Field Station#	11132+00	
Pic 5 Desc.	ECD's and row conditions		Pic 6 Desc.	ECD's and row conditions

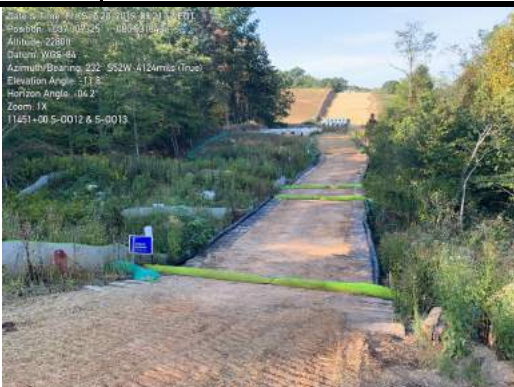
<p>Date & Time: Fri, Sep 20, 2019 9:41:11 EDT Position: -017 330244 / -080 435126 Altitude: 2161 ft Datum: WGS 84 Azimuth/Bearing: 45° S 51° W 4044mils (True) Elevation Angle: -10.5° Horizon Angle: +00.2° Zoom: 1x 11451+00 S-0012 & S-0013</p>

GPS Location	See photo for GPS location.		GPS Location	See photo for GPS location.	
Field Station#	11473+00		Field Station#	11473+00	
Pic 3 Desc.	Environmental crew spreading seed and mulch.		Pic 4 Desc.	Environmental crew reworking rock outlet at slope drains.

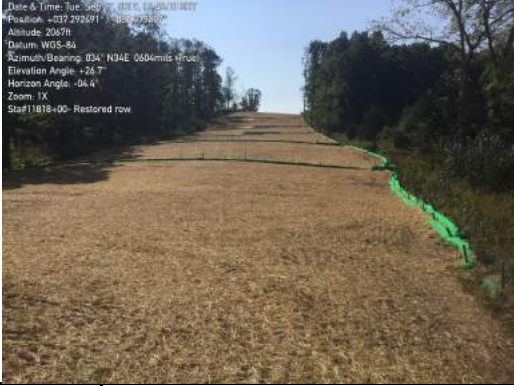
<p>Date & Time: Tue, Sep 17, 2019, 10:26:10 EDT Position: -83.7292491° / -35.336317° Altitude: 2057ft Datum: WGS-84 Azimuth/Bearing: 034° N34E 060mils (True) Elevation Angle: +26.7° Horizon Angle: -04.4° Zoom: IX Sta#11818+00- Restored row</p>

<p>Date & Time: Tue, Sep 17, 2019, 10:28:10 EDT Position: -83.728977° / -35.336317° Altitude: 2091ft Datum: WGS-84 Azimuth/Bearing: 235° N24W 583mils (True) Elevation Angle: +20.4° Horizon Angle: -18.8° Zoom: IX Sta#11900+00- AR-26603-CFS check dams along the road are in acceptable condition</p>			
GPS Location	See photo GPS		GPS Location	See photo GPS	
Field Station#	11818+00		Field Station#	11900+00	
Pic 1 Desc.	Restored row.		Pic 2 Desc.	AR-26603- CFS check dams are in acceptable condition.
