# Visual Site Inspection Report

<b>Project Name</b>	H-600 Pipeline Spread G	<b>AFE</b>	124300137	<b>Spread</b>	H-600 Pipeline Spread
<b>Contractor</b>	Precision			<b>Report #</b>	100031
<b>Inspector</b>	Garrett Barclay			<b>Date/Time</b>	9/27/2019 2:43 PM
<b>Permit #</b>	TBD	<b>Inspection Type</b>	VA SWPP	<b>Station Begin</b>	11520+00
<b>State</b>	VA	<b>Inspection Area</b>	Partial	<b>Station End</b>	11630+00
<b>County</b>	Giles	<b>Ground</b>	Dry	<b>Temperature (°F)</b>	78.00
<b>Municipality</b>	N/A	<b>Weather</b>	Sunny	<b>Rain Gauge (in)</b>	0.00
				<b>Rain Accumulation Time (days)</b>	1.00

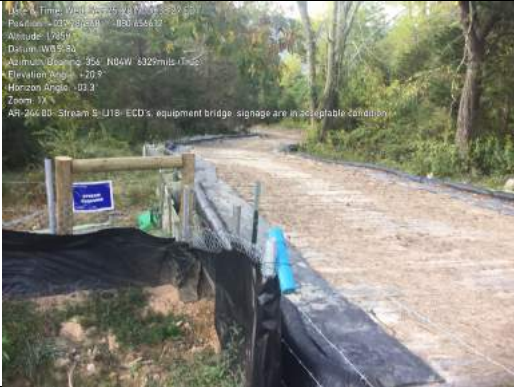
<p>Date &amp; Time: Wed, Sep 25, 2019, 08:58:57 EDT Position: 422° 00' 00" N 83° 45' 00" W Altitude: 1950 ft Datum: WGS 84 Azimuth Bearing: 354° N 84W 5329mils (1000) Elevation Angle: +20.8° Horizon Angle: -12.1° Zoom: IX AR-204-03-Stream S-L1B-ECD's equipment bridge, signage are in acceptable condition.</p>

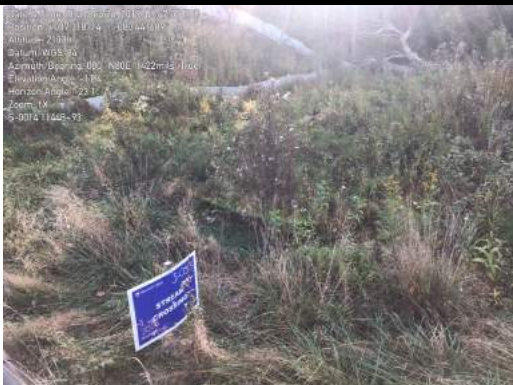
<b>GPS Location</b>	3	<b>GPS Location</b>	4		
<b>Field Station#</b>	11487+00	<b>Field Station#</b>	11487+00		
<b>Pic 3 Desc.</b>	Plunge pool.	<b>Pic 4 Desc.</b>	Temporary stabilization.

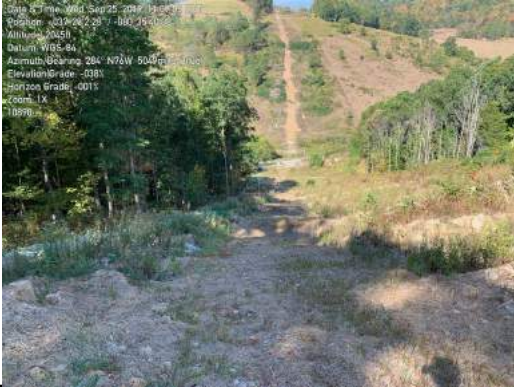
<b>GPS Location</b>	See picture above for GPS coordinates		<b>GPS Location</b>	See picture above for GPS coordinates	
<b>Field Station#</b>	10890+00		<b>Field Station#</b>	10898+00	
<b>Pic 3 Desc.</b>	ECD's and row conditions		<b>Pic 4 Desc.</b>	ECD's and row conditions

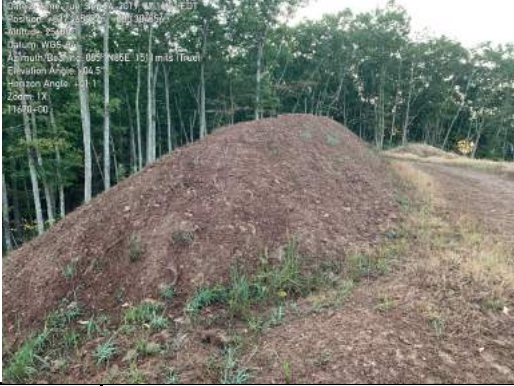
<b>GPS Location</b>	See photo for GPS location.		<b>GPS Location</b>	See photo for GPS location.	
<b>Field Station#</b>	11670+00		<b>Field Station#</b>	11663+00	
<b>Pic 1 Desc.</b>	Top soil spoil pile stabilized with hydro mulch. Application was performed by helicopter.		<b>Pic 2 Desc.</b>	ROW being stabilized with hydro mulch. Application being conducted by helicopter.

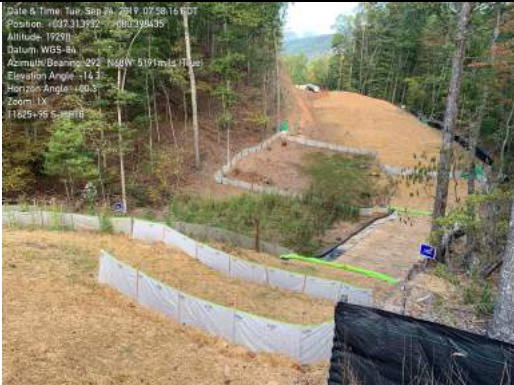
<b>GPS Location</b>	See photo for GPS location.		<b>GPS Location</b>	See photo for GPS location.	
<b>Field Station#</b>	11625+95		<b>Field Station#</b>	11620+00	
<b>Pic 3 Desc.</b>	Sensitive resource buffer in place at stream S-HH18.		<b>Pic 4 Desc.</b>	Clean water diversion pipe and plunge pool in place.

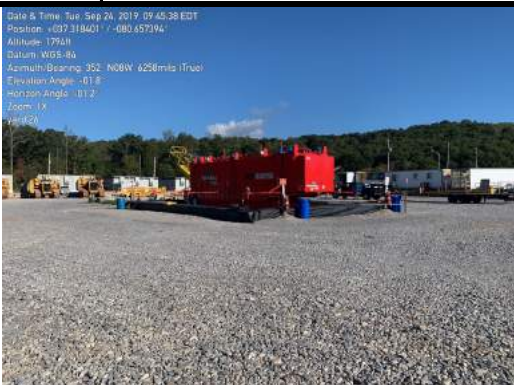
<b>Field Station#</b>	12005+00		<b>Field Station#</b>	12005+00	
<b>Pic 5 Desc.</b>	Secondary containment in place under fuel cell.		<b>Pic 6 Desc.</b>	RCE in place at employee parking lots.

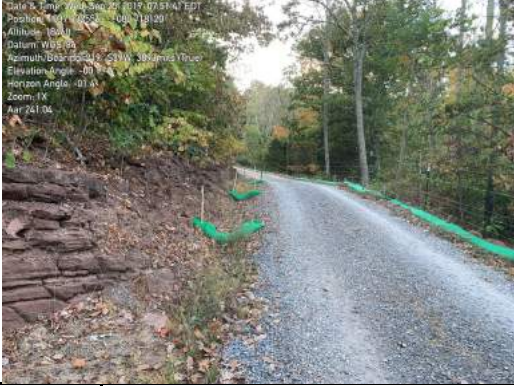
<b>GPS Location</b>	See photo for GPS location.		<b>GPS Location</b>	See photo for GPS location.	
<b>Field Station#</b>	12005+00		<b>Field Station#</b>	10712+50	
<b>Pic 1 Desc.</b>	Sock checks in bar ditch along access road 241.04.		<b>Pic 2 Desc.</b>	Sensitive resource buffer in place at stream S-G33.

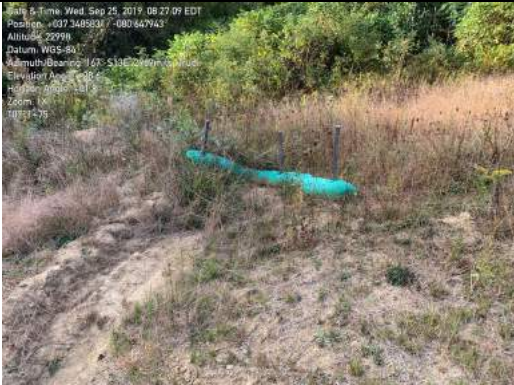
<b>GPS Location</b>	See photo for GPS location.		<b>GPS Location</b>	See photo for GPS location.	
<b>Field Station#</b>	10711+75		<b>Field Station#</b>	10710+00	
<b>Pic 3 Desc.</b>	Waterbar and end treatment in place along disturbed travel lane.		<b>Pic 4 Desc.</b>	ROW is stabilized with natural vegetation.

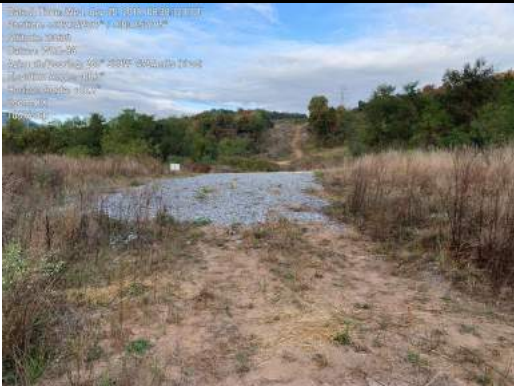
<b>GPS Location</b>	See photo for GPS location.		<b>GPS Location</b>	See photo for GPS location.	
<b>Field Station#</b>	10696+00		<b>Field Station#</b>	10670+00	
<b>Pic 5 Desc.</b>	RCE in place Buffalo Anklets Road to help assist in track out prevention.		<b>Pic 6 Desc.</b>	18 inch compost filter in place as LOD control.

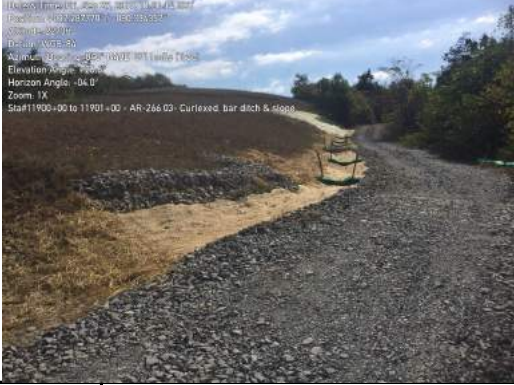
<p>Date &amp; Time: Fri, Sep 27, 2019, 11:01:00 EDT Position: 4307.29318 / -88.756727 Altitude: 2254 ft Datum: WGS 84 Azimuth Bearing: 347° N135W 316mils True Elevation Angle: +21.6° Horizon Angle: -03.9° Zoom: IX Sta# 11900+00 to 11901+00 - AR-266.03 - Curlexed bar ditch &amp; slope</p>

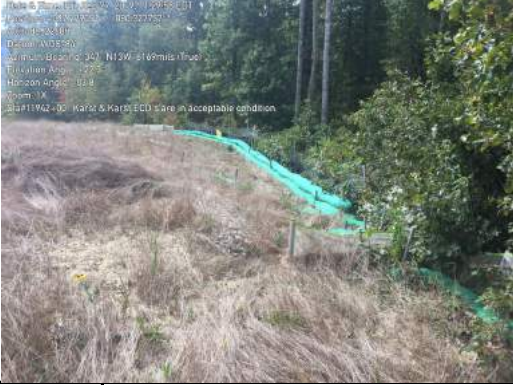
<p>Date &amp; Time: Fri, Sep 27, 2019, 11:51:46 EDT Position: 4307.29318 / -88.756727 Altitude: 2254 ft Datum: WGS 84 Azimuth Bearing: 347° N135W 316mils True Elevation Angle: +21.6° Horizon Angle: -03.9° Zoom: IX Sta# 11942+00 - Karst &amp; Karst ECD's are in acceptable condition</p>		<b>GPS Location</b>	See photo GPS
<b>Field Station#</b>	11900+00	<b>Field Station#</b>	11942+00	<b>GPS Location</b>	See photo GPS
<b>Pic 3 Desc.</b>	Sta# 11900+00 to 11901+00- AR-266.03- Curlexed bar ditch & slope.	<b>Pic 4 Desc.</b>	Karst and Karst ECD's are in acceptable condition	<b>GPS Location</b>	See photo GPS

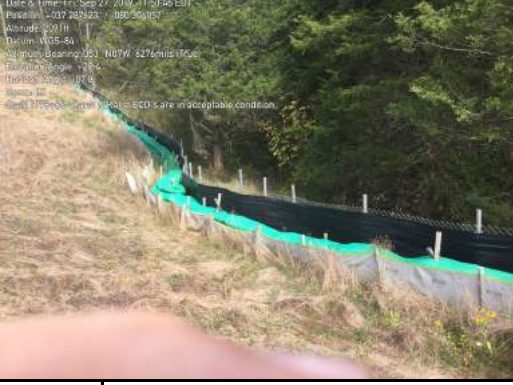
<p>Date &amp; Time: Fri, Sep 27, 2019, 11:51:46 EDT Position: 4307.29318 / -88.756727 Altitude: 2254 ft Datum: WGS 84 Azimuth Bearing: 347° N135W 316mils True Elevation Angle: +21.6° Horizon Angle: -03.9° Zoom: IX Sta# 11978+86 - Karst &amp; Karst ECD's are in acceptable condition</p>		<b>GPS Location</b>	See photo GPS
<b>Field Station#</b>	11950+00	<b>Field Station#</b>	11978+86	<b>GPS Location</b>	See photo GPS
<b>Pic 5 Desc.</b>	Subsidence remains unchanged.	<b>Pic 6 Desc.</b>	Karst and Karst ECD's are in acceptable condition.	<b>GPS Location</b>	See photo GPS

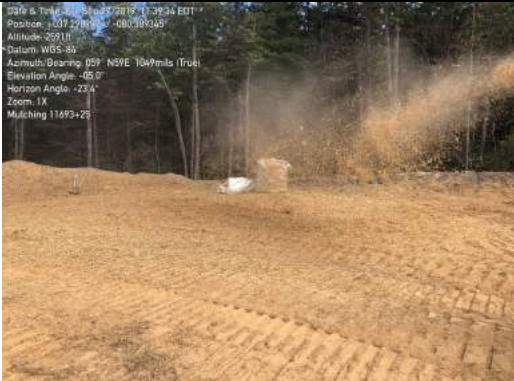
<b>GPS Location</b>	3	<b>GPS Location</b>	4		
<b>Field Station#</b>	11693+25	<b>Field Station#</b>	11697+00		
<b>Pic 3 Desc.</b>	Mulching.	<b>Pic 4 Desc.</b>	Applying temporary seed mix.
