Visual Site Inspection Report

Project Name	H-600 Pipeline Spread G	AFE	124300137	Spread	H-600 Pipeline Spread
Contractor	Precision			Report #	100304
Inspector	Garrett Barclay			Date/Time	9/3/2019 2:30 PM
Permit #	TBD	Inspection Type	VA SWPP	Station Begin	10830+00
State	VA	Inspection Area	Partial	Station End	10929+00
County	Giles	Ground	Dry	Temperature (°F)	86.00
Municipality	N/A	Weather	Sunny	Rain Gauge (in)	0.00
				Rain Accumulation Time (days)	1.00

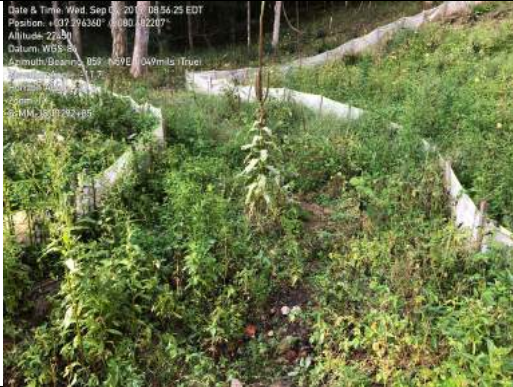
<p>Date & Time: Wed, Sep 04, 2019 08:56:25 EDT Position: +037.296340° / -080.532207° Altitude: 2283ft Datum: WGS-84 Azimuth/Bearing: 059° 00'E 1047mils (True) Elevation Angle: -11.7° Horizon Angle: -22.3° Zoom: 1X S-MM18</p>			
GPS Location	1	GPS Location	2		
Field Station#	11279+00	Field Station#	11292+85		
Pic 1 Desc.	Functional plunge pool.	Pic 2 Desc.	S-MM18.

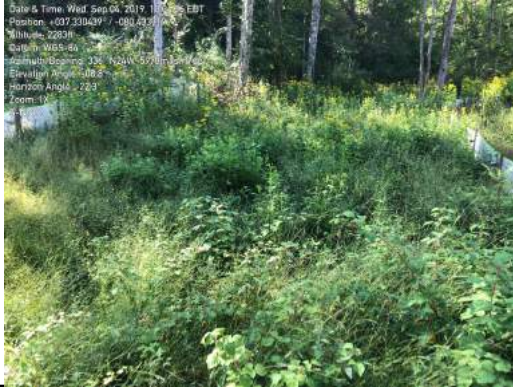
<p>Date & Time: Wed, Sep 04, 2019 10:00:00 EDT Position: +037.330439° / -080.493717° Altitude: 2283ft Datum: WGS-84 Azimuth/Bearing: 338° 00'W 597mils (True) Elevation Angle: -08.8° Horizon Angle: -22.3° Zoom: 1X S-NN12</p>

GPS Location	3	GPS Location	4		
Field Station#	11298+25	Field Station#	11327+85		
Pic 3 Desc.	Freshly re-worked sump.	Pic 4 Desc.	S-NN12.

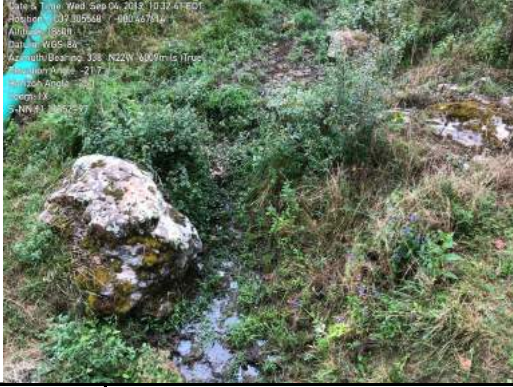
<p>Date & Time: Wed, Sep 04, 2019 10:12:41 EDT Position: +037.335548° / -080.467816° Altitude: 2280ft Datum: WGS-84 Azimuth/Bearing: 301° 00'W 1000mils (True) Elevation Angle: -08.0° Horizon Angle: -20.0° Zoom: 1X S-NN11</p>			
GPS Location	5	GPS Location	6		
Field Station#	11344+00	Field Station#	11352+97		
Pic 5 Desc.	Repairing water bar.	Pic 6 Desc.	S-NN11.

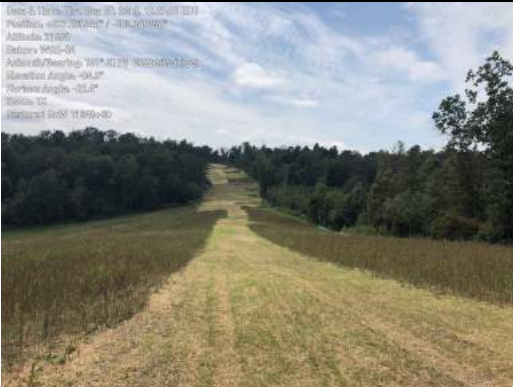
GPS Location	3	GPS Location	4		
Field Station#	11899+50	Field Station#	11842+00		
Pic 3 Desc.	Restored section of RoW.	Pic 4 Desc.	Restored section of RoW.		
  <p> Date & Time: Thu, Sep 05, 2019, 12:42:48 EDT Position: +32° 28'59.0" / -80° 32'40.0" Altitude: 224.00' Datum: WGS-84 Azimuth/Heading: 207° 42'58" 202m/s (True) Magnetic Angle: -94.3° Pitch Angle: -0.2° Roll: 12° Horizontal Speed: 1.120m/s </p>		  <p> Date & Time: Thu, Sep 05, 2019, 12:42:48 EDT Position: +32° 28'59.0" / -80° 32'40.0" Altitude: 224.00' Datum: WGS-84 Azimuth/Heading: 207° 42'58" 202m/s (True) Magnetic Angle: -94.3° Pitch Angle: -0.2° Roll: 12° Horizontal Speed: 1.120m/s </p>			
GPS Location	5	GPS Location	6		
Field Station#	11839+50	Field Station#	11827+00		
Pic 5 Desc.	Restored section of RoW.	Pic 6 Desc.	Recently restored section of RoW.
