Visual Site Inspection Report

Project Name	H-600 Pipeline Spread G	AFE	124300137	Spread	H-600 Pipeline Spread
Contractor	Precision			Report #	100067
Inspector	Garrett Barclay			Date/Time	10/3/2019 2:41 PM
Permit #	TBD	Inspection Type	VA SWPP	Station Begin	11520+00
State	VA	Inspection Area	Partial	Station End	11630+00
County	Giles	Ground	Dry	Temperature (°F)	92.00
Municipality	N/A	Weather	Sunny	Rain Gauge (in)	0.00
				Rain Accumulation Time (days)	1.00

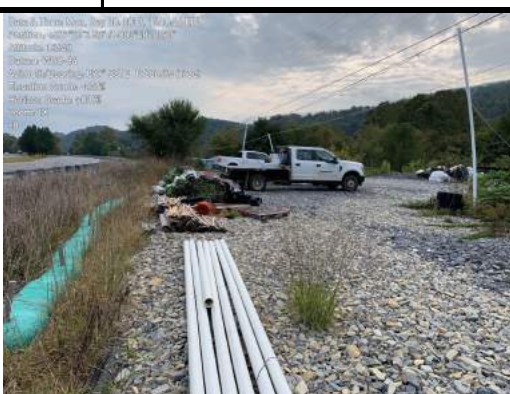
GPS Location	See picture above for GPS coordinates		GPS Location	See picture above for GPS coordinates	
Field Station#	+28		Field Station#	+28	
Pic 3 Desc.	ECD's and row conditions		Pic 4 Desc.	ECD's and row conditions

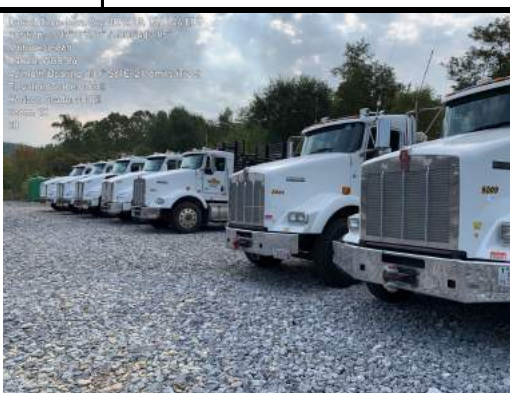
GPS Location	See picture above for GPS coordinates		GPS Location	See picture above for GPS coordinates	
Field Station#	+28		Field Station#	+28	
Pic 5 Desc.	ECD's and row conditions		Pic 6 Desc.	ECD's and row conditions

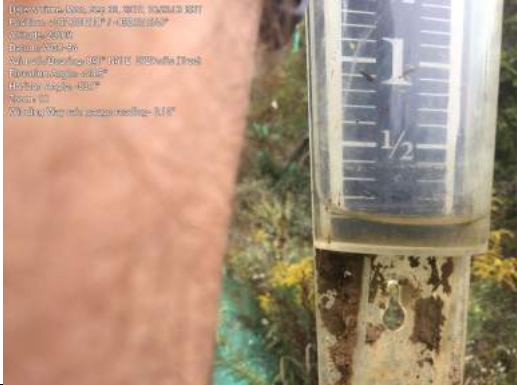
<p> <small> Photo Time: Mon Sep 30 2019 10:51:03 AM Location: 43°11'18.33"N 113°15'11.11"W Altitude: 2150 ft Bearing: 205.9° Azimuth: 180° Horizontal Angle: 113.4° Vertical Angle: 43.0° Photo: 12 Winding Way rain gauge reading: 0.10" </small> </p>			
GPS Location	See photo GPS	GPS Location	See photo GPS		
Field Station#	11022+00	Field Station#	11227+00		
Pic 7 Desc.	AR-244.00 rain gauge reading- 0.20"	Pic 8 Desc.	Winding Way rain gauge reading -0.10"		
Insert image here		Insert image here			
GPS Location		GPS Location			
Field Station#		Field Station#			
Pic 9 Desc.		Pic 10 Desc.

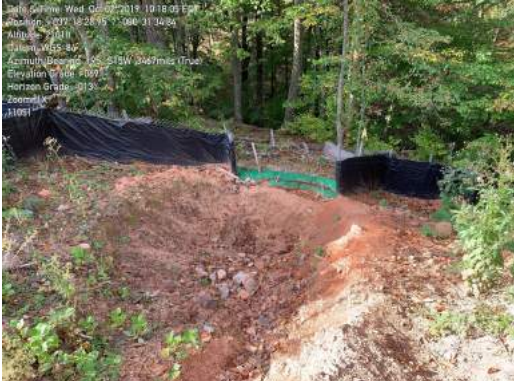
GPS Location	See picture above for GPS coordinates		GPS Location	See picture above for GPS coordinates	
Field Station#	11051+00		Field Station#	11055+00	
Pic 3 Desc.	ECD's and row conditions		Pic 4 Desc.	ECD's and row conditions

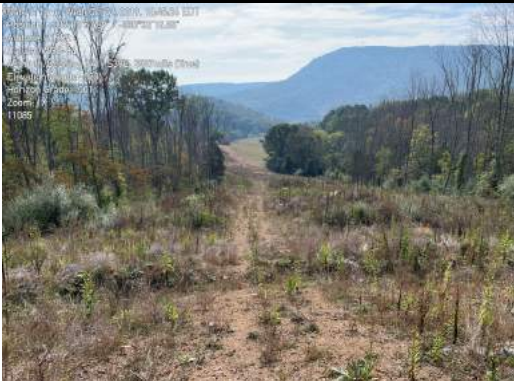
GPS Location	See picture above for GPS coordinates		GPS Location	See picture above for GPS coordinates	
Field Station#	11085+00		Field Station#	11101+00	
Pic 5 Desc.	ECD's and row conditions		Pic 6 Desc.	ECD's and row conditions

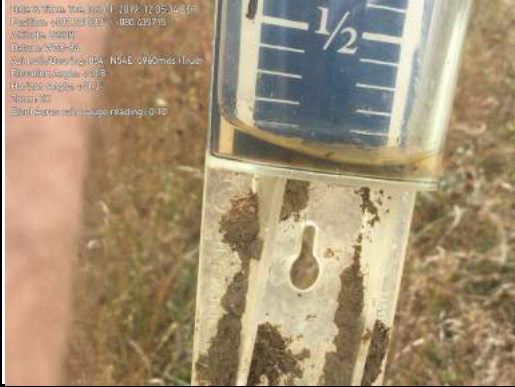
GPS Location	See photo GPS	GPS Location	See photo GPS		
Field Station#	11227+00	Field Station#	11471+00		
Pic 7 Desc.	Winding Way rain gauge reading- 0.20"	Pic 8 Desc.	Steel Acres rain gauge reading- 0.10"		
Insert image here		Insert image here			
GPS Location		GPS Location			
Field Station#		Field Station#			
Pic 9 Desc.		Pic 10 Desc.			
Insert image here		Insert image here			
GPS Location		GPS Location			
Field Station#		Field Station#			
Pic 11 Desc.		Pic 12 Desc.

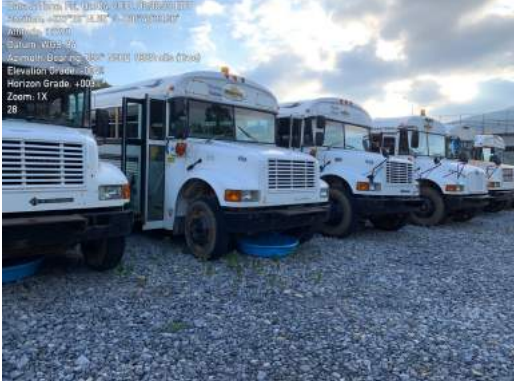
Field Station#		+8		Field Station#	
Pic 1 Desc.		ECD's and row conditions		Pic 2 Desc.

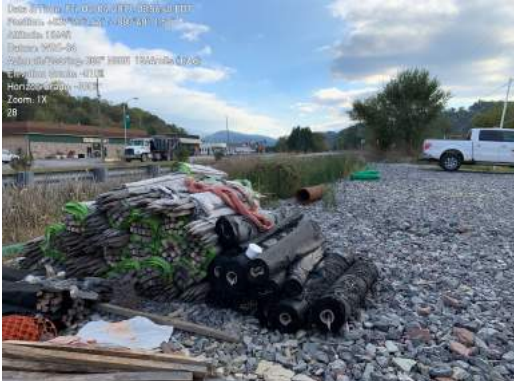
Field Station#		+28		Field Station#	
Pic 3 Desc.		ECD's and row conditions		Pic 4 Desc.

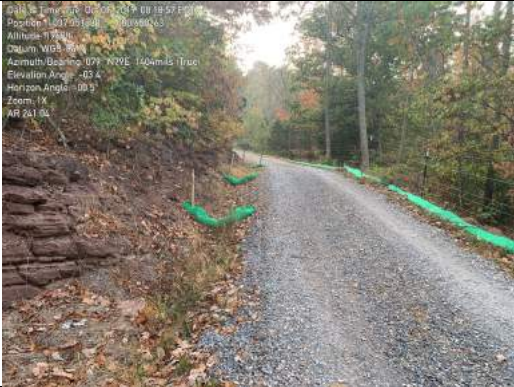
GPS Location	See photo for GPS location.		GPS Location	See photo for GPS location.	
Field Station#	12005+00		Field Station#	10712+50	
Pic 1 Desc.	Sock checks in place in bar ditch along access road.		Pic 2 Desc.	Sensitive resource buffer in place at stream S-G33.
