# Visual Site Inspection Report

| <b>Project Name</b> | H-600 Pipeline Spread H | <b>AFE</b> | 124300138 | <b>Spread</b> | H-600 Pipeline Spread | |
| <b>Contractor</b> | Precision | | | <b>Report #</b> | 4746 | |
| <b>Inspector</b> | Pat Davis | | | <b>Date/Time</b> | 10/16/2019 5:04 PM | |

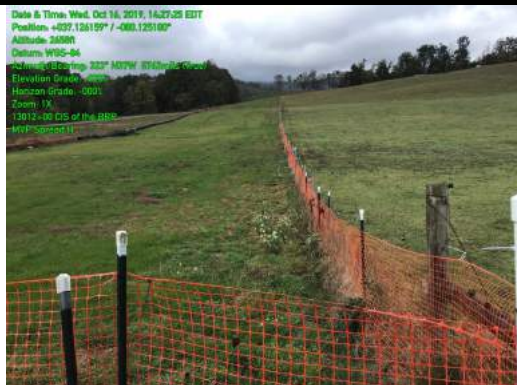
| <b>Field Station#</b> | 13012+00 | | <b>Field Station#</b> | 13012+50 | |

| <b>Pic 9 Desc.</b> | Downstream side of S-G26 had no signs of impact from the project. | | <b>Pic 10 Desc.</b> | Downstream side of S-G27 had no signs of impact from the project. | |

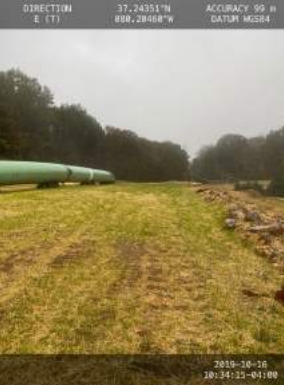
| <b>Field Station#</b> | 12392+00 | | <b>Field Station#</b> | 12409+39 | |

| <b>Pic 3 Desc.</b> | Land owner access crossing the ROW. | | <b>Pic 4 Desc.</b> | Bridge over stream crossing S-NN19 | |

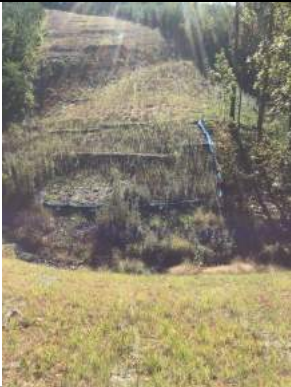
| <b>Field Station#</b> | 13460+00 | | <b>Field Station#</b> | 13510+00 | |

| <b>Pic 1 Desc.</b> | Area recommended for winter seed | | <b>Pic 2 Desc.</b> | Vegetation photo | |
