Visual Site Inspection Report

Project Name	H-600 Pipeline Spread H	AFE	124300138	Spread	H-600 Pipeline Spread H
Contractor	Precision	Report #	5020		
Inspector	Pat Davis	Date/Time	10/22/2019 5:33 PM		
Permit #	TBD	Inspection Type	VA SWPP	Station Begin	+0
State	VA	Inspection Area	Partial	Station End	+0
County	Montgomery	Ground	Damp	Temperature (°F)	67.00
Municipality	N/A	Weather	Light Rain	Rain Gauge (in)	0.70
				Rain Accumulation Time (days)	0.00

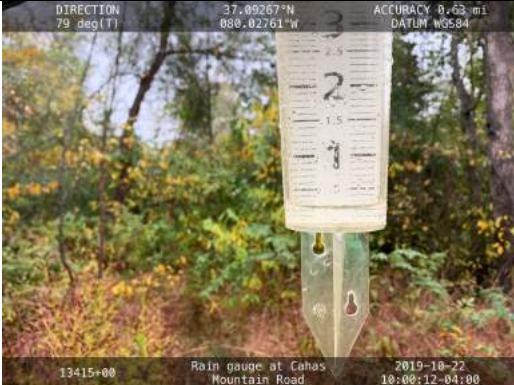
GPS Location	See photo for gps data.		GPS Location	See photo for gps data.	
Field Station#	13415+00		Field Station#	13413+00	
Pic 1 Desc.	Photo shows the rain gauge at Cahas Mountain Road.		Pic 2 Desc.	Photo shows the bridge over stream S-IJ1.

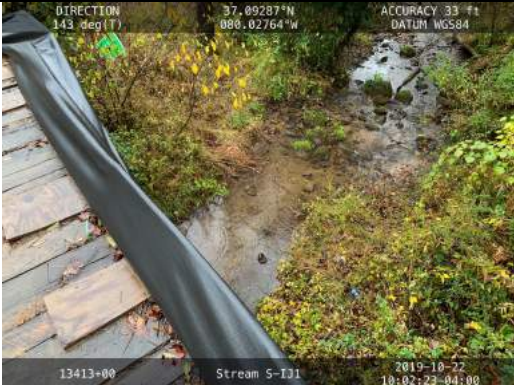
GPS Location	See photo for gps data.		GPS Location	See photo for gps data.	
Field Station#	13413+00		Field Station#	13348+46	
Pic 3 Desc.	Photo shows the stream S-IJ1, downstream from the ROW.		Pic 4 Desc.	Photo shows the bridge over stream S-RR08.

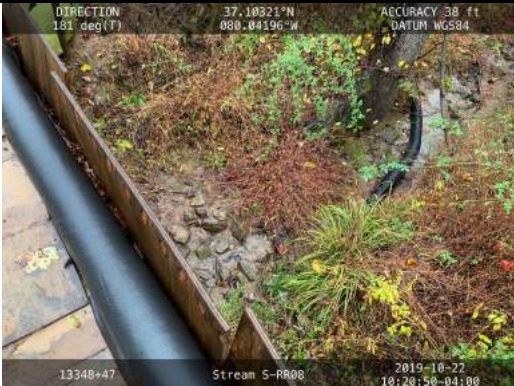
GPS Location	See photo for gps data.		GPS Location	See photo for gps data.	
Field Station#	13348+47		Field Station#	13352+23	
Pic 5 Desc.	Photo shows stream S-RR08 downstream from the bridge.		Pic 6 Desc.	Photo shows the bridge over stream S-RR09.

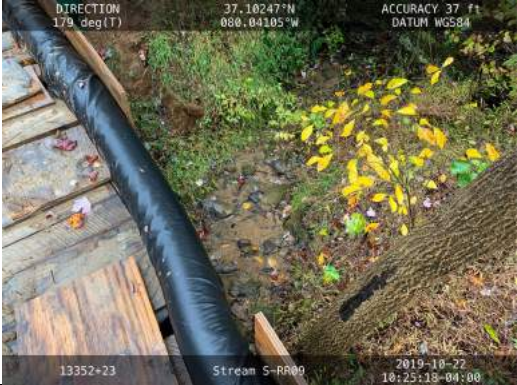
GPS Location	See photo for gps data.		GPS Location	See photo for gps data.	
Field Station#	13352+23		Field Station#	13358+64	
Pic 7 Desc.	Photo shows stream S-RR09 downstream from the bridge.		Pic 8 Desc.	Photo shows the bridge over stream S-RR11.

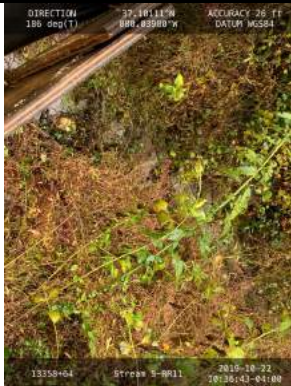
<p>Insert image here</p>	
GPS Location	See photo for gps data.		GPS Location	See photo for gps data.	
Field Station#	13358+64		Field Station#	13337+13	
Pic 9 Desc.	Photo shows stream S-RR11 downstream from the bridge.		Pic 10 Desc.	Photo shows the bridge over stream S-GH9.

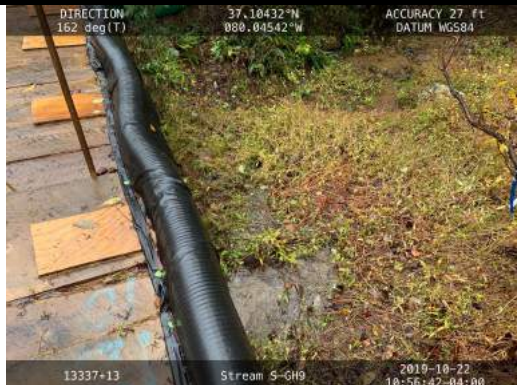
GPS Location	See photo for gps data.		GPS Location	See photo for gps data.	
Field Station#	13337+13		Field Station#	13334+17	
Pic 11 Desc.	Photo shows stream S-GH9 downstream from the bridge.		Pic 12 Desc.	Photo shows the bridge over stream S-GH11.

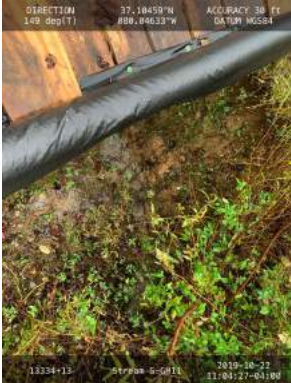
GPS Location	See photo for gps data.	GPS Location	See photo for gps data.		
Field Station#	13334+17	Field Station#	13333+00		
Pic 13 Desc.	Photo shows stream S-GH11 downstream from the bridge.	Pic 14 Desc.	Photo shows the slope from 13331+00 to 13333+00		
Insert image here		Insert image here			
GPS Location		GPS Location			
Field Station#		Field Station#			
Pic 15 Desc.		Pic 16 Desc.			
Insert image here		Insert image here			
GPS Location		GPS Location			
Field Station#		Field Station#			
Pic 17 Desc.		Pic 18 Desc.

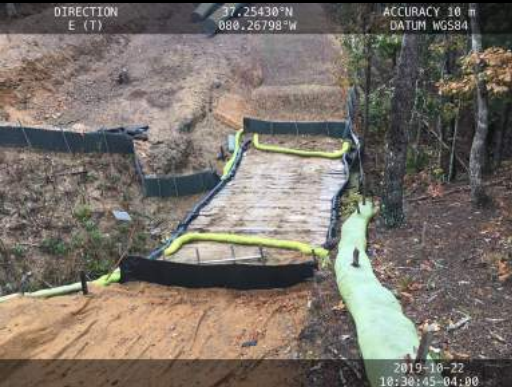
GPS Location	See photo		GPS Location	See photo	
Field Station#	12133+50		Field Station#	12163+05	
Pic 1 Desc.	Triple stacked CFS needs to be reinstalled around the bottom of this open bell hole on the going away side of stream S-C29.		Pic 2 Desc.	Stream S-C25, facing east

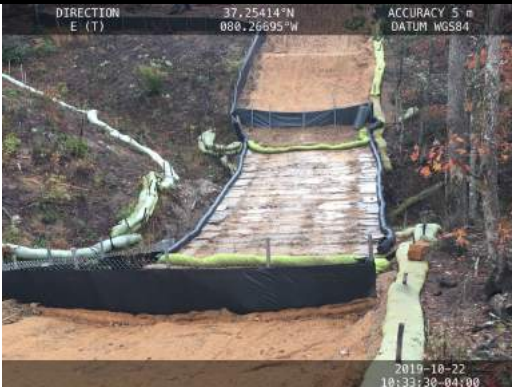
GPS Location	See photo		GPS Location	See photo	
Field Station#	12166+47		Field Station#	12167+50	
Pic 3 Desc.	Stream S-C24, facing east		Pic 4 Desc.	Triple stacked CFS needs to be reinstalled around the bottom edge of this open bell hole on the going away side of stream S-C24.
