Visual Site Inspection Report

Project Name	H-600 Pipeline Spread H	AFE	124300138	Spread	H-600 Pipeline Spread H
Contractor	Precision			Report #	5637
Inspector	Logan Box			Date/Time	11/7/2019 11:16 AM
Permit #	TBD	Inspection Type	VA SWPP	Station Begin	13415+55
State	VA	Inspection Area	Partial	Station End	13670+00
County	Franklin	Ground	Damp	Temperature (°F)	61.00
Municipality	N/A	Weather	Sunny	Rain Gauge (in)	0.00
				Rain Accumulation Time (days)	0.00

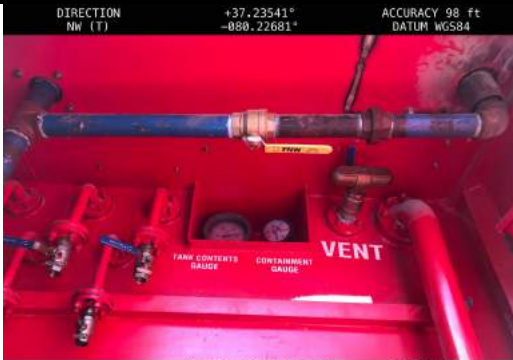
GPS Location	MVP-PY-006 See photo for gps data		GPS Location	MVP-PY-006 See photo for gps data	
Field Station#	+0		Field Station#	+0	
Pic 3 Desc.	Off Road Fuel unit no leaky fittings. Looking NW.		Pic 4 Desc.	Blue Bulk Fuel tanks no leaky fittings. Looking SW.

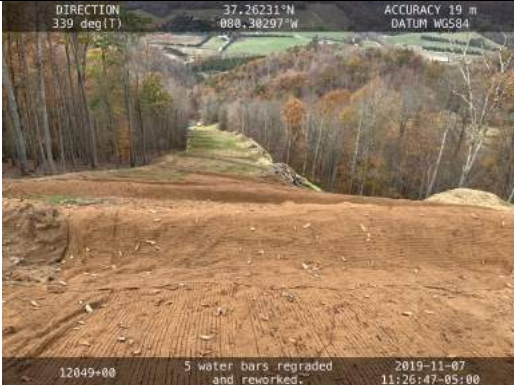
GPS Location	See photo GPS for location		GPS Location	See photo GPS for location	
Field Station#	12049+00		Field Station#	12050+50	
Pic 1 Desc.	Punch list item completed.		Pic 2 Desc.	Punch list item completed.

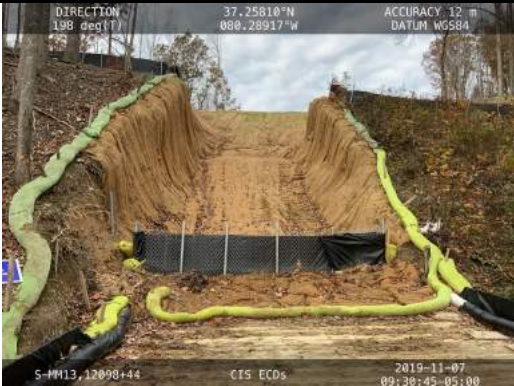
GPS Location	See photo GPS for location		GPS Location	See photo GPS for location	
Field Station#	12098+44		Field Station#	12098+44	
Pic 5 Desc.	ECDs functioning acceptably.		Pic 6 Desc.	No sediment impact in stream.

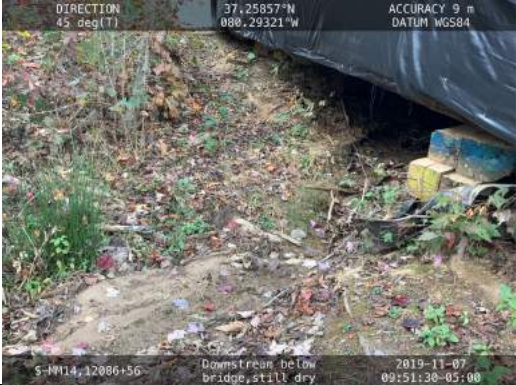
GPS Location	See photo GPS for location		GPS Location	See photo GPS for location	
Field Station#	12097+46		Field Station#	12086+56	
Pic 7 Desc.	Water bar and sump are in acceptable condition.		Pic 8 Desc.	No sediment impact in stream.

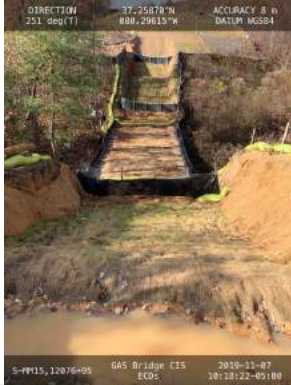
GPS Location	See photo GPS for location		GPS Location	See photo GPS for location	
Field Station#	12076+95		Field Station#	12076+95	
Pic 9 Desc.	ECDs functioning acceptably.		Pic 10 Desc.	No sediment impact in stream.

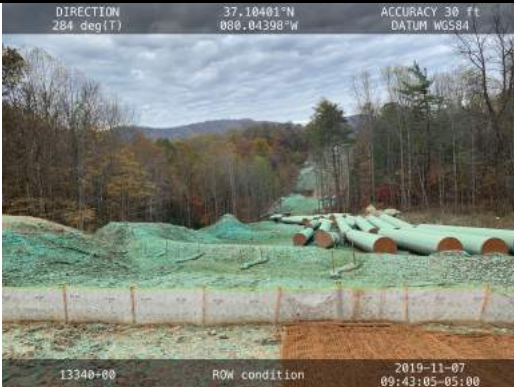
GPS Location	See photo for gps data.		GPS Location	See photo for gps data.	
Field Station#	13340+00		Field Station#	13325+30	
Pic 1 Desc.	Photo shows the ROW condition from about 13338+00 to 13340+00.		Pic 2 Desc.	Photo shows the bridge over stream S-GH14.

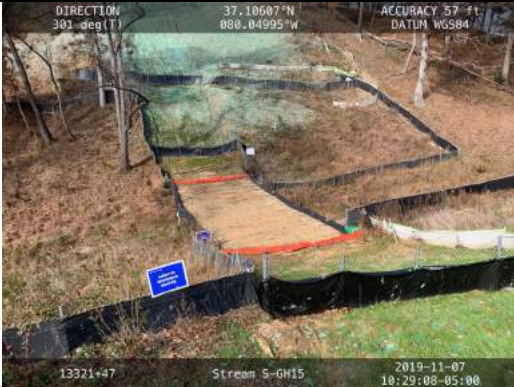
GPS Location	See photo for gps data.		GPS Location	See photo for gps data.	
Field Station#	13321+47		Field Station#	13413+00	
Pic 3 Desc.	Photo shows the bridge over stream S-GH15.		Pic 4 Desc.	Photo shows stream S-IJ1.

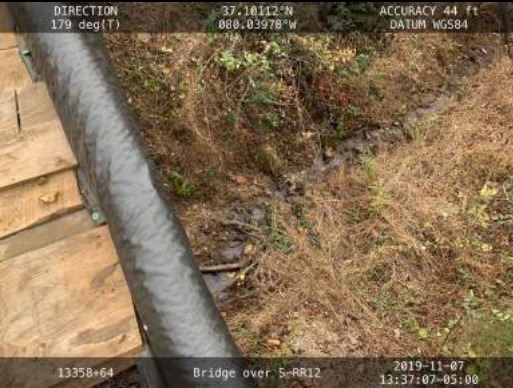
GPS Location	See photo for gps data.		GPS Location	See photo for gps data.	
Field Station#	13402+00		Field Station#	13358+64	
Pic 5 Desc.	Photo shows the area where the fallen tree was removed and the perimeter SSF was repaired. Punch list item 454.		Pic 6 Desc.	Photo shows stream S-RR11.

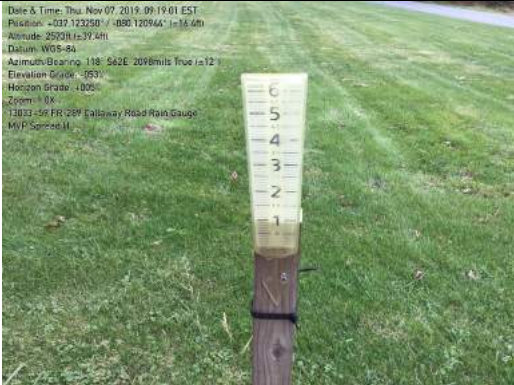
GPS Location	See pic for GPS location		GPS Location	See pic for GPS location	
Field Station#	13033+59		Field Station#	12974+29	
Pic 1 Desc.	No rainfall accumulation to report in the Callaway Road rain gauge.		Pic 2 Desc.	CFS is discoloring from the sun but remains in functional state.

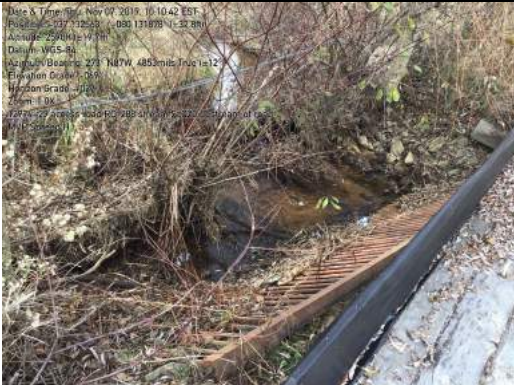
GPS Location	See pic for GPS location		GPS Location	See pic for GPS location	
Field Station#	12974+29		Field Station#	12957+30	
Pic 3 Desc.	Upstream condition of the S-Q20 crossing on access road RO-288.		Pic 4 Desc.	Down stream of access RO-287, stream S-217.

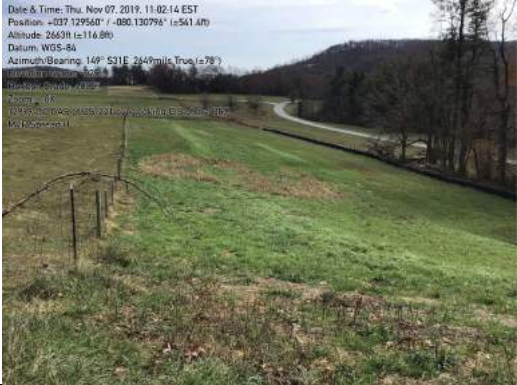
GPS Location	See pic for GPS location		GPS Location	See pic for GPS location	
Field Station#	12999+50		Field Station#	12998+50	
Pic 7 Desc.	BRP has substantial amount of permanent vegetative stabilization throughout the area.		Pic 8 Desc.	The GAS of US-221 where permanent restoration was performed has a substantial amount of permanent vegetative growth.

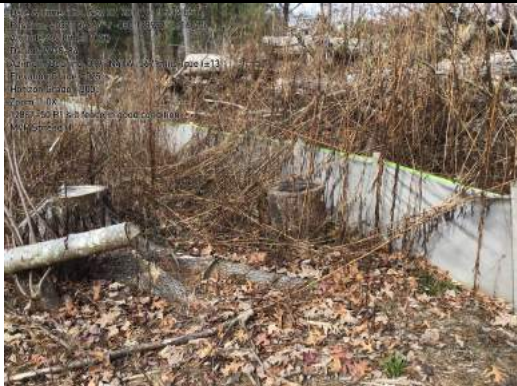
GPS Location	See pic for GPS location		GPS Location	See pic for GPS location	
Field Station#	12867+50		Field Station#	12866+50	
Pic 9 Desc.	No issues were observed with the P1 perimeter.		Pic 10 Desc.	No issues or impacts observed on the GAS of the Bottom Creek road crossing.	
<p>Date & Time: Thu, Nov 07, 2019, 11:10:37 EST Position: +037.128660° / -080.128789° (±16.4M) Altitude: 2591ft (±16.4M) Datum: WGS-84 Azimuth/Bearing: 149° 53'E 264Ymils True (±78°) Elevation Grade: -0.84 Horizontal Grade: 0.02 Project: OK Location: 124300138 (12866+50) (±107) MVP Screen 11</p>

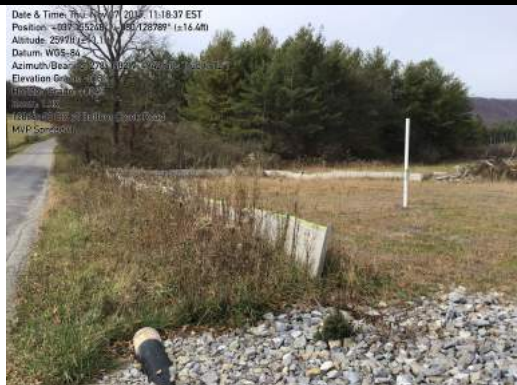
GPS Location	See pic for GPS location		GPS Location	See pic for GPS location	
Field Station#	12866+00		Field Station#	13040+00	
Pic 11 Desc.	No issues or impacts observed on the CIS of the Bottom Creek Road crossing.		Pic 12 Desc.	No issues or impacts to report near stream S-H1 or the GAS of FR-289.

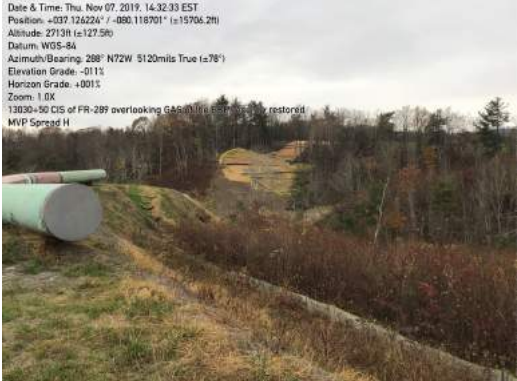
Insert image here			
GPS Location	See pic for GPS location		GPS Location		
Field Station#	13030+50		Field Station#		
Pic 13 Desc.	GAS of the BRP has been permanently restored and has a good amount of permanent vegetation growing. No issues or impacts.		Pic 14 Desc.		
Insert image here			Insert image here		
GPS Location			GPS Location		
Field Station#			Field Station#		
Pic 15 Desc.			Pic 16 Desc.		
Insert image here			Insert image here		
GPS Location			GPS Location		
Field Station#			Field Station#

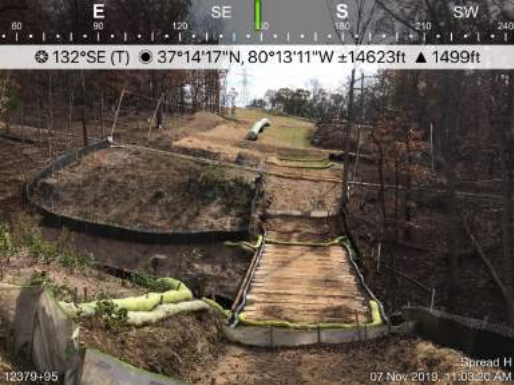
GPS Location	See photo	GPS Location	See photo		
Field Station#	12356+50	Field Station#	12379+95		
Pic 7 Desc.	Subsidence occurring in this area, this will be a maintenance item, continue to monitor this area closely.		Pic 8 Desc.	Bridge controls in good condition.

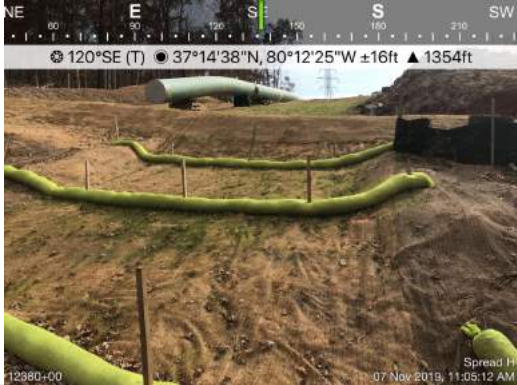
GPS Location	See photo	GPS Location	See photo		
Field Station#	12380+00	Field Station#	12417+00		
Pic 9 Desc.	CFS controls in good condition		Pic 10 Desc.	Waterbars and controls in good condition along this slope (MLV-27).

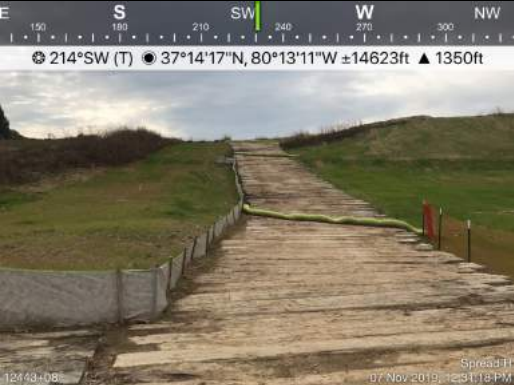
GPS Location	See photo	GPS Location	See photo		
Field Station#	12414+00	Field Station#	12443+08		
Pic 11 Desc.	Excavating and grading work occurring adjacent to the ROW		Pic 12 Desc.	Controls in good condition between Roanoke River Crossing and Rte 11.

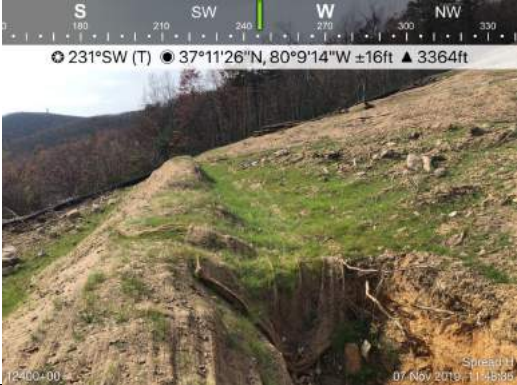
GPS Location	see photo		GPS Location	see photo	
Field Station#	12692+33		Field Station#	12700+00	
Pic 7 Desc.	Controls in place and in good condition on this slope.		Pic 8 Desc.	Waterbars on this slope in good condition.

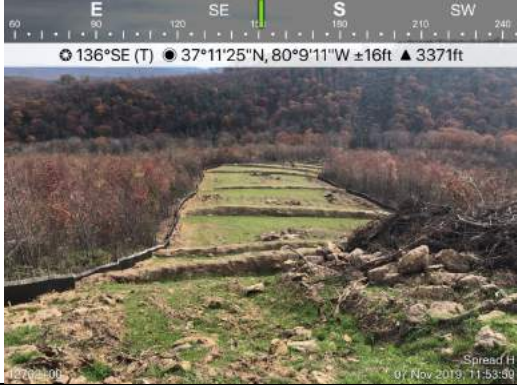
GPS Location	see photo		GPS Location	see photo	
Field Station#	12702+00		Field Station#	280+00	
Pic 9 Desc.	Vegetation filling in on this slope.		Pic 10 Desc.	AR-280 controls in place

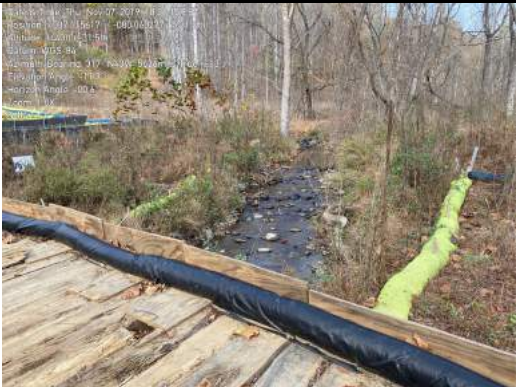
GPS Location	See photo for coordinates.		GPS Location	See photo for coordinates.	
Field Station#	13260+70		Field Station#	13252+00	
Pic 1 Desc.	S-II4, looking upstream of equipment bridge, ECDs functioning acceptably, geotech and sideboards in acceptable condition.		Pic 2 Desc.	ROW, head of drainage feature, vegetation taking hold, erosion control blanket stable, some sediment noted in SSF.

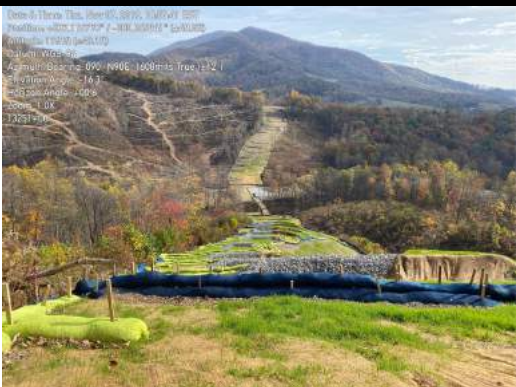
GPS Location	See photo for coordinates.		GPS Location	See photo for coordinates.	
Field Station#	13251+00		Field Station#	13246+00	
Pic 3 Desc.	ROW, permanent vegetation establishing across limits of disturbance, waterbars stable..		Pic 4 Desc.	ROW, good vegetative cover noted, some bare areas on waterbar berms.

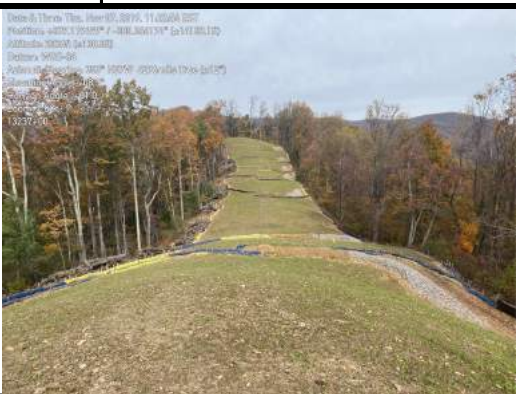
Pic 5 Desc.	ROW, vegetation noted across right of way, moderate ground cover.		Pic 6 Desc.	CIS of Wade's Gap, germination noted in temporary stabilized section, sparse growth noted in permanent.

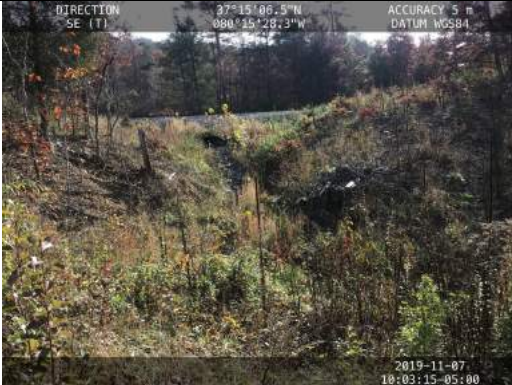
GPS Location	See photo		GPS Location	See photo	
Field Station#	12196+00		Field Station#	12192+50	
Pic 1 Desc.	Stream S-0011, facing southeast, upstream		Pic 2 Desc.	Stream S-C21, Bradshaw Creek, facing southeast, downstream

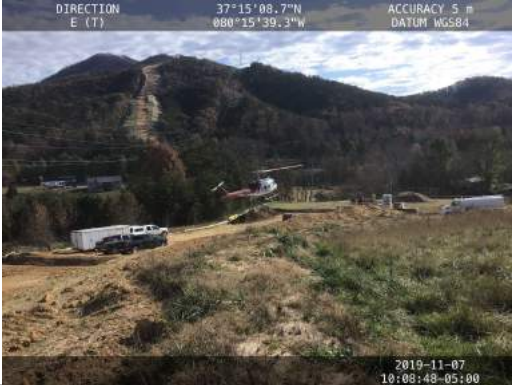
GPS Location	See photo		GPS Location	See photo	
Field Station#	12188+40		Field Station#	12166+47	
Pic 3 Desc.	Arnold's Seeding was staging from the coming in side of Bradshaw Road again today.		Pic 4 Desc.	Stream S-C24, facing east

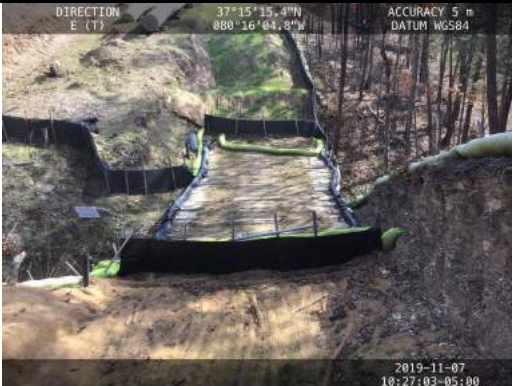
GPS Location	See photo		GPS Location	See photo	
Field Station#	12163+05		Field Station#	12148+00	
Pic 5 Desc.	Stream S-C25, facing east		Pic 6 Desc.	Sediment and debris have been clean up from off ROW in the drainage feature between AR 272 and 273 and channel was stabilized.

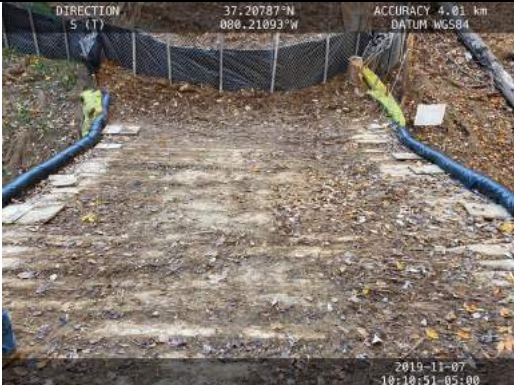
GPS Location	See picture for GPS data		GPS Location	See picture for GPS data	
Field Station#	12519+49		Field Station#	12537+00	
Pic 3 Desc.	Bridge crossing S-EF19		Pic 4 Desc.	Repaired rill erosion within the row.

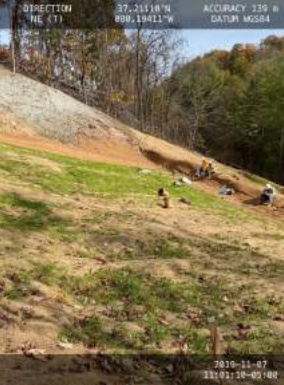
GPS Location	See picture for GPS data		GPS Location	See picture for GPS data	
Field Station#	12542+00		Field Station#	12543+56	
Pic 5 Desc.	Environmental crew rolling out curlex over the repaired waterbars.		Pic 6 Desc.	Opposition wall and trash just outside the LOD
