# Visual Site Inspection Report

<b>Project Name</b>	H-600 Pipeline Spread H	<b>AFE</b>	124300138	<b>Spread</b>	H-600 Pipeline Spread H
<b>Contractor</b>	Precision			<b>Report #</b>	18426
<b>Inspector</b>	Pat Davis			<b>Date/Time</b>	6/10/2019 5:17 PM
<b>Permit #</b>	TBD	<b>Inspection Type</b>	VA SWPP	<b>Station Begin</b>	+0
<b>State</b>	VA	<b>Inspection Area</b>	Partial	<b>Station End</b>	+0
<b>County</b>	Montgomery	<b>Ground</b>	Wet	<b>Temperature (°F)</b>	74.00
<b>Municipality</b>	N/A	<b>Weather</b>	Light Rain	<b>Rain Gauge (in)</b>	1.00
				<b>Rain Accumulation Time (days)</b>	0.00

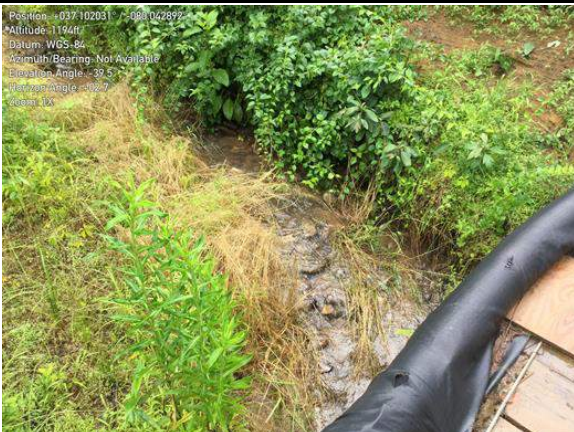
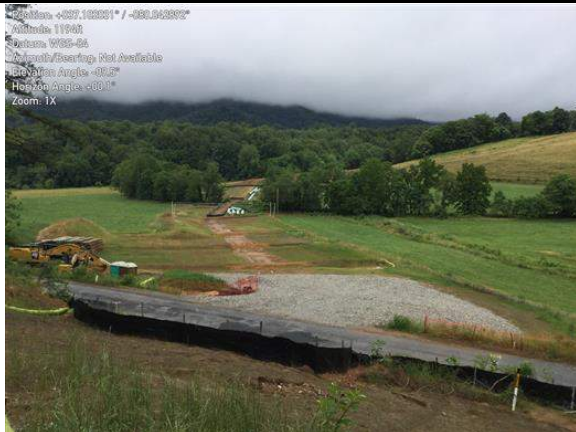
GPS Location	35.75	Field Station#	13352+23	GPS Location	35.75	Field Station#	13317+02
Description	Upstream side of waterway S-RR09. View: Northeast from northern side of equipment bridge, see photo for GPS data			Description	CIS of Wade's Gap Road in background. View: West from GAS of Wade's Gap Road at center of LOD, see photo for GPS data

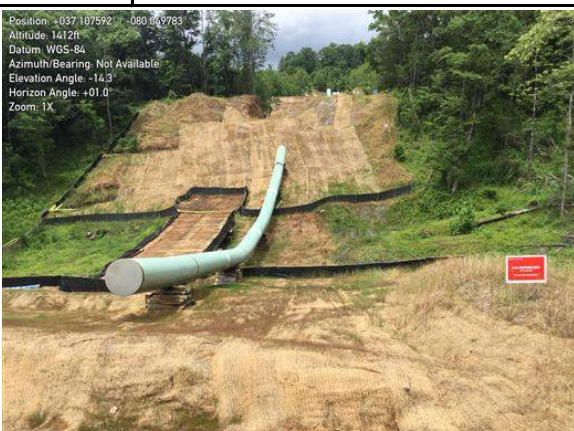
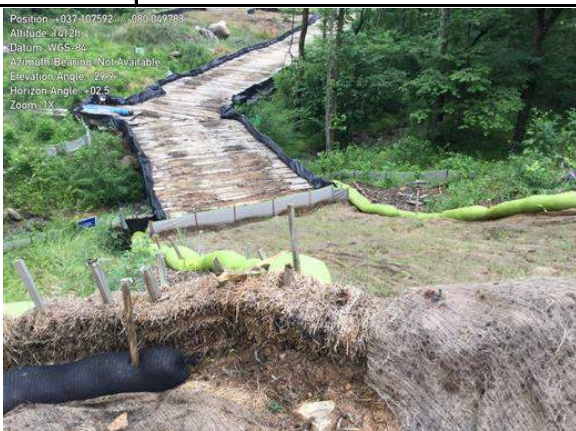
GPS Location	35.75	Field Station#	13355+50	GPS Location	35.75	Field Station#	13411+83
Description	Equipment bridge, staged pipe & blanketed/stabilized LOD. View: West from center of LOD, see photo for GPS data.			Description	Equipment bridge over Waterways SIJ-1 & S-IJ2. View: East from center of LOD, see photo for GPS data

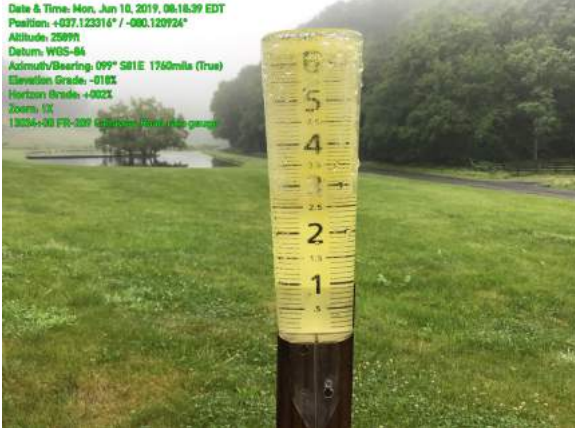
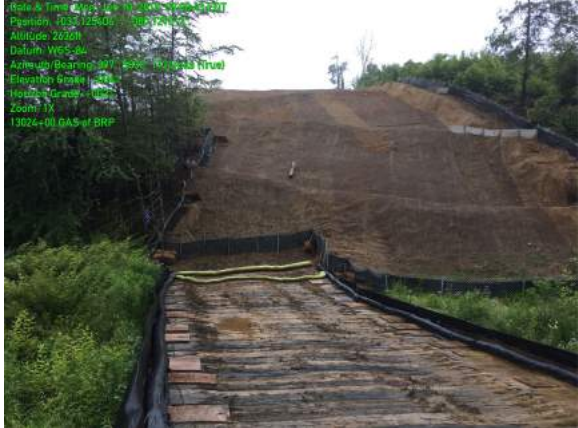
GPS Location	37.12	Field Station#	13034+00	GPS Location	37.12	Field Station#	13024+00
Description	2.9" total precipitation since Saturday at 4:00pm.			Description	No issues or impacts observed near S-G24 and S-G25		
<p>Date &amp; Time: Mon, Jun 10, 2019, 10:16:59 EDT Position: +037.12316° / -080.120924° Altitude: 2669ft Datum: WGS-84 Azimuth/Bearing: 099° S81E 1750m (True) Elevation Grade: -0185 Horizon Grade: +0823 Zoom: 1X 13044+00 FR-309 (Bottom Creek road) BRP</p>

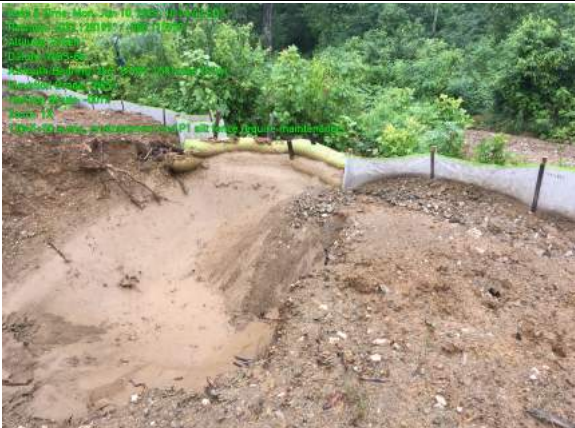
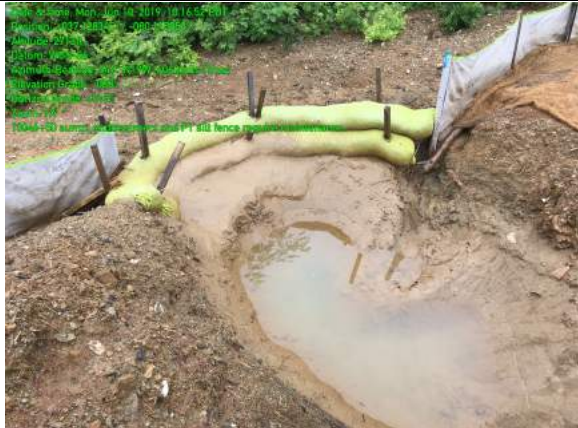
GPS Location	37.12	Field Station#	13045+50	GPS Location	37.12	Field Station#	13046+50
Description	Sump, water bar, end treatment, and P1 silt fence are in need of maintenance.			Description	Sump, water bar, end treatment, and P1 silt fence are in need of maintenance.		
<p>Date &amp; Time: Tue, June 10, 2019, 12:07:04 EDT Position: +037.127074° / -080.110190° Altitude: 2669ft Datum: WGS-84 Azimuth/Bearing: 099° S75W 5047m (True) Elevation Grade: -0185 Horizon Grade: +0823 Zoom: 1X 13044+00 G-24 at BRP</p>

E&S BMPs	Compliance Level	Corrective Action	Corrective Time Frame	Date Repaired
Waterbar End Treatment	Communication	Repair where undermined	24 Hours	6/11/2019
Sump Pit	Communication	Clean out full sumps	24 Hours	6/11/2019
Broad-Based Dip	Acceptable			
Cleanwater Diversion Berm	Acceptable			
Cleanwater Diversion Pipe	Acceptable			
Compost Filter Sock	Acceptable			
Equipment Bridge	Acceptable			
Erosion Control Blanket	Acceptable			
Plunge Pool	Acceptable

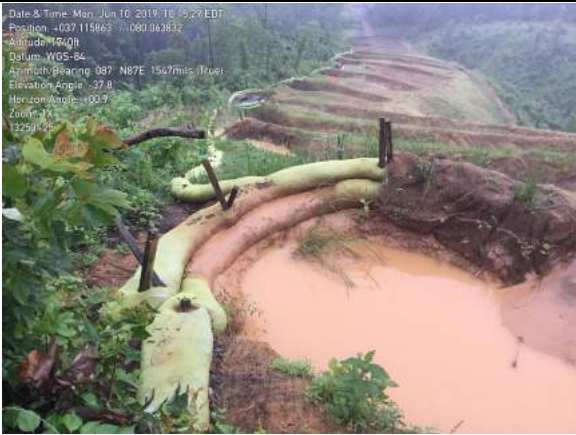
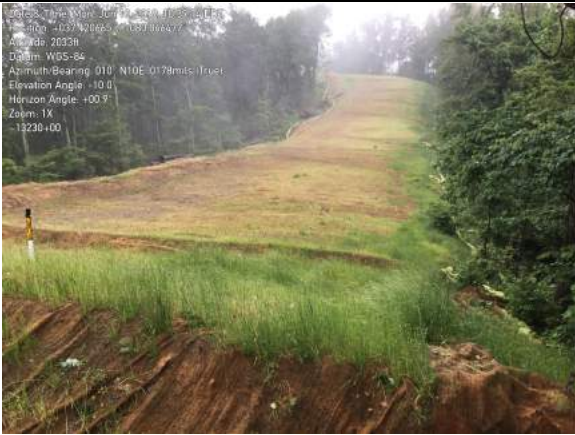
GPS Location 37.32		Field Station# 1320+25		GPS Location 37.32	
Field Station# 13230+00		Description		Please see photo for accurate coordinates. ROW, waterbar outlets functioning acceptably.	
<p>Insert image here</p>			<p>Insert image here</p>		
GPS Location		Field Station#		GPS Location	
Field Station#		Description		Description

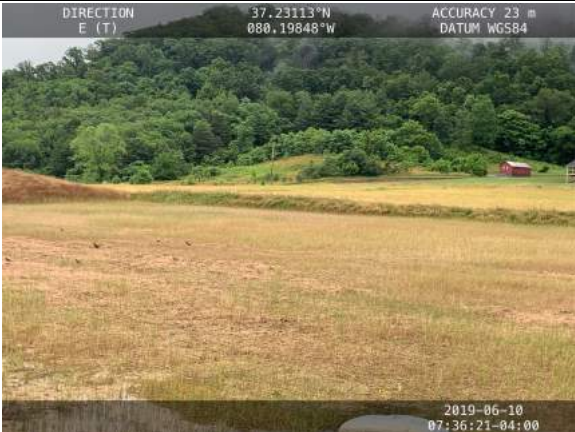
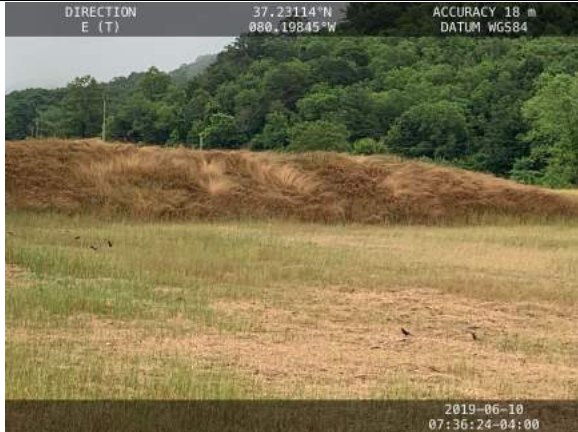
GPS Location		37.33	Field Station#		12445+86	GPS Location		37.33	Field Station#		12445+86
Description		Stabilized ROW. Looking E. See picture for GPS data.				Description		Stabilized topsoil pile. Looking W. See picture for GPS data.

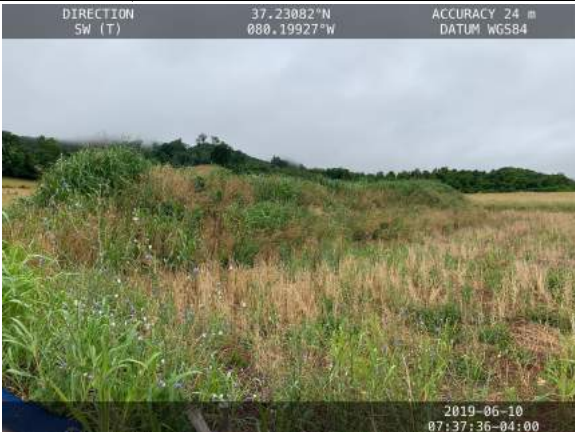
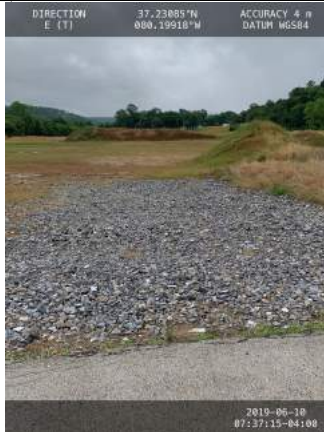
GPS Location		37.33	Field Station#		12448+50	GPS Location		37.33	Field Station#		12448+12
Description		Stabilized topsoil pile. Looking SW. See picture for GPS data.				Description		RCE. Looking E. See picture for GPS data.

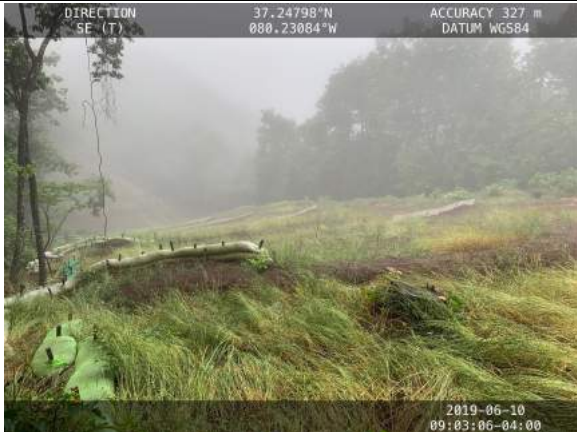
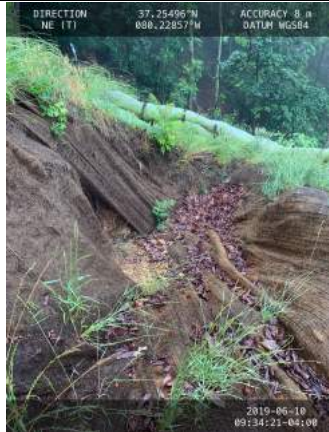
GPS Location	37.23	Field Station#	12290+50	GPS Location	37.23	Field Station#	12289+00
Description	Stabilized ROW. Looking SE. See picture for GPS data.			Description	Sump pit. Looking NE. See picture for GPS data.

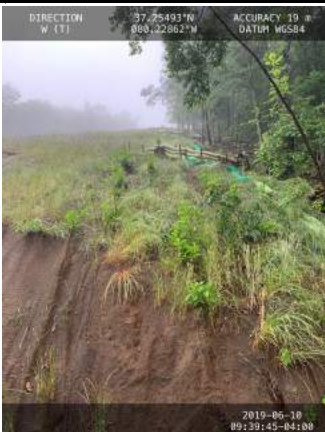
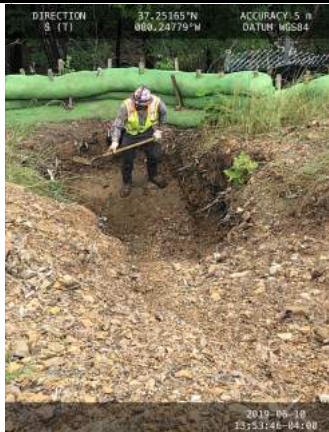
GPS Location	37.23	Field Station#	12290+50	GPS Location	37.23	Field Station#	12230+00
Description	Stabilized ROW and end treatments. Looking W. See picture for GPS data.			Description	Laborer cleaning out sump pit. Looking S. See picture for GPS data.

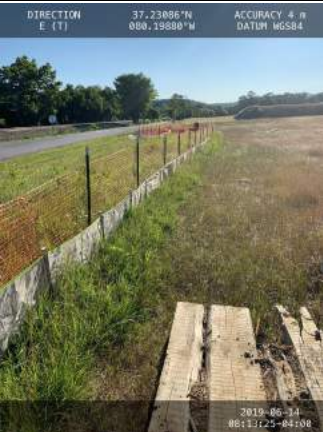
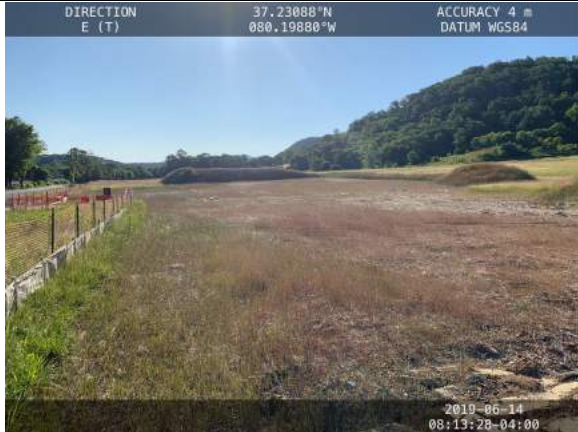
GPS Location	37.33	Field Station#	12447+00	GPS Location	37.33	Field Station#	12446+00
Description	P1 perimeter controls. Looking E. See picture for GPS data.			Description	Stabilized ROW. Looking E. See picture for GPS data.

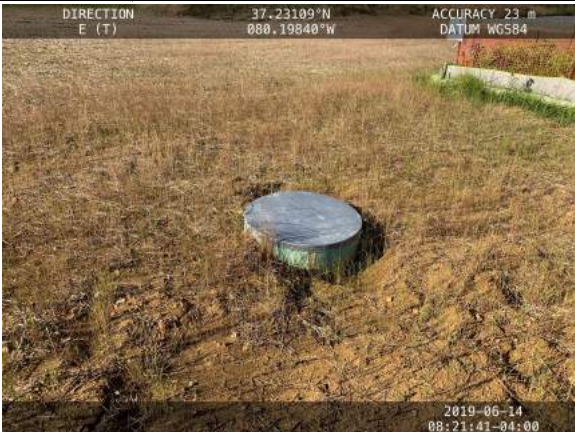
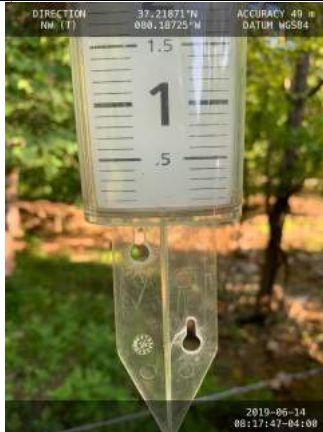
GPS Location	37.33	Field Station#	12445+50	GPS Location	37.33	Field Station#	12543+56
Description	Night cap covering well point system. Looking E. See picture for GPS data.			Description	Yellow Finch Rd rain gauge. (0.0") Looking NW. See picture for GPS data.

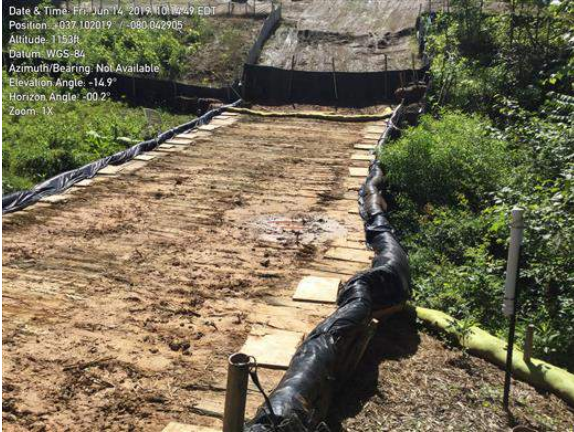
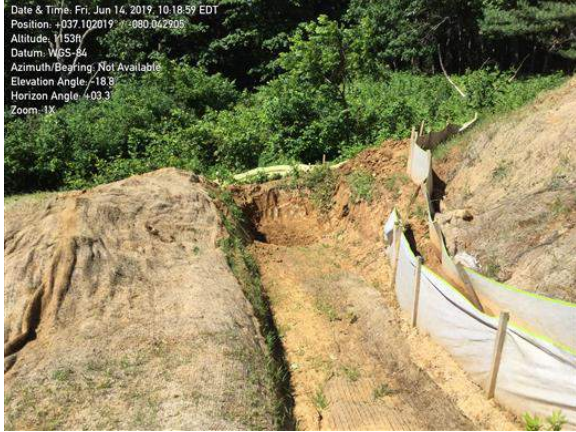
GPS Location	35.75	Field Station#	13334+17	GPS Location	35.75
Description	Waterway S-GH11 & accompanying permit holder. View: East from northern perimeter of LOD, see photo for GPS data.		Description	Recently cleaned sump pit at hillside above GAS of Wade's Gap Road. View: South from center of LOD, see photo for GPS data.	
<p>Date &amp; Time: Fri, Jun 14, 2019, 10:35:05 EDT Position: +037.104162 / -080.045530 Altitude: 1188ft Datum: WGS-84 Azimuth/Bearing: Not Available Elevation Angle: -11.4° Horizon Angle: +00.3° Zoom: 1X</p>

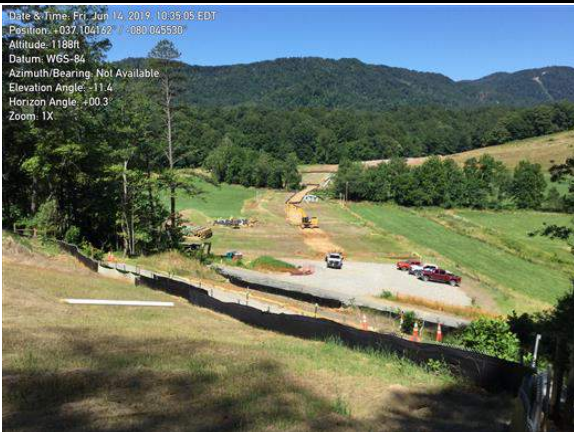
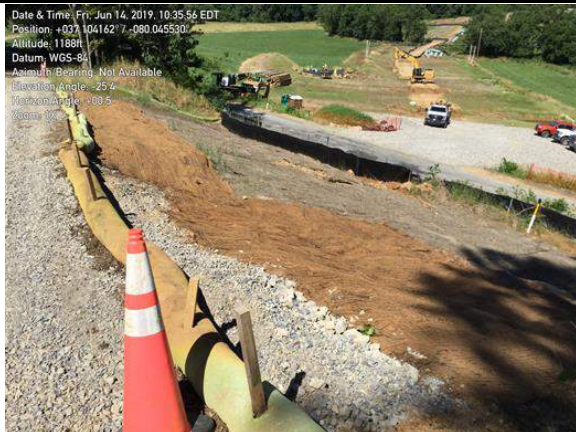
GPS Location	35.75	Field Station#	13318+02	GPS Location	35.75
Description	CIS of Wade's Gap Road from GAS. Personnel installing dewatering structure. View: West from northern perimeter of LOD, see photo for GPS data.		Description	Personnel improved ECB and re-positioned CFS at northern edge of driveway. View: West from southern perimeter of LOD, see photo for GPS data.	
<p>Date &amp; Time: Fri, Jun 14, 2019, 10:41:10 EDT Position: +037.104162 / -080.045530 Altitude: 1188ft Datum: WGS-84 Azimuth/Bearing: Not Available Elevation Angle: -07.5° Horizon Angle: -01.3° Zoom: 1X</p>

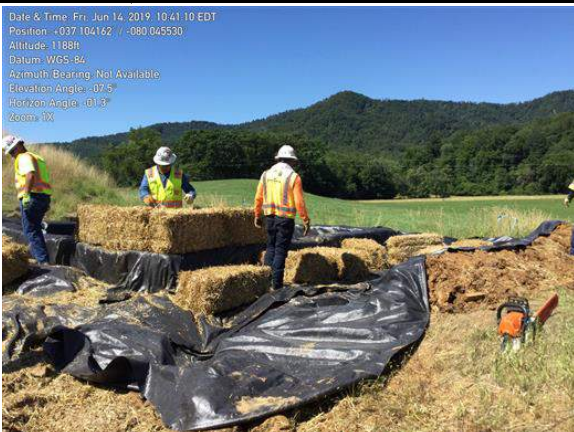
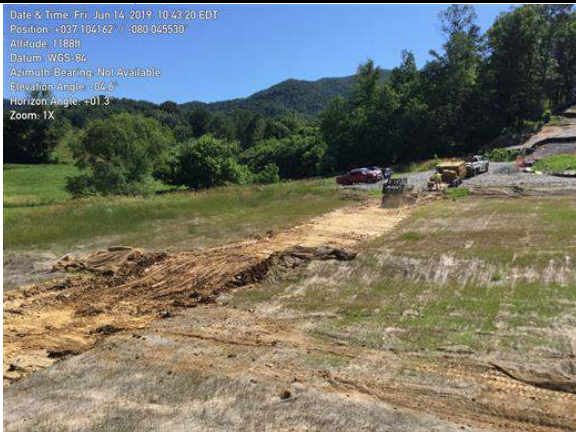
GPS Location	35.75	Field Station#	13312+50	GPS Location	35.75
Description	Personnel installing dewatering structure. View: Southwest from junction of southern perimeter of LOD & ATWS, see photo for GPS data.		Description	Personnel unloading straw bales for dewatering structure. View: Northeast from junction of southern perimeter of LOD and ATWS, see photo for GPS data.
