Visual Site Inspection Report

Project Name	H-600 Pipeline Spread H	AFE	124300138	Spread	H-600 Pipeline Spread H
Contractor	Precision			Report #	18616
Inspector	Logan Box			Date/Time	6/17/2019 6:11 PM
Permit #	TBD	Inspection Type	VA SWPP	Station Begin	13415+51
State	VA	Inspection Area	Partial	Station End	13670+00
County	Franklin	Ground	Damp	Temperature (°F)	74.00
Municipality	N/A	Weather	Sunny	Rain Gauge (in)	0.00
				Rain Accumulation Time (days)	0.00

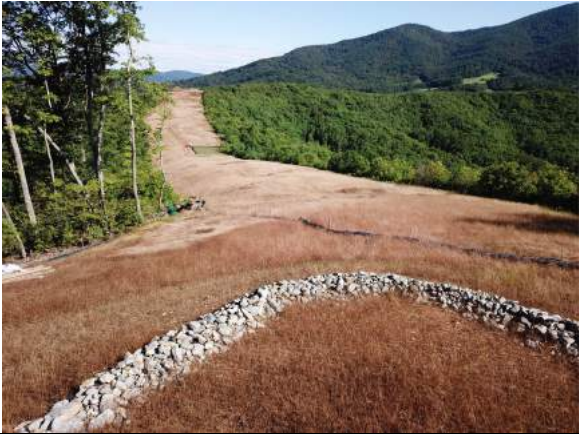
GPS Location	37.08	Field Station#	13461+23	GPS Location	37.08	Field Station#	13454+34
Description	Row photo showing vegetation and environmental controls			Description	Photo showing vegetation		
Insert image here				Insert image here			
GPS Location		Field Station#		GPS Location		Field Station#	
Description				Description

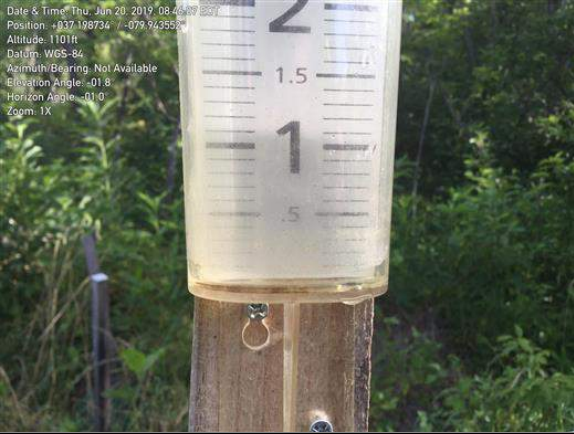
GPS Location	37.19	Field Station#	13415+00	GPS Location	37.19
Description	Rain gauge at CIS of Cahas Mtn Road reads 0.00".		Field Station#	13315+94	Description

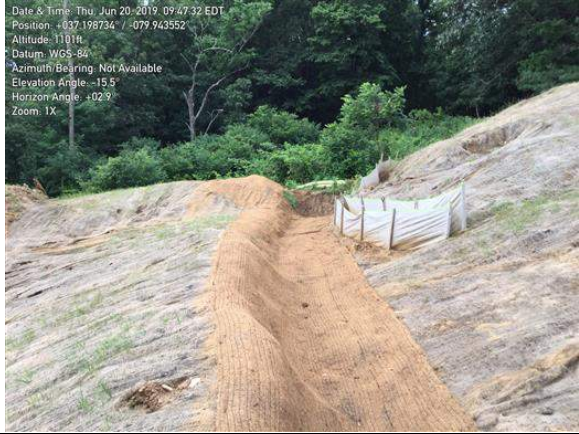
GPS Location	37.19	Field Station#	13331+10	GPS Location	37.19
Description	Waterbar recently had fresh ECB installed. View: north		Field Station#	13331+11	Description

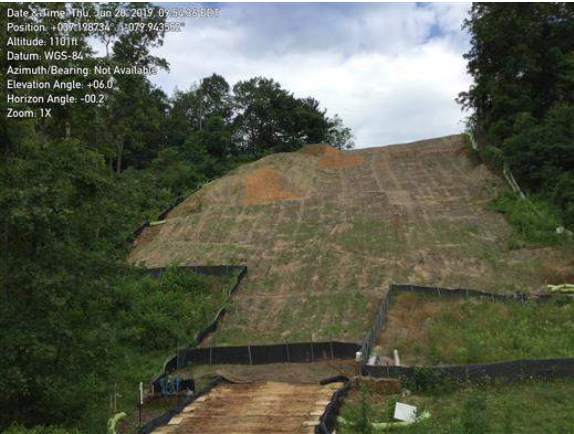
GPS Location	37.19	Field Station#	13332+24	GPS Location	37.19
Description	CIS hillside above waterway S-GH11. View: west.		Field Station#	13348+46	Description

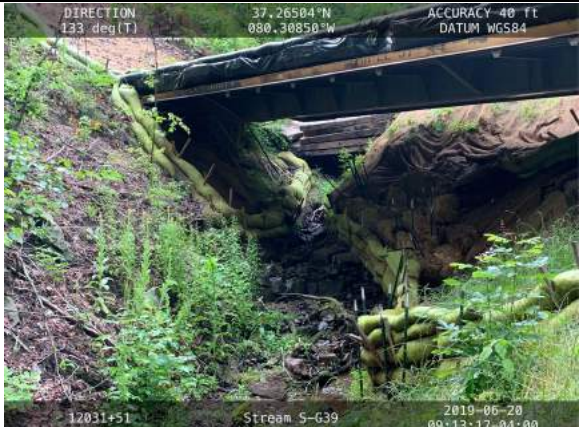
GPS Location	37.26	Field Station#	12072+00	GPS Location	37.26	Field Station#	12031+51
Description	See photo for gps data. Photo shows the sump along access road MVP-MN-270 that was over half full. Should be cleaned out.			Description	See photo for gps data. Photo shows stream S-39.

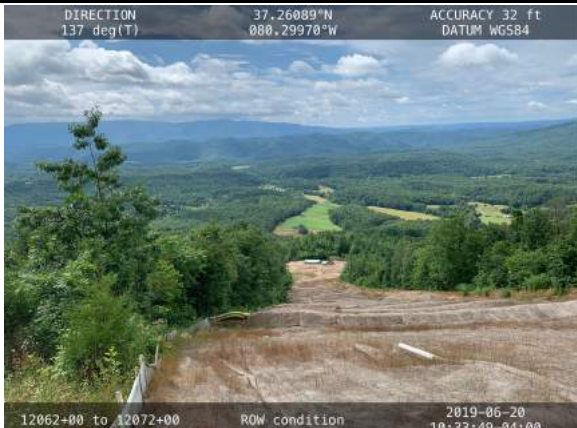
GPS Location	37.26	Field Station#	12062+00	GPS Location	37.26	Field Station#	12052+00
Description	See photo for gps data. Photo shows the ROW condition from about 12062+00 to 12072+00.			Description	See photo for gps data. Photo shows the ROW condition from about 12040+00 to 12052+00.

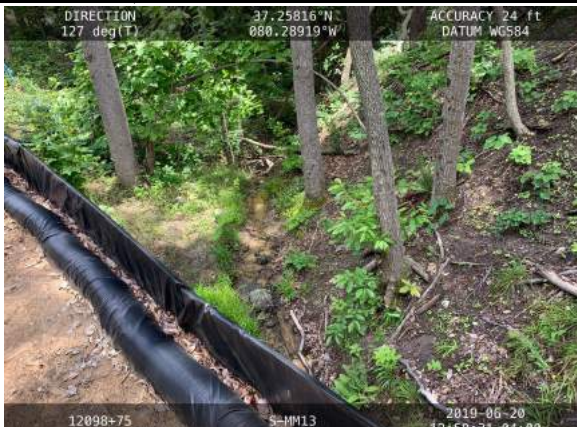
GPS Location	37.26	Field Station#	12098+75	GPS Location	37.26	Field Station#	12091+00
Description	See photo for gps data. Photo shows stream S-MM13.			Description	See photo for gps data. Photo shows the ROW condition from about 12091+00 to 12097+00.

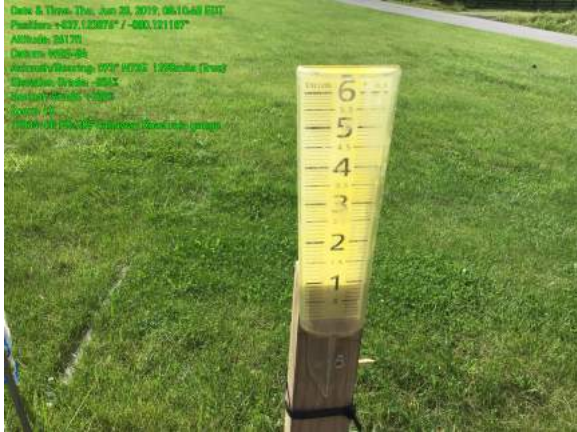
GPS Location	37.12	Field Station#	13034+00	GPS Location	37.12	Field Station#	12690+20
Description	0.0" total precipitation at Callaway Road			Description	All ECD's and BMP's remain in good condition near Honeysuckle Road.

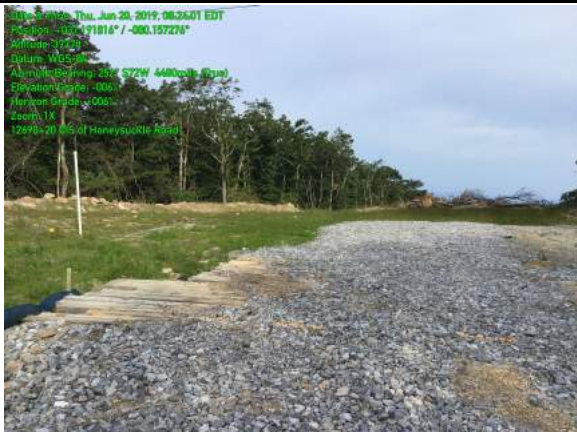
GPS Location	37.12	Field Station#	12690+20	GPS Location	37.12	Field Station#	12866+00
Description	No issues or impacts observed in the area.			Description	Disturbed work areas are very well stabilized with vegetation.

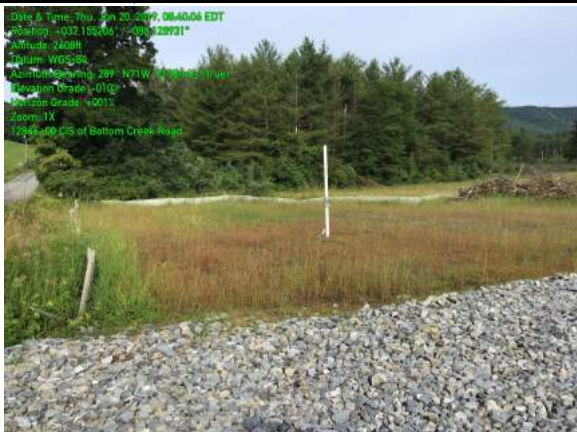
GPS Location	37.12	Field Station#	12866+00	GPS Location	37.12	Field Station#	12973+00
Description	No issues or impacts observed.			Description	No issues found where RO-288 meets the ROW.

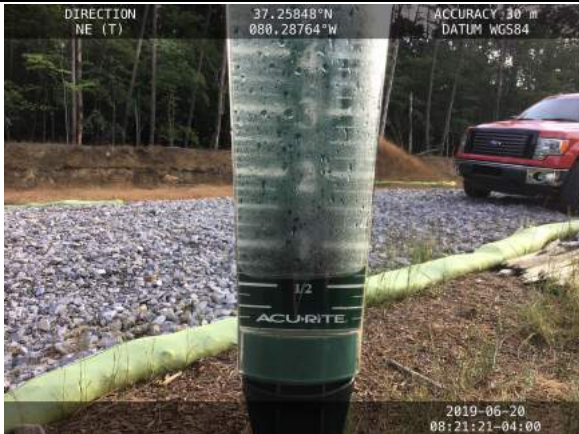
GPS Location	37.25	Field Station#	12102+75	GPS Location	37.25	Field Station#	12108+41
Description	There was 0.6 inches of precipitation accumulated in the rain gauge at Half Acre Rock Road.			Description	Stream S-F15, facing west.

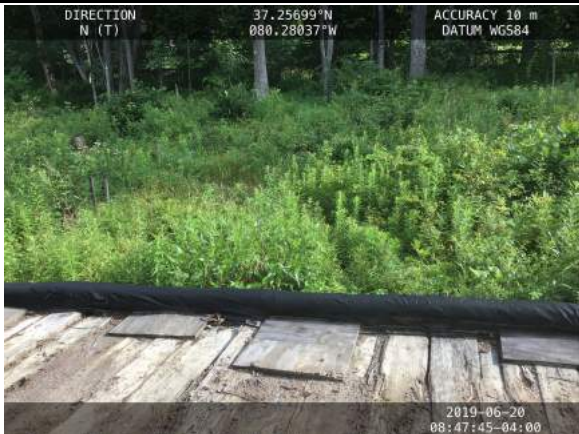
GPS Location	37.25	Field Station#	12125+65	GPS Location	37.25	Field Station#	12132+73
Description	Stream S-MM31, facing north.			Description	Stream S-C29, facing west.

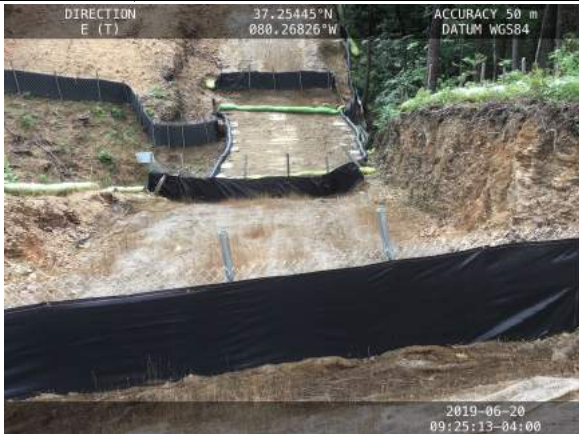
GPS Location	37.25	Field Station#	12163+05	GPS Location	37.25	Field Station#	12211+00
Description	Stream S-C25, facing east.			Description	A blast was deployed from station 12211+00 to 12212+00, the bottom of the ravine up the going away side.

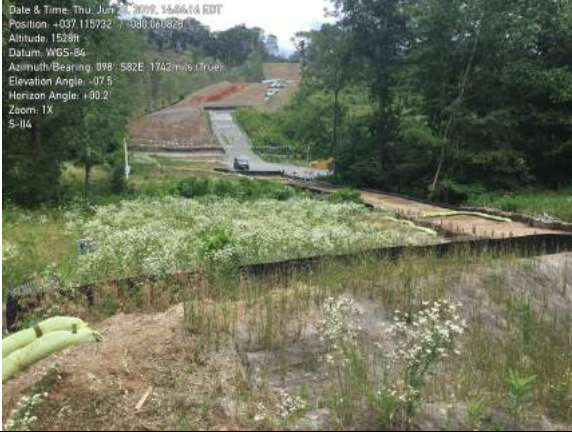
<p>Date & Time: Thu, Jun 20, 2019 14:06:14 EDT Position: +037.115732 / -080.063282 Altitude: 1528ft Datum: WGS-84 Azimuth/Bearing: 898° S82E 1742mils (True) Elevation Angle: -07.5 Horizon Angle: +00.2 Zoom: 1X S-II4</p>

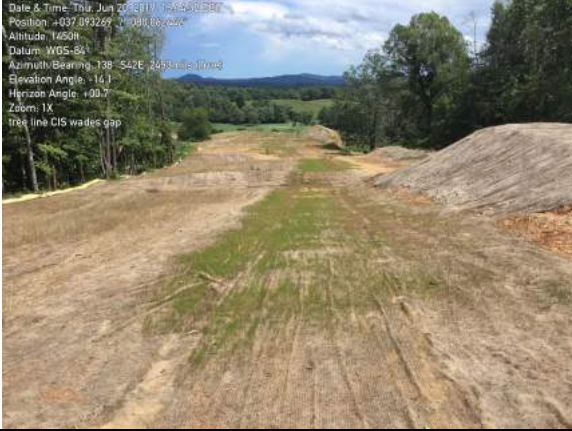
<p>Date & Time: Thu, Jun 20, 2019 15:54:09 EDT Position: +037.093269 / -080.064007 Altitude: 1450ft Datum: WGS-84 Azimuth/Bearing: 138° S42E 2496mils (True) Elevation Angle: -14.1 Horizon Angle: +00.7 Zoom: 1X tree line CIS wades gap</p>

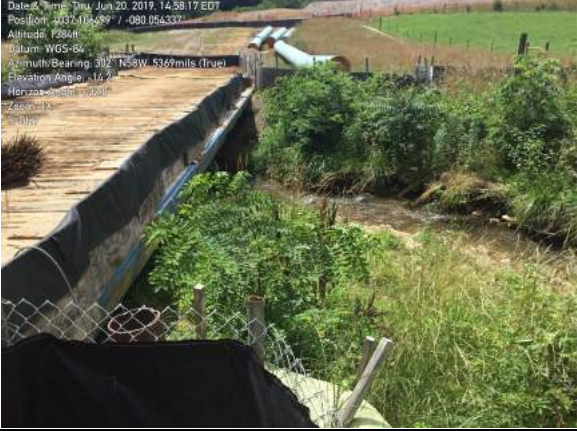
<p>Date & Time: Thu, Jun 20, 2019 14:58:17 EDT Position: +037.104489 / -080.056337 Altitude: 1580ft Datum: WGS-84 Azimuth/Bearing: 302° N59W 5369mils (True) Elevation Angle: -14.7 Horizon Angle: +00.0 Zoom: 1X S-GH7</p>		
GPS Location	37.32	Field Station#	13293+00	GPS Location	37.32 Field Station# 13309+09
Description			Please see photo for accurate coordinates. ROW, soil piles and ROW stabilized, no off ROW impacts noted.

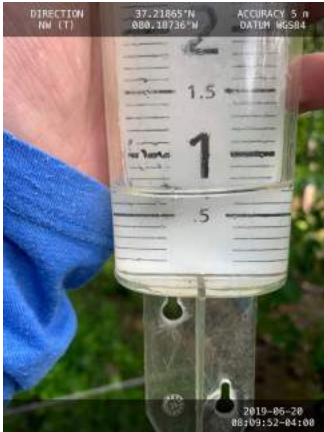
GPS Location	37.33	Field Station#	12543+56	GPS Location	37.33	Field Station#	12448+12
Description	Yellow Finch rain gauge 0.7". Looking NW. See picture for GPS data.			Description	RCE. Looking W. See picture for GPS data.

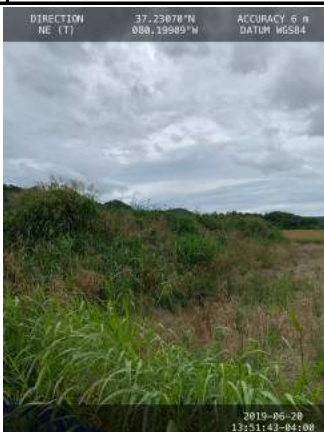
GPS Location	37.33	Field Station#	12448+50	GPS Location	37.33	Field Station#	12448+50
Description	Stabilized topsoil. Looking NE. See picture for GPS data.			Description	Stabilized ROW. Looking E. See picture for GPS data.

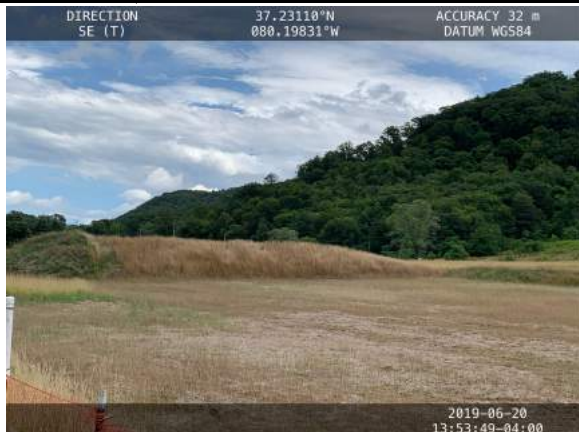
GPS Location	37.33	Field Station#	12445+86	GPS Location	37.33	Field Station#	12445+86
Description	Stabilized topsoil and ROW. Looking SE. See picture for GPS data.			Description	Curlexed drain crossing ROW. Looking S. See picture for GPS data.

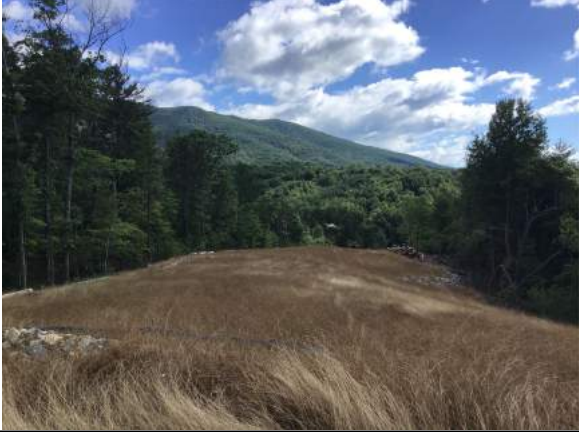
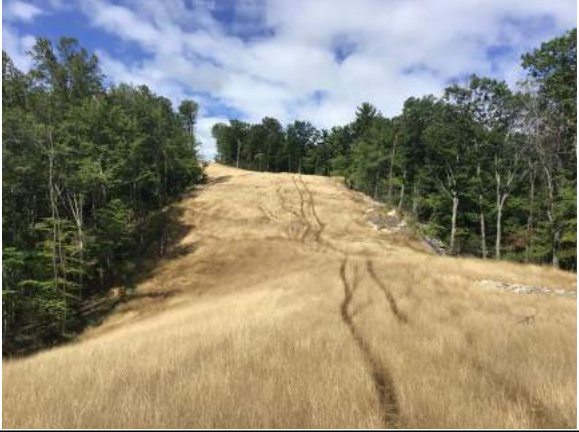
GPS Location	37.02	Field Station#	13490+00	GPS Location	37.02
Field Station#	13488+00	Description		Photo showing vegetation and slope breakers

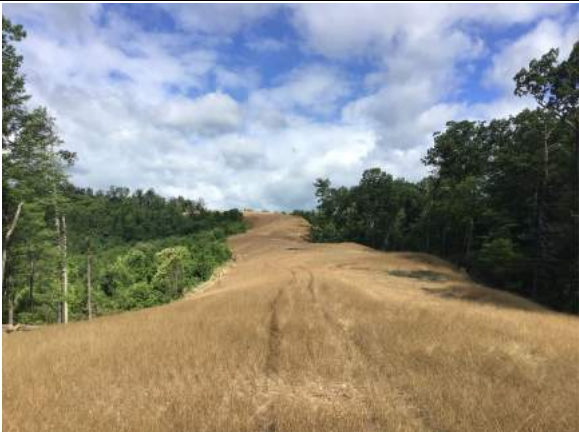
GPS Location	37.02	Field Station#	13470+00	GPS Location	37.02
Field Station#	13450+00	Description		Photo of temporary vegetation
