Visual Site Inspection Report

Project Name	H-600 Pipeline Spread H	AFE	124300138	Spread	H-600 Pipeline Spread H	
Contractor	Precision			Report #	19261	
Inspector	Pat Davis			Date/Time	6/26/2019 5:44 PM	
Permit #	TBD	Inspection Type	VA SWPP	Station Begin	+0	
State	VA	Inspection Area	Partial	Station End	+0	
County	Montgomery	Ground	Dry	Temperature (°F)	89.00	
Municipality	N/A	Weather	Sunny	Rain Gauge (in)	0.00	
				Rain Accumulation Time (days)	0.00

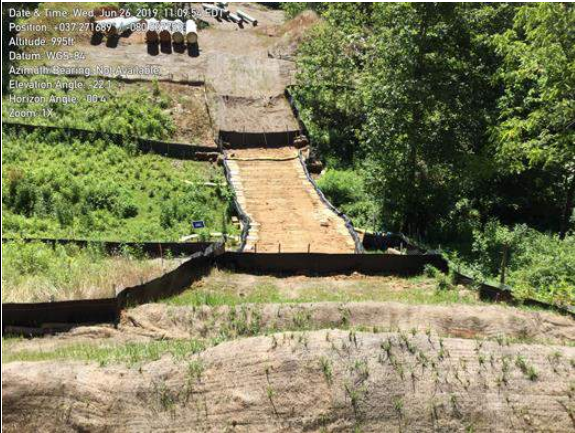
<p><small>Date & Time: Wed Jun 26, 2019 11:04:53 Position: +037.271689 / -080.037753 Altitude: 995ft Datum: WGS-84 Azimuth/Heading: Not Available Elevation Angle: +22.1 Horizon Angle: +00.1 Zoom: 1X</small></p>			<div>Insert image here</div>					
GPS Location	37.26	Field Station#	13334+17	GPS Location		Field Station#		
Description	Waterway S-GH11. View: East. See Photo for GPS Data.			Description

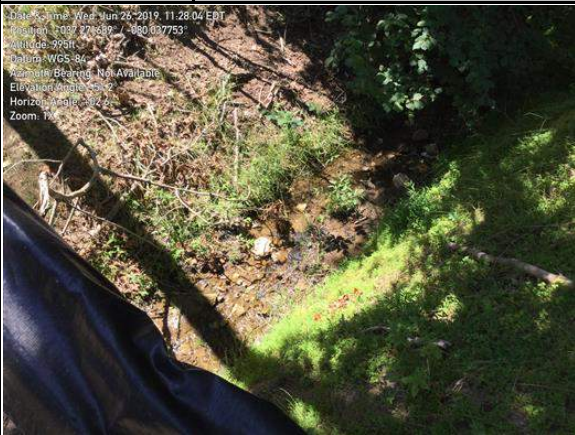
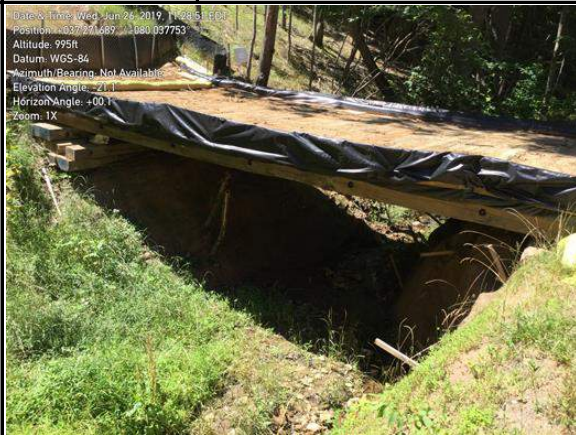
GPS Location	37.26	Field Station#	13325+30	GPS Location	37.26	Field Station#	13325+25	
Description	Downstream side of Waterway S-GH14. View: Southeast. See Photo for GPS Data.			Description	Equipment bridge over Waterway S-GH14. View: Southeast. See Photo for GPS Data.

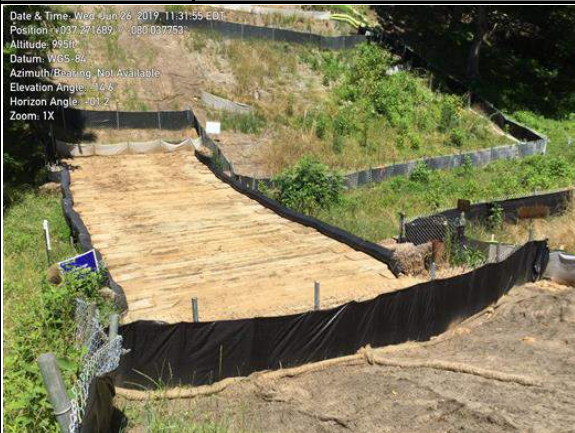
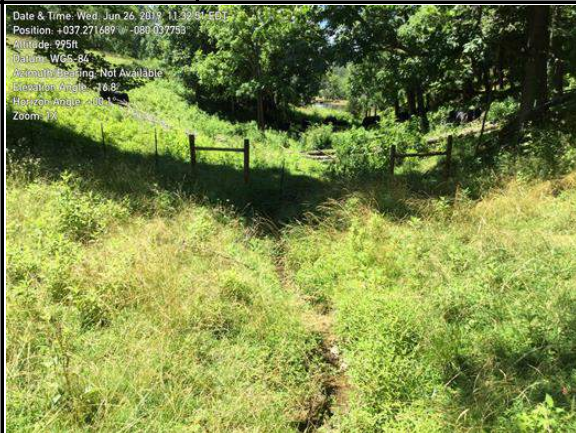
<p><small>Date & Time: Wed Jun 26, 2019 11:32:44 EDT Position: +037.271689 / -080.037753 Altitude: 995ft Datum: WGS-84 Azimuth/Heading: Not Available Elevation Angle: +16.8 Horizon Angle: +00.1 Zoom: 1X</small></p>					
GPS Location	37.26	Field Station#	13321+57	GPS Location	37.26	Field Station#	13321+47	
Description	Equipment bridge over Waterway S-GH15. View: Northwest. See Photo for GPS Data.			Description	Downstream side of Waterway S-GH15. Cows present. View: South. See Photo for GPS Data.

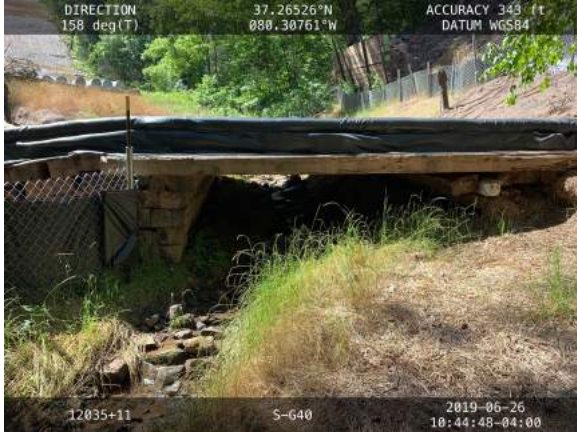
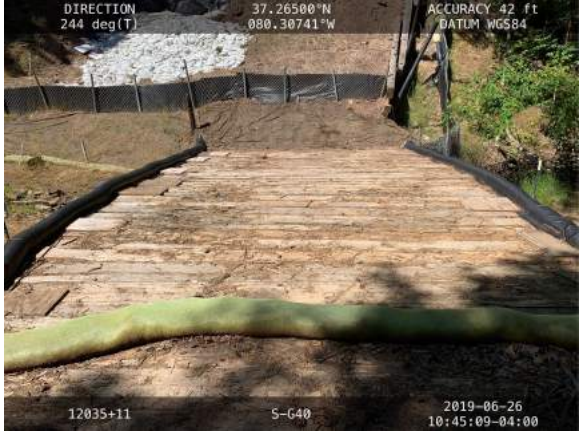
GPS Location	37.27	Field Station#	12035+11	GPS Location	37.27	
Description	See photo for gps data. Photo shows stream S-G40.			Description	See photo for gps data. Photo shows the bridge over S-G40.

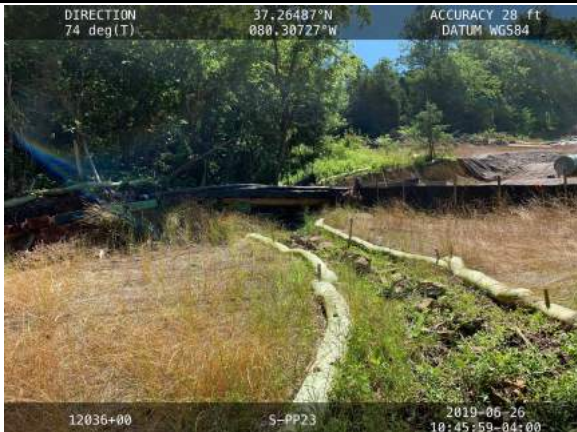
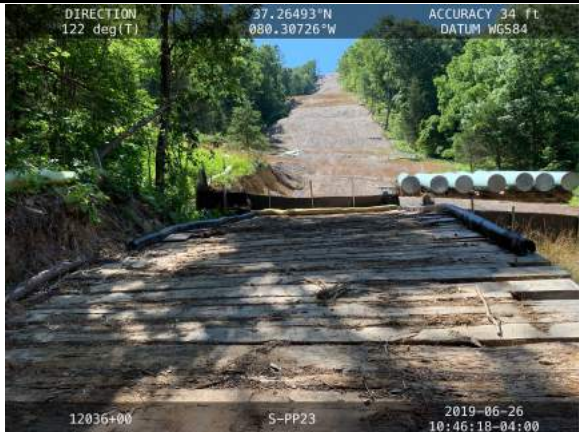
GPS Location	37.27	Field Station#	12036+00	GPS Location	37.27	
Description	See photo for gps data. Photo shows stream S-PP23.			Description	See photo for gps data. Photo shows the bridge over S-PP23.

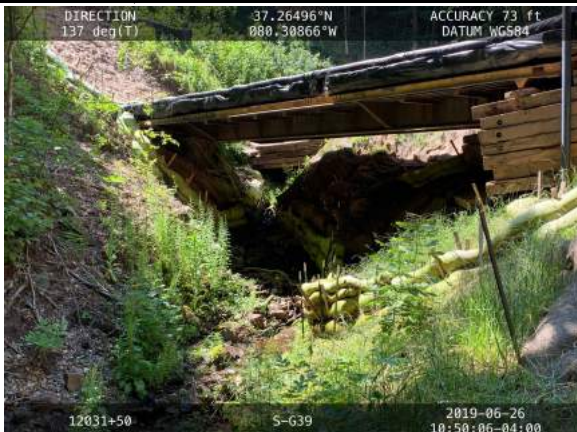
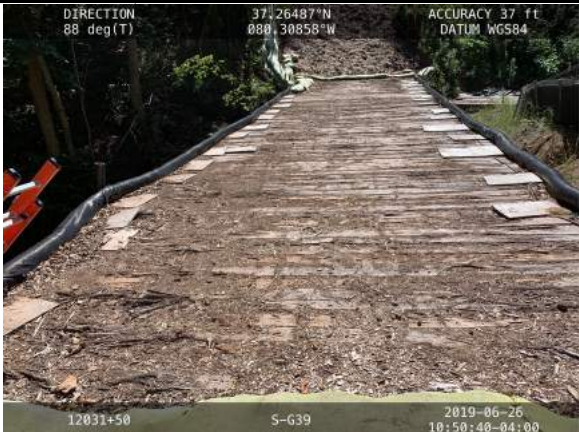
GPS Location	37.27	Field Station#	12031+50	GPS Location	37.27	
Description	See photo for gps data. Photo shows stream S-G39.			Description	See photo for gps data. Photo shows the bridge over S-G39.

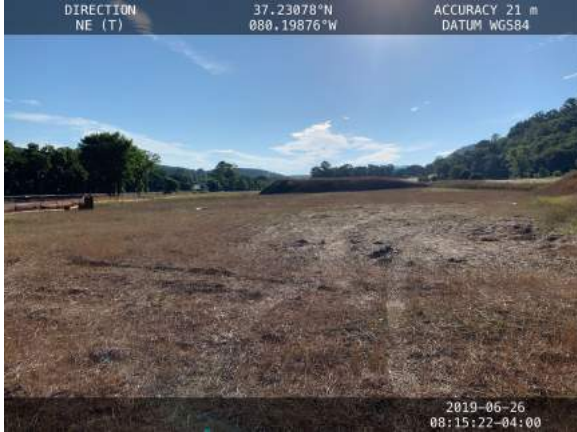
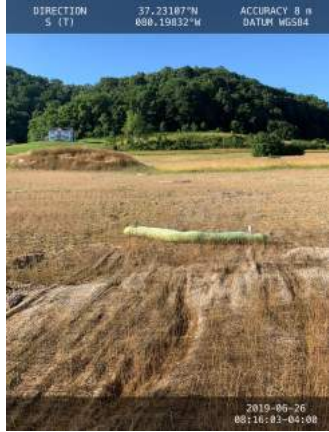
<div>2019-06-26 08:16:02-04:00</div>				
GPS Location	37.25	Field Station#	12447+00	GPS Location	37.25	Field Station#	12445+86
Description	Stabilized ROW. Looking NE. See picture for GPS data.			Description	Curlexed drain crossing the ROW. Looking S. See picture for GPS data.		
<div>DIRECTION E (T)</div> <div>37.23101°N 080.19800°W</div> <div>ACCURACY 6 m DATUM WGS84</div>

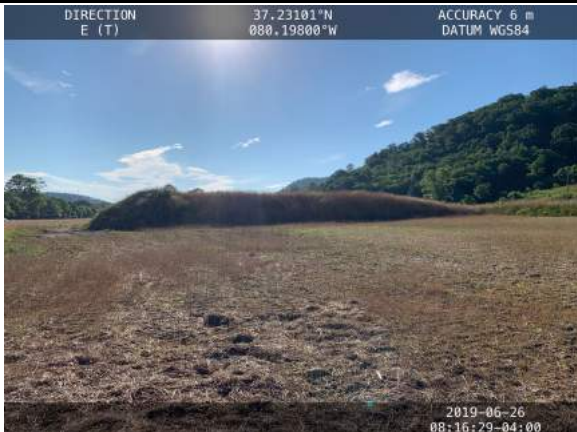
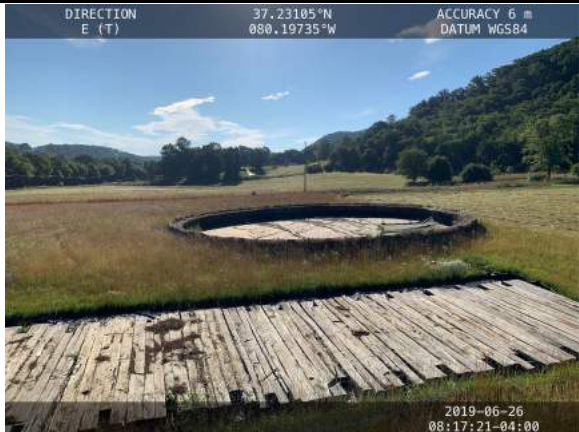
Description	Stabilized top soil pile. Looking E. See picture for GPS data.			Description	Dewatering structure. Looking E. See picture for GPS data.		
<div>DIRECTION Unavailable</div> <div>LOCATION Unavailable</div> <div>ACCURACY/DATUM Unavailable</div>

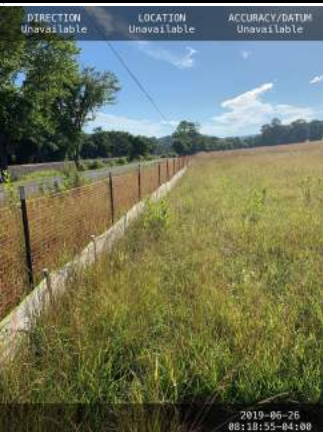
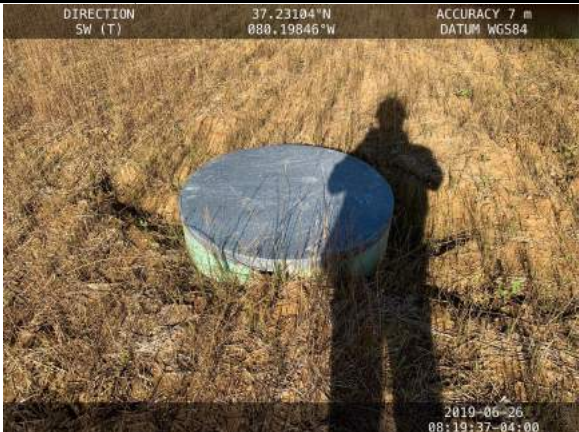
<div>2019-06-26 08:19:37-04:00</div>				
GPS Location	37.25	Field Station#	12445+40	GPS Location	37.25	Field Station#	12445+40
Description	P1 Silt fence and safety fence perimeter controls.			Description	Night cap covering well point system. Looking SW. See picture for GPS.

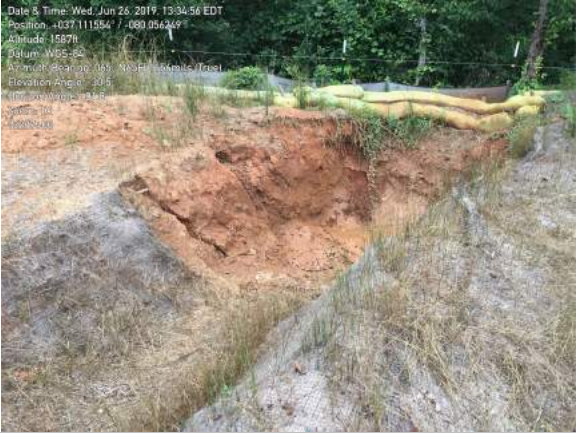
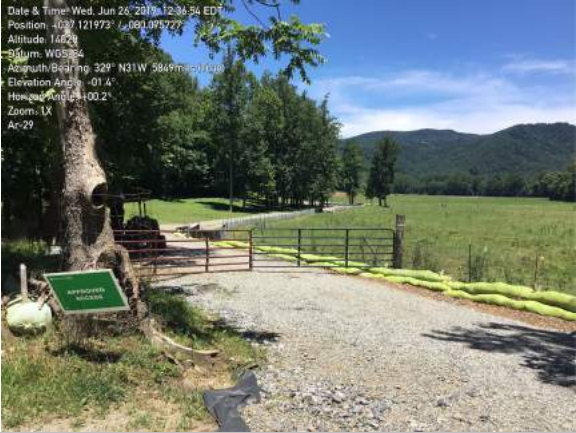
<p><small>Date & Time: Wed Jun 26 2019 12:36:56 EDT Position: -83.712197° / -35.054277° Altitude: 1623ft Datum: WGS84 Azimuth/Bearing: 329° N31W 5849m=001m Elevation Angle: -01.4° Horizontal Angle: 100.2° Zoom: LX Arc: 29</small></p>		
GPS Location	37.32	Field Station#	13287+00	GPS Location	37.32
Description	Please see photo for accurate coordinates. ROW, minor erosion noted at sump, not currently an environmental issue.		Description	Please see photo for accurate coordinates. MVP-MLV-AR-29, cattle observe in field, ECD functioning acceptably.	
Insert image here			Insert image here

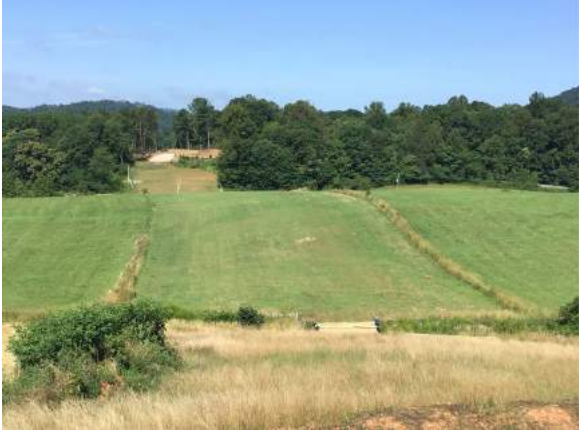
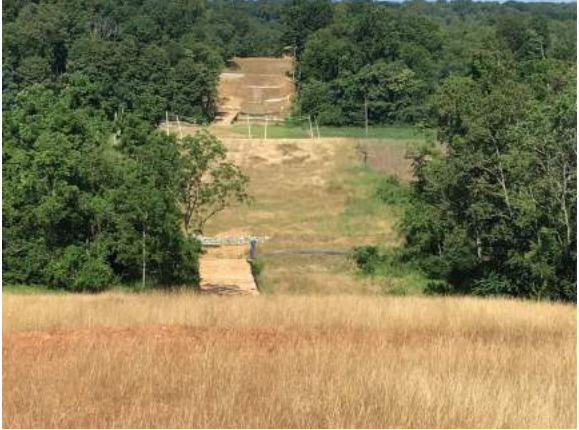
GPS Location	37.06	Field Station#	13570+00	GPS Location	37.06
Field Station#	13555+00	Description		Photo showing temporary vegetation

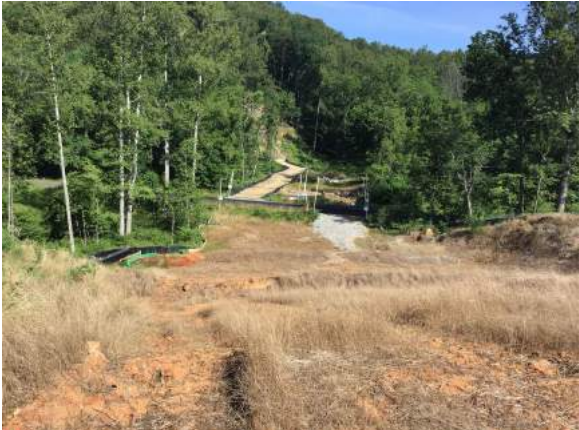
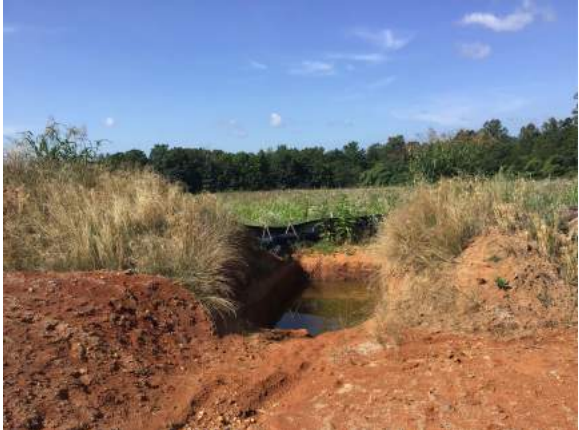
GPS Location	37.06	Field Station#	13424+00	GPS Location	37.06
Field Station#	13430+00	Description		Functioning sump pit	
<p style="text-align: center;">Insert image here</p>			<p style="text-align: center;">Insert image here</p>		
GPS Location		Field Station#		GPS Location	
Description			Description
