## Visual Site Inspection Report

<b>Project Name</b>	H-600 Pipeline Spread H	<b>AFE</b>	124300138	<b>Spread</b>	H-600 Pipeline Spread H
<b>Contractor</b>	Precision			<b>Report #</b>	19595
<b>Inspector</b>	Pat Davis			<b>Date/Time</b>	7/2/2019 6:14 AM
<b>Permit #</b>	TBD	<b>Inspection Type</b>	VA SWPP	<b>Station Begin</b>	+0
<b>State</b>	VA	<b>Inspection Area</b>	Partial	<b>Station End</b>	+0
<b>County</b>	Montgomery	<b>Ground</b>	Dry	<b>Temperature (°F)</b>	93.00
<b>Municipality</b>	N/A	<b>Weather</b>	Sunny	<b>Rain Gauge (in)</b>	0.00
				<b>Rain Accumulation Time (days)</b>	0.00

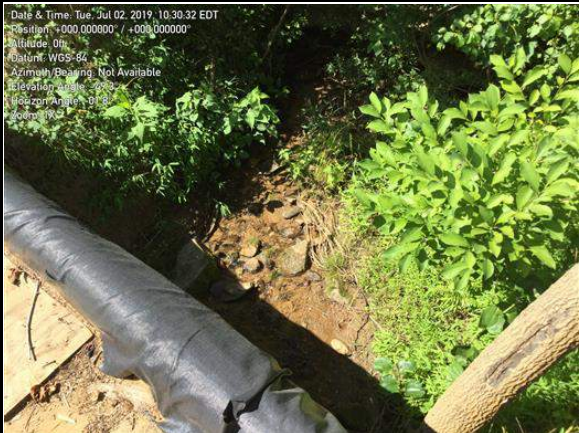
GPS Location	37.19	Field Station#	13348+46	GPS Location	37.19	Field Station#	13352+17
Description	See Photo for GPS data. Downstream side of Waterway S-RR08. View: Southeast.			Description	See Photo for GPS data. Waterway S-RR09. View: East.

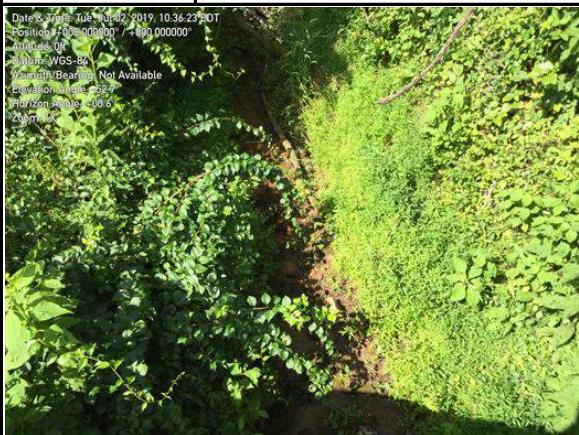
</div></div></div>							
GPS Location		37.19	Field Station#		13352+23	GPS Location		37.19	Field Station#		13358+14
Description		See Photo for GPS data. Downstream side of Waterway S-RR09. View: South.					Description		See Photo for GPS data. Waterway S-RR11. View: East.		
<div><div><div>Date &amp; Time: Tue, Jul 02, 2019, 10:36:23 EDT Position: +000 000000 / +000 000000 Altitude: 0ft Datum: WGS-84 Azimuth/Bearing: Not Available Elevation Angle: -25.5 Horizon Angle: 016.5 Zoom: 1X</div><div>

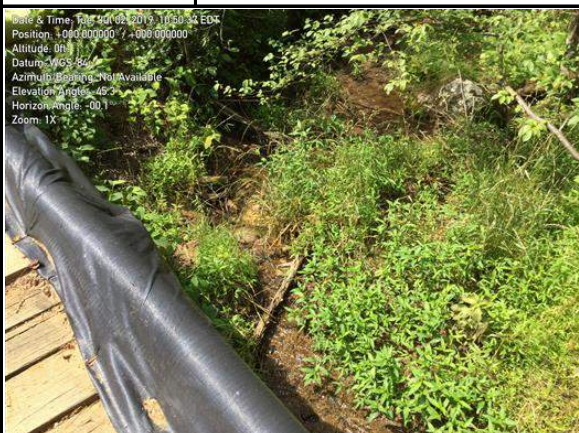
GPS Location		37.19	Field Station#		13358+64	GPS Location		37.19	Field Station#		13337+33
Description		See Photo for GPS data. Downstream side of Waterway S-RR11. View: South.					Description		See Photo for GPS data. Waterway S-GH9. View: West.		
<div><div><div>Date &amp; Time: Tue, Jul 02, 2019, 10:50:44 EDT Position: +000 000000 / +000 000000 Altitude: 0ft Datum: WGS-84 Azimuth/Bearing: Not Available Elevation Angle: -45.3 Horizon Angle: -00.1 Zoom: 1X</div><div>

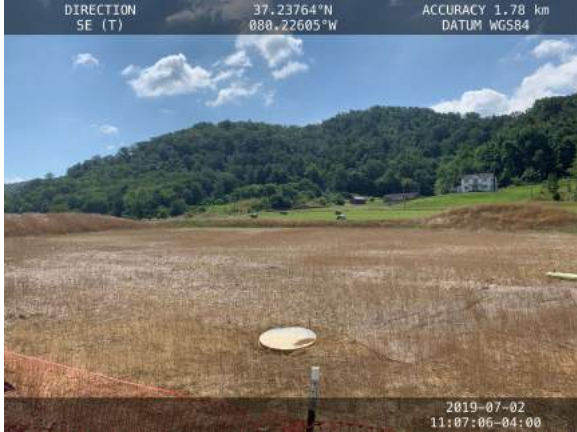
<div>2019-07-02 11:07:11-04:00</div>											
GPS Location		37.33		Field Station#		12451+23		GPS Location		37.33		Field Station#		12451+23	
Description		Stabilized ROW. Looking SE. See picture for GPS data.						Description		Stabilized top soil pile. Looking E. See picture for GPS data.					
<div>DIRECTION SW (T)</div> <div>37.22979°N 080.20152°W</div> <div>ACCURACY 34 m DATUM WGS84</div>

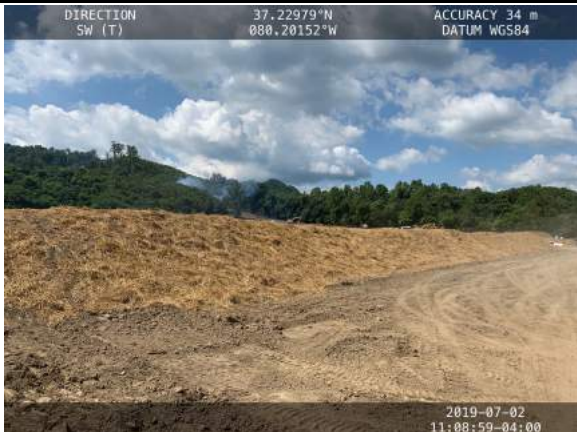
GPS Location		37.33		Field Station#		12461+58		GPS Location		37.33		Field Station#		12460+58	
Description		Stabilized topsoil pile. Looking SW. See picture for GPS data.						Description		Air bridge spanning S-CD12b. Looking NE. See picture for GPS data.					
<div>DIRECTION N (T)</div> <div>37.22979°N 080.20122°W</div> <div>ACCURACY 6 m DATUM WGS84</div>

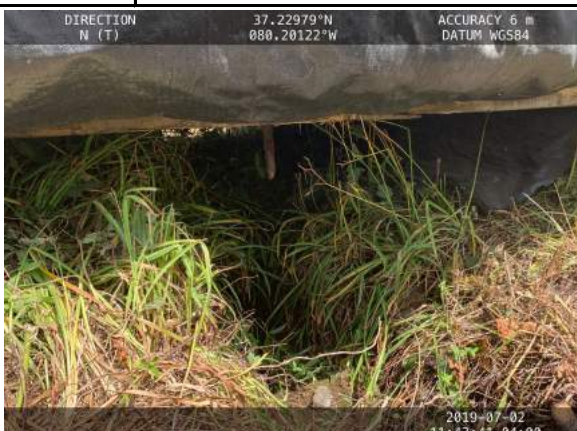
<div>2019-07-02 11:44:47-04:00</div>											
GPS Location		37.33		Field Station#		12460+58		GPS Location		37.33		Field Station#		12456+37	
Description		Underneath bridge spanning S-CD12b. Looking N. See picture for GPS data.						Description		Dozer grading ROW. Looking W. See picture for GPS data.

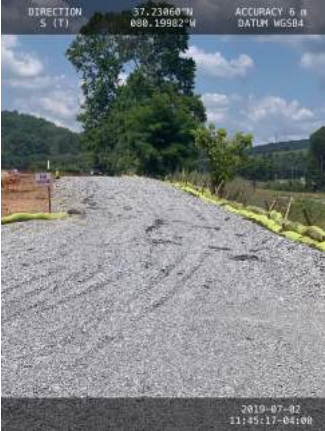
<p>image here</p>			
<p>GPS Location</p> <p>37.33</p>		<p>Field Station#</p> <p>12455+29</p>		<p>GPS Location</p> <p></p>	
<p>Description</p> <p>RCE. Looking S. See picture for GPS data.</p>		<p>Description</p> <p></p>			
<p>Insert image here</p>		<p>Insert image here</p>			
<p>GPS Location</p> <p></p>		<p>Field Station#</p> <p></p>		<p>GPS Location</p> <p></p>	
<p>Description</p> <p></p>		<p>Description</p> <p></p>			
<p>Insert image here</p>		<p>Insert image here</p>			
<p>GPS Location</p> <p></p>		<p>Field Station#</p> <p></p>		<p>GPS Location</p> <p></p>	
<p>Description</p> <p></p>		<p>Description</p> <p></p>			
<p>Insert image here</p>		<p>Insert image here</p>			
<p>GPS Location</p> <p></p>		<p>Field Station#</p> <p></p>		<p>GPS Location</p> <p></p>	
<p>Description</p> <p></p>		<p>Description</p> <p></p>
