Visual Site Inspection Report

Project Name	H-600 Pipeline Spread H	AFE	124300138	Spread	H-600 Pipeline Spread H	
Contractor	Precision			Report #	20785	
Inspector	Pat Davis			Date/Time	7/24/2019 5:30 PM	
Permit #	TBD	Inspection Type	VA SWPP	Station Begin	+0	
State	VA	Inspection Area	Partial	Station End	+0	
County	Montgomery	Ground	Wet	Temperature (°F)	81.00	
Municipality	N/A	Weather	Sunny	Rain Gauge (in)	1.10	
				Rain Accumulation Time (days)	0.00

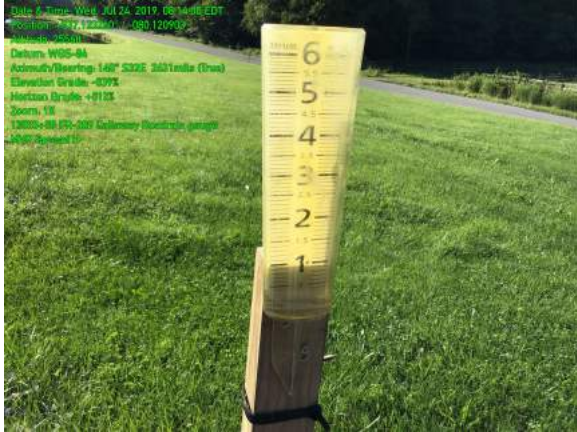
<p>Date & Time: Wed, Jul 24, 2019, 09:14:46 EDT Location: 33.7172260, -84.120937 Altitude: 2622ft Datum: WGS-84 Azimuth/Bearing: 140° S33E 2631m (True) Elevation Grade: -89% Horizontal Grade: +012% Zoom: 1X 130033+58 FR-289 Callaway Roadside, gauge 3400' Speed 10</p>				
GPS Location	37.12	Field Station#	13033+59	GPS Location	37.12	Field Station#	13025+00
Pic 1 Description	FR-289 Callaway Road rain gauge. 0.3" total precipitation			Pic 2 Description	No issues or impacts observed in the area.

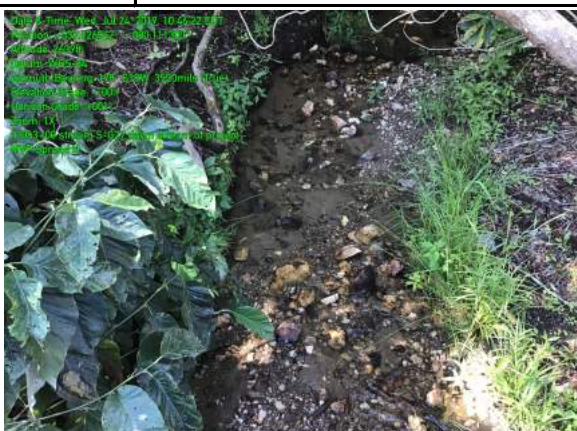
<p>Date & Time: Wed, Jul 24, 2019, 10:46:22 EDT Location: 33.7172260, -84.120937 Altitude: 2622ft Datum: WGS-84 Azimuth/Bearing: 140° S33E 2631m (True) Elevation Grade: -89% Horizontal Grade: +012% Zoom: 1X 130063+00 Stream S-G27 down stream of project 3400' Speed 10</p>

<p>Date & Time: Wed, Jul 24, 2019, 10:49:50 EDT Location: 33.7172260, -84.120937 Altitude: 2622ft Datum: WGS-84 Azimuth/Bearing: 140° S33E 2631m (True) Elevation Grade: -89% Horizontal Grade: +012% Zoom: 1X 130141+50 Access road to project 3400' Speed 10</p>				
GPS Location	37.12	Field Station#	13063+00	GPS Location	37.12	Field Station#	13141+50
Pic 5 Description	No stream impacts observed at S-G27.			Pic 6 Description	ECD's installed along access road remain sufficient.
