Visual Site Inspection Report

Project Name	H-600 Pipeline Spread H	AFE	124300138	Spread	H-600 Pipeline Spread	
Contractor	Precision			Report #	42	
Inspector	Pat Davis			Date/Time	7/30/2019 5:30 PM	
Permit #	TBD	Inspection Type	VA SWPP	Station Begin	+0	
State	VA	Inspection Area	Partial	Station End	+0	
County	Montgomery	Ground	Dry	Temperature (°F)	91.00	
Municipality	N/A	Weather	Sunny	Rain Gauge (in)	0.00	
				Rain Accumulation Time (days)	0.00

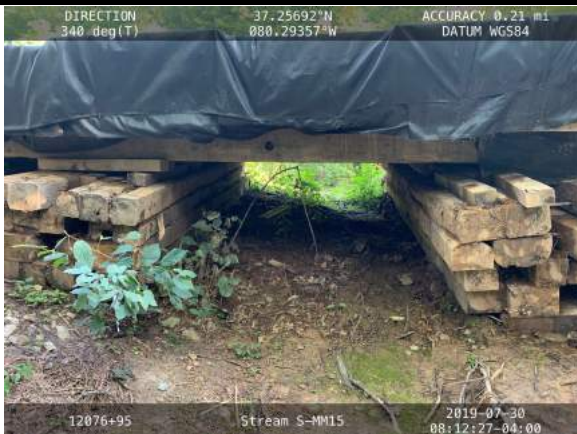
GPS Location	See photo for gps data.		GPS Location	See photo for gps data.	
Field Station#	12076+95		Field Station#	12086+56	
Pic 5 Desc.	Stream S-MM15 under bridge at 12076+95		Pic 6 Desc.	Stream S-MM14 under bridge at 12086+56

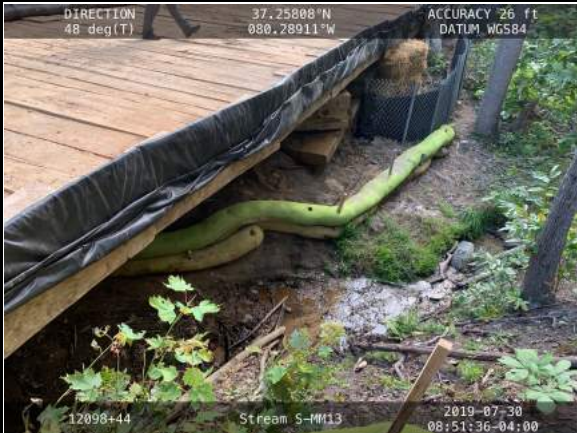
GPS Location	See photo for gps data.		GPS Location	See photo for gps data.	
Field Station#	12098+44		Field Station#	12101+57	
Pic 7 Desc.	Stream S-MM13 under bridge at 12098+44		Pic 8 Desc.	Stream S-MM11 under bridge at 12101+57

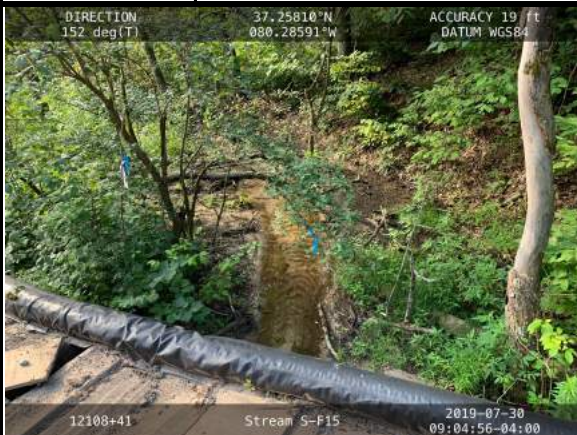
GPS Location	See photo for gps data.		GPS Location	See photo for gps data.	
Field Station#	12108+41		Field Station#	12112+70	
Pic 9 Desc.	Stream SF15 downstream from ROW		Pic 10 Desc.	Stream S-F16A/B downstream from ROW

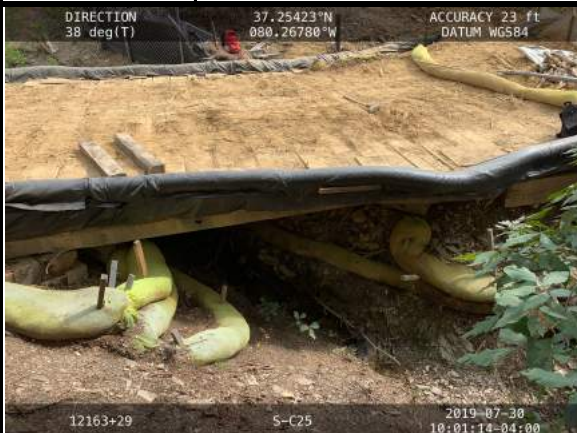
GPS Location	See photo for gps data.		GPS Location	See photo for gps data.	
Field Station#	12163+29		Field Station#	12186+00	
Pic 11 Desc.	Stream S-C25 under bridge at 12163+29		Pic 12 Desc.	Stream S-C24 under bridge at 12166+00

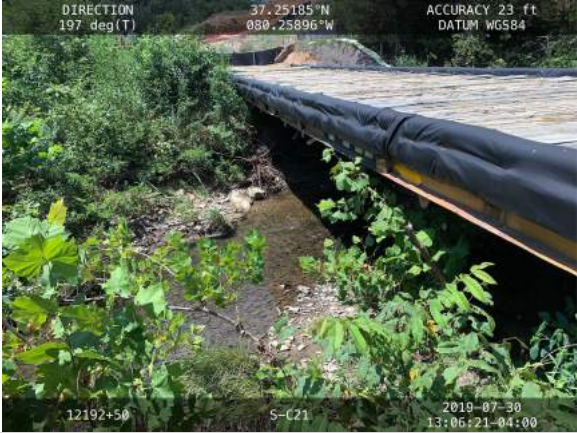
GPS Location	See photo for gps data.		GPS Location	See photo for gps data.	
Field Station#	12192+50		Field Station#	12013+97	
Pic 13 Desc.	Stream S-C21 under bridge at 12192+50.		Pic 14 Desc.	Stream S-G40 downstream from AR-268.01

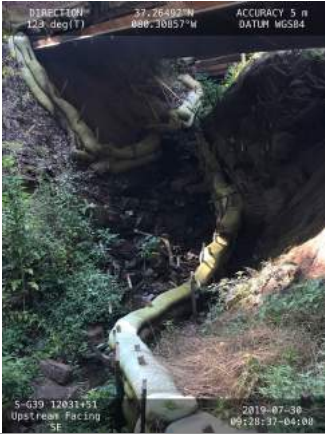
GPS Location	See photo for gps data.		GPS Location	See photo for gps data.	
Field Station#	12031+51		Field Station#	12035+11	
Pic 15 Desc.	Stream S-G39		Pic 16 Desc.	Stream S-G40

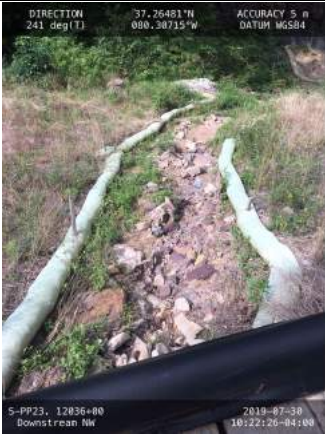
<p style="text-align: center;">Insert image here</p>			
GPS Location	See photo for gps data.		GPS Location		
Field Station#	12036+00		Field Station#		
Pic 17 Desc.	Stream S-PP23		Pic 18 Desc.

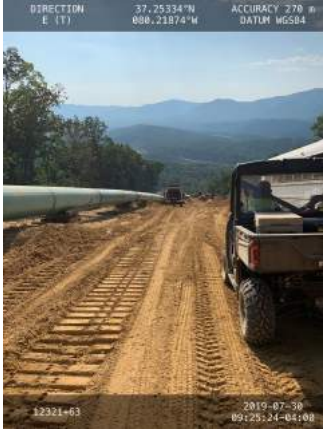
GPS Location	See picture for GPS data		GPS Location	See picture for GPS data	
Field Station#	12343+00		Field Station#	12421+73	
Pic 1 Desc.	All fill slope drains have been installed		Pic 2 Desc.	X-Ray and pipe gang activity

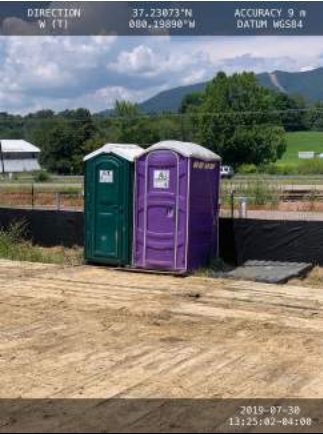
GPS Location	See picture for GPS data.		GPS Location	See picture for GPS data.	
Field Station#	12453+58		Field Station#	12451+23	
Pic 3 Desc.	Portable Toilet location.		Pic 4 Desc.	Clean water diversion berm.

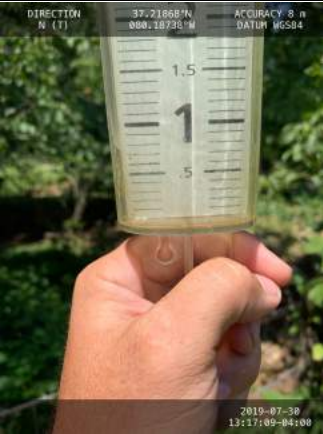
GPS Location	See picture for GPS data.		GPS Location	See picture for GPS data.	
Field Station#	12543+56		Field Station#	12450+80	
Pic 5 Desc.	Yellow Finch rain gauge (0.0")		Pic 6 Desc.	Night cap covering well point system.

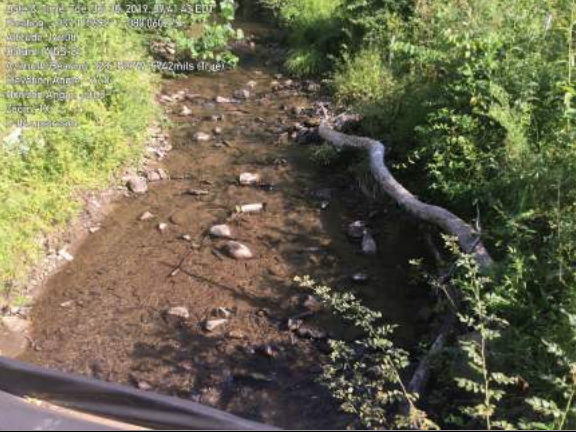
GPS Location	Please see photo for accurate coordinates.		GPS Location	Please see photo for accurate coordinates.	
Field Station#	13260+70		Field Station#	13261+28	
Pic 1 Desc.	S-II4, looking upstream, no issues noted.		Pic 2 Desc.	W-II4, wetland drainage along LOD.

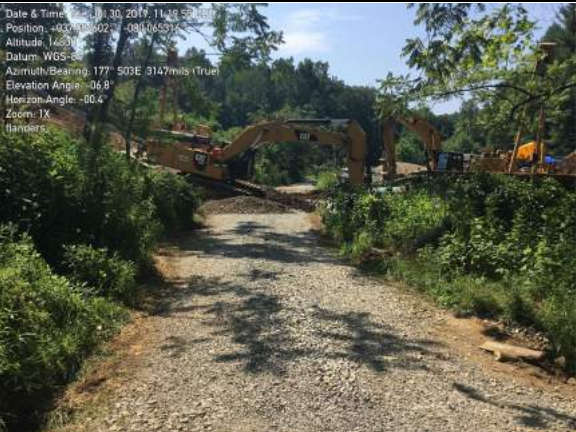
GPS Location	Please see photo for accurate coordinates.		GPS Location	Please see photo for accurate coordinates.	
Field Station#	13262+60		Field Station#	13293+00	
Pic 3 Desc.	Flanders Road, open cutting road.		Pic 4 Desc.	ROW, travel lane open.

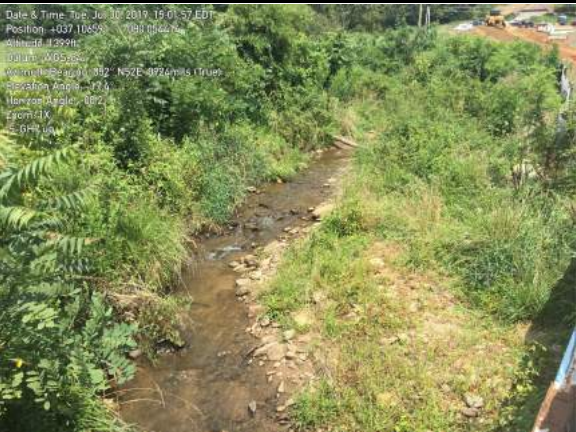
GPS Location	Please see photo for accurate coordinates.		GPS Location	Please see photo for accurate coordinates.	
Field Station#	13309+09		Field Station#	13261+00	
Pic 5 Desc.	S-GH7, looking upstream, no issues noted.		Pic 6 Desc.	Approved off ROW dewatering structure.
