# Visual Site Inspection Report

<b>Project Name</b>	H-600 Pipeline Spread H	<b>AFE</b>	124300138	<b>Spread</b>	H-600 Pipeline Spread H
<b>Contractor</b>	Precision			<b>Report #</b>	19883
<b>Inspector</b>	Tyler Cremeens			<b>Date/Time</b>	7/8/2019 6:31 AM
<b>Permit #</b>	TBD	<b>Inspection Type</b>	VA SWPP	<b>Station Begin</b>	13316+13
<b>State</b>	VA	<b>Inspection Area</b>	Partial	<b>Station End</b>	13415+57
<b>County</b>	Franklin	<b>Ground</b>	Damp	<b>Temperature (°F)</b>	89.
<b>Municipality</b>	N/A	<b>Weather</b>	Cloudy	<b>Rain Gauge (in)</b>	0.1
				<b>Rain Accumulation Time (days)</b>	2.

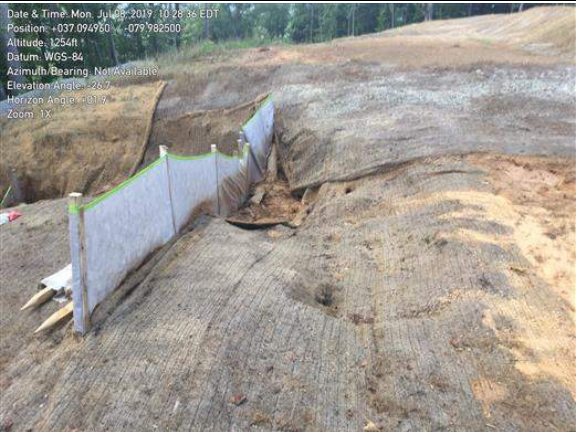
<p>Insert image here</p>			
<b>GPS Location</b>	37.19	<b>Field Station#</b>	13403+00	<b>GPS Location</b>	37.19
<b>Pic 3 Description</b>	See Photo for GPS data. Punchlist item: Severe erosion underneath ECB & SF used as checks. View: East.			<b>Pic 4 Description</b>

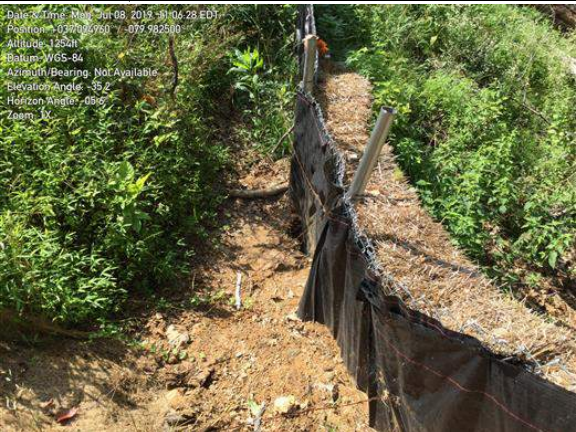
<p>Insert image here</p>			
<b>GPS Location</b>	37.19	<b>Field Station#</b>	13386+50	<b>GPS Location</b>	37.19
<b>Pic 5 Description</b>	See Photo for GPS data. Punchlist item: Undermined SF & Bales. View: East.			<b>Pic 6 Description</b>

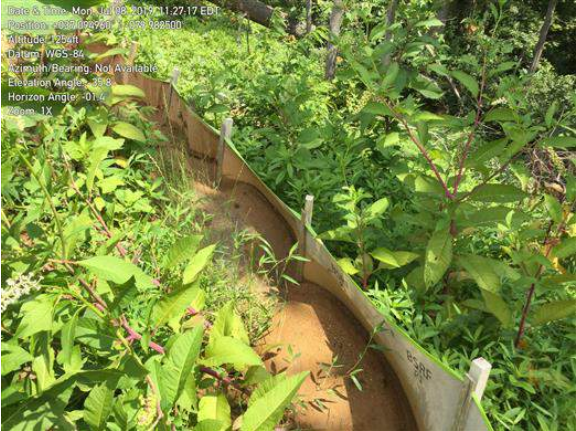
<p>Insert image here</p>			
<b>GPS Location</b>	37.26	<b>Field Station#</b>	13380+85	<b>GPS Location</b>	
<b>Pic 7 Description</b>	See Photo for GPS data. Punchlist item: sediments at SF above 50%. View: Northwest.		<b>Pic 8 Description</b>

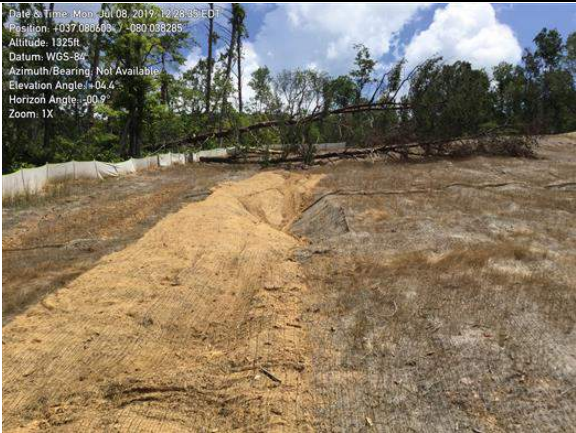
<p>Insert image here</p>			
<b>GPS Location</b>	37.26	<b>Field Station#</b>	13368+50	<b>GPS Location</b>	
<b>Pic 9 Description</b>	See Photo for GPS data. Punchlist item: Major Gully in upland area at ditchline. View: East.		<b>Pic 10 Description</b>

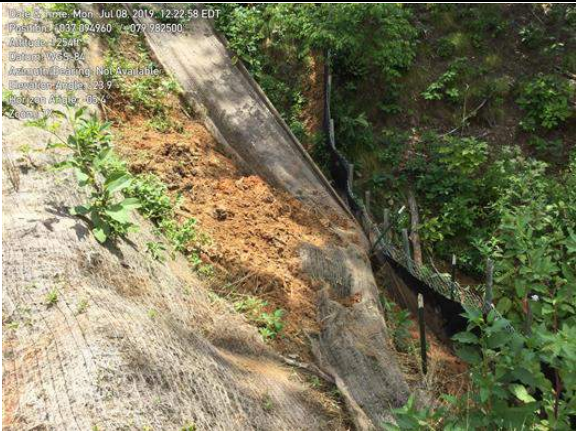
<p>Insert image here</p>			
<b>GPS Location</b>	37.26	<b>Field Station#</b>	13369+72	<b>GPS Location</b>	
<b>Pic 11 Description</b>	See Photo for GPS data. Punchlist item: minor slip along south edge of LOD near the 90 degree PI. View: East.		<b>Pic 12 Description</b>

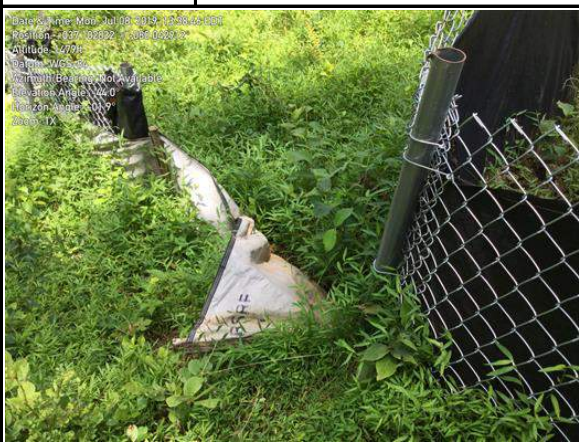
GPS Location	37.23	Field Station#		GPS Location	37.23	Field Station#	
Pic 17 Description	See Photo for GPS data.Broken stake of silt fence.View: West.			Pic 18 Description

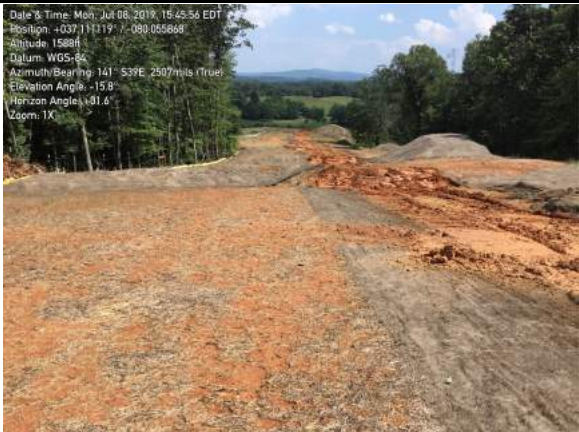
GPS Location	37.23	Field Station#	13261+20	GPS Location	37.23	Field Station#	13289+00
Pic 5 Description	Please see photo for accurate coordinates. W-II4, water flowing along LOD from wetland.			Pic 6 Description	Please see photo for accurate coordinates. ROW, travel lane open, waterbars put back, remainder of ROW stabilized.

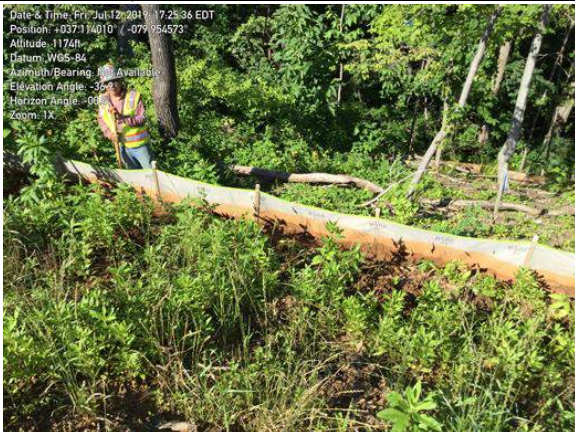
Pic 5 Description	See Photo for GPS data. Punchlist item: Silt fence had sediment above 50%. Sediments removed. View: Northeast.			Pic 6 Description	See Photo for GPS data. Punchlist item: Undermined sump and erosion above waterbar repaired. View: Northwest.

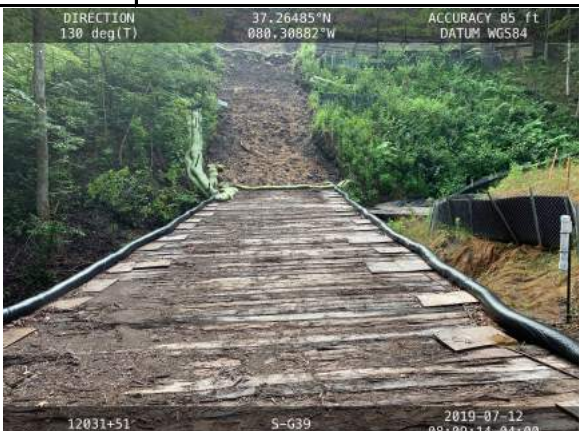
GPS Location	37.26	Field Station#	12031+51	GPS Location	37.26	Field Station#	12031+51
Pic 5 Description	See photo for gps data. Photo shows stream S-G39.			Pic 6 Description	See photo for gps data. Photo shows the bridge over stream S-G39.

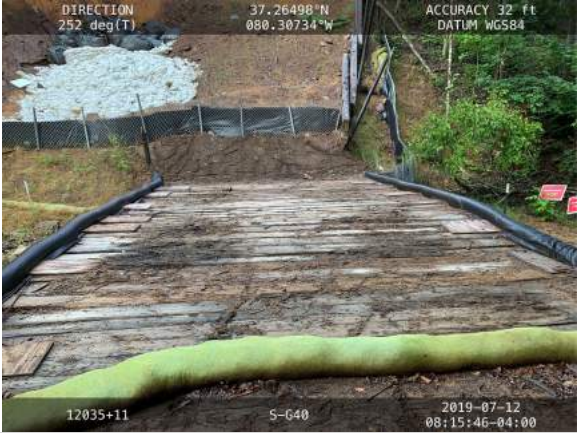
<p>DIRECTION 252 deg(T) 37.26498°N 080.30734°W ACCURACY 32 ft DATUM WGS84</p> <p>12035+11 S-G40 2019-07-12 08:15:46-04:00</p>		
GPS Location 37.26		Field Station# 12035+11		GPS Location 37.26	
Pic 7 Description		See photo for gps data. Photo shows stream S-G40.		Pic 8 Description	
  <p>DIRECTION 122 deg(T) 37.26488°N 080.30717°W ACCURACY 24 ft DATUM WGS84</p> <p>12036+00 S-PP23 2019-07-12 08:17:07-04:00</p>		  <p>DIRECTION 44 deg(T) 37.26484°N 080.30704°W ACCURACY 29 ft DATUM WGS84</p> <p>12036+00 S-PP23 2019-07-12 08:17:25-04:00</p>			
GPS Location 37.26		Field Station# 12036+00		GPS Location 37.26	
Pic 9 Description		See photo for gps data. Photo shows the bridge over stream S-PP23.		Pic 10 Description

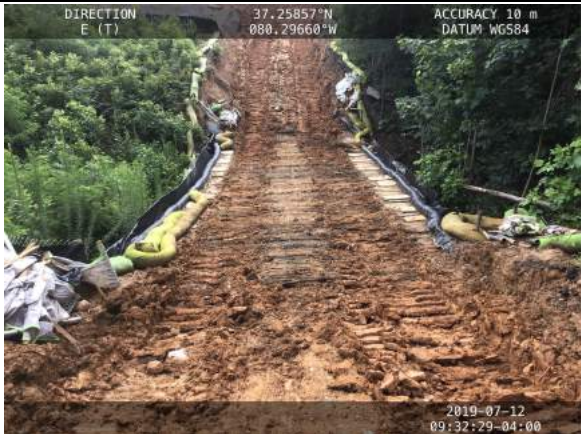
GPS Location	37.25	Field Station#	12076+95	GPS Location	37.25	Field Station#	12086+56
Pic 1 Description	Stream S-MM15, facing east. ECDs in satisfactory condition, bridge needs new deck mats, waiting on approval from Army Corps.			Pic 2 Description	Stream S-MM14, facing east. Bridge and ECDs in satisfactory condition.

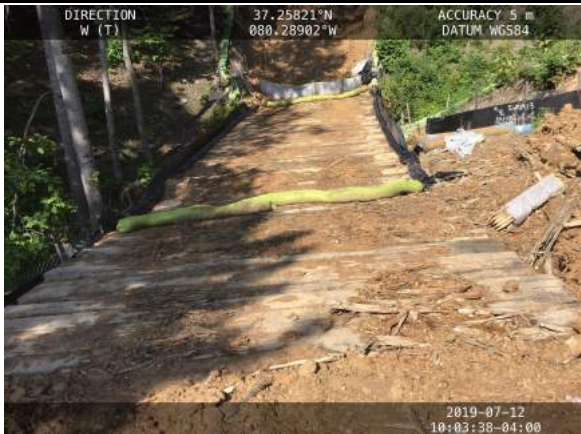
GPS Location	37.25	Field Station#	12098+44	GPS Location	37.25	Field Station#	12101+57
Pic 3 Description	Stream S-MM13, facing west. Bridge and ECDs in satisfactory condition.			Pic 4 Description	Stream S-MM11, facing west. Bridge and ECDs in satisfactory condition.

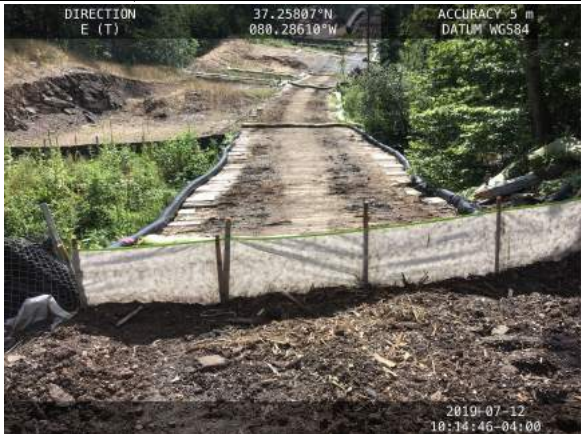
GPS Location	37.25	Field Station#	12108+41	GPS Location	37.25	Field Station#	12112+13
Pic 5 Description	Stream S-F15, facing east. Bridge and ECDs in good condition.			Pic 6 Description	Stream S-F16, facing east. Bridge and ECDs in good condition.

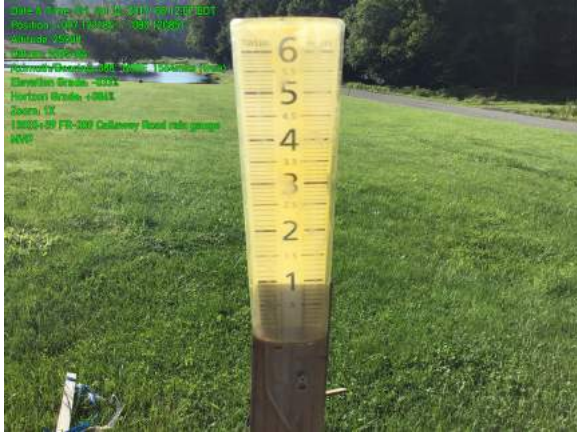
GPS Location	37.12	Field Station#	13033+59		GPS Location	37.12	Field Station#	13141+50
Pic 1 Description	No rainfall accumulation from yesterday's afternoon showers. 0.0" total precipitation.			Pic 2 Description	No issues or impacts observed near FR-292.

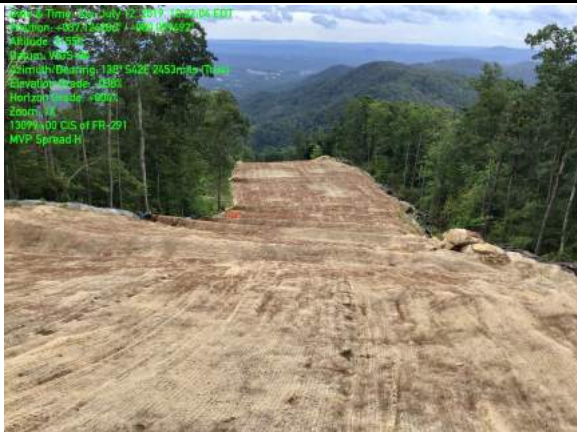
GPS Location	37.12	Field Station#	13099+00		GPS Location	37.12	Field Station#	13040+20
Pic 3 Description	ROW remains well stabilized between FR-290 and FR-291.			Pic 4 Description	No issues or impacts observed near stream S-H1.

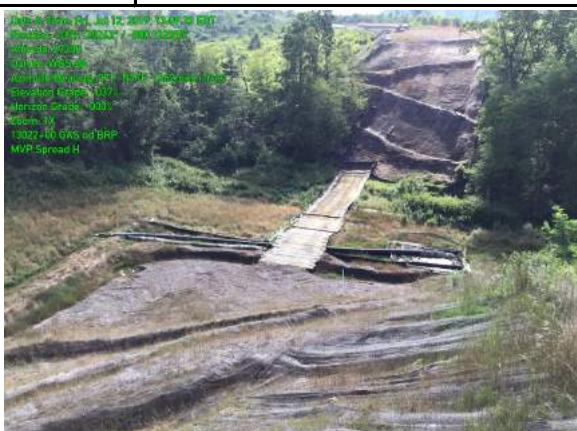
GPS Location	37.12	Field Station#	13022+00		GPS Location	37.15	Field Station#	12957+30
Pic 5 Description	No issues or impacts observed near streams S-G24 and S-G25			Pic 6 Description	ECD's installed along access roads RO-288 and RO-287 remain sufficient.

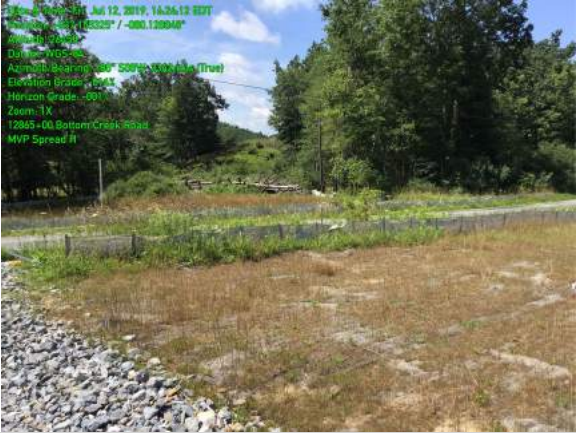
<b>GPS Location</b> 37.14		<b>Field Station#</b> 12865+00		<b>GPS Location</b> 37.15	
<b>Field Station#</b> 12865+00		<b>GPS Location</b> 37.15		<b>Field Station#</b> 13062+00	
<b>Pic 7 Description</b>		No deficiencies in the ECD's and BMP's at Bottom Creek Road.		<b>Pic 8 Description</b>

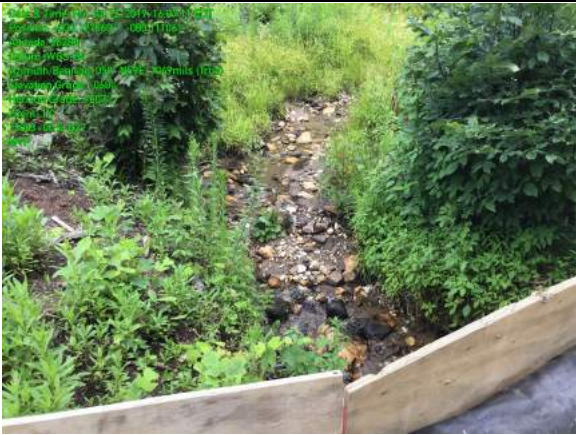
<p style="text-align: center;">Insert image here</p>	
<b>GPS Location</b> 37.15		<b>Field Station#</b> 13063+00		<b>GPS Location</b>	
<b>Field Station#</b> 13063+00		<b>GPS Location</b>		<b>Field Station#</b>	
<b>Pic 9 Description</b>		No impacts from work activities in the area to stream S-G27.		<b>Pic 10 Description</b>	
<p style="text-align: center;">Insert image here</p>		<p style="text-align: center;">Insert image here</p>		<p style="text-align: center;">Insert image here</p>	
<b>GPS Location</b>		<b>Field Station#</b>		<b>GPS Location</b>

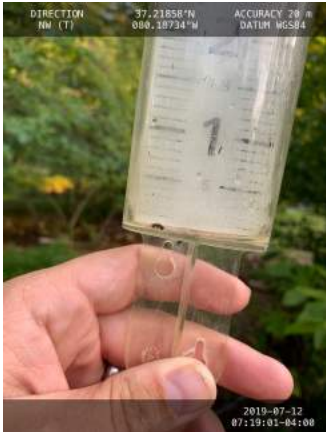
GPS Location	37.33	Field Station#	12543+56	GPS Location	37.33	Field Station#	12451+23
Pic 1 Description	YellowFinch rain gauge. Looking NW. See picture for GPS data.			Pic 2 Description	Stabilized ROW. Looking SE. See picture for GPS data.

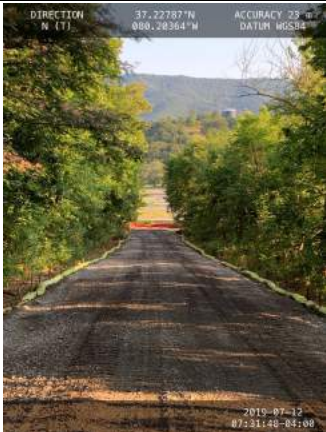
GPS Location	37.33	Field Station#	12469+62	GPS Location	37.33	Field Station#	12460+58
Pic 3 Description	Access road MVP-MLV-AR-27. Looking N. See picture for GPS data.			Pic 4 Description	Bridge crossing feature S-CD12b. Looking NE. See picture for GPS data.

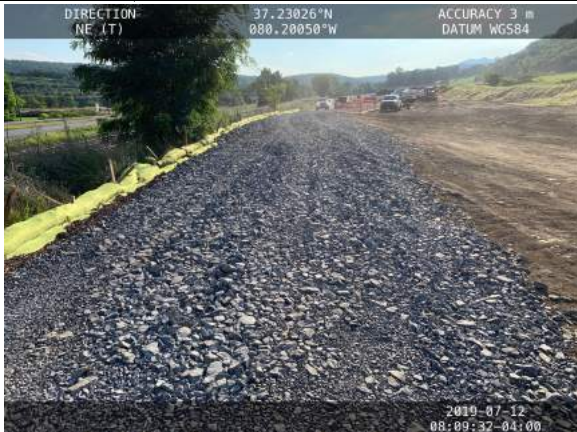
GPS Location	37.33	Field Station#	12456+00	GPS Location	37.33	Field Station#	12457+00
Pic 5 Description	RCE. Looking NE. See picture for GPS data.			Pic 6 Description	Stabilized top soil pile. Looking E. See picture for GPS data.

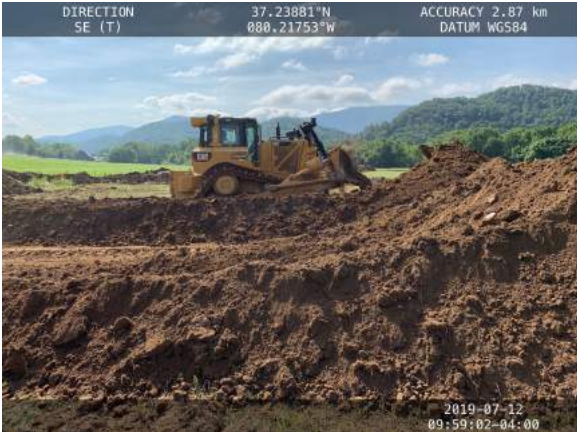
<div>2019-07-12 10:34:06-04:00</div>				
GPS Location	37.33	Field Station#	12425+00	GPS Location	37.33	Field Station#	12430+00
Pic 1 Description	Dozer topsoiling the ROW. Looking SE. See picture for GPS data.			Pic 2 Description	Crew getting drain pipe set in the right location. Looking W. See picture for GPS data.		
<div>DIRECTION N (T)</div> <div>37.23576°N 088.19984°W</div> <div>ACCURACY 28 m DATUM WGS84</div>

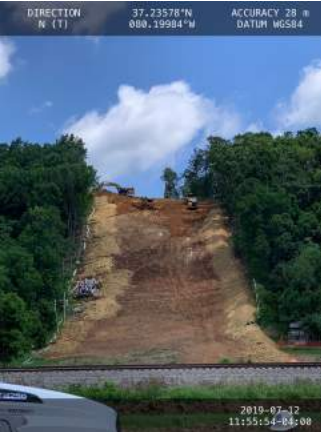
GPS Location	37.33	Field Station#	12416+65	GPS Location	37.33	Field Station#	12234+50
Pic 3 Description	Grade crew grading down the hill side coming down to the RR tracks. Looking N. See picture for GPS.			Pic 4 Description	CFS repaired along the access road. Looking S. See picture for GPS data.		
<div>DIRECTION E (T)</div> <div>37.24064°N 088.20077°W</div> <div>ACCURACY 31 m DATUM WGS84</div>
