Visual Site Inspection Report

Project Name	H-600 Pipeline Spread H	AFE	124300138	Spread	H-600 Pipeline Spread
Contractor	Roberts Corrosion			Report #	774
Inspector	Logan Box			Date/Time	8/14/2019 6:34 PM
Permit #	TBD	Inspection Type	VA SWPP	Station Begin	13415+55
State	VA	Inspection Area	Partial	Station End	13670+00
County	Franklin	Ground	Dry	Temperature (°F)	86.00
Municipality	N/A	Weather	Sunny	Rain Gauge (in)	0.00
				Rain Accumulation Time (days)	0.00

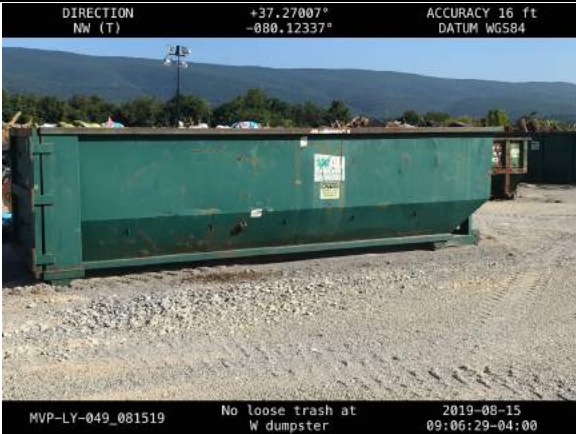
GPS Location	MVP-LY-049 See photo for gps data		GPS Location	MVP-LY-049 See photo for gps data	
Field Station#	+0		Field Station#	+0	
Pic 3 Desc.	No loose trash around W dumpster. Looking NW		Pic 4 Desc.	Debris pile from ROW. Looking N

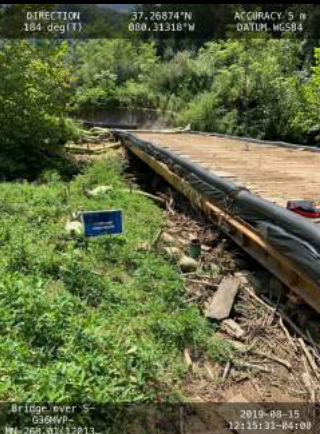
GPS Location	See photo GPS data		GPS Location	See photo GPS data	
Field Station#	12013+97		Field Station#	12013+97	
Pic 5 Desc.	New erosion blanket and 12" CFS		Pic 6 Desc.	Upstream side of bridge over S-G36.

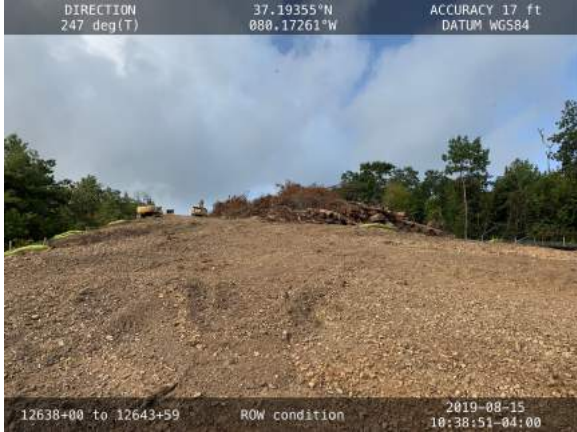
GPS Location	See photo for gps data.		GPS Location	See photo for gps data.	
Field Station#	12643+00		Field Station#	12644+00	
Pic 1 Desc.	ROW condition		Pic 2 Desc.	ROW condition

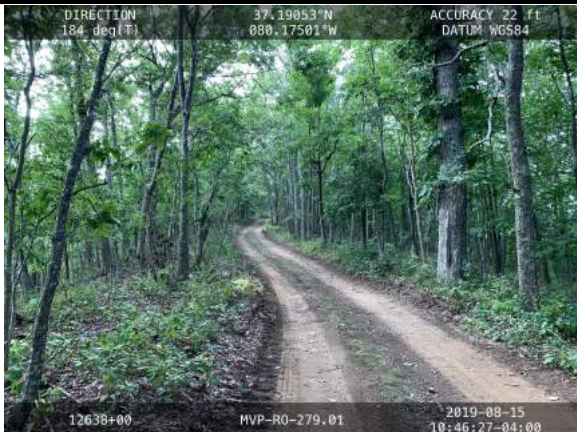
GPS Location	See photo for gps data.		GPS Location	See photo for gps data.	
Field Station#	12638+00		Field Station#	12702+00	
Pic 3 Desc.	Access road MVP-RO-279.01		Pic 4 Desc.	Access road MVP-RO-280.

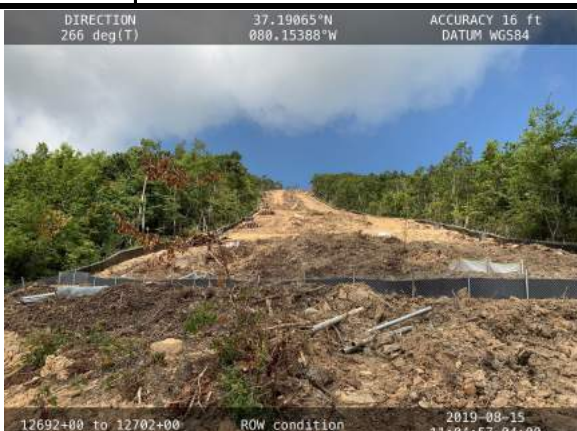
GPS Location	See photo for gps data.		GPS Location	See photo for gps data.	
Field Station#	12702+00		Field Station#	12703+00	
Pic 5 Desc.	ROW condition		Pic 6 Desc.	ROW condition

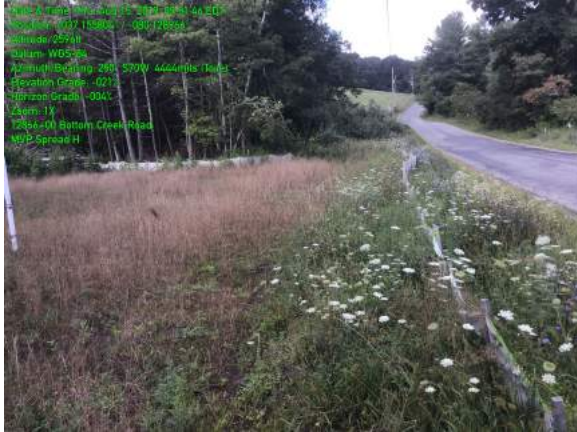
GPS Location	See pic for GPS location		GPS Location	See pic for GPS location	
Field Station#	12866+00		Field Station#	12865+80	
Pic 1 Desc.	GAS of the Bottom Creek road crossing.		Pic 2 Desc.	CIS of the Bottom Creek Road crossing.

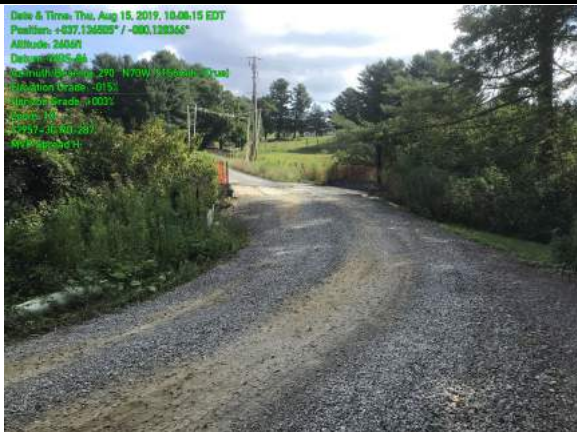
GPS Location	See pic for GPS location		GPS Location	See pic for GPS location	
Field Station#	12957+30		Field Station#	12974+29	
Pic 3 Desc.	Access Road RO-287 stream S-Z16		Pic 4 Desc.	Stream S-Q20 @ RO-288.

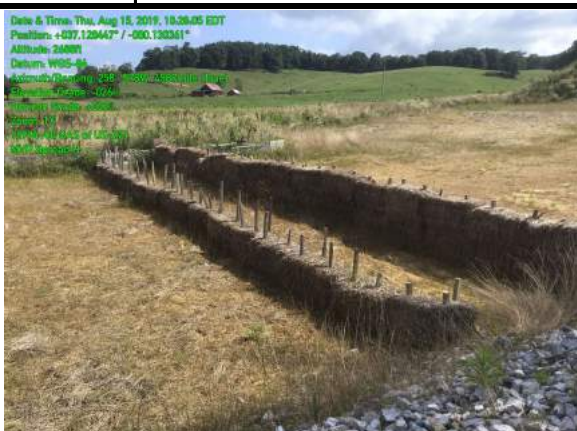
GPS Location	See pic for GPS location		GPS Location	See pic for GPS location	
Field Station#	12944+00		Field Station#	13040+80	
Pic 5 Desc.	GAS of US-221.		Pic 6 Desc.	Stream crossing S-H1. No impacts observed.

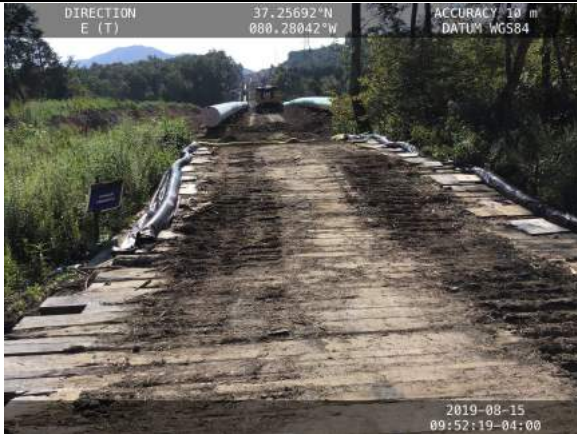
GPS Location	See photo		GPS Location	See photo	
Field Station#	12125+65		Field Station#	12132+73	
Pic 3 Desc.	Stream S-MM31		Pic 4 Desc.	Stream S-C29

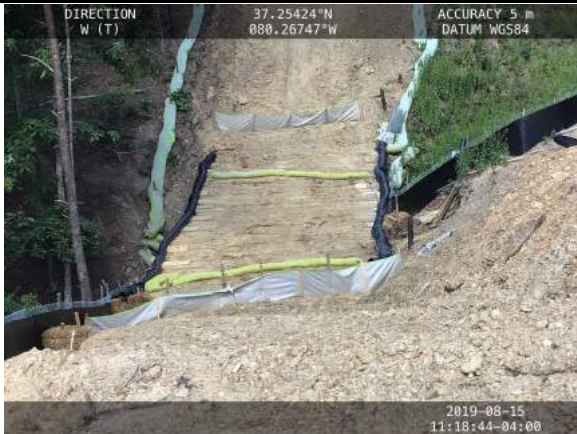
GPS Location	See photo		GPS Location	See photo	
Field Station#	12163+05		Field Station#	12166+41	
Pic 5 Desc.	Stream S-C25, facing west		Pic 6 Desc.	Stream S-C24, facing east

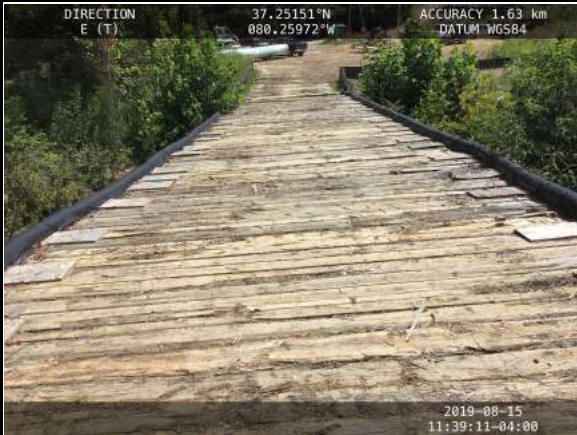
GPS Location	See photo		GPS Location	See photo	
Field Station#	12192+50		Field Station#	12129+50	
Pic 7 Desc.	Stream S-C21, facing east		Pic 8 Desc.	A temporary trench breaker was installed

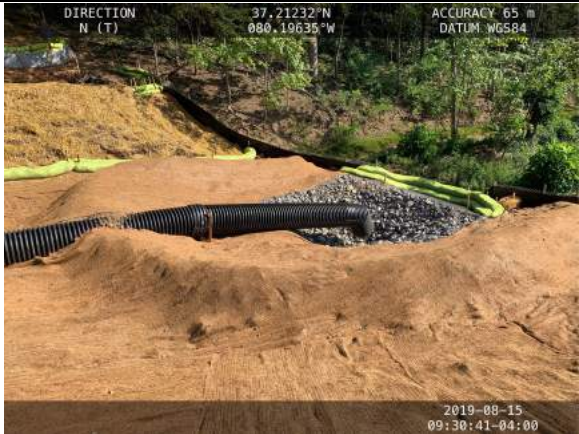
GPS Location	See picture for GPS		GPS Location	See picture for GPS data	
Field Station#	12543+56		Field Station#	12533+00	
Pic 1 Desc.	SSF materials stolen and used by opposition		Pic 2 Desc.	Clear water crossing outlet.

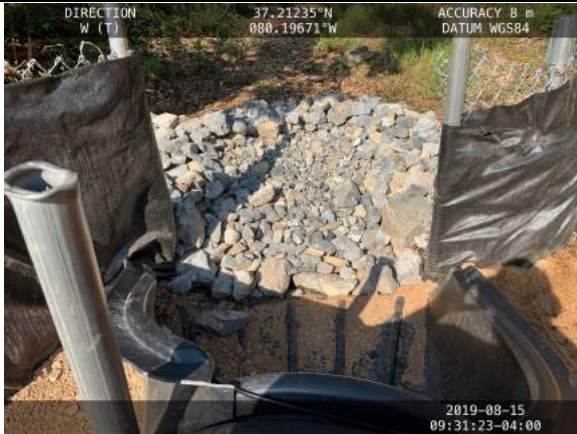
GPS Location	See picture for GPS data		GPS Location	See picture for GPS data	
Field Station#	12533+00		Field Station#	12521+50	
Pic 3 Desc.	Clear water entrance.		Pic 4 Desc.	Water bar rebuilt with positive drainage

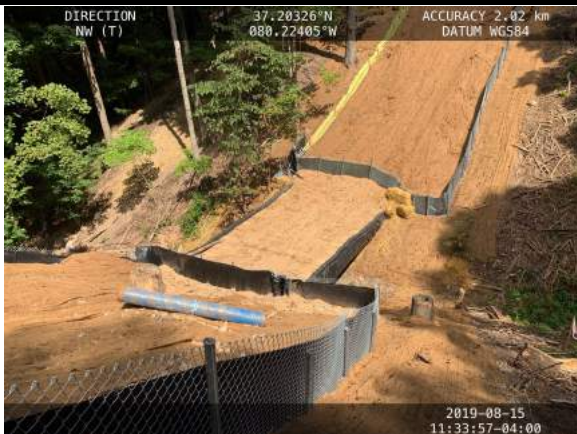
GPS Location	See picture for GPS data		GPS Location	See picture for GPS data	
Field Station#	12519+41		Field Station#	12504+00	
Pic 5 Desc.	Bridge crossing S-EF19		Pic 6 Desc.	Clear water crossing.
