Visual Site Inspection Report

Project Name	H-600 Pipeline Spread H	AFE	124300138	Spread	H-600 Pipeline Spread
Contractor	Precision			Report #	1114
Inspector	Logan Box			Date/Time	8/20/2019 8:22 PM
Permit #	TBD	Inspection Type	VA SWPP	Station Begin	13415+55
State	VA	Inspection Area	Partial	Station End	13670+00
County	Franklin	Ground	Dry	Temperature (°F)	93.00
Municipality	N/A	Weather	Sunny	Rain Gauge (in)	0.00
				Rain Accumulation Time (days)	0.00

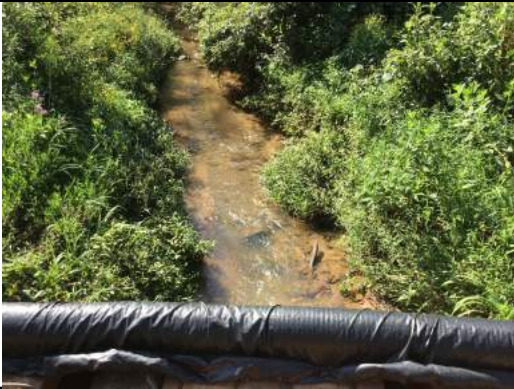
GPS Location	000000	GPS Location	00000		
Field Station#	13643+66	Field Station#	13643+66		
Pic 3 Desc.	Photo down stream	Pic 4 Desc.	Photo facing upstream		
Insert image here		Insert image here			
GPS Location		GPS Location			
Field Station#		Field Station#			
Pic 5 Desc.		Pic 6 Desc.

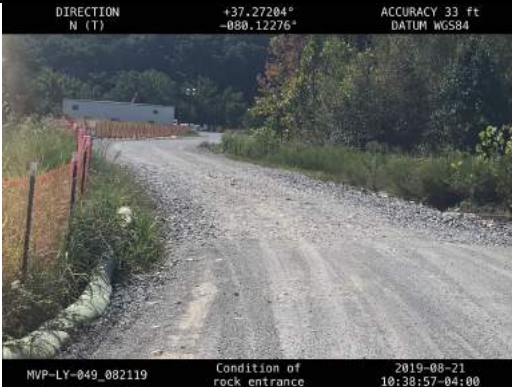
GPS Location	MVP-LY-049 See photo for gps data		GPS Location	MVP-LY-049 See photo for gps data	
Field Station#	+0		Field Station#	+0	
Pic 1 Desc.	MVP-LY-049_082119 Condition of rock entrance. Looking S.		Pic 2 Desc.	MVP-LY-049_082119 no loose trash around East dumpster. Looking NE.

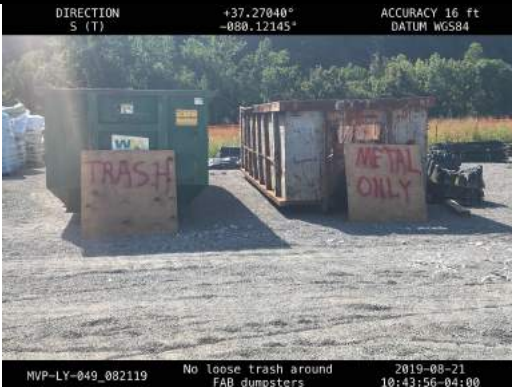
GPS Location	MVP-LY-049 See photo for gps data		GPS Location	MVP-LY-049 See photo for gps data	
Field Station#	+0		Field Station#	+0	
Pic 3 Desc.	MVP-LY-049_082119 no loose trash around FAB Section dumpsters. Looking S.		Pic 4 Desc.	MVP-LY-049_082119 Compost Filter Sock in good condition around sand pile. Looking W.

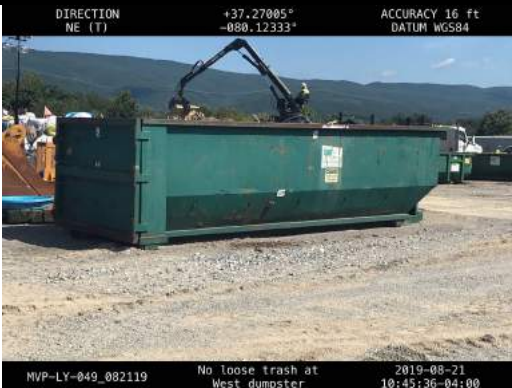
GPS Location	MVP-LY-049 See photo for gps data		GPS Location	MVP-LY-049 See photo for gps data	
Field Station#	+0		Field Station#	+0	
Pic 5 Desc.	MVP-LY-049_082119 No loose trash around West dumpster. Looking NE.		Pic 6 Desc.	MVP-LY-049_082119 crew loading dumpsters with debris from the ROW. Parkway tree debris hauled away. Looking N

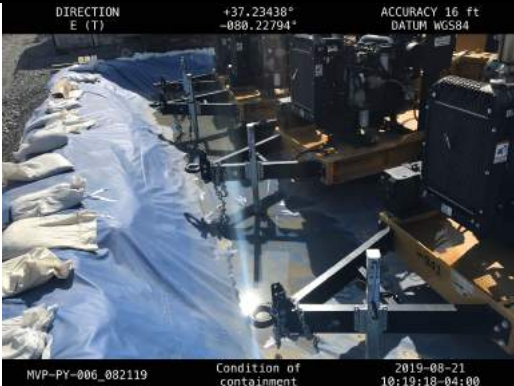
GPS Location	MVP-PY-006 See photo for gps data		GPS Location	MVP-PY-006 See photo for gps data	
Field Station#	+0		Field Station#	+0	
Pic 5 Desc.	MVP-PY-006_082119 condition of containment no sheen. Looking E.		Pic 6 Desc.	MVP-PY-006_082119 tanker in containment while filling. Looking SE.

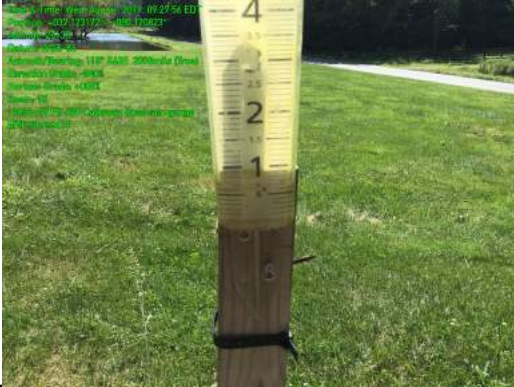
GPS Location	See pic for GPS location		GPS Location	See pic for GPS location	
Field Station#	13033+59		Field Station#	12866+15	
Pic 3 Desc.	0.8" total precipitation		Pic 4 Desc.	No issues or impacts observed in the area

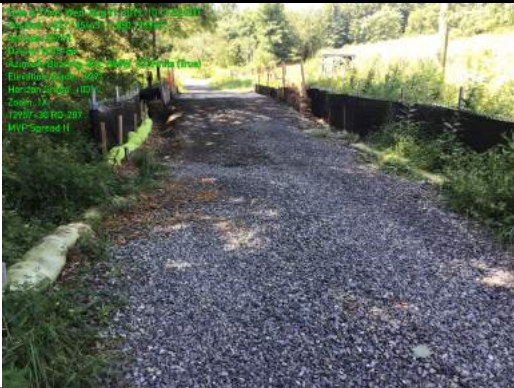
GPS Location	See pic for GPS location		GPS Location	See pic for GPS location	
Field Station#	12957+30		Field Station#	12974+29	
Pic 5 Desc.	No issues or impacts were observed along access road RO-287.		Pic 6 Desc.	No issues or impacts observed along the access road or at the ROW.

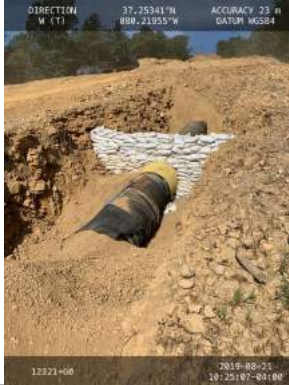
GPS Location	See picture for GPS data		GPS Location	See picture for GPS data	
Field Station#	12306+00		Field Station#	12321+60	
Pic 3 Desc.	Pipe laid in open ditch waiting to be backfilled.		Pic 4 Desc.	Trench breaker.

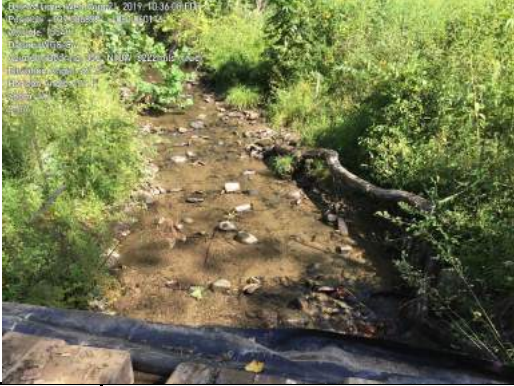
GPS Location	See Photo for Coordinates.	GPS Location	See Photo for Coordinates.		
Field Station#	13260+70	Field Station#	13260+70		
Pic 1 Desc.	S-II4, looking upstream, no turbidity noted, no environmental concerns observed.	Pic 2 Desc.	S-II4, looking downstream of equipment bridge, water flowing clear, no environmental issues noted.
