Visual Site Inspection Report

Project Name	H-600 Pipeline Spread H	AFE	124300138	Spread	H-600 Pipeline Spread
Contractor	Precision			Report #	344
Inspector	Pat Davis			Date/Time	8/5/2019 8:32 AM
Permit #	TBD	Inspection Type	VA SWPP	Station Begin	13315+70
State	VA	Inspection Area	Partial	Station End	13415+51
County	Franklin	Ground	Dry	Temperature (°F)	85.00
Municipality	N/A	Weather	Cloudy	Rain Gauge (in)	0.00
				Rain Accumulation Time (days)	0.00

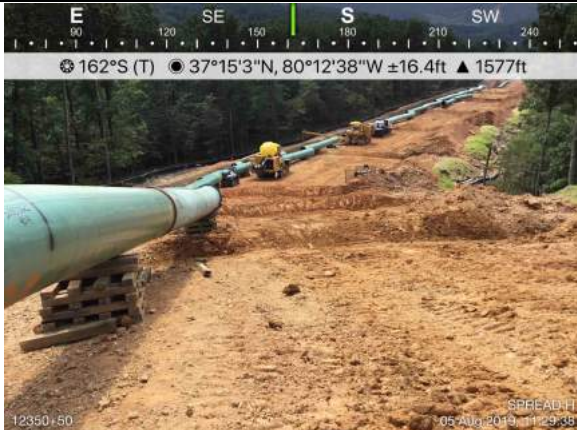
GPS Location	37 15,3 N 80 12,38 W		GPS Location	37 14,36 N 80 12,20 W	
Field Station#	12350+50		Field Station#	12385+00	
Pic 3 Desc.	Example of waterbars being built back into travel lane going up to the top of Reese		Pic 4 Desc.	CFS should be installed at end of sump/waterbar end treatment

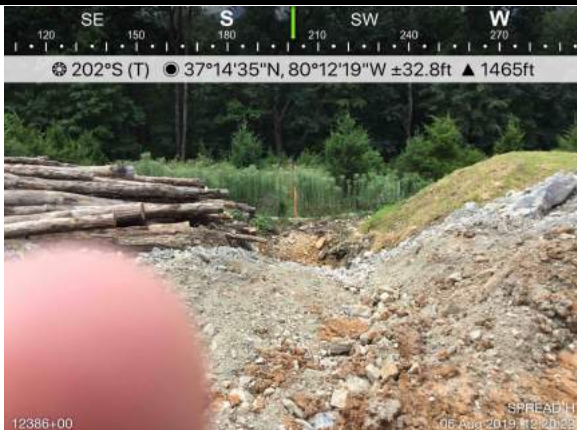
GPS Location	37 14,35 N 80 12,19 W		GPS Location	37 14,21 N 80 11,57 W	
Field Station#	12386+00		Field Station#	12410+00	
Pic 5 Desc.	CFS should be installed at end of sump/waterbar end treatment		Pic 6 Desc.	Fill slip from new dirt coming from trenching should be stabilized if dormant for more than 7

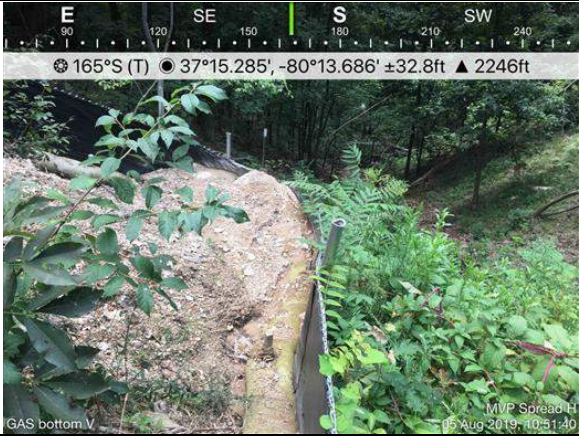
GPS Location	See picture watermark	GPS Location	See picture watermark		
Field Station#	12292+00	Field Station#	12284+30		
Pic 5 Desc.	SSF overtopped and needs clean out.	Pic 6 Desc.	Waterbar flowpath needs clean out.

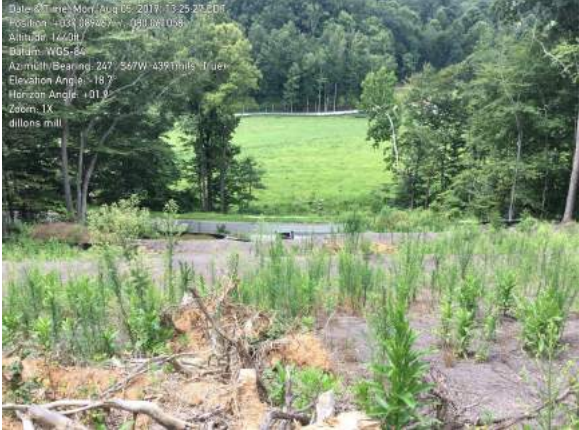
GPS Location	See photo for coordinates.		GPS Location	See photo for coordinates.	
Field Station#	13202+00		Field Station#	13208+00	
Pic 1 Desc.	Dillon's Mill, ROW stabilized.		Pic 2 Desc.	ROW stable, waterbars and sumps functioning

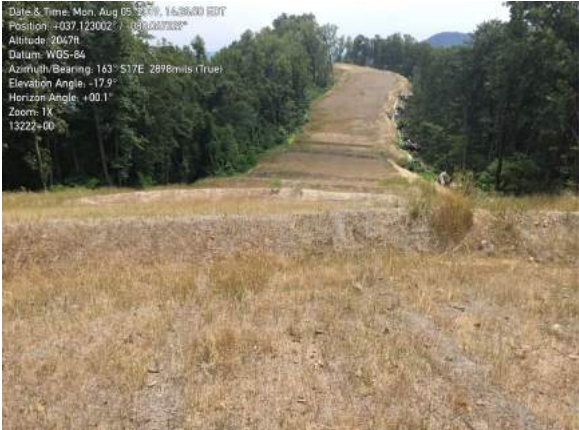
GPS Location	See photo for coordinates.		GPS Location	See photo for coordinates.	
Field Station#	13222+00		Field Station#	13250+25	
Pic 3 Desc.	ROW stable, waterbars and sumps functioning		Pic 4 Desc.	ROW, sparse vegetative cover.

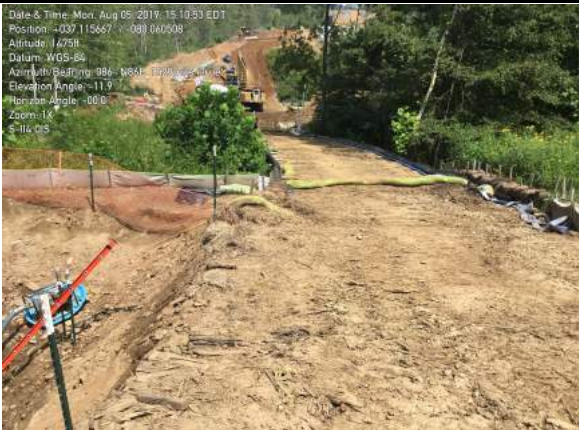
GPS Location	See photo for coordinates.		GPS Location	See photo for coordinates.	
Field Station#	13260+00		Field Station#	13260+65	
Pic 5 Desc.	S-II4, tie in activities in progress, bridge clean.		Pic 6 Desc.	S-II4, looking upstream, water clear.

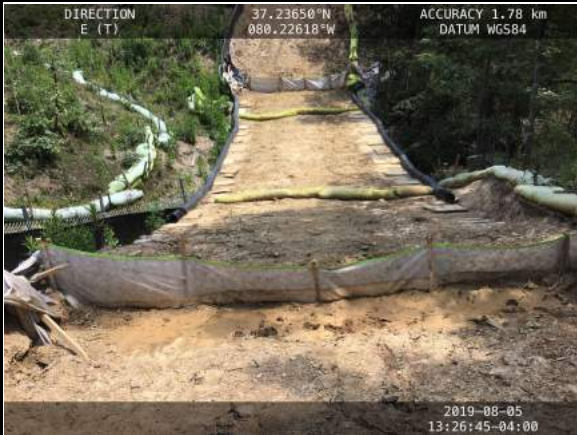
GPS Location	See photo		GPS Location	See photo	
Field Station#	12166+47		Field Station#	12204+25	
Pic 7 Desc.	Stream S-C24, facing east		Pic 8 Desc.	End treatment installed

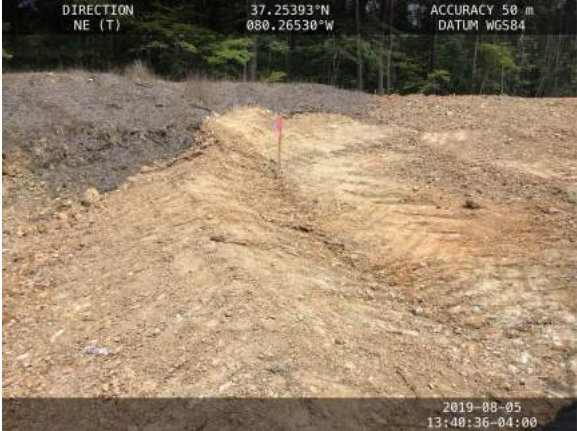
<p>Insert image here</p>			
GPS Location	See photo	GPS Location			
Field Station#	12175+00	Field Station#			
Pic 13 Desc.	Waterbar with too much slope was corrected	Pic 14 Desc.			
<p>Insert image here</p>		<p>Insert image here</p>			
GPS Location		GPS Location			
Field Station#		Field Station#			
Pic 15 Desc.		Pic 16 Desc.			
<p>Insert image here</p>		<p>Insert image here</p>			
GPS Location		GPS Location			
Field Station#		Field Station#			
Pic 17 Desc.		Pic 18 Desc.

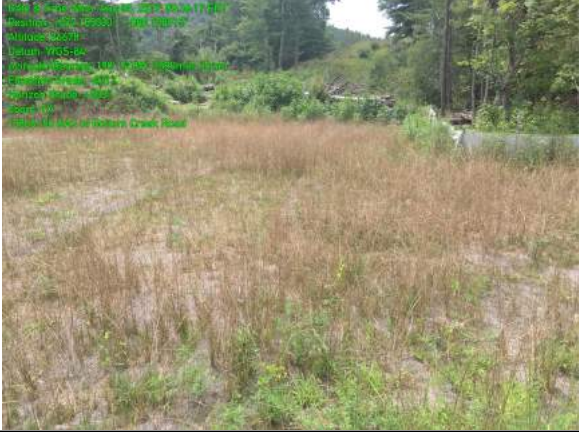
GPS Location	see pic for GPS location	GPS Location	see pic for GPS location		
Field Station#	12866+50	Field Station#	12998+80		
Pic 1 Desc.	No issues or impacts observed at BCR.	Pic 2 Desc.	No erosion issues in the area.

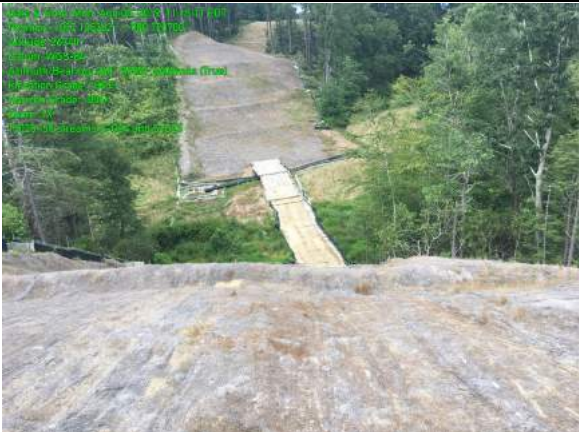
GPS Location	see pic for GPS location	GPS Location	see pic for GPS location		
Field Station#	13025+50	Field Station#	13040+00		
Pic 3 Desc.	No stream impacts observed	Pic 4 Desc.	No issues or impacts throughout the area

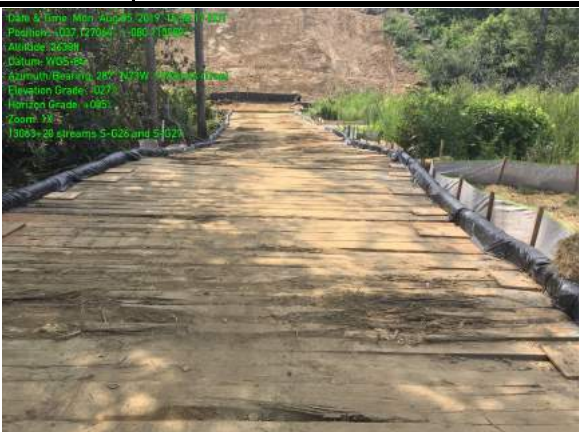
GPS Location	see pic for GPS location	GPS Location	see pic for GPS location		
Field Station#	13063+20	Field Station#	13141+50		
Pic 5 Desc.	Bridge recently rebuilt. No issues found.	Pic 6 Desc.	No issues or impacts observed along access.

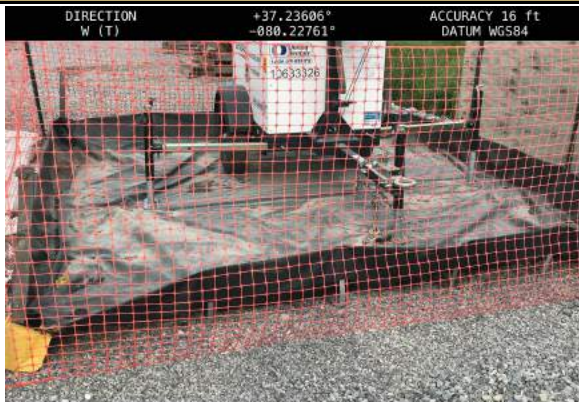
GPS Location	MVP-PY-006 See photo for gps data		GPS Location	MVP-PY-006 See photo for gps data	
Field Station#	+0		Field Station#	+0	
Pic 1 Desc.	Condition of containment. Looking W.		Pic 2 Desc.	N fluid deposits N of tanks. Looking NE.

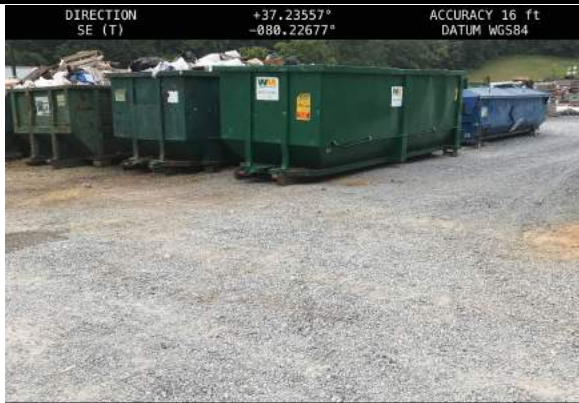
GPS Location	MVP-PY-006 See photo for gps data		GPS Location	MVP-PY-006 See photo for gps data	
Field Station#	+0		Field Station#	+0	
Pic 3 Desc.	No loose trash around dumpster. Looking SE.		Pic 4 Desc.	No leaky fittings. Looking W.

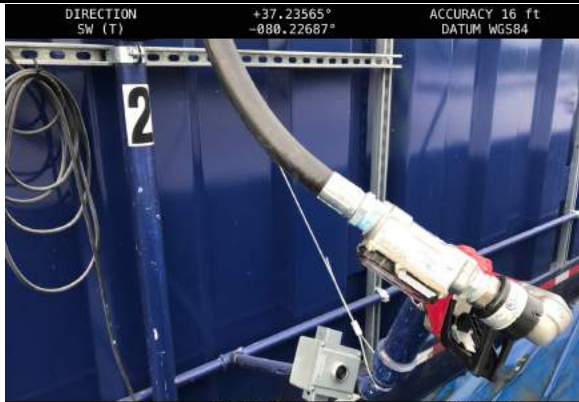
GPS Location	MVP-PY-006 See photo for gps data		GPS Location	MVP-PY-006 See photo for gps data	
Field Station#	+0		Field Station#	+0	
Pic 5 Desc.	Nozzles and fittings not leaky. Looking SW.		Pic 6 Desc.	No leaky fittings. Looking W.

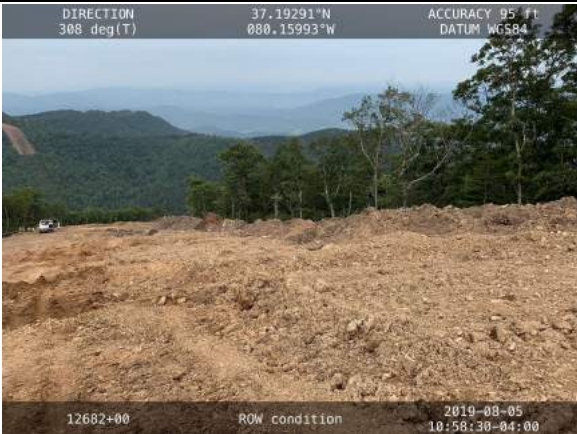
<div>12682+00 ROW condition 2019-08-05 10:58:30-04:00</div>			<div>DIRECTION 301 deg(T) 37.19417°N 080.16364°W ACCURACY 201 ft DATUM WGS84</div>

<div>12670+00 ROW Condition 2019-08-05 11:28:48-04:00</div>		
GPS Location	See photo for gps data.		GPS Location	See photo for gps data.	
Field Station#	12682+00		Field Station#	12670+00	
Pic 1 Desc.	ROW condition, partially topsoiled.		Pic 2 Desc.	ROW condition. Cleared, partially grubbed	
<div>DIRECTION 151 deg(T) 37.19358°N 080.16704°W ACCURACY 51 ft DATUM WGS84</div>

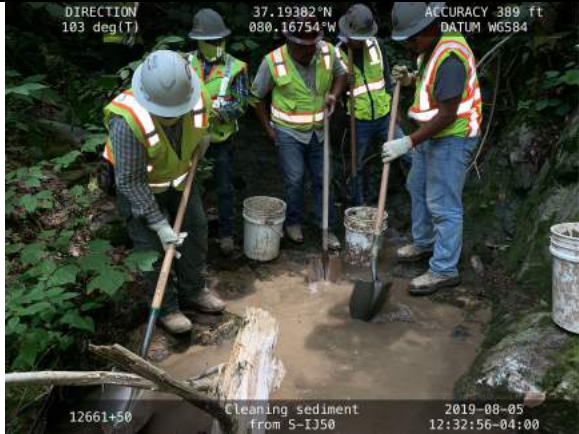
<div>12661+50 Cleaning sediment from S-IJ50 2019-08-05 12:32:56-04:00</div>

GPS Location	See photo for gps location		GPS Location	See photo for gps location.	
Field Station#	12661+00		Field Station#	12661+00	
Pic 3 Desc.	Sediment in S-IJ50		Pic 4 Desc.	Retrieving sediment from S-IJ50	
<div>DIRECTION 294 deg(T) 37.19877°N 080.15365°W ACCURACY 68 ft DATUM WGS84</div>

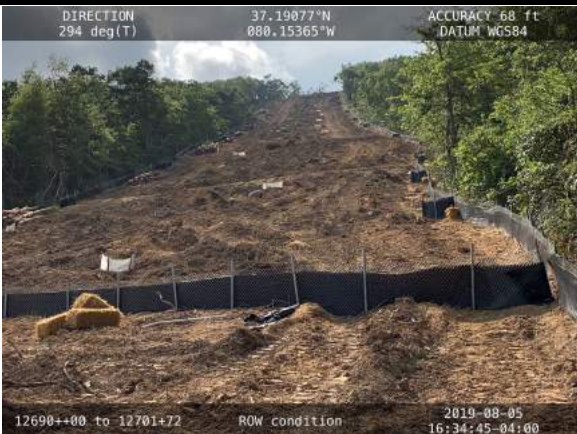
<div>12690+00 to 12701+72 ROW condition 2019-08-05 16:34:45-04:00</div>			<div>DIRECTION 16 deg(T) 37.19359°N 080.17156°W ACCURACY 63 ft DATUM WGS84</div>

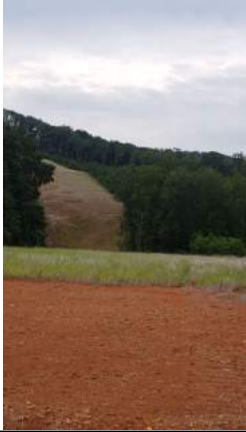
GPS Location	00000	GPS Location	00000		
Field Station#	13423+61	Field Station#	13420+00		
Pic 1 Desc.	Row photo on CAHAS mountain showing vegetation	Pic 2 Desc.	Vegetation photo at Kickoff .

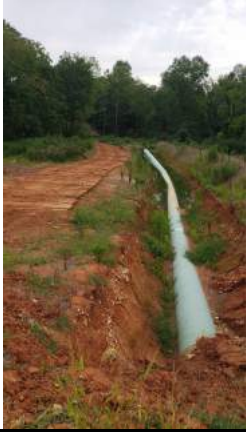
GPS Location	0000	GPS Location	0000		
Field Station#	13659+00	Field Station#	13496+31		
Pic 3 Desc.	Photo showing open ditch with pipe in the ground, recently installed mats on row	Pic 4 Desc.	Recently installed silt fence to protect stream while work was being done to anode beds		
Insert image here		Insert image here			
GPS Location		GPS Location			
Field Station#		Field Station#			
Pic 5 Desc.		Pic 6 Desc.

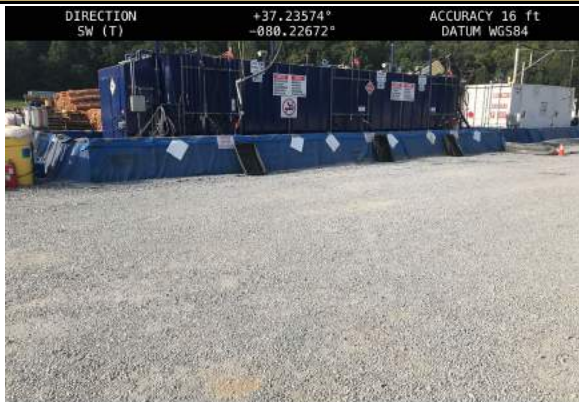
GPS Location	MVP-PY-006 See photo for gps data		GPS Location	MVP-PY-006 See photo for gps data	
Field Station#	+0		Field Station#	+0	
Pic 1 Desc.	No fluid deposits N of tanks. Looking SW		Pic 2 Desc.	Blue Bulk tank no leaky fittings. Looking SW

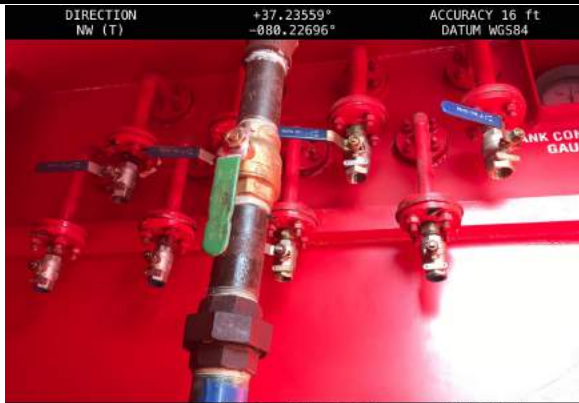
GPS Location	MVP-PY-006 See photo for gps data		GPS Location	MVP-PY-006 See photo for gps data	
Field Station#	+0		Field Station#	+0	
Pic 3 Desc.	Off Road Fuel unit no leaky fittings.LookingNW		Pic 4 Desc.	Condition of CFS E boundary. Looking N

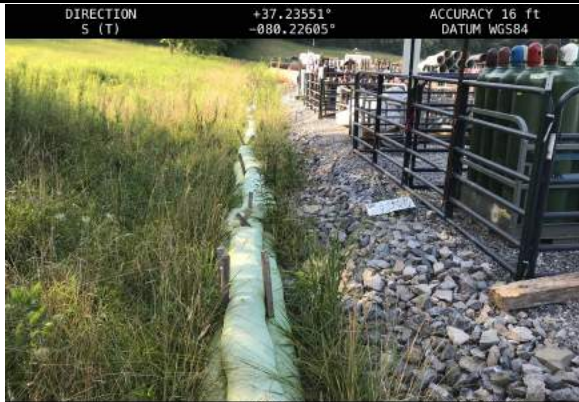
GPS Location	MVP-PY-006 See photo for gps data		GPS Location	MVP-PY-006 See photo for gps data	
Field Station#	+0		Field Station#	+0	
Pic 5 Desc.	Condition of CFS E boundary. Looking S		Pic 6 Desc.	Signage & buffer for feature. Looking NW

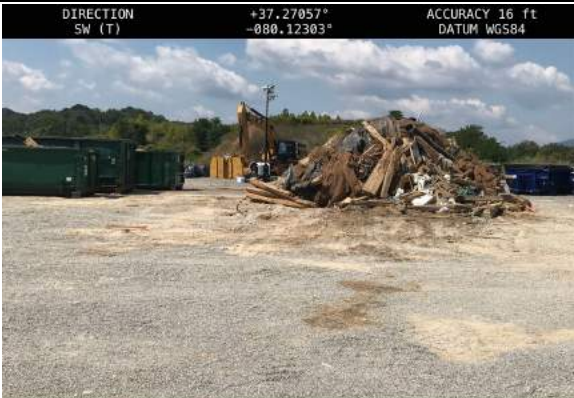
<div>MVP-LY-049_080919</div> <div>ROW debris and dumpsters</div> <div>2019-08-09 11:36:51-04:00</div> </div>		<div> <div>DIRECTION N (T)</div> <div>+37.27156° -080.12034°</div> <div>ACCURACY 16 ft DATUM WGS84</div>

<div>MVP-LY-049_080919</div> <div>No loose trash around E dumpster</div> <div>2019-08-09 11:39:24-04:00</div> </div>			
GPS Location MVP-LY-049 See photo for GPS data		GPS Location MVP-LY-049 See photo for GPS data			
Field Station# +0		Field Station# +0			
Pic 1 Desc. Debris from ROW to be hauled out. Looking SW		Pic 2 Desc. No loose trash at E dumpster. Looking N			
<div> <div>DIRECTION N (T)</div> <div>+37.27108° -080.12159°</div> <div>ACCURACY 16 ft DATUM WGS84</div>

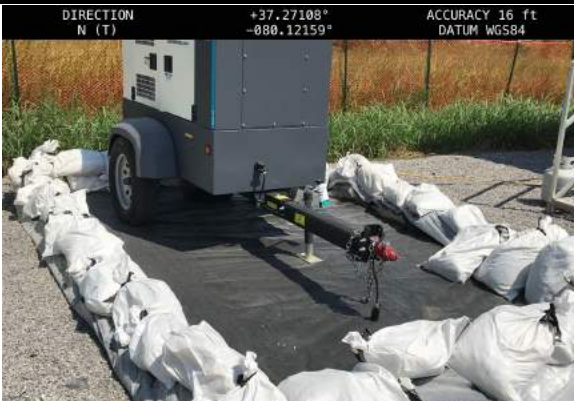
<div>MVP-LY-049_080919</div> <div>Condition of containment</div> <div>2019-08-09 11:38:37-04:00</div> </div>		<div> <div>DIRECTION NE (T)</div> <div>+37.27091° -080.12015°</div> <div>ACCURACY 16 ft DATUM WGS84</div>

GPS Location MVP-LY-049 See photo for GPS data		GPS Location MVP-LY-049 See photo for GPS data			
Field Station# +0		Field Station# +0			
Pic 3 Desc. Condition of containment. Looking N		Pic 4 Desc. Toilets for FAB yard. Looking NE			
<div> <div>DIRECTION SW (T)</div> <div>+37.27110° -080.12063°</div> <div>ACCURACY 16 ft DATUM WGS84</div>

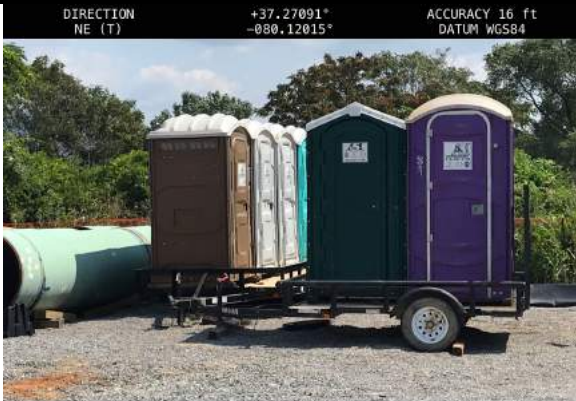
<div>MVP-LY-049_080919</div> <div>Porta toilets on trailers for FAB Sec...</div> <div>2019-08-09 11:41:14-04:00</div> </div>

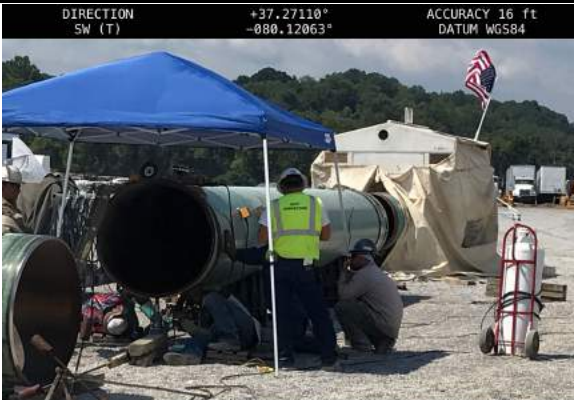
<div>MVP-LY-049_080919</div> <div>Welders working in FAB Section</div> <div>2019-08-09 11:42:02-04:00</div> </div>		<div> <div>DIRECTION SE (T)</div> <div>+37.27041° -080.12138°</div> <div>ACCURACY 16 ft DATUM WGS84</div>

<div>MVP-LY-049_080919</div> <div>Dumpsters for FAB Section no loose tra...</div> <div>2019-08-09 11:43:45-04:00</div> </div>			
GPS Location MVP-LY-049 See photo for GPS data		GPS Location MVP-LY-049 See photo for GPS data			
Field Station# +0		Field Station# +0			
Pic 5 Desc. Welders working on pipe. Looking SW		Pic 6 Desc. Dumpsters for FAB yard. Looking SE

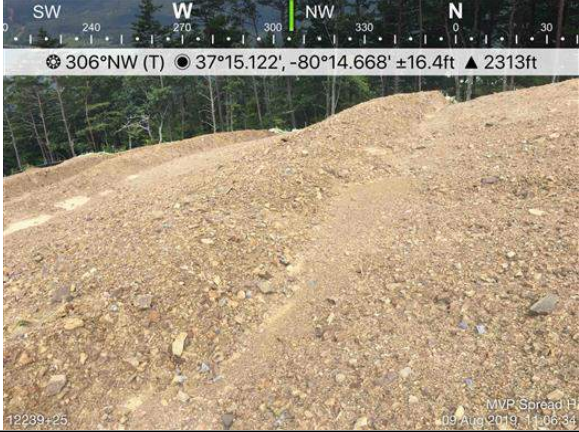
GPS Location	See picture watermark	GPS Location	See picture watermark		
Field Station#	12239+25	Field Station#	12297+50		
Pic 1 Desc.	Waterbar installed and functional	Pic 2 Desc.	Waterbar end treatment installed properly

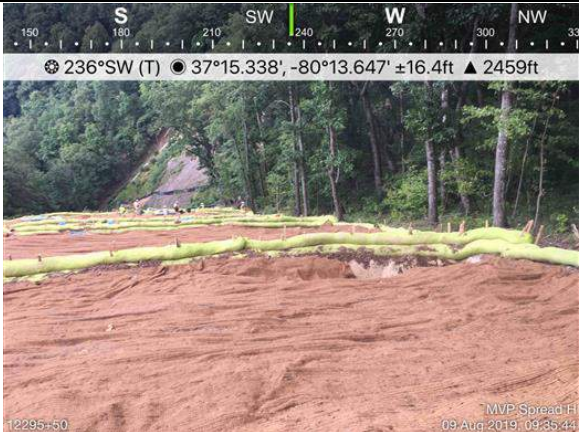
GPS Location	See picture watermark	GPS Location	See picture watermark		
Field Station#	12295+50	Field Station#	12291+00		
Pic 3 Desc.	3x CFS waterbar and stabilization matting	Pic 4 Desc.	SSF installed and appears functional

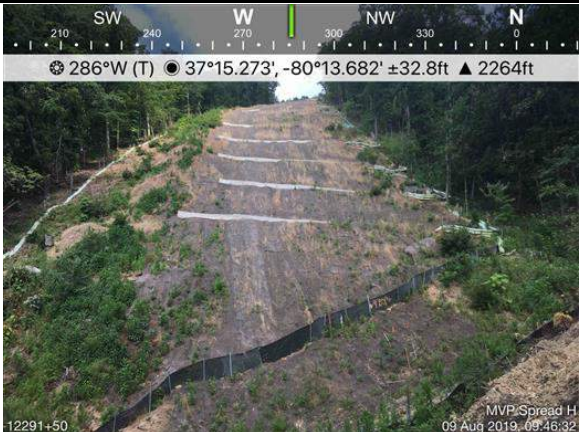
GPS Location	See picture watermark	GPS Location	N/A		
Field Station#	12290+00	Field Station#	12291+50		
Pic 5 Desc.	CIS "V" controls/stabilization functional.	Pic 6 Desc.	Repaired SSF at bottom GAS "V"

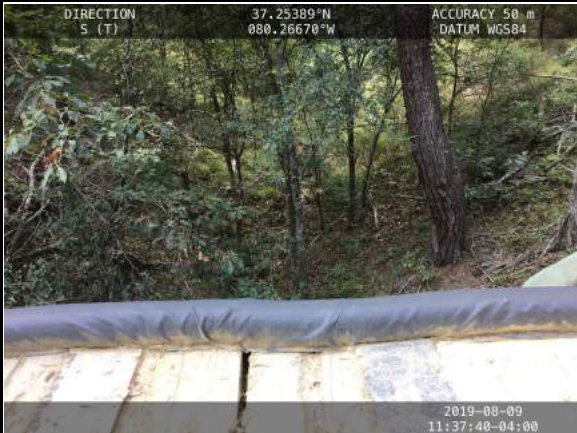
image here	
GPS Location	See photo		GPS Location	See photo	
Field Station#	12166+47		Field Station#	12210+00	
Pic 7 Desc.	Stream S-C24, facing south, downstream		Pic 8 Desc.	Operator was padding pipe GAS Bradshaw

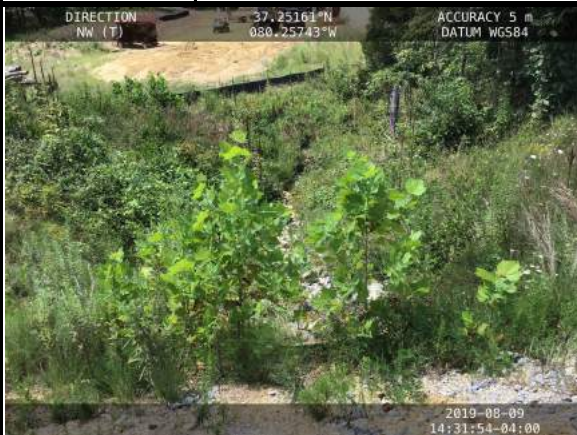
GPS Location	See photo		GPS Location	See photo	
Field Station#	12197+37		Field Station#	12192+50	
Pic 9 Desc.	Stream S-0011, facing northwest, dwnstream		Pic 10 Desc.	Stream S-C21, facing south, downstream

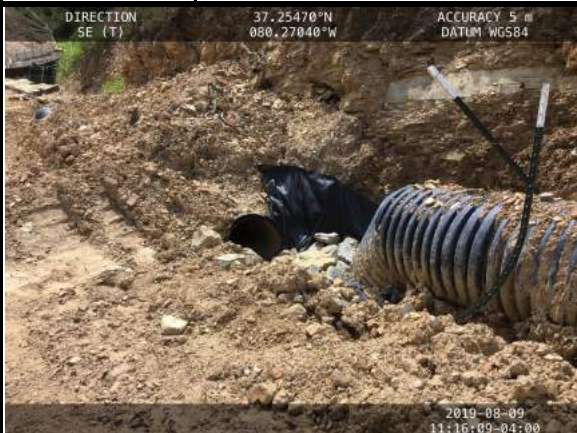
Insert image here			
GPS Location	See photo		GPS Location		
Field Station#	12156+00		Field Station#		
Pic 11 Desc.	Sump has been pushed in by equipment		Pic 12 Desc.

E&S BMPs	Compliance Level	Corrective Action	Corrective Time Frame	Date Repaired
Sump Pit	Communication	12156+00: repair damaged sumps	24 Hours	
Compost Filter Sock	Acceptable			
Silt Fence (Filter Fabric Fence)	Acceptable			
Silt Fence (Reinforced Filter Fabric Fence)	Acceptable			
Waterbar	Acceptable			
Waterbar End Treatment	Acceptable			
Sump Pit	Acceptable			
Equipment Bridge	Acceptable			
Housekeeping	Acceptable

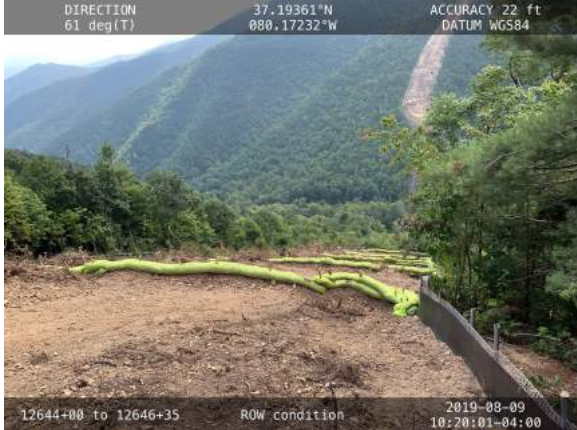
GPS Location	See photo for gps data.		GPS Location	See photo for gps data.	
Field Station#	12644+00		Field Station#	12661+50	
Pic 1 Desc.	Triple stacked 18" CFS ROW diversions		Pic 2 Desc.	Stream after sediment retrieval

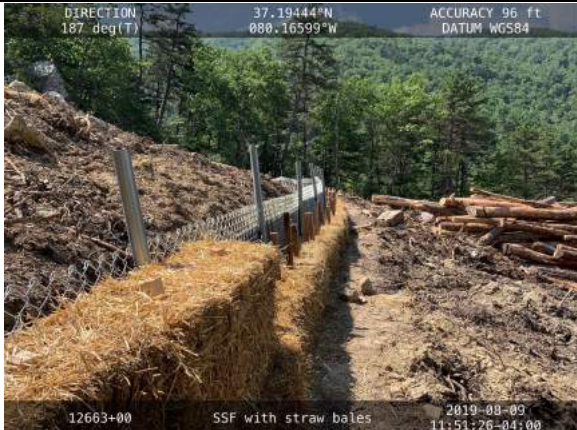
GPS Location	See photo for gps data.		GPS Location	See photo for gps data.	
Field Station#	12663+00		Field Station#	12663+00	
Pic 3 Desc.	SSF across ROW near end of disturbance.		Pic 4 Desc.	ROW condition, not grubbed or topsoiled

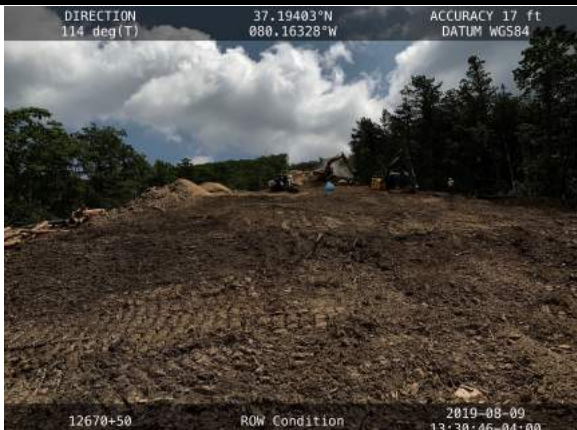
GPS Location	See photo for gps data.		GPS Location	See photo for gps data.	
Field Station#	12670+50		Field Station#	12702+00	
Pic 5 Desc.	Partially topsoiled, building water bars/sumps		Pic 6 Desc.	ROW condition, not grubbed

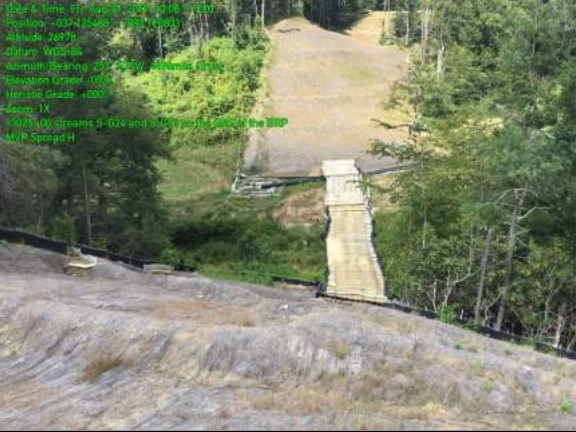
<p>Date & Time: Fri, Aug 09, 2019, 12:06:48 EDT Position: +33° 41' 25.48" N - 83° 11' 58.00" W Altitude: 2697 ft Datum: WGS-84 Azimuth/Bearing: 128° S 54E - 224.0000 (True) Elevation/Ground: 1603 ft Horizontal/Ground: 0021 Zoom: 1X 13021+00 Stream S-626 and S-627 near the WRP MVP Spread H</p>			
GPS Location	see pic for GPS location	GPS Location	see pic for GPS location		
Field Station#	13025+00	Field Station#	13045+00		
Pic 1 Desc.	No issues or impacts observed	Pic 2 Desc.	No issues or impacts observed

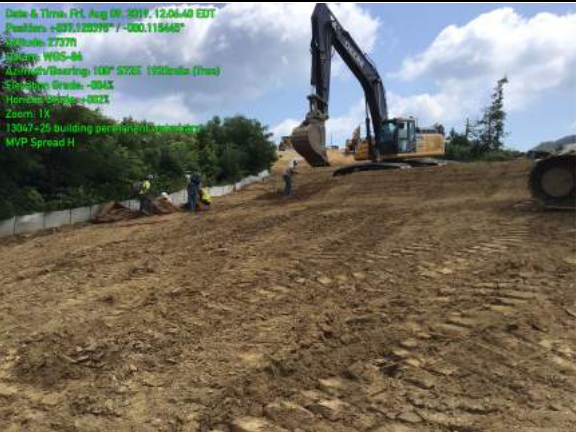
GPS Location	see pic for GPS location	GPS Location	see pic for GPS location		
Field Station#	13047+26	Field Station#	13060+00		
Pic 3 Desc.	Building permanent waterbars	Pic 4 Desc.	No issues or impacts observed

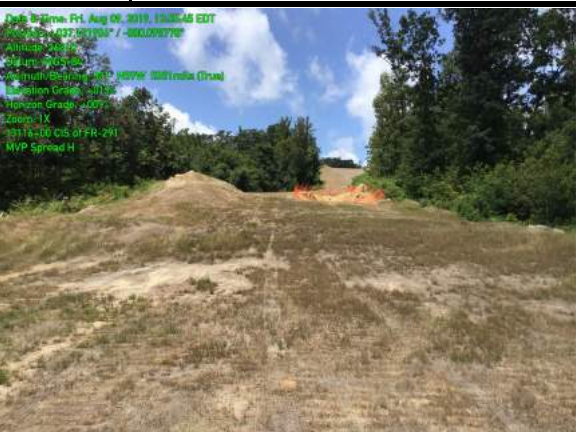
<p>Date & Time: Fri, Aug 09, 2019, 13:05:11 EDT Position: +33° 41' 17.04" N - 83° 09' 07.77" W Altitude: 2697 ft Datum: WGS-84 Azimuth/Bearing: 128° S 54E - 224.0000 (True) Elevation/Ground: 1603 ft Horizontal/Ground: 0021 Zoom: 1X 13011+00 C/S of FR-291 MVP Spread H</p>			
GPS Location	see pic for GPS location	GPS Location	see pic for GPS location		
Field Station#	13116+00	Field Station#	13011+00		
Pic 5 Desc.	No issues or impacts observed	Pic 6 Desc.	No issues or impacts observed

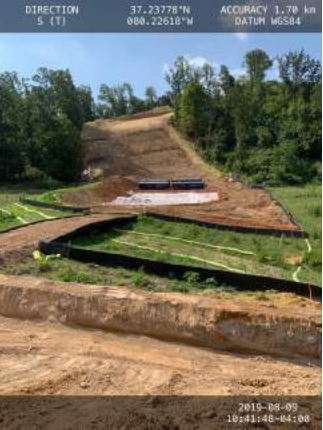
GPS Location	See picture for GPS data		GPS Location	See picture for GPS data	
Field Station#	12580+00		Field Station#	12579+60	
Pic 1 Desc.	ROW with unknown substance		Pic 2 Desc.	Water extended to edge of LOD

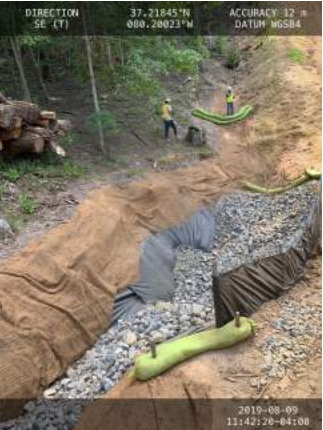
GPS Location	See picture for GPS data		GPS Location	See picture for GPS data	
Field Station#	12504+00		Field Station#	12514+57	
Pic 3 Desc.	CWD inlet		Pic 4 Desc.	Waterbars crossing ROW

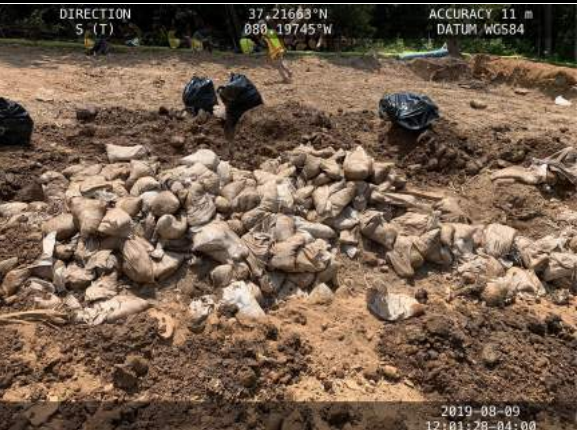
GPS Location	See picture for GPS data		GPS Location	See picture for GPS data	
Field Station#	12518+00		Field Station#	12519+41	
Pic 5 Desc.	Sand bags full of sediment from S-EF19		Pic 6 Desc.	Crew finishing up stream clean up

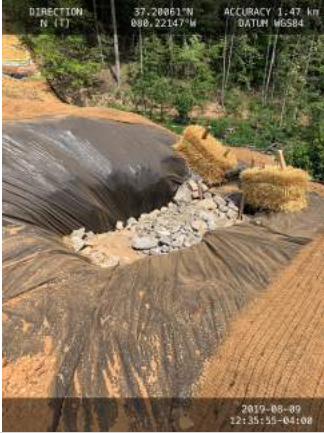
GPS Location	See picture for GPS data		GPS Location	See picture for GPS data	
Field Station#	12534+00		Field Station#	12535+00	
Pic 7 Desc.	ROW with fill slope drains		Pic 8 Desc.	Inlet on fill slope drains

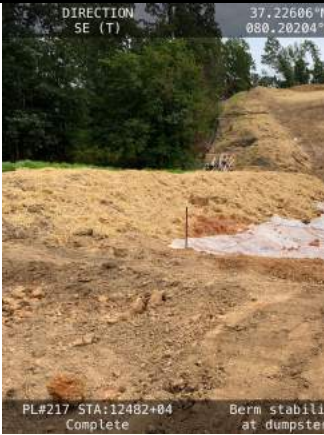
GPS Location	See picture for GPS data		GPS Location	See picture for GPS data	
Field Station#	12543+00		Field Station#	12482+04	
Pic 9 Desc.	Sump cleaned out		Pic 10 Desc.	Berm stabilized	
 		image here		 	
GPS Location	See picture for GPS data		GPS Location	See picture for GPS data	
Field Station#	12481+00		Field Station#	12480+00	
Pic 11 Desc.	End treatment installed		Pic 12 Desc.	End treatment installed

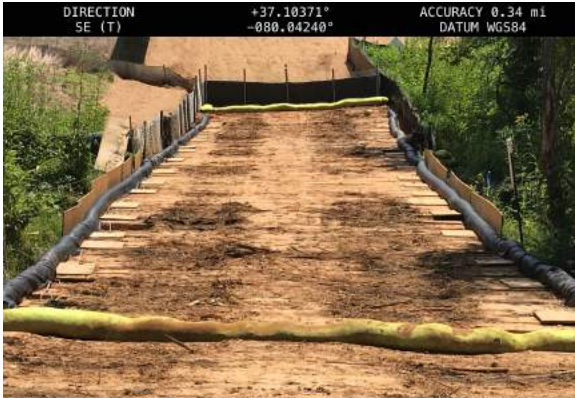
<p>DIRECTION SE (T) +37.10371° -080.04240° ACCURACY 0.34 mi DATUM WGS84</p> <p>13348+46_080919 S-RR08 condition of mat bridge 2019-08-09 13:07:25-04:00</p>			  <p>DIRECTION SE (T) +37.10250° -080.04144° ACCURACY 16 ft DATUM WGS84</p> <p>13352+23_080919 S-RR09 condition of mat bridge 2019-08-09 13:11:49-04:00</p>		
GPS Location	See photo for gps data		GPS Location	See photo for gps data	
Field Station#	13348+46		Field Station#	13352+23	
Pic 1 Desc.	S-RR08 condition of bridge. Looking SE		Pic 2 Desc.	S-RR09 condition of bridge. Looking SE

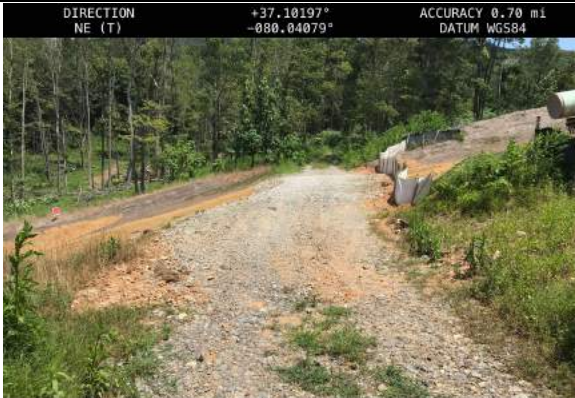
<p>DIRECTION NE (T) +37.10197° -080.04079° ACCURACY 0.70 mi DATUM WGS84</p> <p>13355+94_080919 Condition of gun club drive 2019-08-09 13:22:52-04:00</p>

GPS Location	See photo for gps data		GPS Location	See photo for gps data	
Field Station#	13355+94		Field Station#	13458+64	
Pic 3 Desc.	Condition of gun club drive. Looking NE		Pic 4 Desc.	S-RR11 condition of bridge. Looking SE.

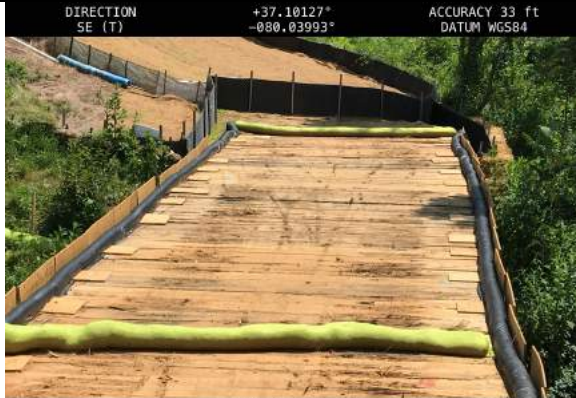
<p>DIRECTION SE (T) +37.10127° -080.03993° ACCURACY 33 ft DATUM WGS84</p> <p>13358+64_080919 S-RR11 condition of mat bridge 2019-08-09 13:27:42-04:00</p>

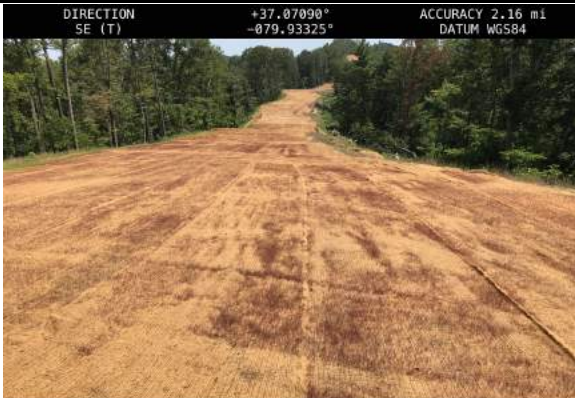
<p>DIRECTION SE (T) +37.07090° -079.93325° ACCURACY 2.16 mi DATUM WGS84</p> <p>13372+50_080919 Condition of stabilized ROW 2019-08-09 14:30:56-04:00</p>

<p>DIRECTION E (T) +37.09302° -080.02813° ACCURACY 33 ft DATUM WGS84</p> <p>13413+05_080919 S-IJ1 condition of mat bridge 2019-08-09 15:38:38-04:00</p>		
GPS Location	See photo for gps data		GPS Location	See photo for gps data	
Field Station#	13372+50		Field Station#	13413+05	
Pic 5 Desc.	Condition of stabilized ROW. Looking SE		Pic 6 Desc.	S-IJ1 condition of bridge. Looking E.

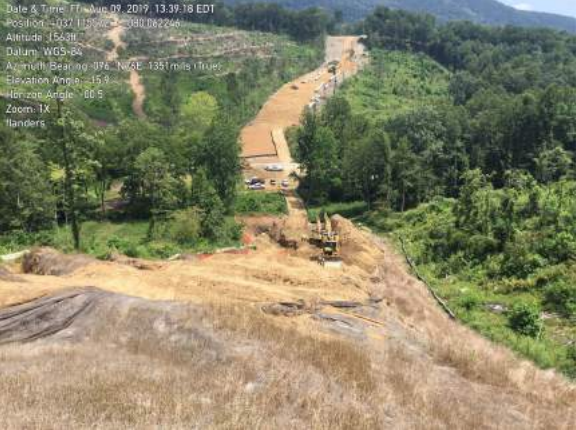
GPS Location	See photo for coordinates.		GPS Location	See photo for coordinates.	
Field Station#	13252+00		Field Station#	13218+55	
Pic 1 Desc.	Tie-in activities, ROW stable above.		Pic 2 Desc.	Waterbars and end treatments acceptable.

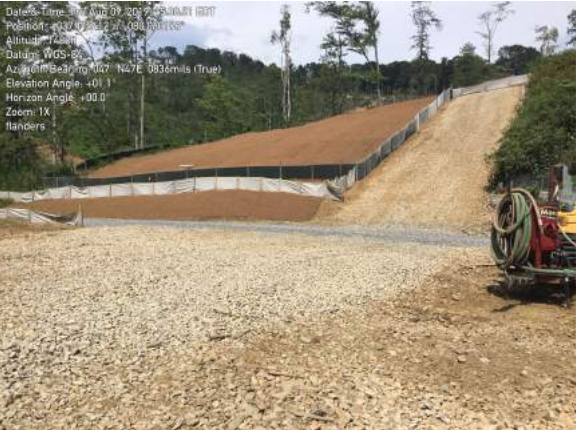
GPS Location	See photo for coordinates.		GPS Location	See photo for coordinates.	
Field Station#	13262+58		Field Station#	13275+00	
Pic 3 Desc.	Flanders Rd, road repaired, ROW stabilized.		Pic 4 Desc.	Temporary vegetation moderate.

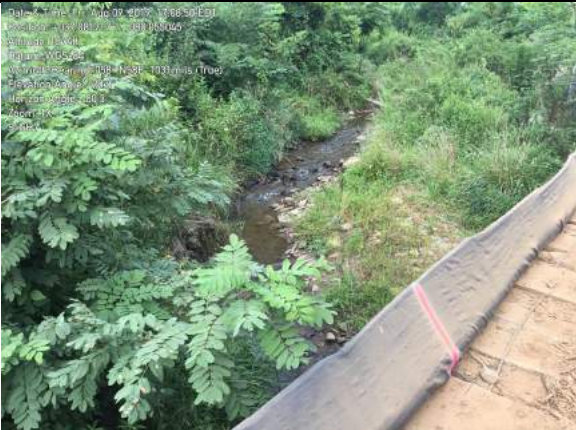
GPS Location	See photo for coordinates.		GPS Location	See photo for coordinates.	
Field Station#	13288+99		Field Station#	13309+09	
Pic 5 Desc.	Travel lane not stabilized.		Pic 6 Desc.	S-GH7, no environmental issues noted.
