Visual Site Inspection Report

Project Name	H-600 Pipeline Spread H	AFE	124300138	Spread	H-600 Pipeline Spread	
Contractor	Precision			Report #	100312	
Inspector	Pat Davis			Date/Time	9/15/2019 8:53 AM	
Permit #	TBD	Inspection Type	VA SWPP	Station Begin	+0	
State	VA	Inspection Area	Partial	Station End	+0	
County	Roanoke	Ground	Wet	Temperature (°F)	81.00	
Municipality	N/A	Weather	Sunny	Rain Gauge (in)	0.30	
				Rain Accumulation Time (days)	0.00

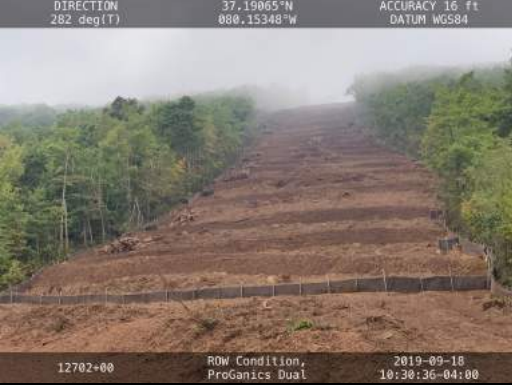
GPS Location	See photo for gps data.		GPS Location	See photo for gps data.	
Field Station#	12703+00		Field Station#	12702+00	
Pic 5 Desc.	Photo shows the ROW condition from about 12703+00 to 12710+00. ProGanics Dual.		Pic 6 Desc.	Photo shows the ROW condition from about 12697+00 to 12702+00. ProGanics Dual.

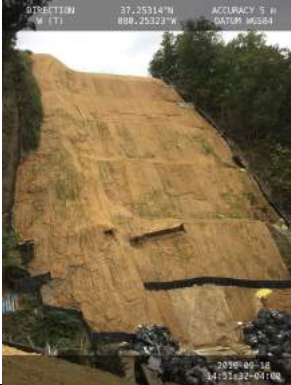
GPS Location	See photo		GPS Location	See photo	
Field Station#	12121+33		Field Station#	12210+00	
Pic 7 Desc.	Stream S-C33, facing west		Pic 8 Desc.	Vegetation is slowly developing on the recently stabilized slope on the coming in side of the ravine between Bradshaw Rd & Reese Mt.

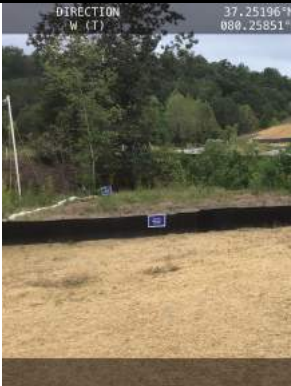
GPS Location	See photo		GPS Location	See photo	
Field Station#	12196+25		Field Station#	12193+50	
Pic 9 Desc.	Stream S-OO11, facing east		Pic 10 Desc.	Buffer zone and bridge of stream S-C21, Bradshaw Creek, facing west.

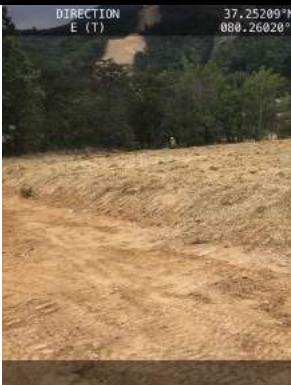
GPS Location	See photo		GPS Location	See photo	
Field Station#	12189+00		Field Station#	12189+00	
Pic 11 Desc.	Another waterbar was built per DEQ/MBP action item immediately to the going away side of where AR 274 meets the ROW.		Pic 12 Desc.	ROW was temporarily stabilized per DEQ/MBP action item between AR 274 and the top of the road bank of Bradshaw Road.
