Visual Site Inspection Report

Project Name	H-600 Pipeline Spread H	AFE	124300138	Spread	H-600 Pipeline Spread
Contractor	Precision			Report #	100169
Inspector	Tammy Kruizenga			Date/Time	9/3/2019 10:12 AM
Permit #	TBD	Inspection Type	VA SWPP	Station Begin	12001+00
State	VA	Inspection Area	Partial	Station End	12129+17
County	Montgomery	Ground	Dry	Temperature (°F)	85.00
Municipality	N/A	Weather	Sunny	Rain Gauge (in)	0.00
				Rain Accumulation Time (days)	1.00

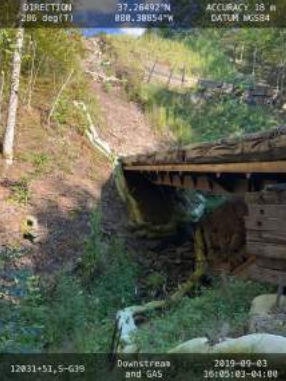
GPS Location	See photo GPS for location		GPS Location	See photo GPS for location	
Field Station#	12031+51		Field Station#	12034+00	
Pic 1 Desc.	Downstream of S-G39 and GAS		Pic 2 Desc.	CIS, Bridge S-G40, GAS

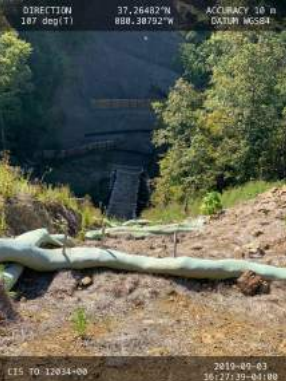
GPS Location	See photo GPS for location		GPS Location	See photo GPS for location	
Field Station#	12034+00		Field Station#	12034+00	
Pic 3 Desc.	GAS, Bridge S-G39, CIS		Pic 4 Desc.	CIS to S-G39

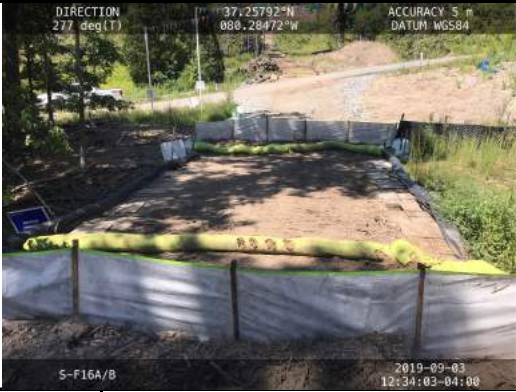
GPS Location	See photo GPS for location		GPS Location	See photo GPS for location	
Field Station#	12112+13		Field Station#	12098+64	
Pic 5 Desc.	S-F16A/B Bridge		Pic 6 Desc.	Timber transferred off ROW per land owner request on VA-MO-062.

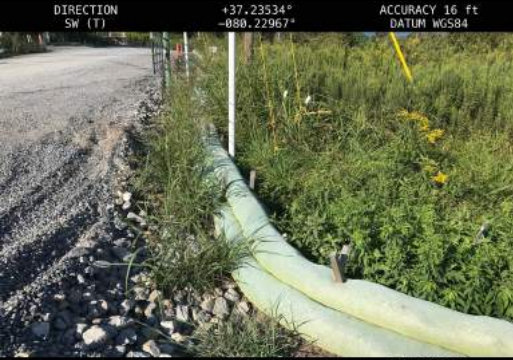
<p>DIRECTION SW (T) +37.23534° -080.22967° ACCURACY 16 ft DATUM WGS84</p> <p>MVP-PY-006_080319 Condition of CFS along drive 2019-09-03 09:14:35-04:00</p>			
GPS Location	MVP-PY-006 See photo for gps data		GPS Location	MVP-PY-006 See photo for gps data	
Field Station#	+0		Field Station#	+0	
Pic 1 Desc.	Condition of containment under light plant. Looking SW.		Pic 2 Desc.	Condition of CFS along west drive. Looking SW.

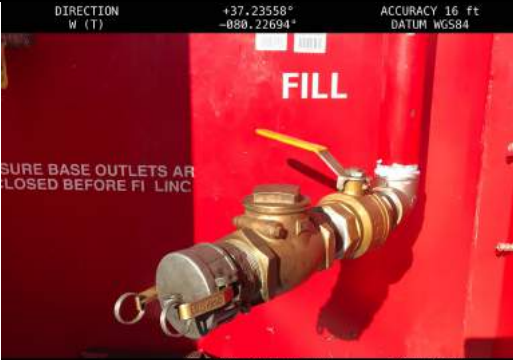
<p>DIRECTION W (T) +37.23558° -080.22694° ACCURACY 16 ft DATUM WGS84</p> <p>MVP-PY-006_080319 Off Road Fuel unit no leaky fittings 2019-09-03 09:20:31-04:00</p>

GPS Location	MVP-PY-006 See photo for gps data		GPS Location	MVP-PY-006 See photo for gps data	
Field Station#	+0		Field Station#	+0	
Pic 3 Desc.	Buffer and signage at feature. Looking NE.		Pic 4 Desc.	Off Road Fuel unit no leaky fittings. Looking W.

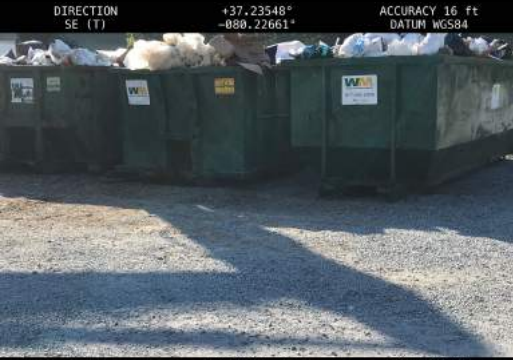
<p>DIRECTION SE (T) +37.23548° -080.22661° ACCURACY 16 ft DATUM WGS84</p> <p>MVP-PY-006_080319 No loose trash around dumpsters 2019-09-03 09:21:33-04:00</p>			
GPS Location	MVP-PY-006 See photo for gps data		GPS Location	MVP-PY-006 See photo for gps data	
Field Station#	+0		Field Station#	+0	
Pic 5 Desc.	Blue Bulk Fuel tank no leaky fittings. Looking SW.		Pic 6 Desc.	No loose trash around dumpsters. Looking SE.

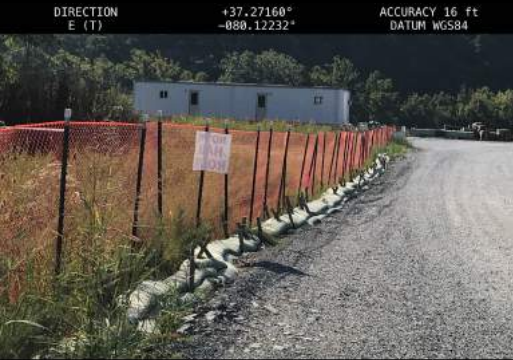
GPS Location	MVP-LY-049 See photo for gps data	GPS Location	MVP-LY-049 See photo for gps data		
Field Station#	+0	Field Station#	+0		
Pic 1 Desc.	Condition of rock entrance on center drive. Looking S.	Pic 2 Desc.	Condition of CFS & safety fence along center drive. Looking S.

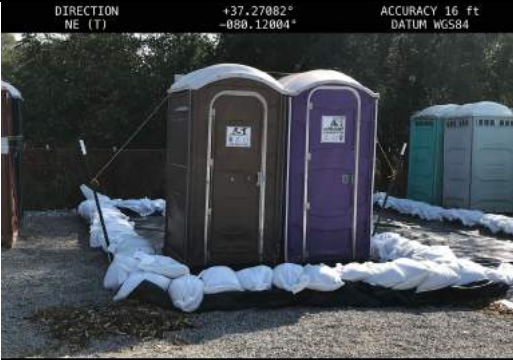
GPS Location	MVP-LY-049 See photo for gps data	GPS Location	MVP-LY-049 See photo for gps data		
Field Station#	+0	Field Station#	+0		
Pic 3 Desc.	Condition of trays and containment under porta toilets north boundary. Looking N.	Pic 4 Desc.	Condition of trays and containment under newly added porta toilets in FAB Area. Looking SE.

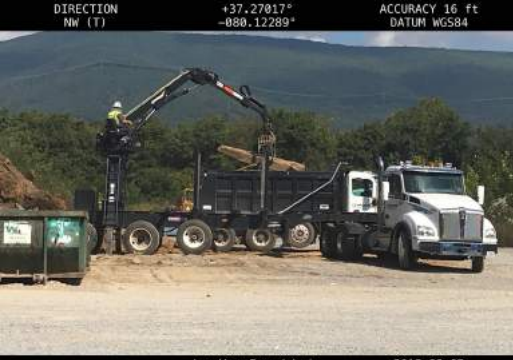
GPS Location	MVP-LY-049 See photo for gps data	GPS Location	MVP-LY-049 See photo for gps data		
Field Station#	+0	Field Station#	+0		
Pic 5 Desc.	No loose trash around West dumpster. Looking NW.	Pic 6 Desc.	Crew loading ROW debris onto dump trucks and dumpster from pile. Looking NW.

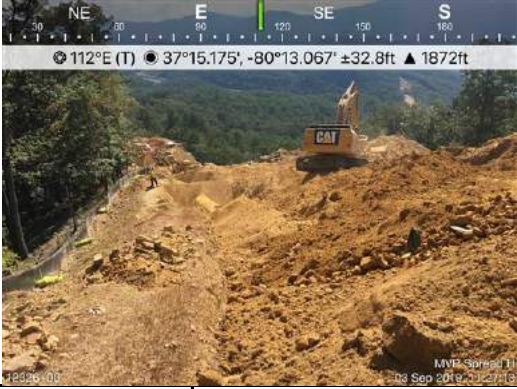
GPS Location	See picture watermark		GPS Location	See picture watermark	
Field Station#	12326+00		Field Station#	12234+50	
Pic 7 Desc.	Pipe backfilling.		Pic 8 Desc.	"Fluid-fill" material backfilling at switchback tie-in.

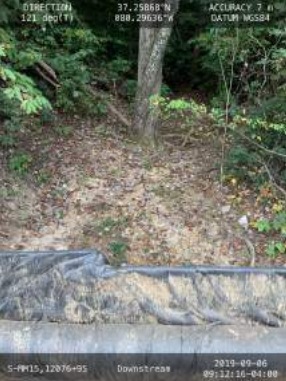
GPS Location	See photo GPS for location		GPS Location	See photo GPS for location	
Field Station#	12076+95		Field Station#	12076+95	
Pic 1 Desc.	S-MM-15, downstream. Stream is completely dry.		Pic 2 Desc.	Bridge S-MM15i stable has been well maintained.

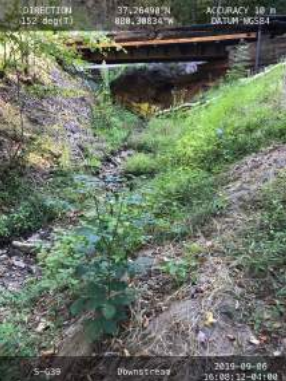
GPS Location	See photo GPS for location		GPS Location	See photo GPS for location	
Field Station#	12031+51		Field Station#	12030+51	
Pic 3 Desc.	Stream is dry, Bridge is in acceptable condition. ECDs are in place.		Pic 4 Desc.	SSF fabric replaced on fence. Rocks cleaned out from behind mat walls.

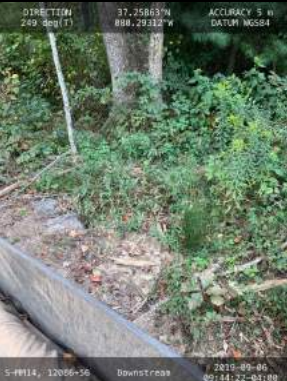
GPS Location	See photo GPS for location		GPS Location	See photo GPS for location	
Field Station#	12097+44		Field Station#	12086+56	
Pic 5 Desc.	Sump added per DEQ red-line recommendation. Located at the CIS, north side, stream buffer of S-MM13.		Pic 6 Desc.	Stream is dry at S-MM14.

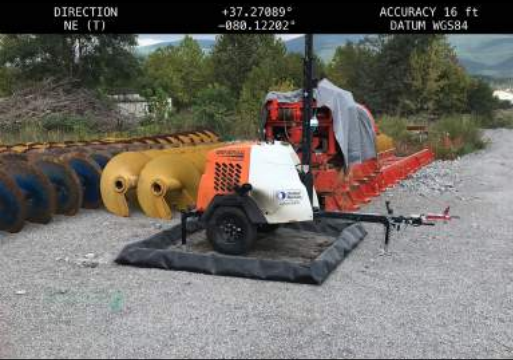
GPS Location	MVP-PY-049 See photo for gps data	GPS Location	MVP-PY-049 See photo for gps data		
Field Station#	+0	Field Station#	+0		
Pic 1 Desc.	Condition of north rock entrance. Looking SW	Pic 2 Desc.	Condition of containment under light plant. Looking NE.

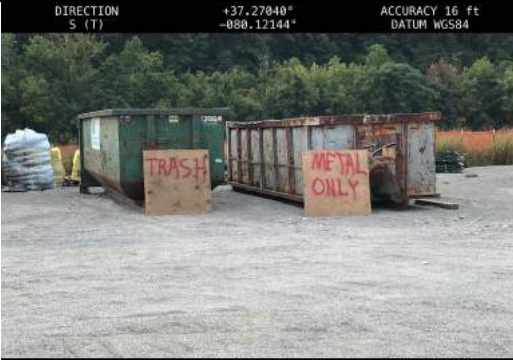
GPS Location	MVP-PY-049 See photo for gps data	GPS Location	MVP-PY-049 See photo for gps data		
Field Station#	+0	Field Station#	+0		
Pic 3 Desc.	Compost filter sock around sand pile. Looking N.	Pic 4 Desc.	No loose trash around the FAB Area dumpsters. Looking S.

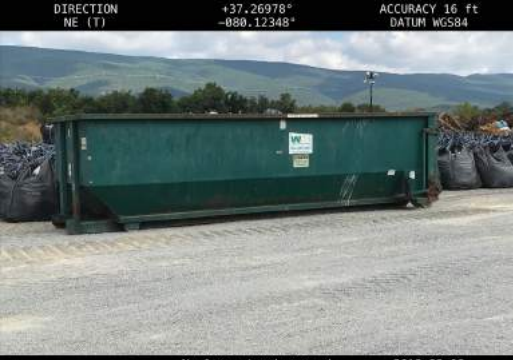
GPS Location	MVP-PY-049 See photo for gps data	GPS Location	MVP-PY-049 See photo for gps data		
Field Station#	+0	Field Station#	+0		
Pic 5 Desc.	Condition of compost filter sock and safety fence along South boundary. Looking E.	Pic 6 Desc.	No loose trash around West dumpster. Looking NE.

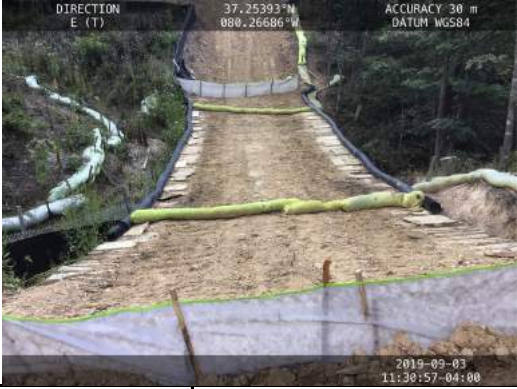
GPS Location	See photo		GPS Location	See photo	
Field Station#	12166+47		Field Station#	12192+50	
Pic 7 Desc.	Stream S-C24, facing east		Pic 8 Desc.	Stream S-C21, facing south

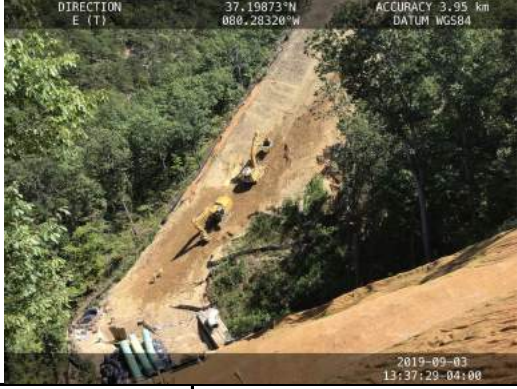
GPS Location	See photo		GPS Location	See photo	
Field Station#	12213+00		Field Station#	12125+55	
Pic 9 Desc.	Operators were relaying fill uphill of the ravine between Bradshaw Road and Reese Mountain in order to start ditching.		Pic 10 Desc.	Side treatment was pushed back up on top of the bridge and secured.

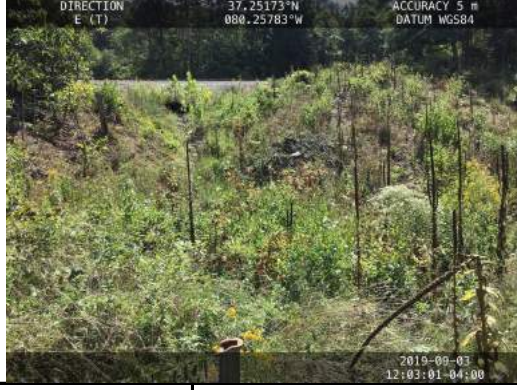
GPS Location	See photo		GPS Location	See photo	
Field Station#	12196+25		Field Station#	12233+12	
Pic 11 Desc.	Stream S-0011, facing east		Pic 12 Desc.	Flowable fill was poured in the open ditch at this road crossing near the switchback on Reese Mountain Road.

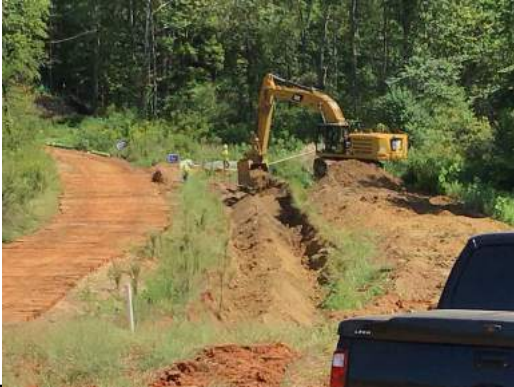
GPS Location	0000	GPS Location	0000		
Field Station#	13658+33	Field Station#	13643+66		
Pic 3 Desc.	Open ditch being backfilled		Pic 4 Desc.	Pump in secondary containment	
Insert image here			Insert image here		
GPS Location		GPS Location			
Field Station#		Field Station#			
Pic 5 Desc.			Pic 6 Desc.

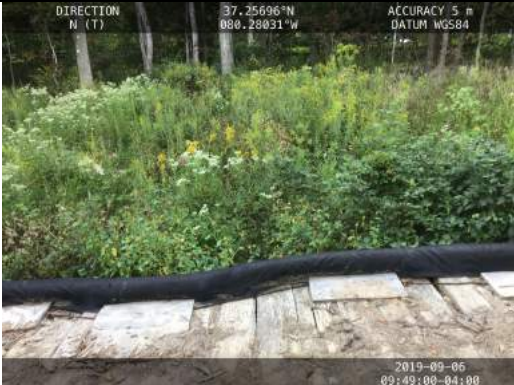
GPS Location	See photo		GPS Location	See photo	
Field Station#	12125+65		Field Station#	12132+73	
Pic 3 Desc.	Stream S-MM31, facing north		Pic 4 Desc.	Stream S-C29, facing east

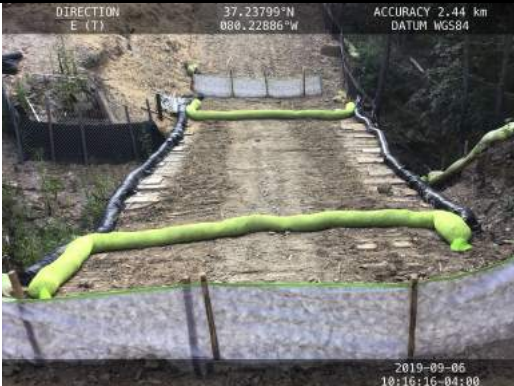
GPS Location	See photo		GPS Location	See photo	
Field Station#	12163+05		Field Station#	12166+47	
Pic 5 Desc.	Stream S-C25, facing east		Pic 6 Desc.	Stream S-C24, facing east

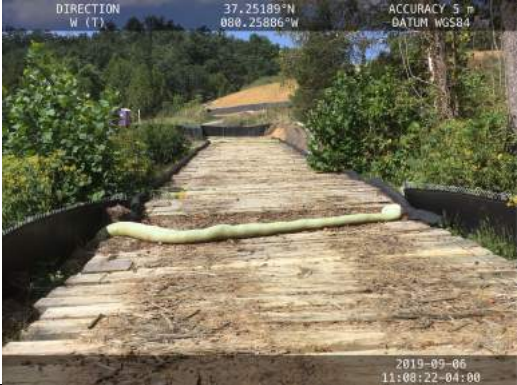
GPS Location	See photo	GPS Location	See photo		
Field Station#	12192+50	Field Station#	12197+37		
Pic 7 Desc.	Stream S-C21, Bradshaw Creek, facing west	Pic 8 Desc.	Stream S-OO11, facing northwest

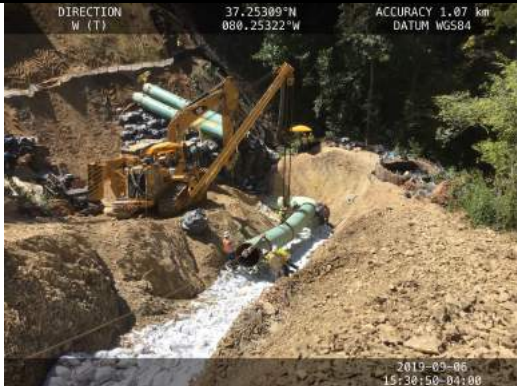
<p>Insert image here</p>	
GPS Location	See photo	GPS Location	See photo		
Field Station#	12211+50	Field Station#	12158+59		
Pic 9 Desc.	A fitting was welded onto the end of the existing pipe coming out of the GAS of the ravine between Bradshaw Rd. and Reese Mt.	Pic 10 Desc.	Laborers cleaned obstructions out of this waterbar with shovels.
