Visual Site Inspection Report

Project Name	H-600 Pipeline Spread H	AFE	124300138	Spread	H-600 Pipeline Spread
Contractor	Precision			Report #	100019
Inspector	Tammy Kruizenga			Date/Time	9/30/2019 6:43 AM
Permit #	TBD	Inspection Type	VA SWPP	Station Begin	12001+00
State	VA	Inspection Area	Partial	Station End	12119+17
County	Montgomery	Ground	Dusty	Temperature (°F)	86.00
Municipality	N/A	Weather	Cloudy	Rain Gauge (in)	0.00
				Rain Accumulation Time (days)	1.00

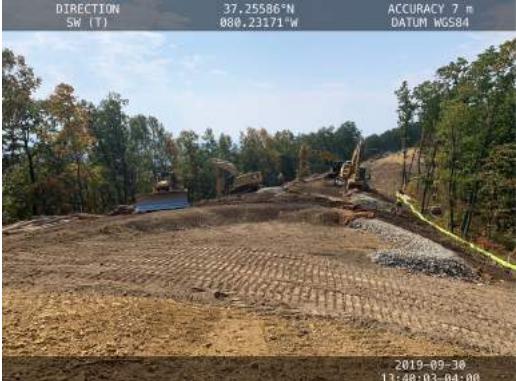
GPS Location	see picture for GPS data		GPS Location	See picture for GPS data	
Field Station#	12278+00		Field Station#	12443+07	
Pic 3 Desc.	Crew putting topsoil back with final grade		Pic 4 Desc.	Stabilized hill side on CIS of Lafayette road.

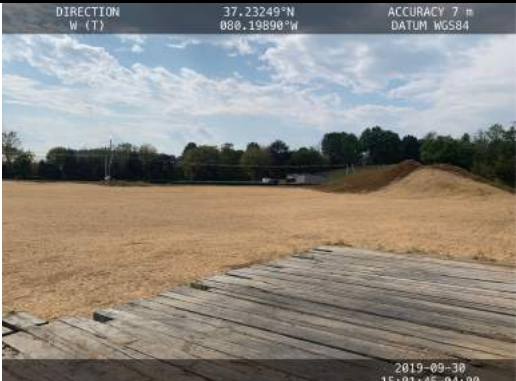
GPS Location	see picture for GPS data		GPS Location	See picture for GPS data	
Field Station#	12445+37		Field Station#	12410+70	
Pic 5 Desc.	Stabilized ATWS-727		Pic 6 Desc.	Clearwater crossing outlet

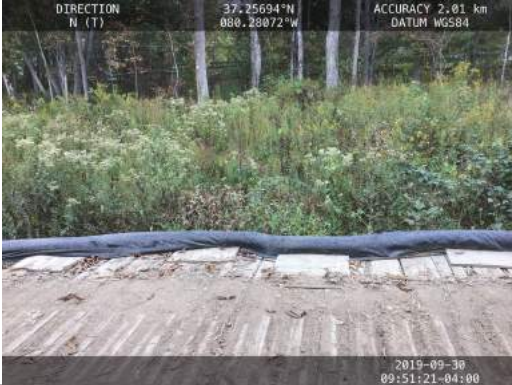
GPS Location	See photo		GPS Location	See photo	
Field Station#	12125+65		Field Station#	12132+73	
Pic 3 Desc.	Stream S-MM31, facing north, upstream		Pic 4 Desc.	Stream S-C29, facing east

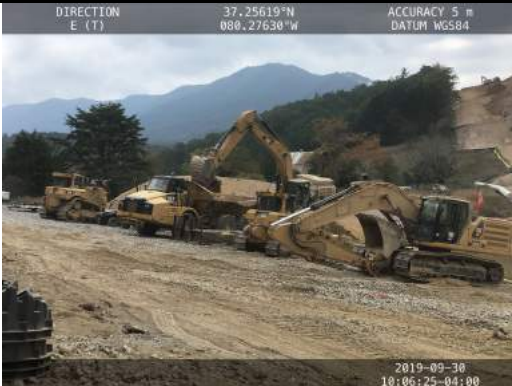
GPS Location	See photo		GPS Location	See photo	
Field Station#	12139+00		Field Station#	12146+00	
Pic 5 Desc.	Justin Jackson's crew began hauling this stockpile of subsoil back up the ROW as they restore rough grade between AR 272 & 273.		Pic 6 Desc.	An operator was moving a log pile in order to restore grade between AR 272 & 273.

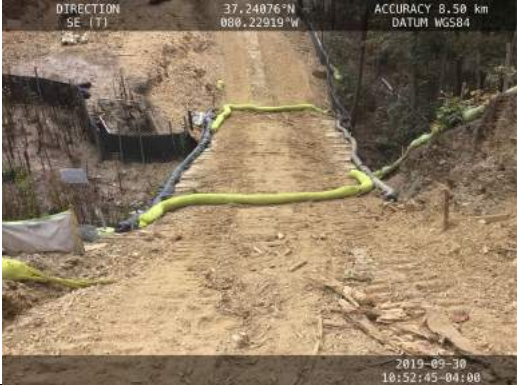
GPS Location	See photo		GPS Location	See photo	
Field Station#	12163+05		Field Station#	12166+47	
Pic 7 Desc.	Stream S-C25, facing southeast		Pic 8 Desc.	Stream S-C24, facing northwest

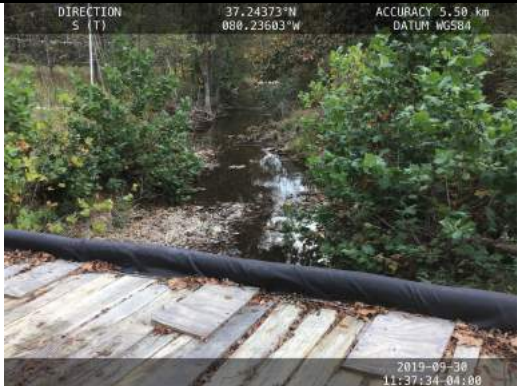
GPS Location	See photo		GPS Location	See photo	
Field Station#	12192+50		Field Station#	12197+37	
Pic 9 Desc.	Stream S-C21, facing south		Pic 10 Desc.	Stream S-OO11, facing northwest, downstream

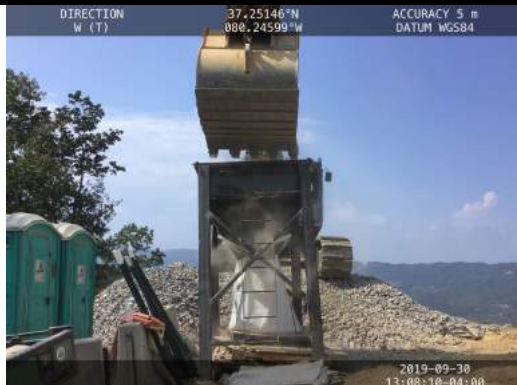
GPS Location	See photo		GPS Location	See photo	
Field Station#	12234+50		Field Station#	12211+25	
Pic 11 Desc.	Zane Hudson's operator was using a hopper to load super sacks with rock for the permanent waterbars.		Pic 12 Desc.	Triple stacked 18" CFS was installed above and below the new permanent waterbar in the ravine between Bradshaw Rd and Reese Mt.

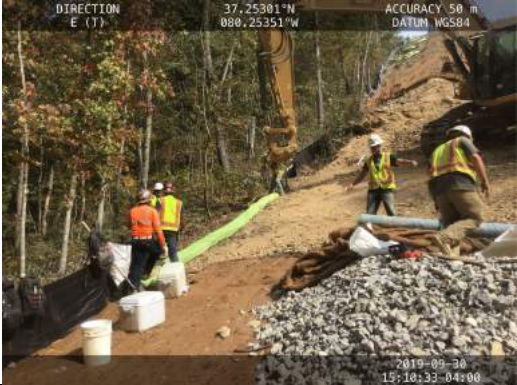
GPS Location	See photo	GPS Location			
Field Station#	12211+75	Field Station#			
Pic 13 Desc.	12" CFS was installed along the perimeter after the SSF was removed and the edge of LOD blended.	Pic 14 Desc.			
Insert image here		Insert image here			
GPS Location		GPS Location			
Field Station#		Field Station#			
Pic 15 Desc.		Pic 16 Desc.			
Insert image here		Insert image here			
GPS Location		GPS Location			
Field Station#		Field Station#			
Pic 17 Desc.		Pic 18 Desc.

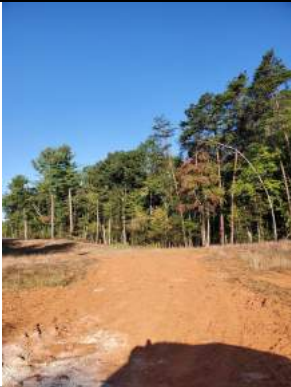
GPS Location	00000	GPS Location	00000		
Field Station#	13562+21	Field Station#	13497+20		
Pic 3 Desc.	Area of row needing to be stabilized and seeded, added to the punch list	Pic 4 Desc.	Vegetation growing in the anode bed location		
Insert image here			Insert image here		
GPS Location		GPS Location			
Field Station#		Field Station#			
Pic 5 Desc.		Pic 6 Desc.

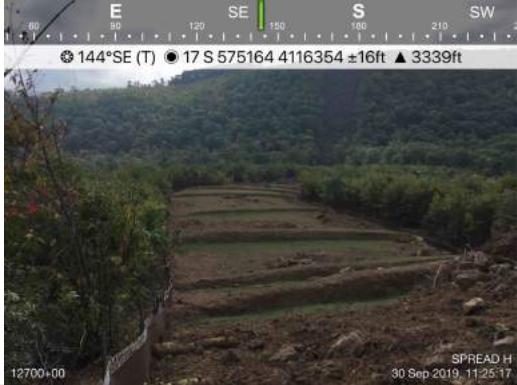
GPS Location	See Photo Above		GPS Location	See Photo Above	
Field Station#	12700+00		Field Station#	12700+00	
Pic 9 Desc.	Water bars with SSF at perimeter and erosion control blanket/hydraulically applied blanket installed		Pic 10 Desc.	Water bar sump/end treatments and SSF installed at perimeter

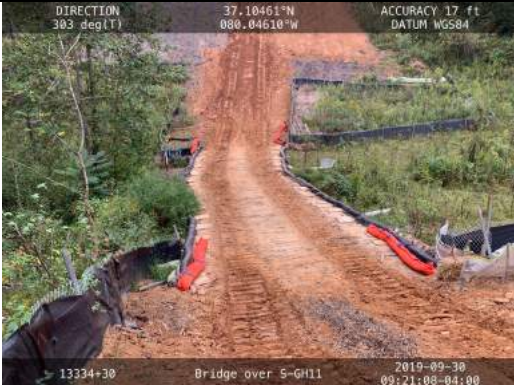
GPS Location	See photo for gps data.		GPS Location	See photo for gps data.	
Field Station#	13334+30		Field Station#	13319+00	
Pic 3 Desc.	Photo shows the bridge over stream S-GH11.		Pic 4 Desc.	Photo shows the contractor reworking the temporary stabilization between 13318+00 and 13319+00.

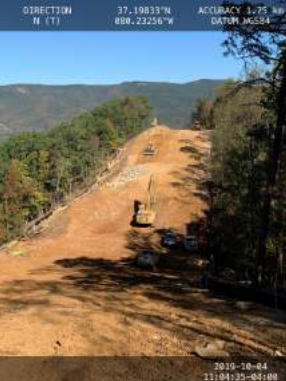
GPS Location	See picture for GPS data		GPS Location	See picture for GPS data	
Field Station#	12495+06		Field Station#	12543+60	
Pic 3 Desc.	Equipment working the row will preparing for stabilization		Pic 4 Desc.	Stump just off the ROW from previous clearing activities.

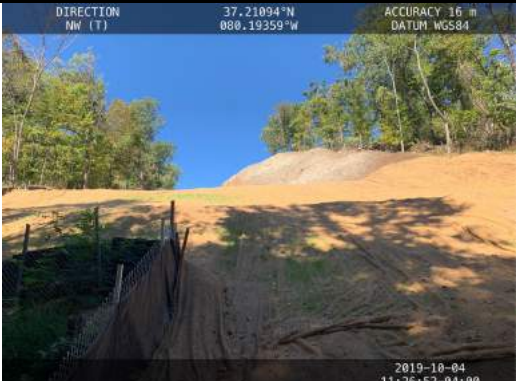
GPS Location	See picture for GPS data		GPS Location	See picture for GPS data	
Field Station#	12542+00		Field Station#	12451+63	
Pic 5 Desc.	Stabilized steep slop CIS of Yellow Finch Road.		Pic 6 Desc.	Arnolds seeding helicopter and trucks for hydro seeding.

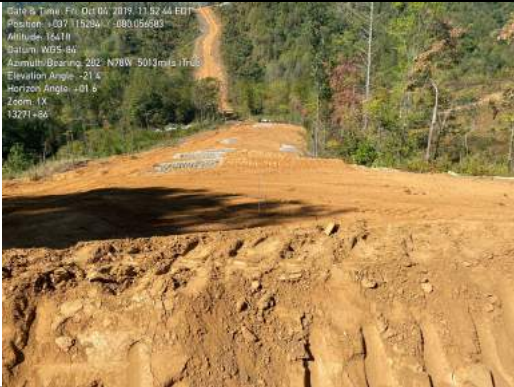
GPS Location	See photo for coordinates.		GPS Location	See photo for coordinates.	
Field Station#	13271+86		Field Station#	13235+00	
Pic 3 Desc.	ROW, permanent waterbars installed, perimeter ECDs and temporary waterbars functioning acceptably.		Pic 4 Desc.	ROW, permanent waterbars installed, curlexed, CFS perimeter controls and upgrades installed.

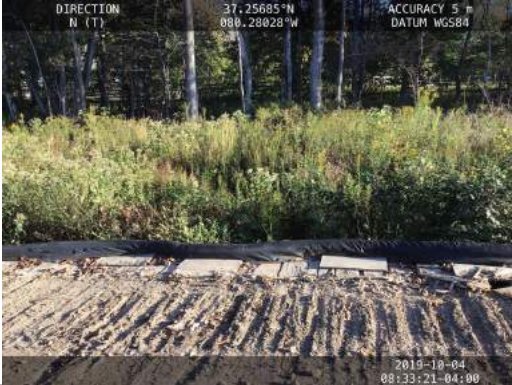
GPS Location	See photo		GPS Location	See photo	
Field Station#	12125+65		Field Station#	12132+73	
Pic 3 Desc.	Stream S-MM31, facing north, upstream		Pic 4 Desc.	Stream S-C29, facing southwest, downstream

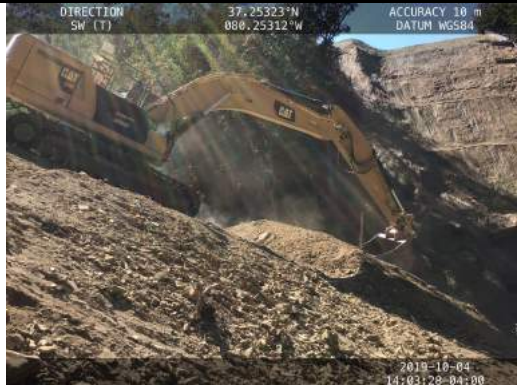
GPS Location	See photo		GPS Location	See photo	
Field Station#	12112+00		Field Station#	12211+75	
Pic 11 Desc.	An operator built the earthen berm part of the 3rd permanent waterbar coming up from the ravine between Bradshaw Rd and Reese Mt.		Pic 12 Desc.	P1 silt fence was installed below the work area to prevent rock and dirt clods from rolling down into the previous waterbars.

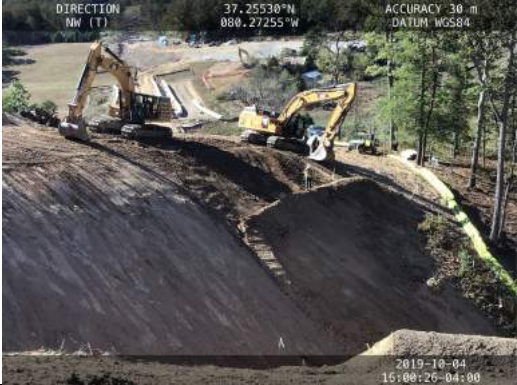
GPS Location	See photo		GPS Location	See photo	
Field Station#	12147+50		Field Station#	12150+00	
Pic 13 Desc.	The earthen berm for the permanent waterbar immediately to the CIS		Pic 14 Desc.	The environmental crew installed a CFS waterbar extension behind the new waterbars on the coming in side of AR 273.	
Insert image here			Insert image here		
GPS Location			GPS Location		
Field Station#			Field Station#		
Pic 15 Desc.			Pic 16 Desc.		
Insert image here			Insert image here		
GPS Location			GPS Location		
Field Station#			Field Station#		
Pic 17 Desc.			Pic 18 Desc.
