Visual Site Inspection Report

Project Name	H-600 Pipeline Spread I	AFE	124300139	Spread	H-600 Pipeline Spread I
Contractor	Precision			Report #	19021
Inspector	Charles Head			Date/Time	6/21/2019 9:26 AM
Permit #	TBD	Inspection Type	VA SWPP	Station Begin	13958+31
State	VA	Inspection Area	Partial	Station End	14454+22
County	Franklin	Ground	Damp	Temperature (°F)	75.00
Municipality	N/A	Weather	Sunny	Rain Gauge (in)	2.00
				Rain Accumulation Time (days)	4.00

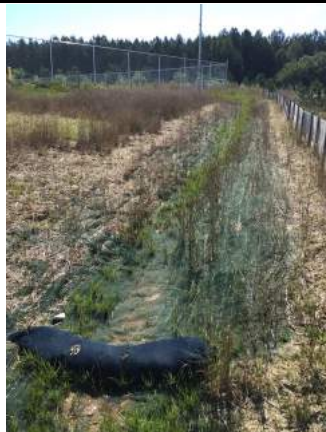
GPS Location	36.83	Field Station#	00+00	GPS Location	36.83	Field Station#	00+00
Description	Observing outlet and outlet protection.			Description	Observing rock check dam.

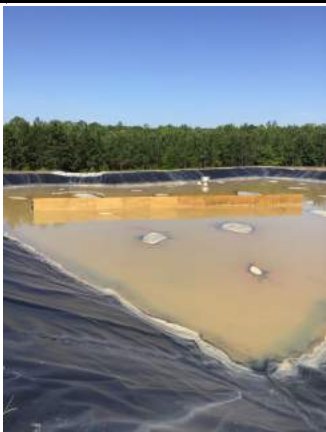
GPS Location	36.83	Field Station#	00+00	GPS Location	36.83	Field Station#	00+00
Description	Observing baffles in the storm water pond.			Description	Observing drainage channel performing as it should.
