Visual Site Inspection Report

Project Name	H-600 Pipeline Spread I	AFE	124300139	Spread	H-600 Pipeline Spread I
Contractor	Precision			Report #	19627
Inspector	Logan Box			Date/Time	7/3/2019 4:27 PM
Permit #	TBD	Inspection Type	VA SWPP	Station Begin	13670+00
State	VA	Inspection Area	Partial	Station End	13958+31
County	Franklin	Ground	Damp	Temperature (°F)	88.00
Municipality	N/A	Weather	Sunny	Rain Gauge (in)	0.00
				Rain Accumulation Time (days)	0.00

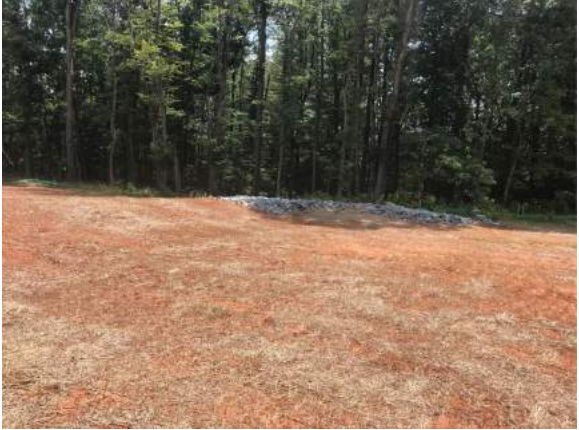
GPS Location	37.04	Field Station#	14132+50	GPS Location	37.04
Field Station#	14121+50	Description	Approximately 13132+50. CWD inlet. CWD appears to be installed and functioning correctly at time of inspection.

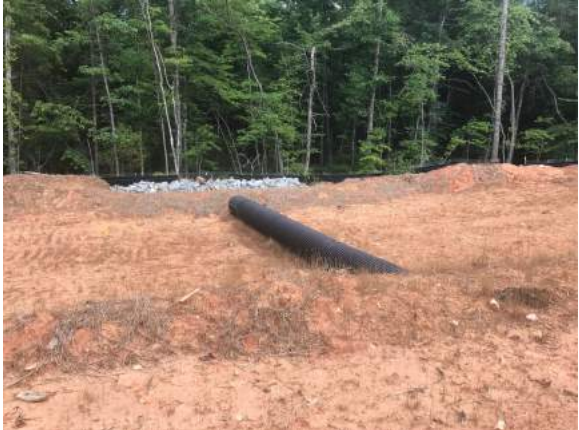
GPS Location	37.04	Field Station#	14105+26	GPS Location	37.04
Field Station#	14057+00	Description	Approximately 14105+26. Overview of stream crossing and equipment bridge at stream S-KL41. Resource buffer ECDs installed and appear to be functioning correctly at time of		
<p style="text-align: center;">Insert image here</p>			<p style="text-align: center;">Insert image here</p>		
GPS Location		Field Station#		GPS Location	
Description			Description
