Visual Site Inspection Report

Project Name	H-600 Pipeline Spread G	AFE	124300137	Spread	H-600 Pipeline Spread G
Contractor	Precision			Report #	7503
Inspector	Garrett Barclay			Date/Time	1/20/2020 7:21 AM
Permit #	TBD	Inspection Type	VA SWPP	Station Begin	+28
State	VA	Inspection Area	Partial	Station End	+28
County	Giles	Ground	Damp	Temperature (°F)	10.00
Municipality	N/A	Weather	Below Freezing Temp	Rain Gauge (in)	0.00
				Rain Accumulation Time (days)	1.00

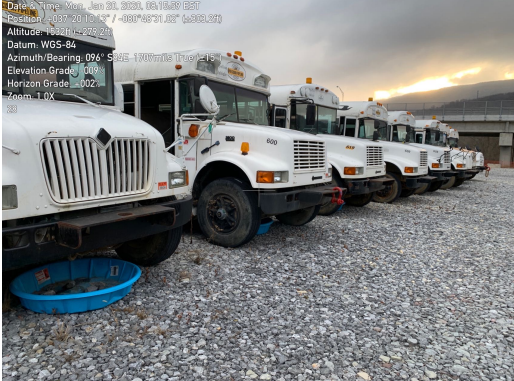
<p>Date & Time Mon, Jan 20, 2020, 05:21:22 EST Position: +38°43'23.37" / -80°46'56.87" (+383.37) Altitude: 1631 ft (+499.1m) Datum: WGS-84 Azimuth/Bearing: 094° S45E 130mils True (+13°) Elevation Grade: +00% Horizon Grade: +00% Tilt (Pitch): +00% Zoom: 1.0X 37 8439 F650</p>			
GPS Location	See picture above for GPS coordinates		GPS Location	See picture above for GPS coordinates	
Field Station#	+28		Field Station#	+28	
Pic 1 Desc.	ECD's and row conditions		Pic 2 Desc.	ECD's and row conditions

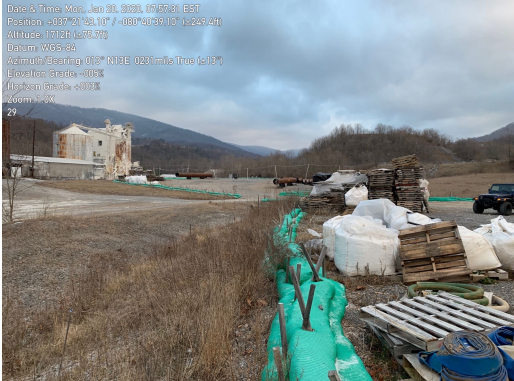
GPS Location	See picture above for GPS coordinates		GPS Location	See picture above for GPS coordinates	
Field Station#	+29		Field Station#	+28	
Pic 3 Desc.	ECD's and row conditions		Pic 4 Desc.	Crews removing contaminated material

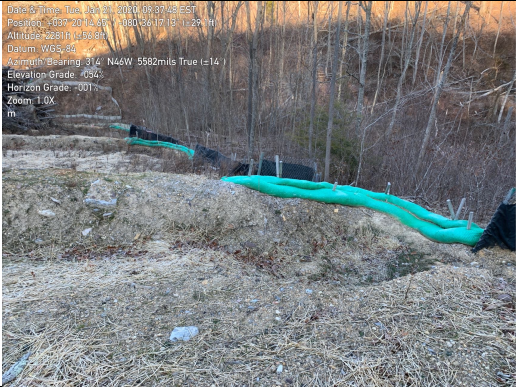
GPS Location	See picture above for GPS coordinates		GPS Location	See picture above for GPS coordinates	
Field Station#	10853+00		Field Station#	10862+00	
Pic 1 Desc.	ECD's and row conditions		Pic 2 Desc.	ECD's and row conditions

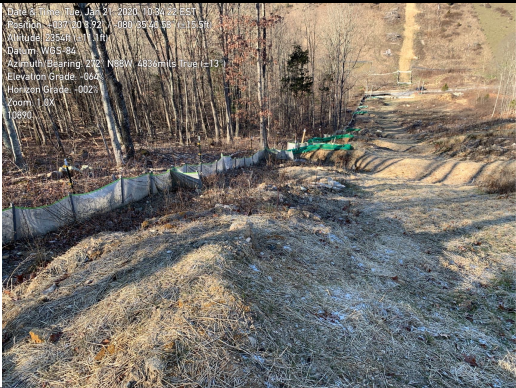
GPS Location	See picture above for GPS coordinates		GPS Location	See picture above for GPS coordinates	
Field Station#	10890+00		Field Station#	10927+00	
Pic 5 Desc.	ECD's and row conditions		Pic 6 Desc.	ECD's and row conditions

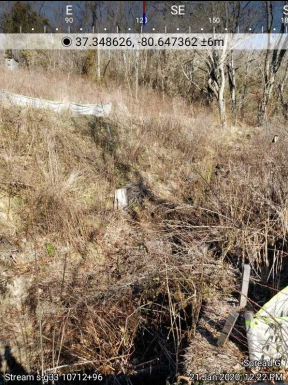
GPS Location	see photo		GPS Location	see photo	
Field Station#	10712+96		Field Station#	10704+00	
Pic 1 Desc.	stream s-g33, no flow.		Pic 2 Desc.	row conditions at 10704+00

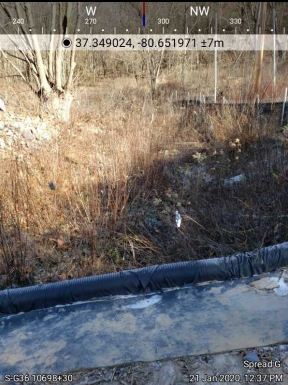
GPS Location	see photo		GPS Location	see photo	
Field Station#	10698+30		Field Station#	10698+30	
Pic 3 Desc.	stream s-g36, no flow.		Pic 4 Desc.	s-g36 downstream, no flow.

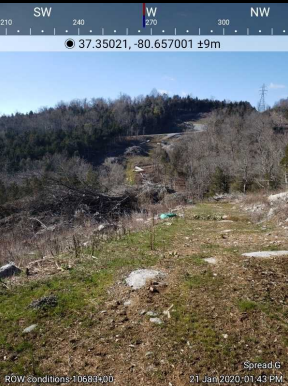
GPS Location	see photo		GPS Location	see photo	
Field Station#	10683+00		Field Station#	10678+00	
Pic 5 Desc.	row conditions at 10683+00		Pic 6 Desc.	stream. s-g30, no flow.

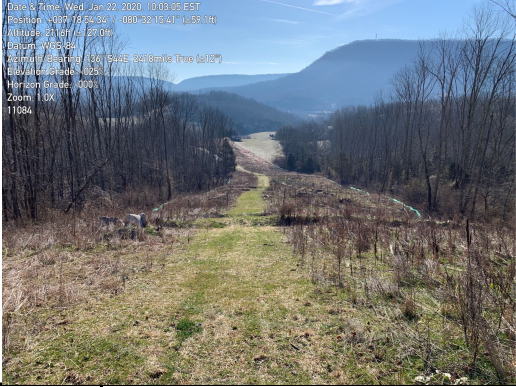
<p>Date & Time: Wed Jan 22, 2020, 10:22:57 EST Position: -037 18 51.831, -080 34 12.11, +103.8N Altitude: 2027ft (+62.0ft) Datum: WGS 84 Azimuth/Bearing: 100° S43E 5413mils True (+12°) Elevation Grade: -028° Horizon Grade: -001° Zoom: 1.0X 11112</p>		GPS Location	See picture above for GPS coordinates
Field Station#	11084+00	Field Station#	11112+00	GPS Location	See picture above for GPS coordinates
Pic 5 Desc.	ECD's and row conditions	Pic 6 Desc.	ECD's and row conditions	Field Station#	11112+00

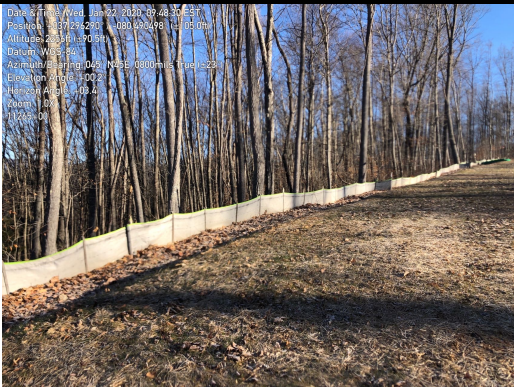
GPS Location	3	GPS Location	4		
Field Station#	11265+00	Field Station#	11286+00		
Pic 3 Desc.	P-1 silt fence perimeter controls functional.	Pic 4 Desc.	SSF perimeter controls functional and vegetation sufficient.		
<p><small>Date & Time: Wed, Jan 22, 2020, 10:33:44 EST Position: +037.203447° / -080.471028° (+10.0m) Altitude: 2054ft (+10.0m) Datum: WGS-84 Azimuth/Bearing: 048° N48E 085mils True (±14°) Elevation Angle: +03.3° Horizon Angle: +00.4° Zoom: 1.0X 11333+25</small></p>

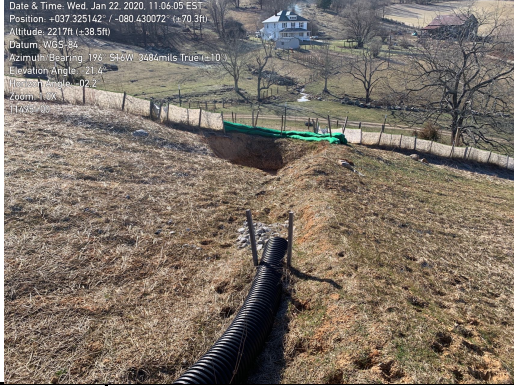
GPS Location	See photo for GPS location.		GPS Location	See photo for GPS location.	
Field Station#	11523+00		Field Station#	11495+00	
Pic 1 Desc.	ROW stabilized with minor vegetation growth.		Pic 2 Desc.	Slope drain, rock outlet, waterbar, sump pit and end treatment in place.	
<p>Date & Time: Wed Jan 22, 2020, 11:07:36 EST Position: +037.329175 / -080.430801 (+2226.0ft) Altitude: 2210ft (+65.0ft) Datum: WGS-84 Azimuth/Bearing: 281.177W 4996mils True (+12.1) Elevation Angle: -12.4 Horizon Angle: +03.0 Zoom: 1.0X 11489+00</p>

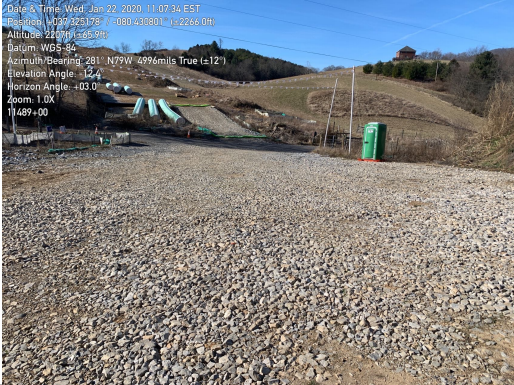
GPS Location	See photo for GPS location.		GPS Location	See photo for GPS location.	
Field Station#	11489+00		Field Station#	11487+00	
Pic 3 Desc.	RCE in place at Stevers Gap Road.		Pic 4 Desc.	Clean water diversion pipe and plunge pool in place.	
<p>Date & Time: Wed Jan 22, 2020, 11:24:11 EST Position: +037.322472 / -080.435204 (+15.4ft) Altitude: 2293ft (+11.3ft) Datum: WGS-84 Azimuth/Bearing: 032.132E 0569mils True (+12.1) Elevation Angle: -06.5 Horizon Angle: +07.2 Zoom: 1.0X 11475+00</p>

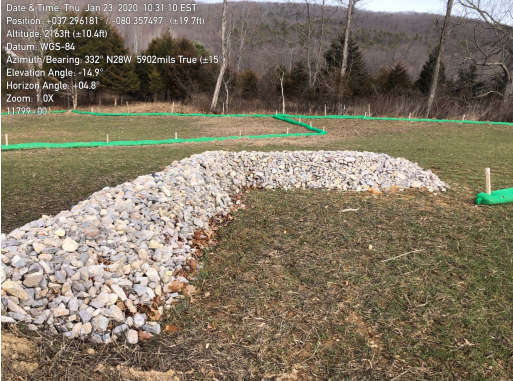
GPS Location	1	GPS Location	2		
Field Station#	11789+00	Field Station#	11799+00		
Pic 1 Desc.	RCE off Mt Tabor rd in good condition.		Pic 2 Desc.	Level spreader.

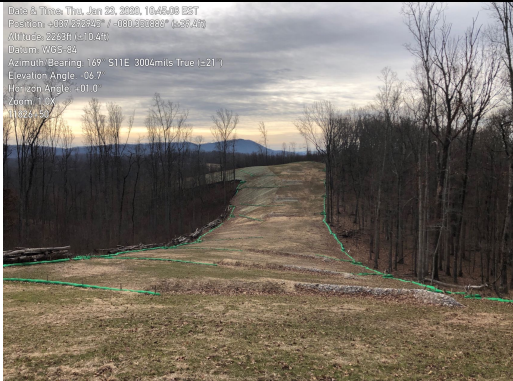
GPS Location	3	GPS Location	4		
Field Station#	11826+50	Field Station#	11863+65		
Pic 3 Desc.	Showing RoW conditions and ECDs on section of restored RoW.		Pic 4 Desc.	P-KL2.

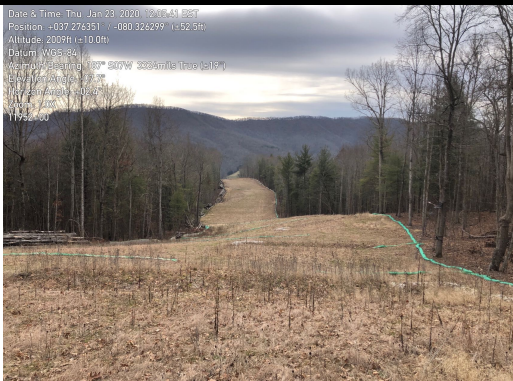
GPS Location	5	GPS Location	6		
Field Station#	11952+00	Field Station#	12002+00		
Pic 5 Desc.	Showing RoW conditions and ECDs.		Pic 6 Desc.	Showing RoW conditions and ECDs.

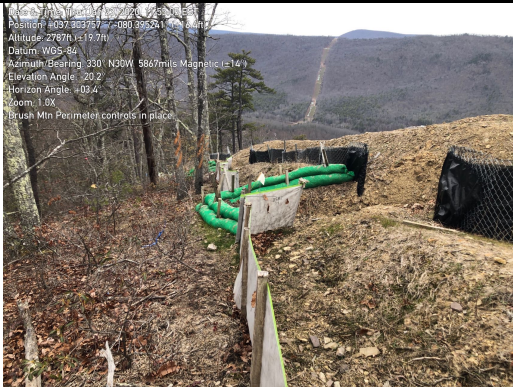
GPS Location	On photo		GPS Location	On photo	
Field Station#	11667+00		Field Station#	11651+50	
Pic 1 Desc.	Perimeter controls are in place and functioning properly		Pic 2 Desc.	Perimeter controls in place and functional

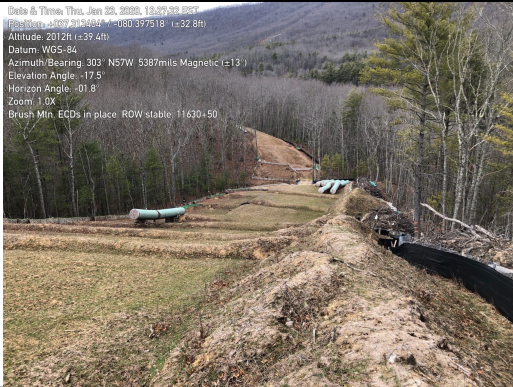
GPS Location	On photo		GPS Location	On photo	
Field Station#	11630+50		Field Station#	11628+00	
Pic 3 Desc.	ECDs including slope breakers in place. ROW stable		Pic 4 Desc.	Perimeter controls functional

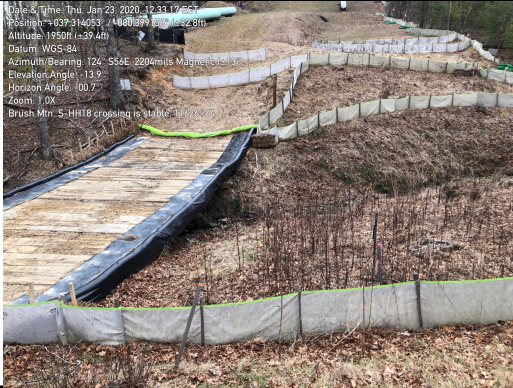
GPS Location	On photo		GPS Location	On photo	
Field Station#	11626+04		Field Station#	11619+75	
Pic 5 Desc.	Resource S-HH18 crossing is stable		Pic 6 Desc.	End treatments and plunge pools in place

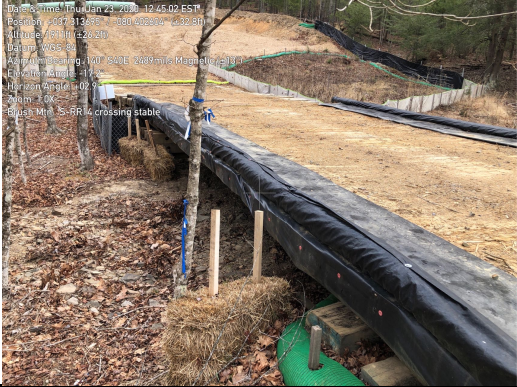
<p> Date/Time: Thu Jan 23, 2020 12:45:02 EST Position: +937.313800 / +090.402220 Altitude: 1509ft (s3924ft) Datum: WGS-84 Azimuth/Bearing: 140° S44E Elevation Angle: +01.9° Horizon Angle: +01.5° Zoom: 1.0X Brush Mtn. S-RR14 crossing stable </p>			
GPS Location	On photo	GPS Location	On photo		
Field Station#	11614+75	Field Station#	11614+20		
Pic 7 Desc.	Perimeter controls effective	Pic 8 Desc.	Resource crossing S-RR14 is stable

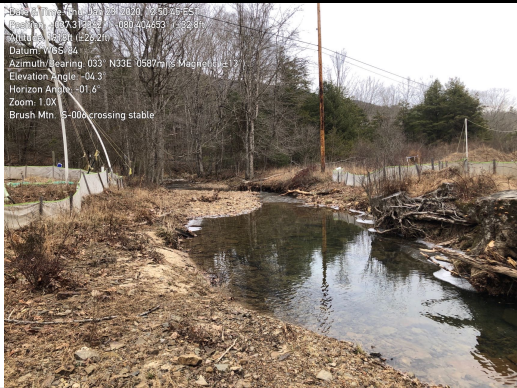
<p> Date/Time: Thu Jan 23, 2020 12:50:55 EST Position: +937.313800 / +090.402220 Altitude: 1509ft (s3924ft) Datum: WGS-84 Azimuth/Bearing: 033° N33E Elevation Angle: -04.3° Horizon Angle: -01.6° Zoom: 1.0X Brush Mtn. S-006 crossing stable </p>		<div style="text-align: center;">Insert image here</div>
