Visual Site Inspection Report

Project Name	H-600 Pipeline Spread G	AFE	124300137	Spread	H-600 Pipeline Spread G
Contractor	Precision			Report #	7119
Inspector	Garrett Barclay			Date/Time	1/6/2020 7:00 AM
Permit #	TBD	Inspection Type	VA SWPP	Station Begin	11250+00
State	VA	Inspection Area	Partial	Station End	11140+00
County	Giles	Ground	Dry	Temperature (°F)	38.00
Municipality	N/A	Weather	Below Freezing Temp	Rain Gauge (in)	0.20
				Rain Accumulation Time (days)	1.00

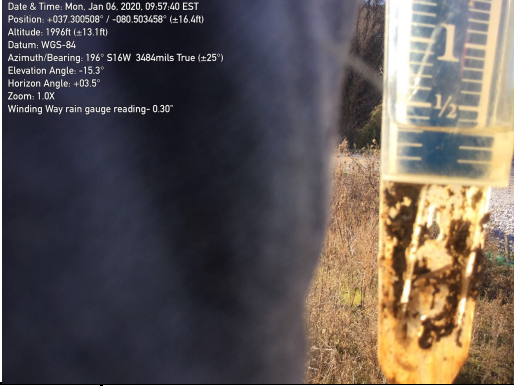
AFE	124300137	Date/Time	1/6/2020 7:17 AM	Report #	
Pictures					
<p>Date & Time: Mon, Jan 06, 2020, 09:57:40 EST Position: +037.309508° / -080.503458° (±16.4ft) Altitude: 1996ft (±13.1ft) Datum: WGS-84 Azimuth/Bearing: 196° S16W 3484mils True (±25°) Elevation Angle: -15.3° Horizon Angle: +03.5° Zoom: 1.0x Winding Way rain gauge reading- 0.30"</p>

GPS Location	See photo GPS	GPS Location	See photo GPS		
Field Station#	11227+00	Field Station#	11225+00		
Pic 1 Desc.	Winding Way rain gauge reading- 0.30"	Pic 2 Desc.	Rock channel is in acceptable condition.		
<p>Date & Time: Mon, Jan 06, 2020, 11:07:40 EST Position: +037.309508° / -080.503458° (±16.4ft) Altitude: 1978ft (±13.1ft) Datum: WGS-84 Azimuth/Bearing: 265° W020° S16mils True (±25°) Elevation Angle: -18.5° Horizon Angle: +03.6° Zoom: 1.0x Sta#11191+00- drainage feature</p>

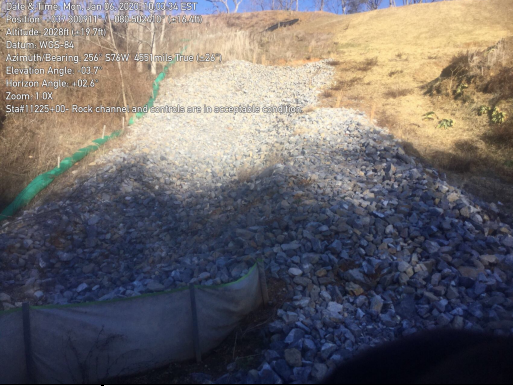
<p>Date & Time: Mon, Jan 06, 2020, 10:14:34 EST Position: +037.309508° / -080.503458° (±16.4ft) Altitude: 2008ft (±13.1ft) Datum: WGS-84 Azimuth/Bearing: 256° S20W 4840mils True (±25°) Elevation Angle: -03.7° Horizon Angle: +02.8° Zoom: 1.0x Sta#11225+00- Rock channel and controls are in acceptable condition.</p>

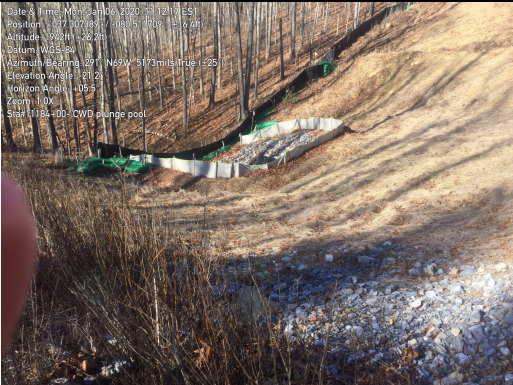
<p>Date & Time: Mon, Jan 06, 2020, 11:08:14 EST Position: +037.309508° / -080.503458° (±16.4ft) Altitude: 2020ft (±13.1ft) Datum: WGS-84 Azimuth/Bearing: 279° N89W 5173mils True (±25°) Elevation Angle: -21.2° Horizon Angle: +06.5° Zoom: 1.0x Sta#11184+00- CWD plunge pool</p>

GPS Location	See photo GPS	GPS Location	See photo GPS		
Field Station#	11191+00	Field Station#	11184+00		
Pic 3 Desc.	Drainage feature and controls are in acceptable condition.	Pic 4 Desc.	CWD pipe and plunge pool are in good condition.		
<p>Date & Time: Mon, Jan 06, 2020, 11:18:14 EST Position: +037.309508° / -080.515028° (±16.4ft) Altitude: 1881ft (±13.1ft) Datum: WGS-84 Azimuth/Bearing: 274° N86W 4871mils True (±25°) Elevation Angle: -22.2° Horizon Angle: +05.0° Zoom: 1.0x Sta#11172+70- slope drain, checks, sump, end treatment.</p>

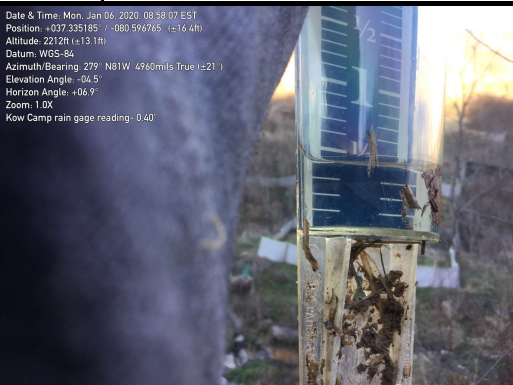
<p>Date & Time: Mon, Jan 06, 2020, 08:38:07 EST Position: +037.339185° / -080.516765° (±16.4ft) Altitude: 2212ft (±13.1ft) Datum: WGS-84 Azimuth/Bearing: 279° N81W 4960mils True (±21°) Elevation Angle: -04.5° Horizon Angle: +06.9° Zoom: 1.0x Kow Camp rain gauge reading- 0.40"</p>

Pic 5 Desc.	Slope drain, checks, sump, end treatment are in acceptable condition.	Pic 6 Desc.	Kow Camp rain gauge reading-0.40"

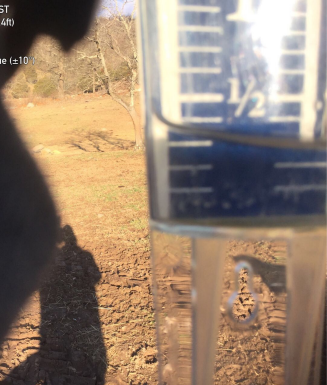
AFE	124300137	Date/Time	1/6/2020 7:17 AM	Report #	
Pictures					
<small>Date & Time: Mon, Jan 06, 2020, 09:10:41 EST Position: +037.317951° / -080.553563° (±16.4ft) Altitude: 2152ft (±19.7ft) Datum: WGS-84 Azimuth/Bearing: 304° N56W 5404mils True (±10°) Elevation Angle: +10.2° Horizon Angle: +04.1° Zoom: 1.0X AR-244 rain gauge reading- 0.30"</small>

GPS Location	See photo GPS	GPS Location	See photo GPS		
Field Station#	11024+00	Field Station#	11607+00		
Pic 7 Desc.	AR-244 rain gauge reading-0.30"	Pic 8 Desc.	Craig Creek rain gauge reading-0.15"		
Insert image here		Insert image here			
GPS Location		GPS Location

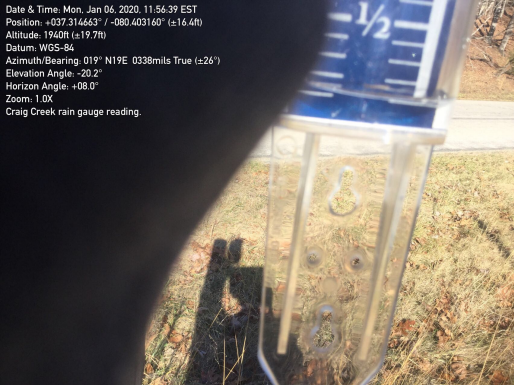
<small>Date & Time: Mon, Jan 06, 2020, 11:56:39 EST Position: +037.316663° / -080.403160° (±16.4ft) Altitude: 1940ft (±19.7ft) Datum: WGS-84 Azimuth/Bearing: 019° N19E 0338mils True (±26°) Elevation Angle: +20.2° Horizon Angle: +08.0° Zoom: 1.0X Craig Creek rain gauge reading.</small>

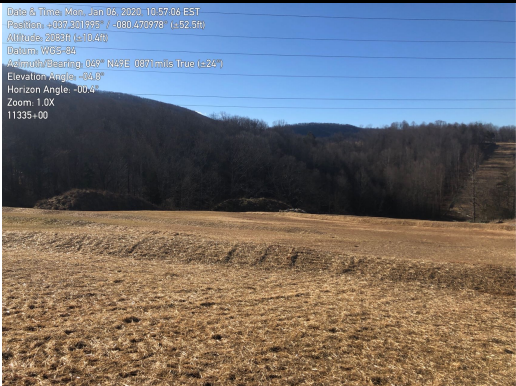
GPS Location	5	GPS Location	6		
Field Station#	11335+00	Field Station#	11352+97		
Pic 5 Desc.	Temporary stabilization sufficient.	Pic 6 Desc.	S-NN11.

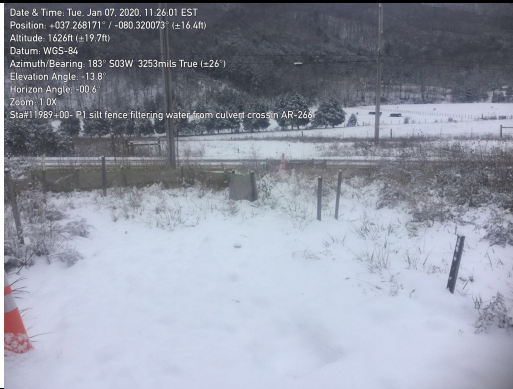
GPS Location	See photo GPS		GPS Location	See photo GPS	
Field Station#	11900+00		Field Station#	11989+00	
Pic 1 Desc.	AR-266.03- Access road is snow covered & slippery.		Pic 2 Desc.	P1 silt fence filtering water from culvert crossing AR-266.00

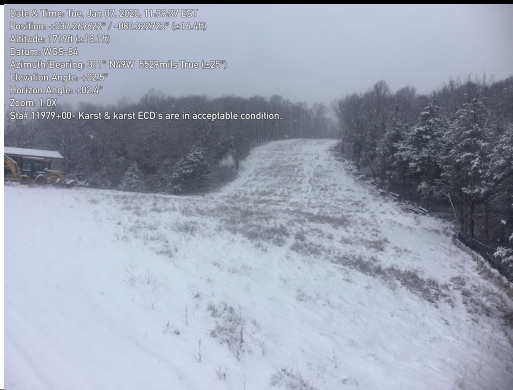
GPS Location	See photo GPS		GPS Location	See photo GPS	
Field Station#	11979+00		Field Station#	11970+00	
Pic 5 Desc.	Karst and Karst ECD's are in acceptable condition.		Pic 6 Desc.	Row is snow covered but in stable condition.

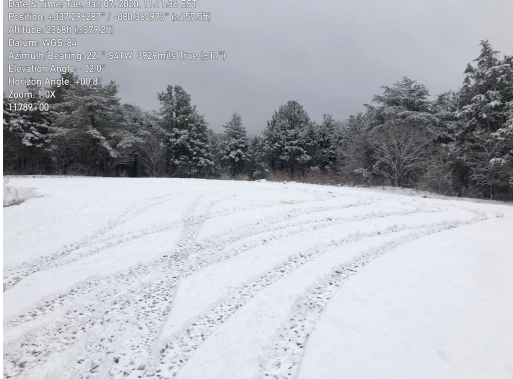
GPS Location	1	GPS Location	2		
Field Station#	11789+00	Field Station#	11792+00		
Pic 1 Desc.	Snow covered RCE.		Pic 2 Desc.	Snow covered section of restored RoW.	
<div><div><div><div><div><div></div><div></div></div></div><div><div><div></div><div></div></div></div><div><div><div></div></div></div></div></div><div><div><div>Date & Time: Tue, Jan 07, 2020, 11:22:26 EST</div><div>Position: +037.295991° / -080.353019° (-19.7m)</div><div>Altitude: 2212ft (+10.4m)</div><div>Datum: WGS-84</div><div>Azimuth/Bearing: 201° S21W 353mils True (+12°)</div><div>Elevation Angle: +22.5</div><div>Horizon Angle: +03.3</div><div>Zoom: 1.0X</div><div>11813+00</div></div></div>

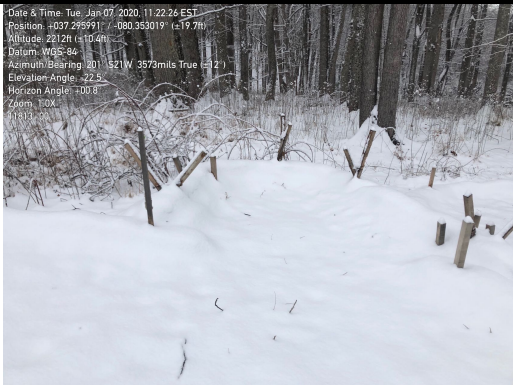
GPS Location	3	GPS Location	4		
Field Station#	11813+00	Field Station#	11815+00		
Pic 3 Desc.	Temporary CFS water bar outlet protection.		Pic 4 Desc.	P-1 silt fence perimeter control functional.	
<div><div><div><div><div><div></div><div></div></div></div><div><div><div></div><div></div></div></div><div><div><div></div></div></div></div></div><div><div><div>Date & Time: Tue, Jan 07, 2020, 11:26:30 EST</div><div>Position: +037.295991° / -080.354554° (-19.8m)</div><div>Altitude: 2277ft (+22.9m)</div><div>Datum: WGS-84</div><div>Azimuth/Bearing: 177° S01E 350mils True (+12°)</div><div>Elevation Angle: +01.2</div><div>Horizon Angle: +01.2</div><div>Zoom: 1.0X</div><div>11819+00</div></div></div>

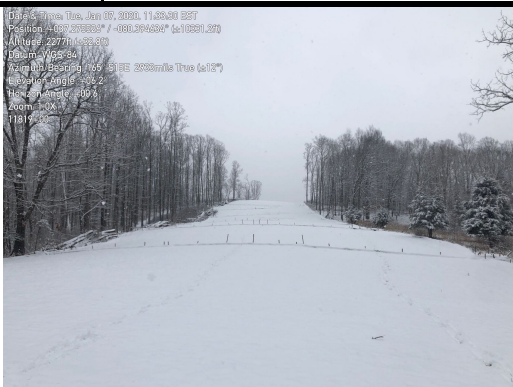
GPS Location	5	GPS Location	6		
Field Station#	11819+00	Field Station#	11826+00		
Pic 5 Desc.	Snow covered section of restored RoW.		Pic 6 Desc.	Snow covered section of restored RoW.

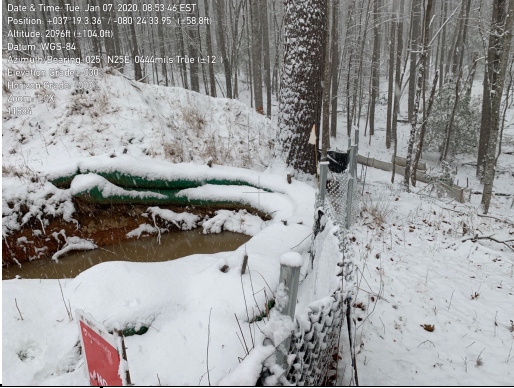
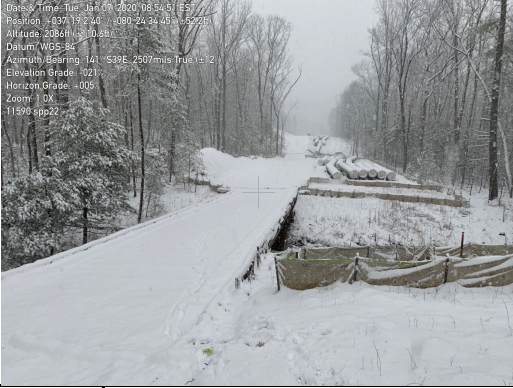
GPS Location	See picture above for GPS coordinates		GPS Location	See picture above for GPS coordinates	
Field Station#	11584+00		Field Station#	11590+00	
Pic 1 Desc.	ECD's and row conditions		Pic 2 Desc.	ECD's and row conditions

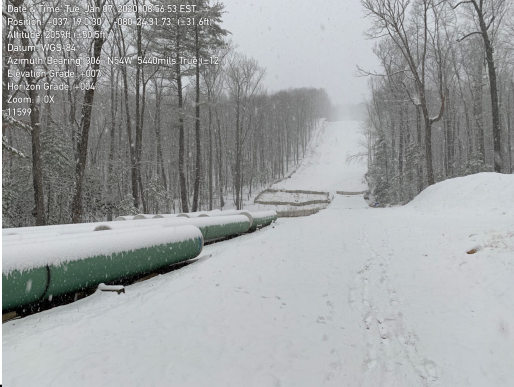
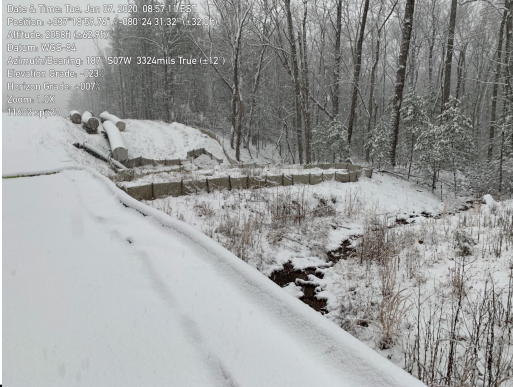
GPS Location	See picture above for GPS coordinates		GPS Location	See picture above for GPS coordinates	
Field Station#	11599+00		Field Station#	11602+00	
Pic 3 Desc.	ECD's and row conditions		Pic 4 Desc.	ECD's and row conditions

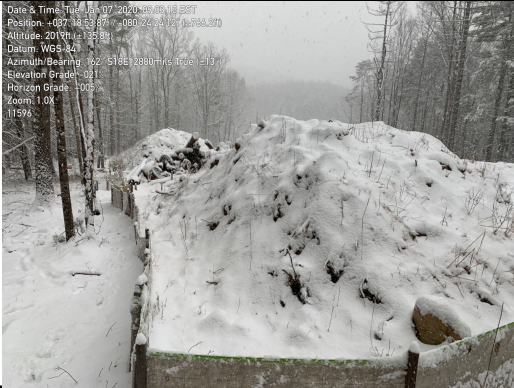
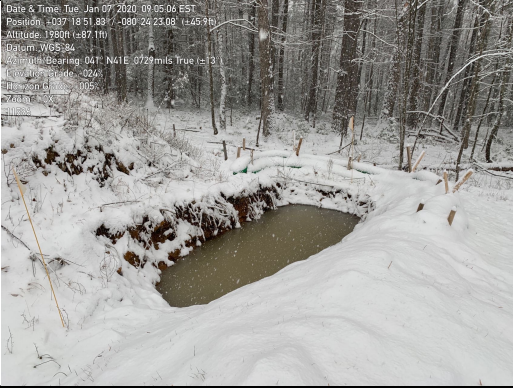
GPS Location	See picture above for GPS coordinates		GPS Location	See picture above for GPS coordinates	
Field Station#	11596+00		Field Station#	11596+00	
Pic 5 Desc.	ECD's and row conditions		Pic 6 Desc.	ECD's and row conditions

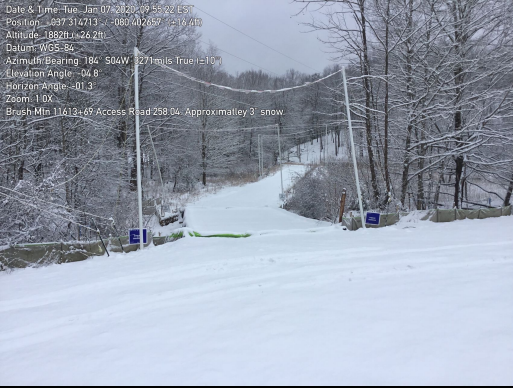
<p>Date & Time: Tue Jan 07, 2020 10:55:22 EST Position: +37.131013° / -80.042657° (±111.4ft) Altitude: 1882ft (±26.2ft) Datum: WGS 84 Azimuth Bearing: 184° S04W 3271mils True (±10°) Elevation Angle: 04.8° Horizon Angle: 01.3° Zoom: 1.0X Brush Min: 11613+69 Access Road 258.04: Approx. malle 3" snow</p>	
GPS Location	On photo	GPS Location	On photo
Field Station#	11614+20	Field Station#	11613+69

Pic 5 Desc.	No apparent environmental impact at the S-RR14 crossing	Pic 6 Desc.	Access Road 258.04 covered with fresh snow. No apparent impact of S-RR13

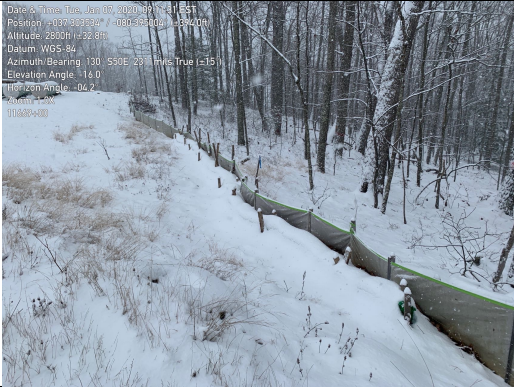
GPS Location	See photo for GPS location.		GPS Location	See photo for GPS location.	
Field Station#	11669+00		Field Station#	11671+00	
Pic 1 Desc.	Triple stack 12 inch CFS and priority one silt fence installed along LOD.		Pic 2 Desc.	Waterbar, sump pit, and waterbar end treatment in place.

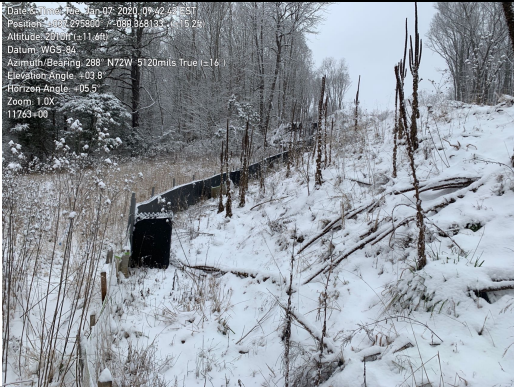
GPS Location	See photo for GPS location.		GPS Location	See photo for GPS location.	
Field Station#	11763+00		Field Station#	11767+50	
Pic 3 Desc.	Reinforced super silt fence installed along LOD.		Pic 4 Desc.	Sensitive resource buffer in place at stream S-IJ52.

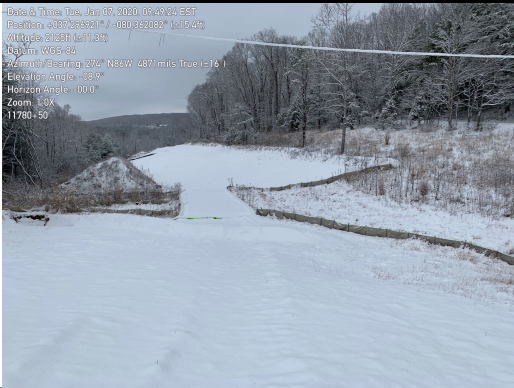
GPS Location	See photo for GPS location.		GPS Location	See photo for GPS location.	
Field Station#	11780+00		Field Station#	11788+50	
Pic 5 Desc.	Clean water drainage feature in place.		Pic 6 Desc.	RCE in place at Mount Tabor Road crossing.

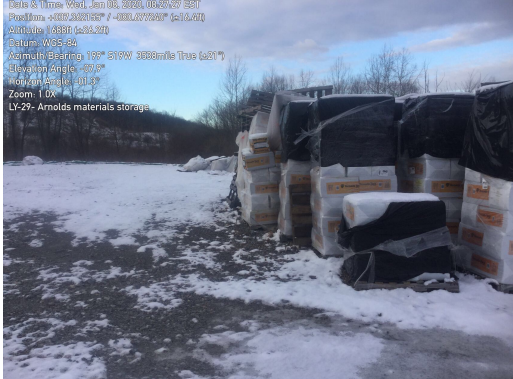
AFE		124300137		Date/Time		1/8/2020 7:11 AM		Report #			
Pictures											
<p>Date & Time: Wed, Jan 08, 2020, 06:29:27 EST Position: +017.063158° / -080.676680° (+16.4ft) Altitude: 172ft (+13.7ft) Datum: WGS-84 Azimuth/Bearing: 12° 51'W 308mils True (+20°) Elevation Angle: -67.2° Horizon Angle: -01.4° Zoom: 1.0X LY-29- Arnold's materials storage</p>

GPS Location				See photo GPS				GPS Location			
Field Station#				12005+00				Field Station#			
Pic 1 Desc.				Arnold's materials storage				Pic 2 Desc.			
								LY-29- PPL Materials storage			
<p>Date & Time: Wed, Jan 08, 2020, 08:33:16 EST Position: +017.063158° / -080.676680° (+16.4ft) Altitude: 172ft (+13.7ft) Datum: WGS-84 Azimuth/Bearing: 25° 58'W 478mils True (+20°) Elevation Angle: -67.2° Horizon Angle: -01.4° Zoom: 1.0X LY-29- The rock surface of the yard is snow covered.</p>

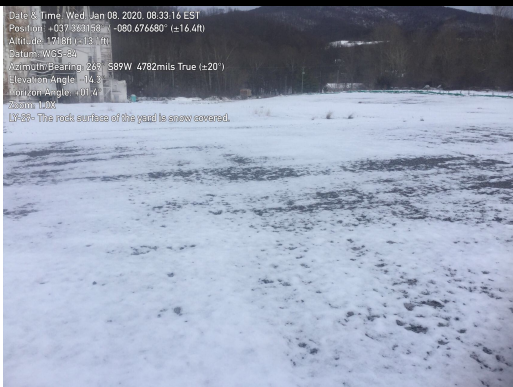
Field Station#				12005+00				Field Station#			
Pic 3 Desc.				LY-29- The rock surface of the yard is snow covered.				Pic 4 Desc.			
								LY-29- CFS 18" triple stack perimeter controls are in acceptable condition.			
<p>Date & Time: Wed, Jan 08, 2020, 08:42:41 EST Position: +017.063158° / -080.676680° (+16.4ft) Altitude: 170ft (+12.7ft) Datum: WGS-84 Azimuth/Bearing: 33° 59'W 451mils True (+20°) Elevation Angle: -68.5° Horizon Angle: -01.5° Zoom: 1.0X LY-29- Goal posts & flagging for utility protection are in acceptable condition.</p>

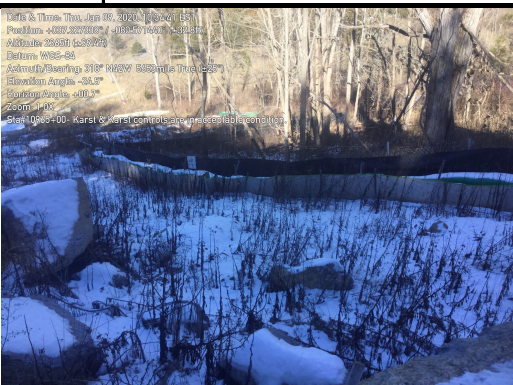
<p>Date & Time: Thu Jan 09, 2020, 10:20:56 EST Position: +037 325524 / +080 564710 (+32.8ft) Altitude: 2365ft (+39.2ft) Datum: WGS-84 Azimuth/Bearing: 318° N03W 635mils True (+5°) Elevation Angle: -04.1° Horizon Angle: +00.1° Zoom: 1.0X Start 10965+00 Karst & Karst controls are in good condition.</p>			
GPS Location	See photo GPS		GPS Location	See photo GPS

Field Station#	10986+00		Field Station#	10965+00	
Pic 5 Desc.	Stream S-E25 Environmental controls are in acceptable condition.		Pic 6 Desc.	Karst and Karst ECD's are in good condition.

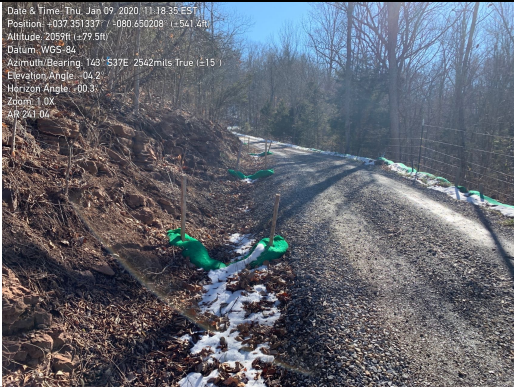
GPS Location	See photo for GPS location.		GPS Location	See photo for GPS location.	
Field Station#	10708+00		Field Station#	10712+50	
Pic 3 Desc.	12 inch compost filter sock checks in bar ditch along access road 241.04.		Pic 4 Desc.	Sensitive resource buffer in place at stream S-G33.

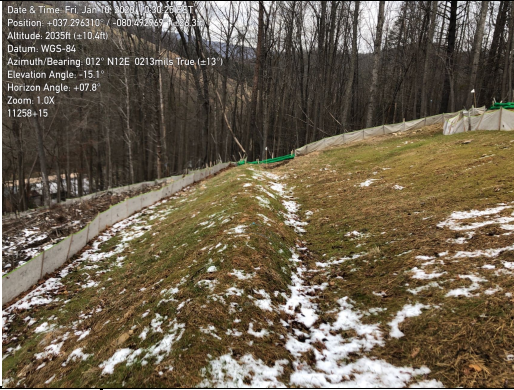
GPS Location	1	GPS Location	2		
Field Station#	11258+15	Field Station#	11265+00		
Pic 1 Desc.	ECDs and temporary vegetation/stabilization sufficient.		Pic 2 Desc.	P-1 silt fence perimeter control functional.	
<p>Date & Time: Fri, Jan 10, 2020, 10:53:18 EST Position: +037.294219° / -080.491532° (±19.7m) Altitude: 2112ft (±10.4m) Datum: WGS-84 Azimuth/Bearing: 083° N83E 1120mils True (±17°) Elevation Angle: -01.6° Horizon Angle: +01.6° Zoom: 1.0X S-MM18</p>

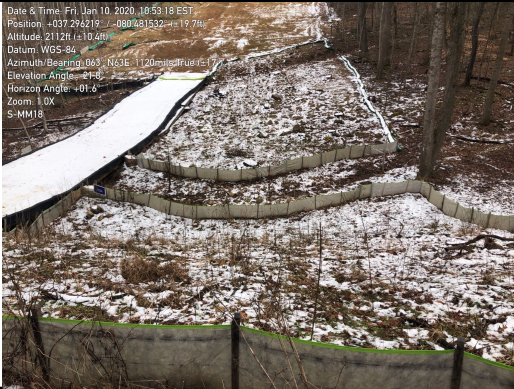
GPS Location	3	GPS Location	4		
Field Station#	11292+80	Field Station#	11301+50		
Pic 3 Desc.	S-MM18.		Pic 4 Desc.	Temporary stabilization/vegetation sufficient.	
<p>Date & Time: Fri, Jan 10, 2020, 11:14:00 EST Position: +037.296687° / -080.496621° (±19.7m) Altitude: 2040ft (±6.8m) Datum: WGS-84 Azimuth/Bearing: 074° S86E 1671mils True (±17°) Elevation Angle: -07.9° Horizon Angle: +03.5° Zoom: 1.0X S-NN12</p>

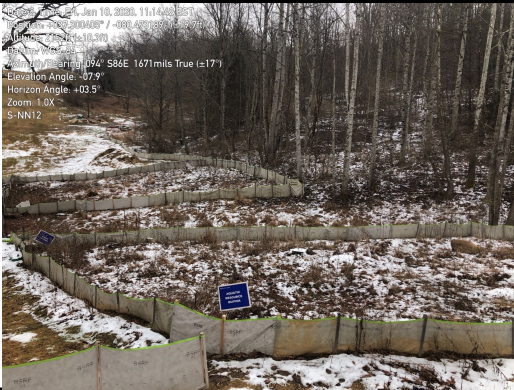
GPS Location	5	GPS Location	6		
Field Station#	11327+85	Field Station#	11352+97		
Pic 5 Desc.	S-NN12		Pic 6 Desc.	S-NN11.

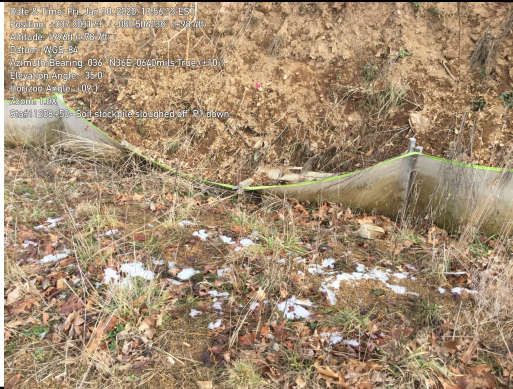
<p>Date & Time: Fri Jan 10, 2020 10:44:38 EST Position: +037.301512, +080.503811, +32.0m Altitude: 1205ft (+32.0m) Datum: WGS-84 Azimuth Bearing: 017° N17E, 0640mils true (+0.1°) Elevation Angle: -01.0° Horizon Angle: -03.1° Zoom: 1.0x Star: 11218+53 - P1 perimeter control down</p>

<p>Date & Time: Fri Jan 10, 2020 10:44:38 EST Position: +037.301512, +080.503811, +32.0m Altitude: 1205ft (+32.0m) Datum: WGS-84 Azimuth Bearing: 032° N32E, 0640mils true (+0.1°) Elevation Angle: -35.0° Horizon Angle: -09.1° Zoom: 1.0x Star: 11208+50 - Soil stockpile sloughed off onto P1, fence down</p>			
GPS Location	See photo GPS		GPS Location	See photo GPS	
Field Station#	11218+53		Field Station#	11208+50	
Pic 3 Desc.	P1 perimeter controls are damaged		Pic 4 Desc.	Soil stockpile sloughed off onto P1, fence down.

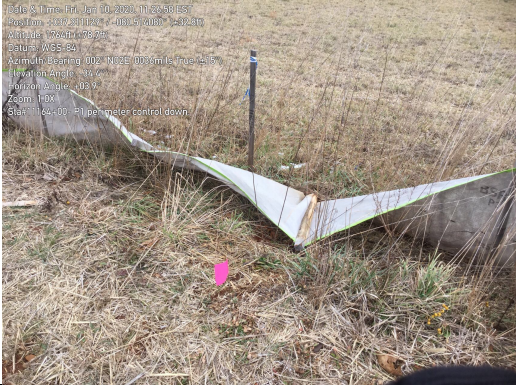
<p>Photo 1 Time: 1/10/2020 7:25:55 AM Position: 43° 37' 39.7431" N - 89° 51' 20.03" W Altitude: 1950ft ± 39.4ft Datum: WGS-84 Azimuth/Bearing: 296° N44W 5262mils True ± 10.1 Elevation Angle: -16.4 Horizon Angle: +08.5 Zoom: 1.0X Sta#11164+00 - P1 perimeter control down</p>

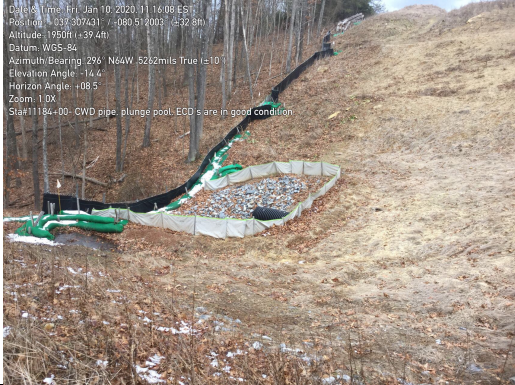
<p>Photo 8 Time: 1/10/2020 01:16:08 EST Position: 43° 37' 39.7431" N - 89° 51' 20.03" W Altitude: 1950ft ± 39.4ft Datum: WGS-84 Azimuth/Bearing: 296° N44W 5262mils True ± 10.1 Elevation Angle: -16.4 Horizon Angle: +08.5 Zoom: 1.0X Sta#11184+00 - CWD pipe, plunge pool, ECD's are in good condition</p>			
GPS Location	See photo GPS	GPS Location	See photo GPS		
Field Station#	11164+00	Field Station#	11184+00		
Pic 7 Desc.	P1 perimeter controls are down.	Pic 8 Desc.	CWD pipe and plunge pool are in good condition.		
Insert image here		Insert image here

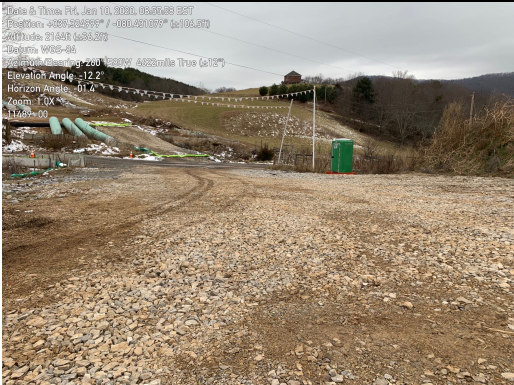
GPS Location	See photo for GPS location.		GPS Location	See photo for GPS location.	
Field Station#	11489+00		Field Station#	11474+00	
Pic 3 Desc.	RCE in place at Stevers Gap Road.		Pic 4 Desc.	Slope drain pipe and rock outlet in place over two-tone.	
<p>Date & Time: Fri, Jan 10, 2020, 09:00:01 EST Position: +37.22422° / -88.45357° (±11.3m) Altitude: 2214ft (±11.3m) Datum: WGS-84 Azimuth/Bearing: 180° 500W 3200mils True (±12°) Elevation Angle: -01.8° Horizon Angle: -00.1° Zoom: 1.0x 11471+00</p>  		<p>Date & Time: Fri, Jan 10, 2020, 09:00:01 EST Position: +37.22422° / -88.45357° (±11.3m) Altitude: 2214ft (±11.3m) Datum: WGS-84 Azimuth/Bearing: 180° 500W 3200mils True (±12°) Elevation Angle: -01.8° Horizon Angle: -00.1° Zoom: 1.0x 11382+00</p>  			
GPS Location	See photo for GPS location.		GPS Location	See photo for GPS location.	
Field Station#	11471+00		Field Station#	11382+00	
Pic 5 Desc.	CFS checks in place along Steele Acres access road in bar ditch.		Pic 6 Desc.	ROW stabilized with seed and mulch. ROW still snow covered in area.
