Visual Site Inspection Report

Project Name	H-600 Pipeline Spread G	AFE	124300137	Spread	H-600 Pipeline Spread G
Contractor	Precision			Report #	8130
Inspector	Chris Burns			Date/Time	2/10/2020 12:50 PM
Permit #	TBD	Inspection Type	VA SWPP	Station Begin	11788+52
State	VA	Inspection Area	Partial	Station End	11899+99
County	Montgomery	Ground	Wet	Temperature (°F)	48.00
Municipality	N/A	Weather	Light Rain	Rain Gauge (in)	0.00
				Rain Accumulation Time (days)	1.00

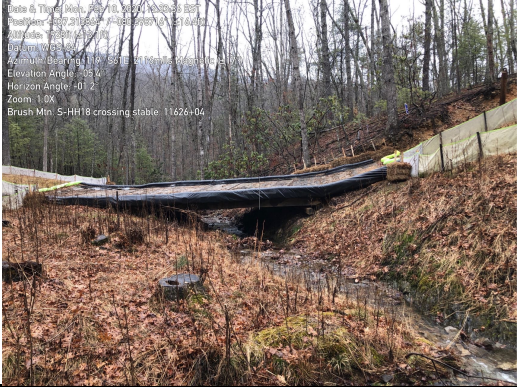
<p>Photo 7: Mon, Feb 10, 2020, 12:41:51 PM Position: +03.0360, -01.0010 Altitude: 1226.1426 Datum: WGS-84 Azimuth/Bearing: 166.534E, 259.6mils Magnetic (+19.7) Elevation Angle: -03.3 Horizon Angle: +00.3 Zoom: 1.0X Brush Min: 5-HH18 crossing stable, 11626+04</p>		  <p>Photo 8: Mon, Feb 10, 2020, 12:41:51 PM Position: +03.0360, -01.0010 Altitude: 1226.1426 Datum: WGS-84 Azimuth/Bearing: 166.534E, 259.6mils Magnetic (+19.7) Elevation Angle: -03.3 Horizon Angle: +00.3 Zoom: 1.0X Brush Min: ECDs frictional 11619+35</p>			
GPS Location	On photo	GPS Location	On photo		
Field Station#	11626+04	Field Station#	11619+35		
Pic 7 Desc.	Resource crossings are stable and ECDs are in place	Pic 8 Desc.	Perimeter controls and plunge pools are in place and functional

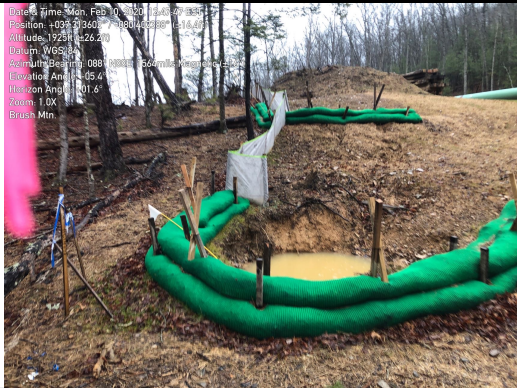
<p>Photo 9: Mon, Feb 10, 2020, 12:43:08 PM Position: +03.0360, -01.0010 Altitude: 1226.1426 Datum: WGS-84 Azimuth/Bearing: 166.534E, 259.6mils Magnetic (+19.7) Elevation Angle: -03.3 Horizon Angle: +00.6 Zoom: 1.0X Brush Min:</p>		  <p>Photo 10: Mon, Feb 10, 2020, 12:43:08 PM Position: +03.0360, -01.0010 Altitude: 1226.1426 Datum: WGS-84 Azimuth/Bearing: 166.534E, 259.6mils Magnetic (+19.7) Elevation Angle: -03.3 Horizon Angle: +00.6 Zoom: 1.0X Brush Min:</p>

GPS Location	On photo	GPS Location	On photo		
Field Station#	11614+75	Field Station#	11614+20		
Pic 9 Desc.	Perimeter controls working as designed.	Pic 10 Desc.	Resource crossings are stable.		
Insert image here		Insert image here			
GPS Location		GPS Location			
Field Station#		Field Station#			
Pic 11 Desc.		Pic 12 Desc.

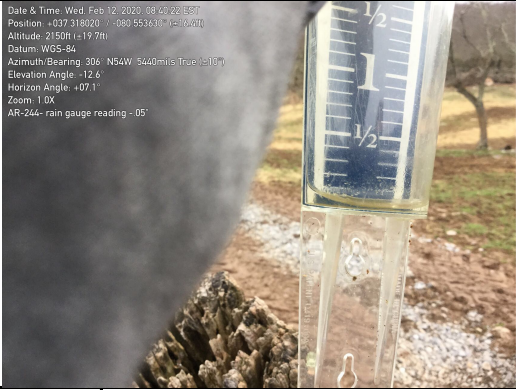
AFE	124300137	Date/Time	2/12/2020 7:07 AM	Report #	
Pictures					
<p>Date & Time: Wed Feb 12 2020 08:22:55 EST Position: +037.3182020 / -080.5536137 / +32.60ft Altitude: 2150ft (+19.7m) Datum: WGS-84 Azimuth/Bearing: 306.554W 5440mils True (+25) Elevation Angle: -12.6 Horizon Angle: +07.1 Zoom: 1.0X AR-244- rain gauge reading - 0.05"</p>

GPS Location	See photo GPS	GPS Location	See photo GPS		
Field Station#	11024+00	Field Station#	11016+00		
Pic 1 Desc.	AR-244 rain gauge reading- 0.05"	Pic 2 Desc.	Stream S- RR5- Stream and controls are in acceptable condition.		
<p>Date & Time: Wed Feb 12 2020 09:22:09 EST Position: +037.3215392 / -080.5426211 / +32.60ft Altitude: 2587ft (+43.8m) Datum: WGS-84 Azimuth/Bearing: 101.579E 1734mils True (+25) Elevation Angle: -13.0 Horizon Angle: +01.5 Zoom: 1.0X S-E245- Stream & controls are in acceptable condition.</p>

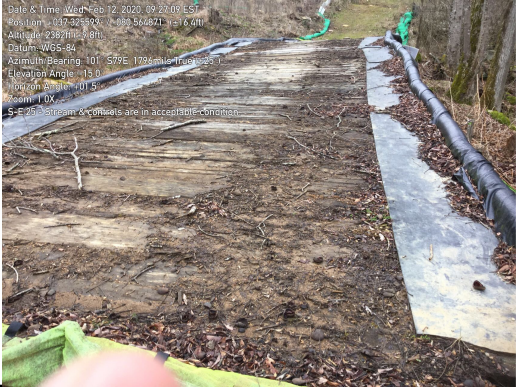
<p>Date & Time: Wed Feb 12 2020 09:27:09 EST Position: +037.3235000 / -080.5448701 / +32.60ft Altitude: 2800ft (+50.8m) Datum: WGS-84 Azimuth/Bearing: 209.581W 5493mils True (+25) Elevation Angle: -13.2 Horizon Angle: -03.1 Zoom: 1.0X S-E24- Stream & controls are in acceptable condition.</p>

GPS Location	See photo GPS	GPS Location	See photo GPS		
Field Station#	10986+00	Field Station#	10985+00		
Pic 3 Desc.	Stream S-E25- Stream and controls are in acceptable condition.	Pic 4 Desc.	Stream S- E24- Stream and controls are in acceptable condition.		
<p>Date & Time: Wed Feb 12 2020 09:35:05 EST Position: +037.3224971 / -080.5478899 / +32.60ft Altitude: 2318ft (+105.0m) Datum: WGS-84 Azimuth/Bearing: 224.544W 4078mils True (+25) Elevation Angle: -35.5 Horizon Angle: +03.9 Zoom: 1.0X Sta 10977+00- P1 check has been repaired.</p>

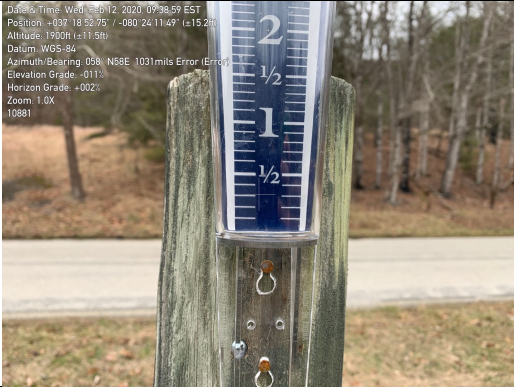
GPS Location	See picture above for GPS coordinates		GPS Location	See picture above for GPS coordinates	
Field Station#	11614+00		Field Station#	10858+00	
Pic 1 Desc.	No rain recorded @ Craig's creek		Pic 2 Desc.	ECD's and row conditions

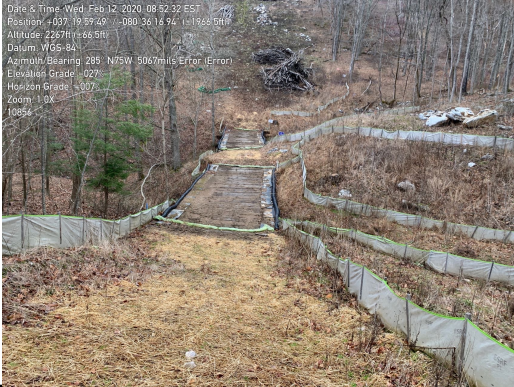
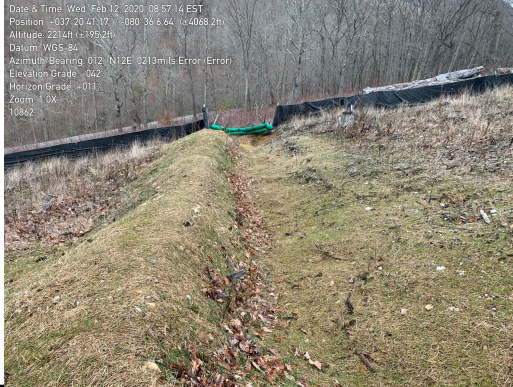
GPS Location	See picture above for GPS coordinates		GPS Location	See picture above for GPS coordinates	
Field Station#	10856+00		Field Station#	10862+00	
Pic 3 Desc.	ECD's and row conditions		Pic 4 Desc.	ECD's and row conditions

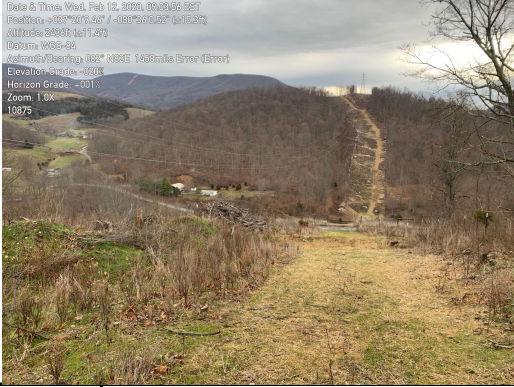
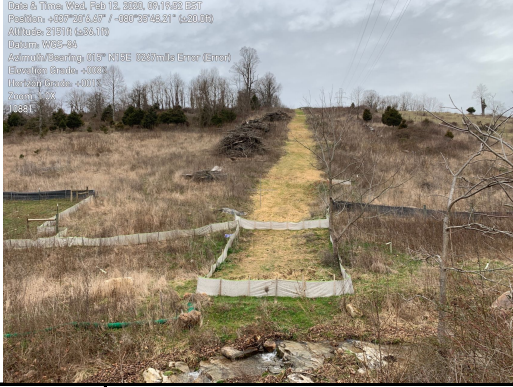
GPS Location	See picture above for GPS coordinates		GPS Location	See picture above for GPS coordinates	
Field Station#	10875+00		Field Station#	10881+00	
Pic 5 Desc.	ECD's and row conditions		Pic 6 Desc.	ECD's and row conditions

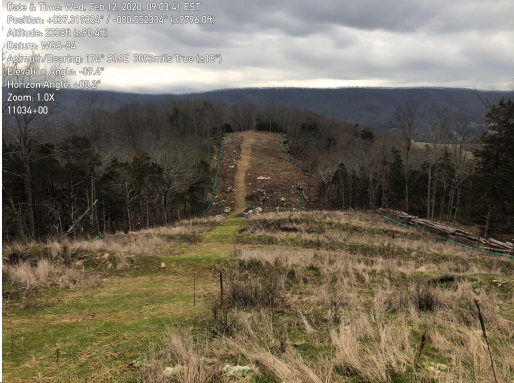
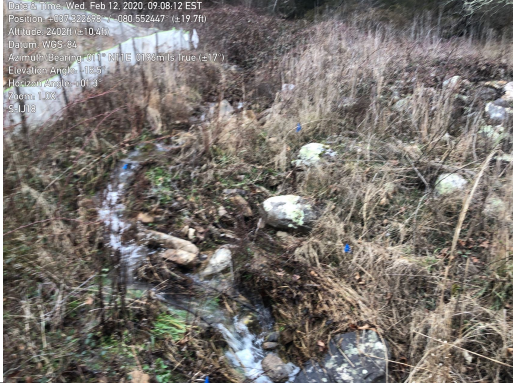
GPS Location	5	GPS Location	6		
Field Station#	11034+00	Field Station#	11025+50		
Pic 5 Desc.	RoW conditions and controls.	Pic 6 Desc.	S-IJ18.

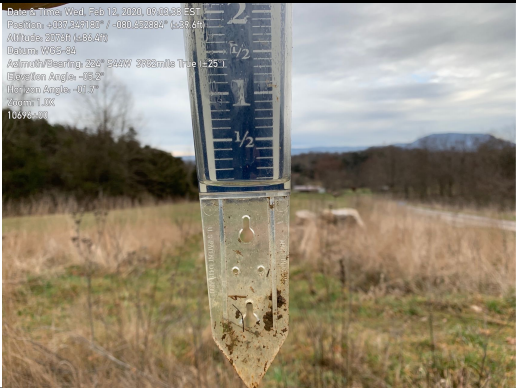
GPS Location	See photo for GPS location.		GPS Location	See photo for GPS location.	
Field Station#	10696+00		Field Station#	12005+00	
Pic 5 Desc.	Rain gauge at Buffalo Anklets Road reads 0.1 inches.		Pic 6 Desc.	Rain gauge at Access Road 234 reads 0.1 inches.

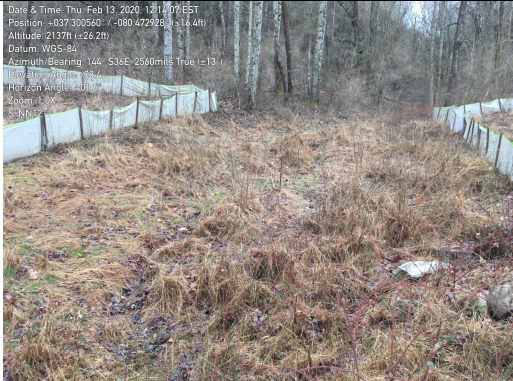
GPS Location	5		GPS Location	6	
Field Station#	11327+97		Field Station#	11352+97	
Pic 5 Desc.	S-NN12.		Pic 6 Desc.	S-NN11.

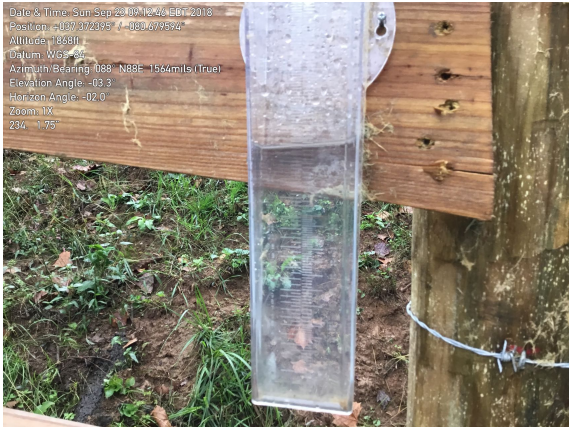
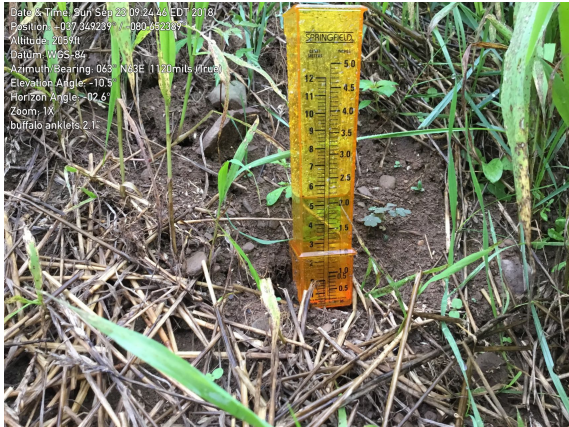
GPS Location	37.3423967371111, -80.6767856330431	GPS Location	37.3422270035719, -80.6770008803165		
Description	1.75" AR234	Description	2.1" buffalo anklets

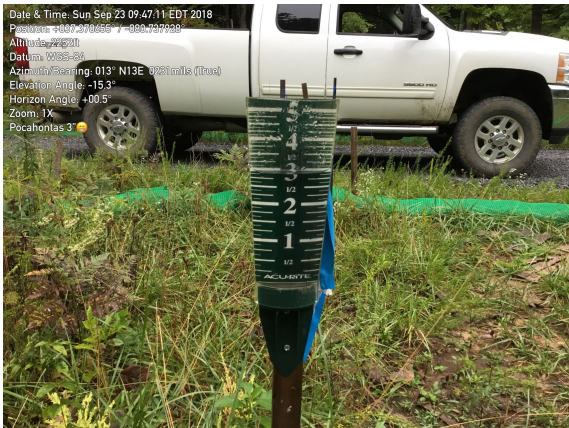
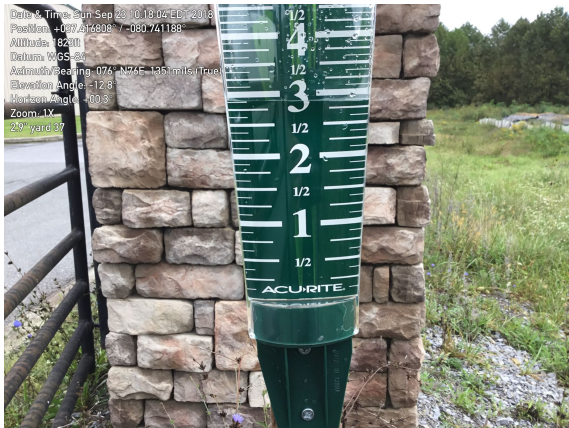
GPS Location	37.3423588928183, -80.6767272111779	GPS Location	37.3424103577038, -80.6770678517229		
Description	Pocahontas 3"	Description	Yard 37 2.9"		
<p>Insert image here</p>		<p>Insert image here</p>			
GPS Location		GPS Location			
Description		Description

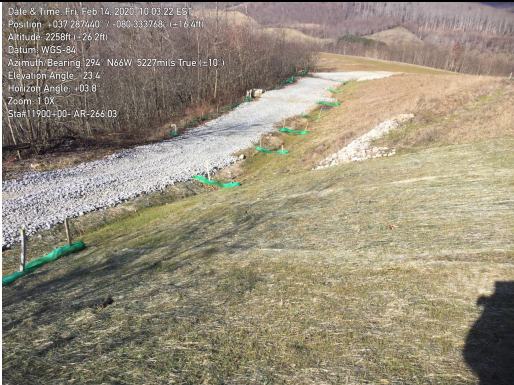
<p>Date & Time: Fri, Feb 14, 2020, 10:01:22 EST Position: +037 225617° / -080 333768° (±16.4ft) Altitude: 2256ft (±39.4ft) Datum: WGS-84 Azimuth/Bearing: 294° N66W 5227mils True (±10°) Elevation Angle: -23.4° Horizon Angle: +03.8° Zoom: 1.0x Star#11900+00- AR-266.03</p>
