Visual Site Inspection Report

Project Name	H-600 Pipeline Spread G	AFE	124300137	Spread	H-600 Pipeline Spread G
Contractor	Precision			Report #	8344
Inspector	Len Kruizenga			Date/Time	2/17/2020 8:21 AM
Permit #	TBD	Inspection Type	VA SWPP	Station Begin	12005+00
State	VA	Inspection Area	Full	Station End	12005+00
County	Giles	Ground	Wet	Temperature (°F)	32.00
Municipality	N/A	Weather	Sunny	Rain Gauge (in)	0.00
				Rain Accumulation Time (days)	2.00

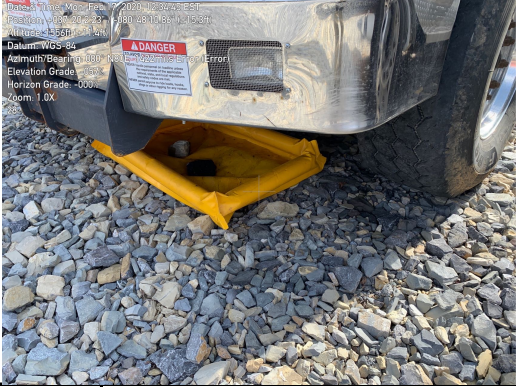
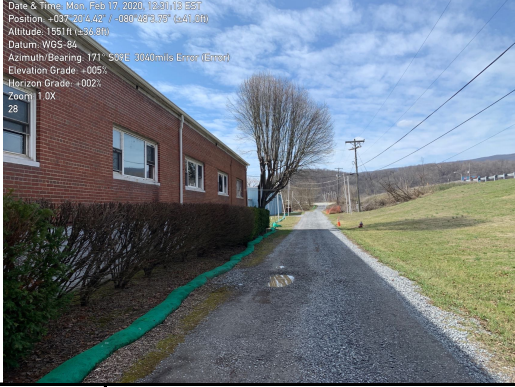
GPS Location	See picture above for GPS coordinates		GPS Location	See picture above for GPS coordinates	
Field Station#	12005+00		Field Station#	12005+00	
Pic 5 Desc.	ECD's and row conditions		Pic 6 Desc.	ECD's and row conditions

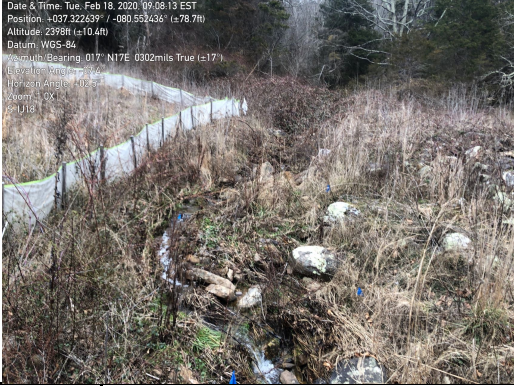
<p>Date & Time: Tue, Feb 18, 2020 09:08:13 EST Position: +037.222439° / -080.532436° (-78.7N) Altitude: 2398ft (+10.4ft) Datum: WGS-84 Azimuth/Bearing: 017° N17E 0302mils True (+17°) Elevation Angle: -04.3° Horizon Angle: +04.3° Zoom: 1.0X 11025+00</p>

<p>Date & Time: Tue, Feb 18, 2020 09:12:13 EST Position: +037.201177° / -080.550423° (-78.13N) Altitude: 2570ft (+6.2ft) Datum: WGS-84 Azimuth/Bearing: 188° S01W 0253mils True (+18°) Elevation Angle: -04.3° Horizon Angle: +04.3° Zoom: 1.0X 11034+00</p>		GPS Location	1
Field Station#		11025+50	GPS Location	2	
Pic 1 Desc.		S-IJ18.	Pic 2 Desc.	RoW conditions and controls.

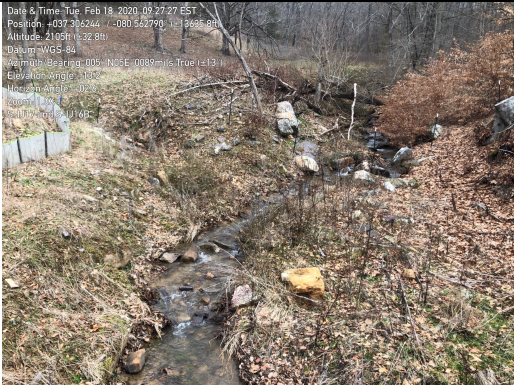
<p>Date & Time: Tue, Feb 18, 2020 09:27:27 EST Position: +037.304244° / -080.542790° (-78.69N) Altitude: 2105ft (+32.8ft) Datum: WGS-84 Azimuth/Bearing: 005° N05E 0089mils True (+19°) Elevation Angle: +00.2° Horizon Angle: -00.2° Zoom: 1.0X 11050+10</p>

Field Station#		11050+10	GPS Location	4	
Pic 3 Desc.		S-IJ16B and S-IJ17.	Pic 4 Desc.	Triple layer perimeter controls.

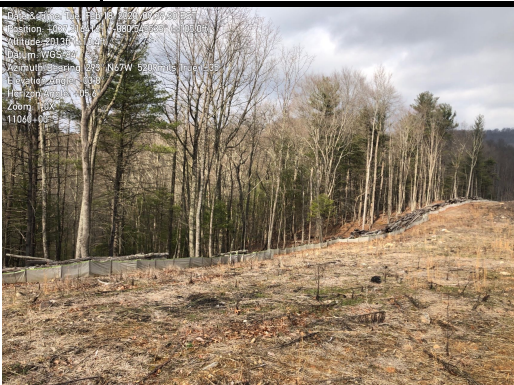
<p>Date & Time: Tue, Feb 18, 2020 09:43:46 EST Position: +037.281267° / -080.544487° (-78.6N) Altitude: 2013ft Datum: WGS-84 Azimuth/Bearing: 001° N01W 5003mils True (+17°) Elevation Angle: +00.2° Horizon Angle: -00.2° Zoom: 1.0X 11060+00</p>

<p>Date & Time: Tue, Feb 18, 2020 09:43:46 EST Position: +037.281267° / -080.544487° (-78.6N) Altitude: 2013ft Datum: WGS-84 Azimuth/Bearing: 001° N01W 5003mils True (+17°) Elevation Angle: +00.2° Horizon Angle: -00.2° Zoom: 1.0X 11064+50</p>		GPS Location	5
Field Station#		11060+00	GPS Location	6	
Pic 5 Desc.		P-1 perimeter controls.	Pic 6 Desc.	RoW conditions.

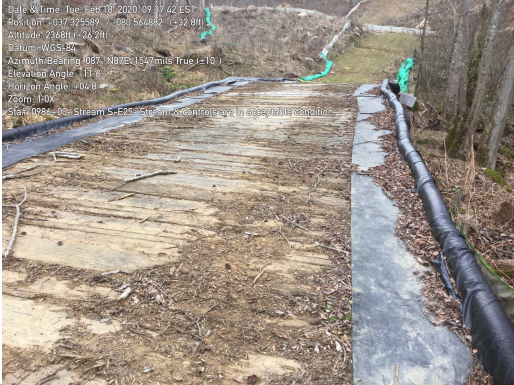
<p>Date & Time: Tue, Feb 18, 2020, 09:20:05 EST Position: +037.325567 / -080.566504 (±32.8ft) Altitude: 2387ft (±39.4ft) Datum: WGS-84 Azimuth/Bearing: 311° N42W 5529mils True (±10°) Elevation Angle: -16.2° Horizon Angle: -02.8° Zoom: 1.0X Start 10985+00- Stream S-E24- Stream & controls are in acceptable condition.</p>

GPS Location	See photo GPS		GPS Location	See photo GPS	
Field Station#	10986+00		Field Station#	10985+00	
Pic 3 Desc.	Stream S-E25- Equipment bridge and controls.		Pic 4 Desc.	Stream S-E24- Equipment bridge and controls.	
<p>Date & Time: Tue, Feb 18, 2020, 10:07:05 EST Position: +037.311122 / -080.562725 (±32.8ft) Altitude: 2205ft (±39.4ft) Datum: WGS-84 Azimuth/Bearing: 334° N26W 5338mils True (±10°) Elevation Angle: -18.5° Horizon Angle: -02.6° Zoom: 1.0X Start 10965+00- Karst and Karst ECD's</p>

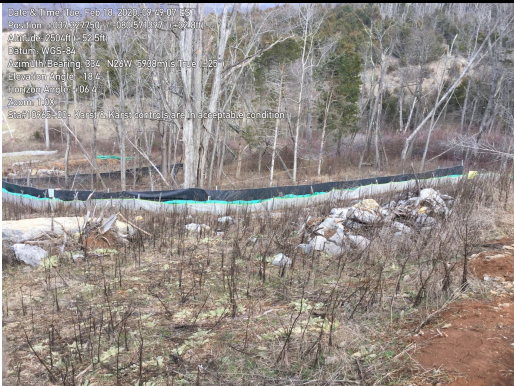
<p>Date & Time: Tue, Feb 18, 2020, 10:06:37 EST Position: +037.311122 / -080.562725 (±32.8ft) Altitude: 2205ft (±39.4ft) Datum: WGS-84 Azimuth/Bearing: 310° N30W 5511mils True (±25°) Elevation Angle: -20.6° Horizon Angle: -00.2° Zoom: 1.0X Start 10930+00- Doe Creek RCE</p>

GPS Location	See photo GPS		GPS Location	See photo GPS	
Field Station#	10965+00		Field Station#	10930+00	
Pic 5 Desc.	Karst and Karst ECD's		Pic 6 Desc.	Doe Creek RCE

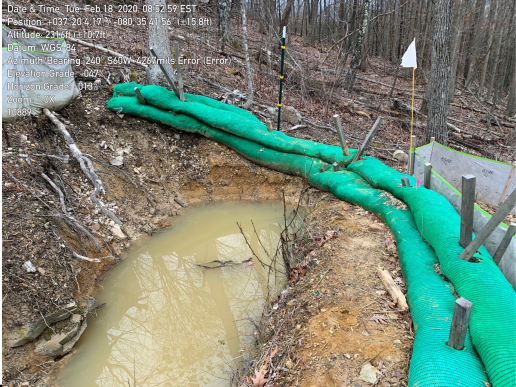
GPS Location	See picture above for GPS coordinates		GPS Location	See picture above for GPS coordinates	
Field Station#	10889+00		Field Station#	10889+00	
Pic 3 Desc.	ECD's and row conditions		Pic 4 Desc.	ECD's and row conditions

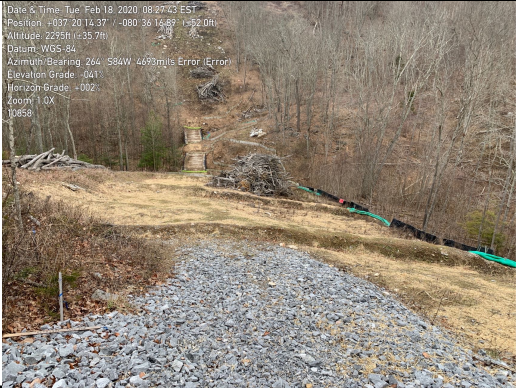
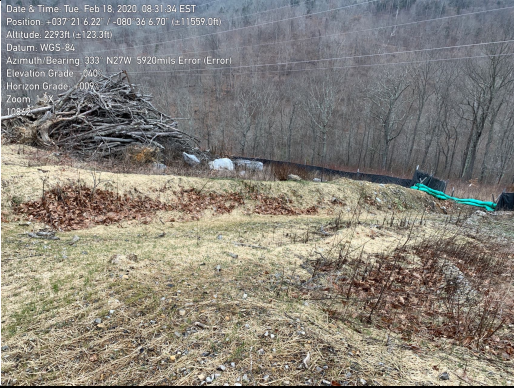
GPS Location	See picture above for GPS coordinates		GPS Location	See picture above for GPS coordinates	
Field Station#	10858+00		Field Station#	10862+00	
Pic 5 Desc.	ECD's and row conditions		Pic 6 Desc.	ECD's and row conditions

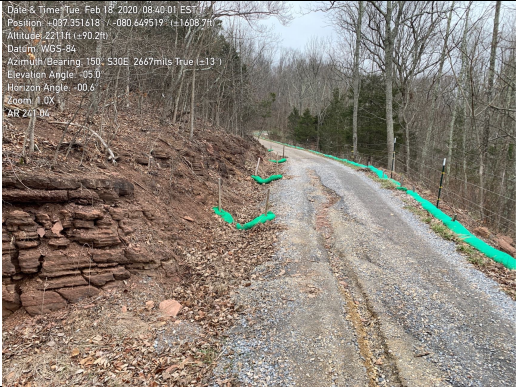
GPS Location	See photo for GPS location.		GPS Location	See photo for GPS location.	
Field Station#	10710+00		Field Station#	10712+50	
Pic 1 Desc.	Compost filter sock checks in place in bar ditch along access road 241.04. Rilling in Road also present.		Pic 2 Desc.	Sensitive resource buffer in place at stream S-G33.

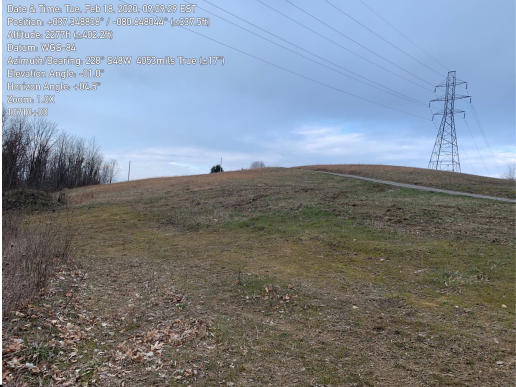
GPS Location	See photo for GPS location.		GPS Location	See photo for GPS location.	
Field Station#	10710+00		Field Station#	10696+00	
Pic 3 Desc.	ROW stabilized with natural vegetation.		Pic 4 Desc.	RCE in place at Buffalo Anklets Road.

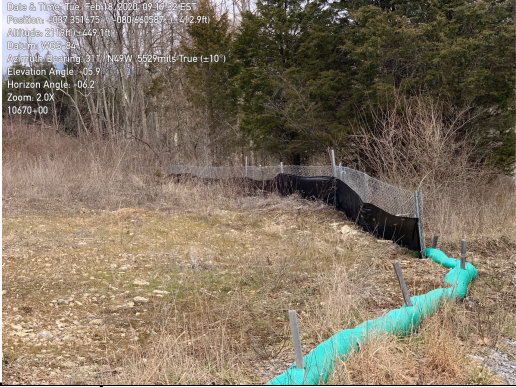
GPS Location	See photo for GPS location.		GPS Location	See photo for GPS location.	
Field Station#	10670+00		Field Station#	10732+50	
Pic 5 Desc.	Reinforced super silt fence in place along LOD.		Pic 6 Desc.	Sensitive resource buffer in place at wetland W-Z11.

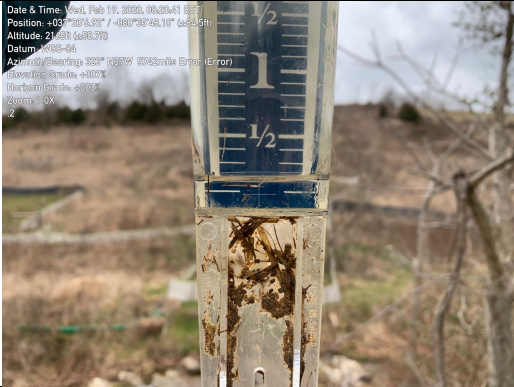
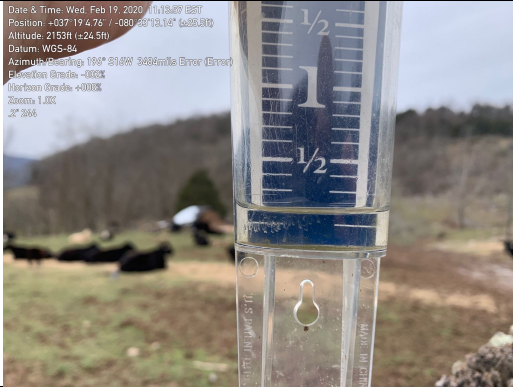
<p>Date & Time: Wed, Feb 19, 2020, 11:13:47 EST Position: +037°19'4.74" / -080°24'13.14" (-44.30) Altitude: 2153ft (+24.5ft) Datum: WGS-84 Azimuth/Bearing: 189° 31.0° 336mils Error (Error) Elevation Grade: +000% Horizon Grade: +000% Zoom: 1.0X 11078</p>			
GPS Location	See picture above for GPS coordinates		GPS Location	See picture above for GPS coordinates	
Field Station#	+1		Field Station#	+1	
Pic 1 Desc.	.2" of rain recorded @ Kow Camp		Pic 2 Desc.	.2" of rain recorded @ AR 244

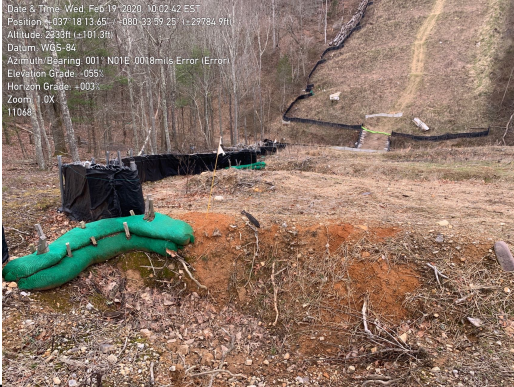
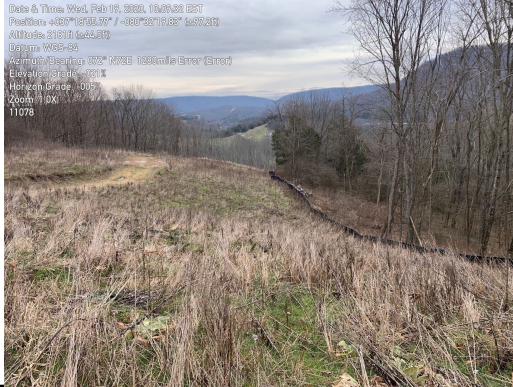
GPS Location	See picture above for GPS coordinates		GPS Location	See picture above for GPS coordinates	
Field Station#	11068+00		Field Station#	11078+00	
Pic 3 Desc.	ECD's and row conditions		Pic 4 Desc.	ECD's and row conditions

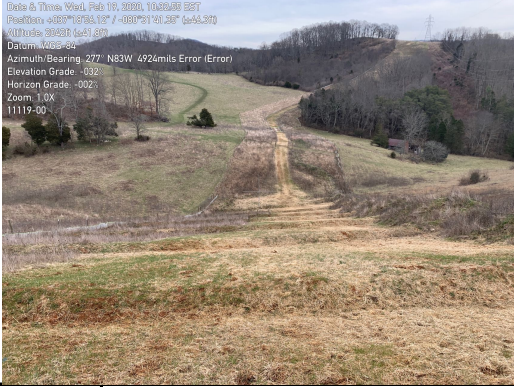
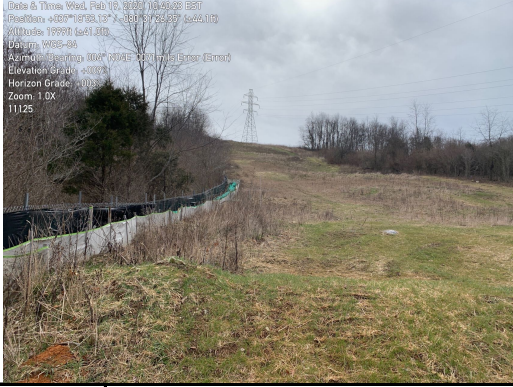
Pic 5 Desc.	ECD's and row conditions		Pic 6 Desc.	ECD's and row conditions

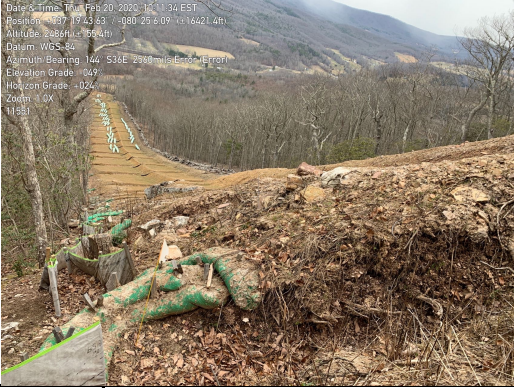
GPS Location	See picture above for GPS coordinates		GPS Location	See picture above for GPS coordinates	
Field Station#	11535+00		Field Station#	11551+00	
Pic 1 Desc.	Damaged SSF		Pic 2 Desc.	ECD's and row conditions

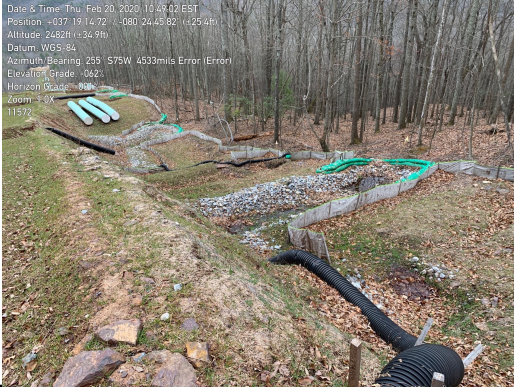
GPS Location	See picture above for GPS coordinates		GPS Location	See picture above for GPS coordinates	
Field Station#	11556+00		Field Station#	11572+00	
Pic 3 Desc.	Damaged curlex		Pic 4 Desc.	ECD's and row conditions

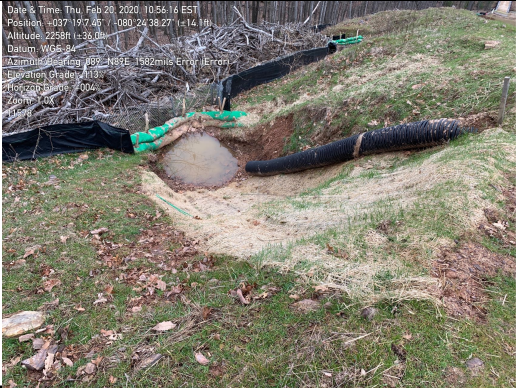
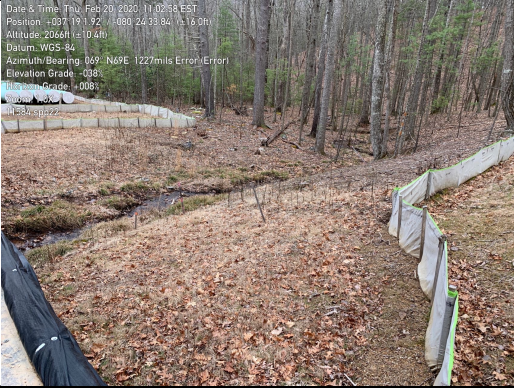
GPS Location	See picture above for GPS coordinates		GPS Location	See picture above for GPS coordinates	
Field Station#	11578+00		Field Station#	11584+00	
Pic 5 Desc.	ECD's and row conditions		Pic 6 Desc.	ECD's and row conditions S-PP22

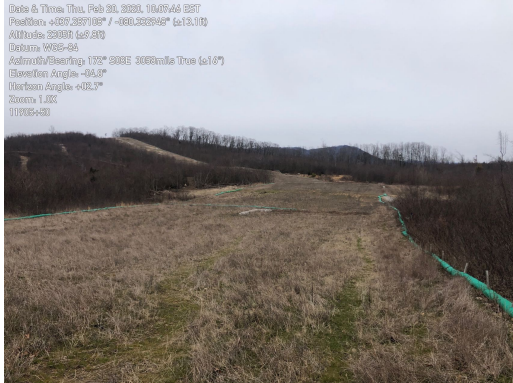
<p> <small> Date & Time: Thu, Feb 20, 2020, 10:05:44 CST Position: +48°29'59" / -88.3497° (±13.3%) Altitude: 2300ft (±6.8%) Datum: WGS-84 Azimuth/Bearing: 172° 3085 3086mils True (±10°) Elevation Angle: -04.5° Horizon Angle: +05.5° Zoom: 1.0X 11905+50 </small> </p>

GPS Location	3	GPS Location	4		
Field Station#	11863+65	Field Station#	11905+50		
Pic 3 Desc.	P-KL2.	Pic 4 Desc.	Partially restored section of RoW and controls.		
<p> <small> Date & Time: Thu, Feb 20, 2020, 10:44:07 CST Position: +48°29'59" / -88.3497° (±13.3%) Altitude: 2370ft (±6.8%) Datum: WGS-84 Azimuth/Bearing: 102° 5135 5136mils True (±10°) Elevation Angle: +0.1° Horizon Angle: -00.0° Zoom: 1.0X 11938+50 </small> </p>

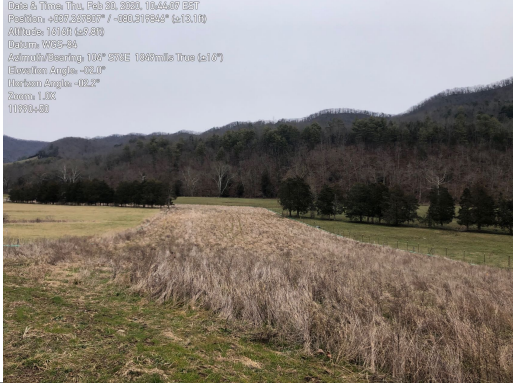
<p> <small> Date & Time: Thu, Feb 20, 2020, 10:44:07 CST Position: +48°29'59" / -88.3497° (±13.3%) Altitude: 2370ft (±6.8%) Datum: WGS-84 Azimuth/Bearing: 102° 5135 5136mils True (±10°) Elevation Angle: +0.1° Horizon Angle: -00.0° Zoom: 1.0X 11990+50 </small> </p>

GPS Location	5	GPS Location	6		
Field Station#	11938+50	Field Station#	11990+50		
Pic 5 Desc.	Partially restored section of RoW and controls.	Pic 6 Desc.	Restored section of RoW and controls.

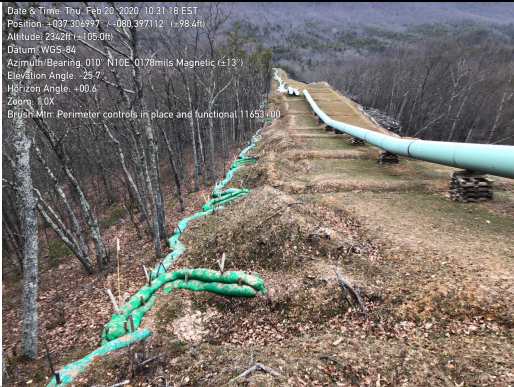
<p>Date & Time: Thu Feb 20, 2020 10:31:16 EST Position: +037.334977 / +080.397112 (+98.4ft) Altitude: 2842ft (+105.0ft) Datum: WGS-84 Azimuth/Bearing: 010° N10E 0178mils Magnetic (+12°) Elevation Angle: -25.7° Horizon Angle: +00.4° Zoom: 1.0X Brush Min. Perimeter controls in place and functional. 11653+00</p>

GPS Location	On photo	GPS Location	On photo		
Field Station#	11653+00	Field Station#	11629+00		
Pic 3 Desc.	Perimeter controls in place. ROW stable.	Pic 4 Desc.	Slope breakers functional. Perimeter controls in place. Surface stable.		
<p>Date & Time: Thu Feb 20, 2020 11:03:36 EST Position: +037.334552 / +080.395911 (+32.8ft) Altitude: 1932ft (+105.0ft) Datum: WGS-84 Azimuth/Bearing: 127° S53E 2268mils Magnetic (+12°) Elevation Angle: -07.2° Horizon Angle: -01.7° Zoom: 1.0X Brush Min. S-HH18 crossing stable. 11626+04</p>

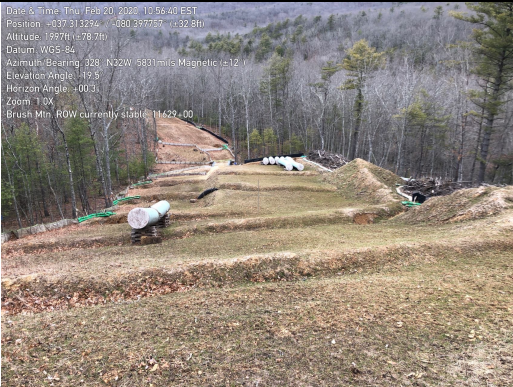
<p>Date & Time: Thu Feb 20, 2020 10:56:40 EST Position: +037.313254 / +080.397252 (+32.8ft) Altitude: 1997ft (+76.7ft) Datum: WGS-84 Azimuth/Bearing: 228° N32W 5831mils Magnetic (+12°) Elevation Angle: +19.9° Horizon Angle: +00.3° Zoom: 1.0X Brush Min. ROW currently stable. 11629+00</p>

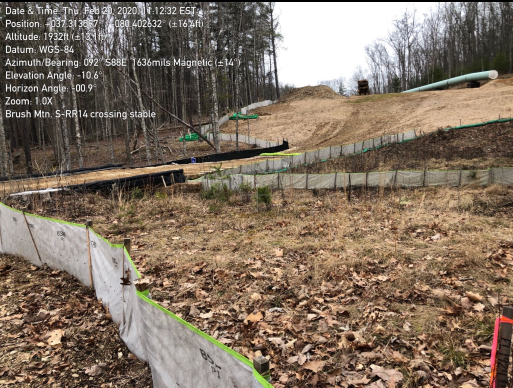
<p>Date & Time: Thu Feb 20, 2020 11:12:32 EST Position: +037.334552 / +080.402322 (+105.0ft) Altitude: 1932ft (+105.0ft) Datum: WGS-84 Azimuth/Bearing: 092° S88E 1636mils Magnetic (+14°) Elevation Angle: -10.6° Horizon Angle: +00.9° Zoom: 1.0X Brush Min. S-RR14 crossing stable</p>

GPS Location	On photo	GPS Location	On photo		
Field Station#	11626+04	Field Station#	11614+20		
Pic 5 Desc.	S-HH18 crossing stable.	Pic 6 Desc.	S-RR14 crossing stable.

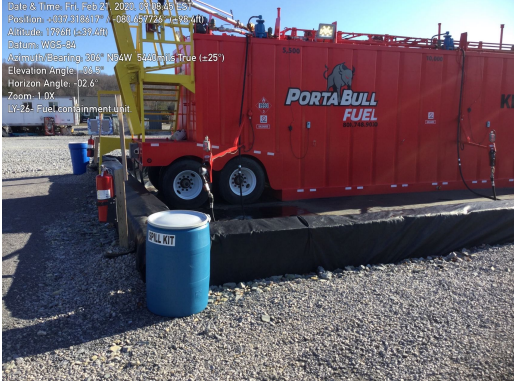
<p>Date & Time: Fri Feb 21, 2020 09:05:50 EST Position: -80.1319213 / -30.0349723 (-25.3 mi) Altitude: 19920 ft (7289 ft) Datum: WGS-84 Azimuth Bearing: 306° 00' 00" W 540 mls True (±25°) Elevation Angle: -12.6° Horizon Angle: -03.6° Zoom: 1.0X LY26- Fuel containment unit</p>

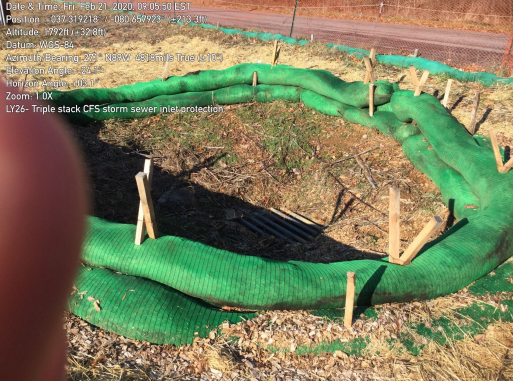
<p>Date & Time: Fri Feb 21, 2020 09:05:50 EST Position: -80.1319213 / -30.0349723 (-25.3 mi) Altitude: 19920 ft (7289 ft) Datum: WGS-84 Azimuth Bearing: 306° 00' 00" W 540 mls True (±25°) Elevation Angle: -12.6° Horizon Angle: -03.6° Zoom: 1.0X LY26- Triple stack CFS storm sewer inlet protection</p>			
GPS Location	See photo for GPS location.	GPS Location	See photo for GPS location.		
Field Station#	12005+00	Field Station#	12005+00		
Pic 1 Desc.	Spill kit on site.	Pic 2 Desc.	TRIPLE STACK CFS.

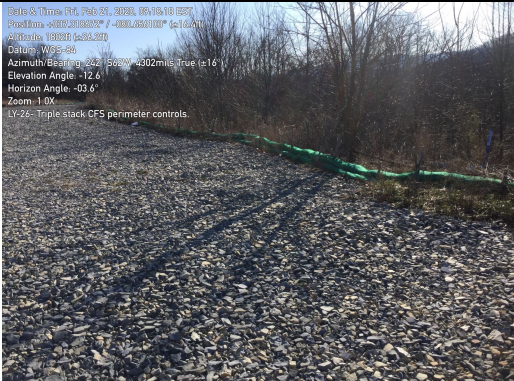
<p>Date & Time: Fri Feb 21, 2020 09:05:50 EST Position: -80.1319213 / -30.0349723 (-25.3 mi) Altitude: 19920 ft (7289 ft) Datum: WGS-84 Azimuth Bearing: 306° 00' 00" W 540 mls True (±25°) Elevation Angle: -12.6° Horizon Angle: -03.6° Zoom: 1.0X LY26- Triple stack CFS perimeter controls</p>
