# Visual Site Inspection Report

<b>Project Name</b>	H-600 Pipeline Spread G	<b>AFE</b>	124300137	<b>Spread</b>	H-600 Pipeline Spread G
<b>Contractor</b>	Precision			<b>Report #</b>	10224
<b>Inspector</b>	Len Kruizenga			<b>Date/Time</b>	4/20/2020 8:13 AM
<b>Permit #</b>	TBD	<b>Inspection Type</b>	VA SWPP	<b>Station Begin</b>	11024+00
<b>State</b>	VA	<b>Inspection Area</b>	Full	<b>Station End</b>	10930+00
<b>County</b>	Giles	<b>Ground</b>	Muddy	<b>Temperature (°F)</b>	51.00
<b>Municipality</b>	N/A	<b>Weather</b>	Light Rain	<b>Rain Gauge (in)</b>	0.60
				<b>Rain Accumulation Time (days)</b>	1.00

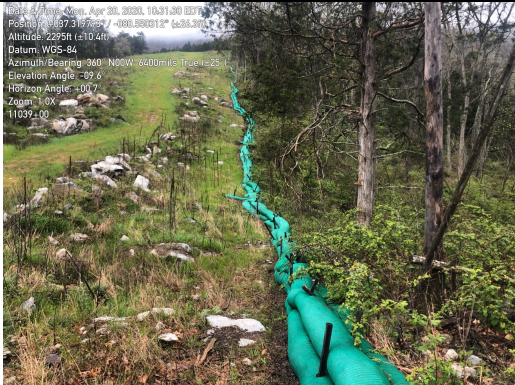
Field Station#		11025+50		11034+00	
Pic 1 Desc.		S-IJ18 and controls.		Pic 2 Desc.	
Pic 2 Desc.		RoW conditions and controls.			
<div><div><div>Date &amp; Time: Mon, Apr 20, 2020, 10:31:00 EDT</div><div>Position: +037.31523° / -80.54595° (±28.1m)</div><div>Altitude: 2295ft (±10.4m)</div><div>Datum: WGS-84</div><div>Azimuth/Bearing: 360° 000° 640mils True (±25°)</div><div>Elevation Angle: -39.6°</div><div>Horizon Angle: -0.7°</div><div>Zoom: 1.0x</div><div>S-IJ16B and S-IJ17</div></div><div>

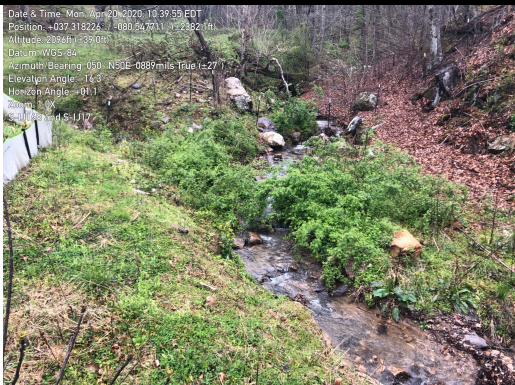
Field Station#		11039+00		4	
Field Station#		11039+00		Field Station#	
Field Station#		11039+00		11050+10	
Pic 3 Desc.		Perimeter controls functional.		Pic 4 Desc.	
Pic 4 Desc.		S-IJ16B and S-IJ17 buffers.			
<div><div><div>Date &amp; Time: Mon, Apr 20, 2020, 10:39:55 EDT</div><div>Position: +037.31523° / -80.54711° (±28.1m)</div><div>Altitude: 2295ft (±10.4m)</div><div>Datum: WGS-84</div><div>Azimuth/Bearing: 050° 050° 639mils True (±27°)</div><div>Elevation Angle: -14.3°</div><div>Horizon Angle: -0.1°</div><div>Zoom: 1.0x</div><div>S-IJ16B and S-IJ17</div></div><div>

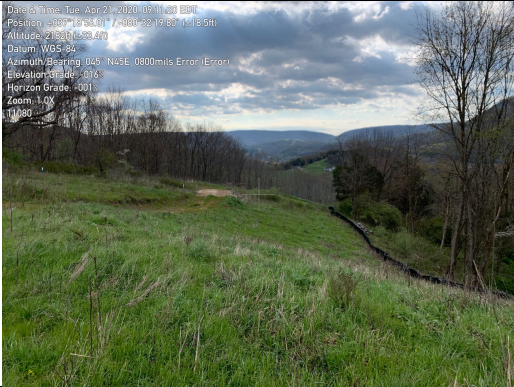
<b>GPS Location</b>	See picture above for GPS coordinates		<b>GPS Location</b>	See picture above for GPS coordinates	
<b>Field Station#</b>	11080+00		<b>Field Station#</b>	11085+00	
<b>Pic 1 Desc.</b>	ECD's and row conditions		<b>Pic 2 Desc.</b>	ECD's and row conditions

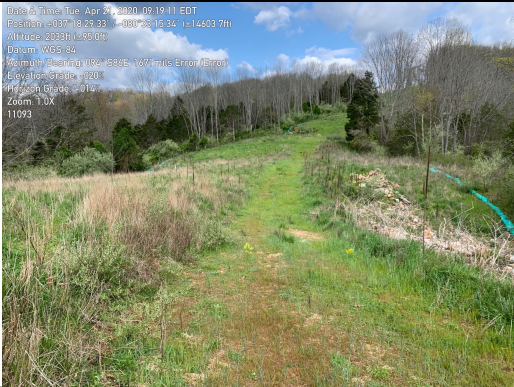
<b>GPS Location</b>	See picture above for GPS coordinates		<b>GPS Location</b>	See picture above for GPS coordinates	
<b>Field Station#</b>	11093+00		<b>Field Station#</b>	111101+00	
<b>Pic 3 Desc.</b>	ECD's and row conditions		<b>Pic 4 Desc.</b>	ECD's and row conditions	
<p>Date &amp; Time: Tue Apr 21, 2020 09:26:29 EDT  Position: +38°16'54.47" / -80°21'41.27" (+15230ft)  Altitude: 2323ft (+11119ft)  Datum: WGS 84  Azimuth/Bearing: 042° N42E 0801mils Error (Error)  Elevation Grade: -001%  Horizon Grade: +001  Zoom: 1.0X  11119</p>

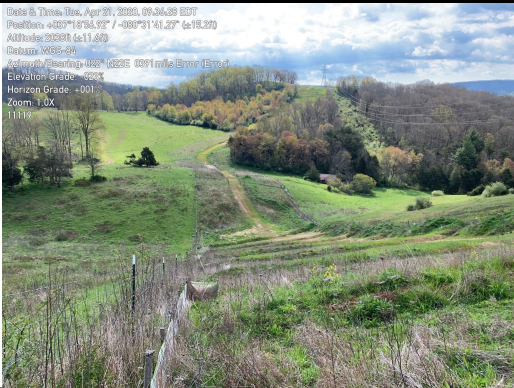
<b>GPS Location</b>	See picture above for GPS coordinates		<b>GPS Location</b>	See picture above for GPS coordinates	
<b>Field Station#</b>	11119+00		<b>Field Station#</b>	11135+00	
<b>Pic 5 Desc.</b>	ECD's and row conditions		<b>Pic 6 Desc.</b>	ECD's and row conditions

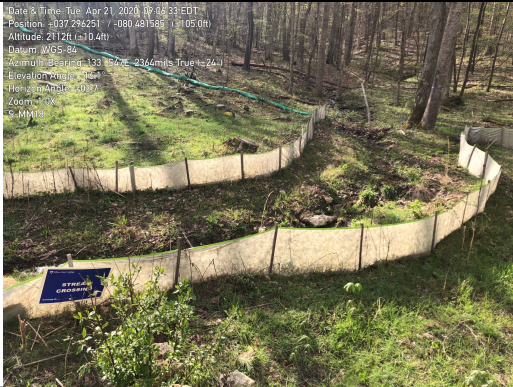
GPS Location				3				GPS Location				4			
Field Station#				11292+80				Field Station#				11327+40			
Pic 3 Desc.				S-MM18 and controls.				Pic 4 Desc.				Turkey nest containing eggs within the buffer of S-NN12.

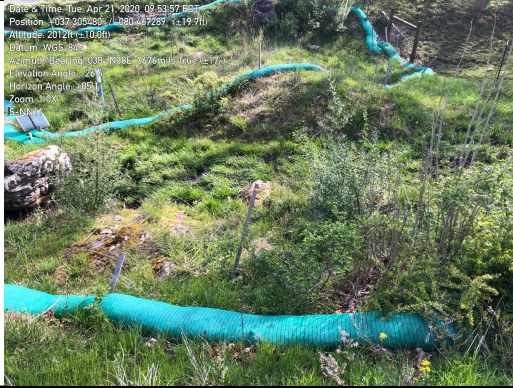
GPS Location				5				GPS Location				6			
Field Station#				11327+85				Field Station#				11352+97			
Pic 5 Desc.				S-NN12 and controls.				Pic 6 Desc.				S-NN11 and controls.

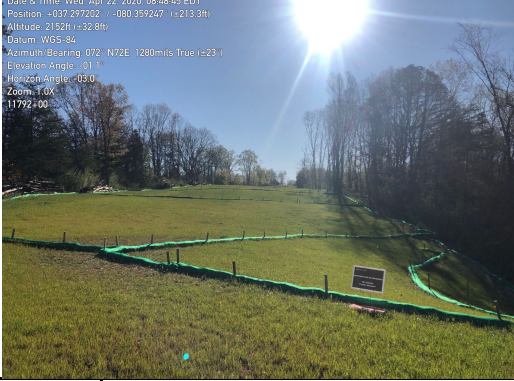
<b>GPS Location</b>	1	<b>GPS Location</b>	2		
<b>Field Station#</b>	11792+00	<b>Field Station#</b>	11818+00		
<b>Pic 1 Desc.</b>	Section of restored RoW showing conditions and controls.		<b>Pic 2 Desc.</b>	Section of restored RoW showing conditions and controls.	
<p>Date &amp; Time: Wed Apr 22, 2020 09:03:19 EDT  Position: +037.288696 / -080.348510 (+13.7ft)  Altitude: 2261ft (+9.8ft)  Datum: WGS-84  Azimuth/Bearing: 131° S45E 3389mils True (±15°)  Elevation Angle: -01°  Horizon Angle: -05.1°  Zoom: 1.0X  11835+00</p>

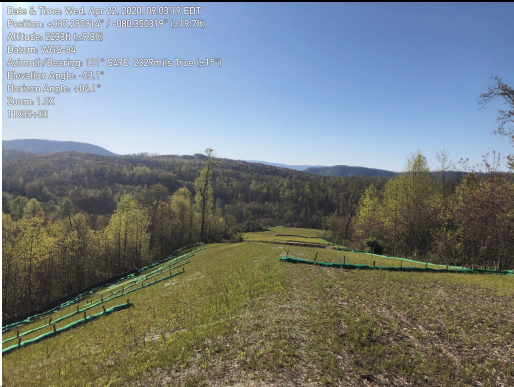
<b>GPS Location</b>	3	<b>GPS Location</b>	4		
<b>Field Station#</b>	11835+00	<b>Field Station#</b>	11844+00		
<b>Pic 3 Desc.</b>	Section of restored RoW showing conditions and controls.		<b>Pic 4 Desc.</b>	Perimeter controls functional.	
<p>Date &amp; Time: Wed Apr 22, 2020 09:26:59 EDT  Position: +037.23777 / -080.339294 (+13.1ft)  Altitude: 2189ft (+9.8ft)  Datum: WGS-84  Azimuth/Bearing: 099° S81E 1740mils True (±15°)  Elevation Angle: -02.2  Horizon Angle: -00.5  Zoom: 1.0X  11886+00</p>  		<p>Date &amp; Time: Wed Apr 22, 2020 09:32:20 EDT  Position: +037.237321 / -080.334748 (+19.7ft)  Altitude: 2241ft (+9.8ft)  Datum: WGS-84  Azimuth/Bearing: 279° N81W 4960mils True (±51°)  Elevation Angle: -02.9°  Horizon Angle: -01.4  Zoom: 1.0X  11899+00</p>

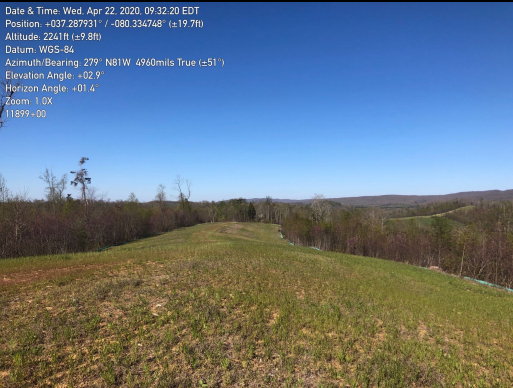
<b>GPS Location</b>	5	<b>GPS Location</b>	6		
<b>Field Station#</b>	11886+00	<b>Field Station#</b>	11899+00		
<b>Pic 5 Desc.</b>	Section of restored RoW showing conditions and controls.		<b>Pic 6 Desc.</b>	Section of restored RoW showing conditions and controls.

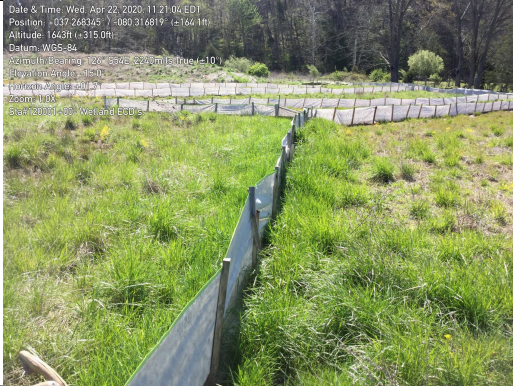
<p>Date &amp; Time: Wed, Apr 22, 2020, 09:58:57 EDT Position: +037.273771° N +080.325511° W (+90.40) Altitude: 1739ft (+210.0m) Datum: WGS-84 Azimuth/Bearing: 232° SSW 416mils True (+25°) Elevation Angle: -13.5° Horizon Angle: +02.8° Zoom: 1.0x Sta#11962+00- Contractor has cut up fallen tree &amp; removed it from ECD's.</p>

<b>GPS Location</b>	See photo GPS		<b>GPS Location</b>	See photo GPS	
<b>Field Station#</b>	11962+00		<b>Field Station#</b>	12001+00	
<b>Pic 5 Desc.</b>	Contractor has removed fallen tree from controls.		<b>Pic 6 Desc.</b>	Wetland ECD's are in acceptable condition.

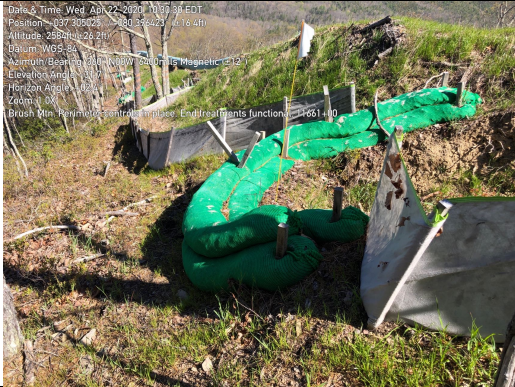
<p>Date &amp; Time: Wed Apr 22, 2020, 10:20:50 EDT  Position: +037.333385 / -080.393884 (-32.81n)  Altitude: 2938ft (-39.4n)  Datum: WGS-84  Azimuth/Bearing: 300° N65W 5333mils Magnetic (-12.6)  Elevation Angle: -02.6  Horizon Angle: -01.3  Zoom: 1.0X  Brush Min. Perimeter controls in place. End treatments functional. 11661+00</p>

<b>GPS Location</b>	On photo	<b>GPS Location</b>	On photo		
<b>Field Station#</b>	11669+70	<b>Field Station#</b>	11661+00		
<b>Pic 1 Desc.</b>	Topsoil piles stable. Perimeter controls in place.	<b>Pic 2 Desc.</b>	End treatments and perimeter controls functional.

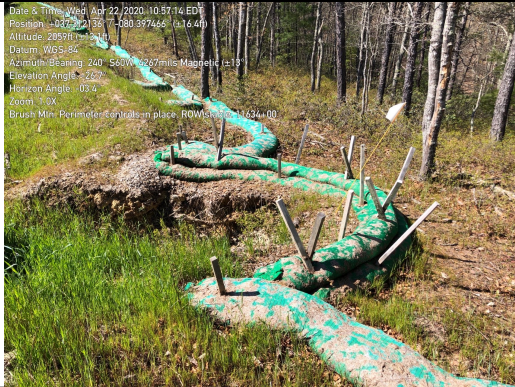
<p>Date &amp; Time: Wed Apr 22, 2020, 10:57:16 EDT  Position: +037.333385 / -080.397461 (-32.81n)  Altitude: 2859ft (-39.4n)  Datum: WGS-84  Azimuth/Bearing: 240° S40W 5533mils Magnetic (-12.6)  Elevation Angle: -02.6  Horizon Angle: -03.4  Zoom: 1.0X  Brush Min. Perimeter controls in place. ROW stable. 11634+00</p>

<b>GPS Location</b>	On photo	<b>GPS Location</b>	On photo		
<b>Field Station#</b>	11644+00	<b>Field Station#</b>	11634+00		
<b>Pic 3 Desc.</b>	Perimeter controls in place. ROW stable.	<b>Pic 4 Desc.</b>	Perimeter controls are in place and effective.		
<p>Date &amp; Time: Wed Apr 22, 2020, 11:08:21 EDT  Position: +037.313626 / -080.398620 (-32.81n)  Altitude: 1918ft (-32.8n)  Datum: WGS-84  Azimuth/Bearing: 273° N87W 4853mils Magnetic (-12.6)  Elevation Angle: -02.6  Horizon Angle: -01.0  Zoom: 1.0X  Brush Min. S-HH18 crossing stable. 11626+04</p>

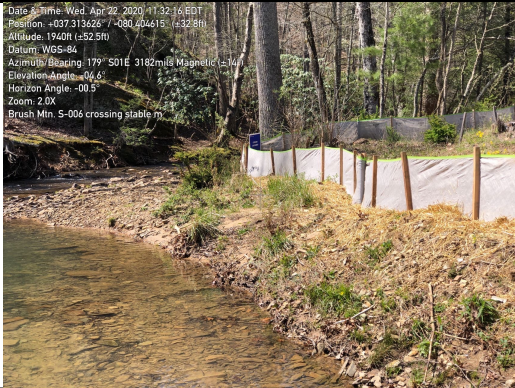
<p>Date &amp; Time: Wed Apr 22, 2020, 11:32:16 EDT  Position: +037.313626 / -080.398620 (-32.81n)  Altitude: 1940ft (-32.5n)  Datum: WGS-84  Azimuth/Bearing: 179° S01E 3182mils Magnetic (-12.6)  Elevation Angle: -06.6  Horizon Angle: -00.6  Zoom: 2.0X  Brush Min. S-006 crossing stable m.</p>

<b>GPS Location</b>	On photo	<b>GPS Location</b>	On photo		
<b>Field Station#</b>	11626+04	<b>Field Station#</b>	11607+81		
<b>Pic 5 Desc.</b>	Buffers at S-HH18 crossing stable with ECDs in place.	<b>Pic 6 Desc.</b>	S-006 crossing is stable.

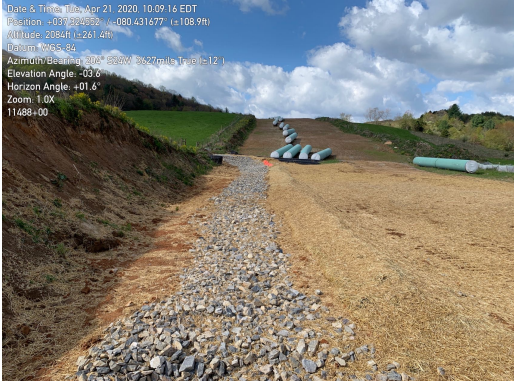
<p>Date &amp; Time: Tue, Apr 21, 2020 08:28:53 EDT Position: +031.231747 / -080.459387 (+12129.00) Altitude: 2000ft (+152.4m) Datum: WGS-84 Azimuth/Bearing: 240° S30W 4200mils True (+13°) Elevation Angle: -01° Horizon Angle: -00.5° Zoom: 1.0X 11503+00</p>			
<b>GPS Location</b>	See photo for GPS location.		<b>GPS Location</b>	See photo for GPS location.	
<b>Field Station#</b>	11507+00		<b>Field Station#</b>	11503+00	
<b>Pic 1 Desc.</b>	Clean water diversion pipe and plunge pool in place.		<b>Pic 2 Desc.</b>	Conveyance channel with rock checks in place at double cut section of ROW.

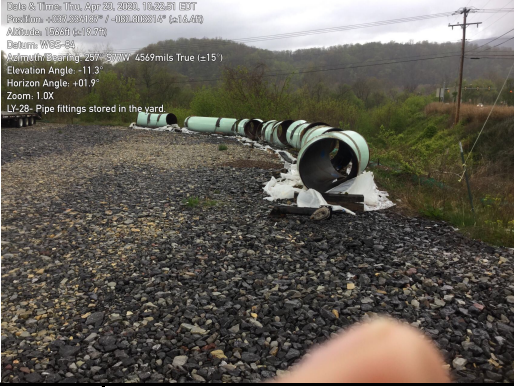
<b>GPS Location</b>	See photo GPS		<b>GPS Location</b>	See photo GPS	
<b>Field Station#</b>	12005+00		<b>Field Station#</b>	12005+00	
<b>Pic 3 Desc.</b>	LY-28- CFS perimeter controls.		<b>Pic 4 Desc.</b>	LY-28- Truck storage, containment under trucks.

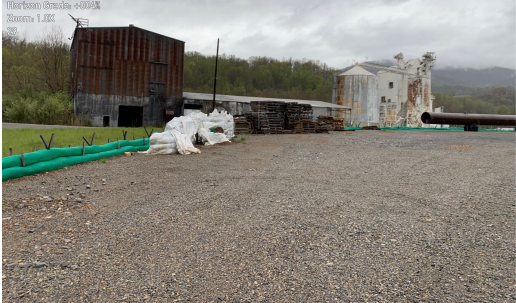
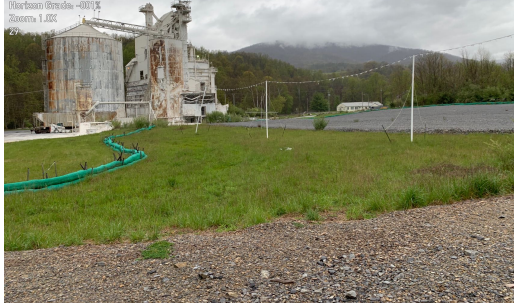
GPS Location	See picture above for GPS coordinates		GPS Location	See picture above for GPS coordinates	
Field Station#	12005+00		Field Station#	12005+00	
Pic 1 Desc.	ECD's and row conditions		Pic 2 Desc.	ECD's and row conditions	
		<p>Date &amp; Time: Thu Apr 23 2020 09:45:00 EDT  Position: -037°22'36.39" / -080°40'44.38" (-15.9M)  Altitude: 2120ft (-11.5M)  Datum: WGS-84  Azimuth: Bearing: 222° S22W 222mils Error: Error  Elevation Grade: -03%  Horizon Grade: -01%  Zoom: 1.00X  234</p>

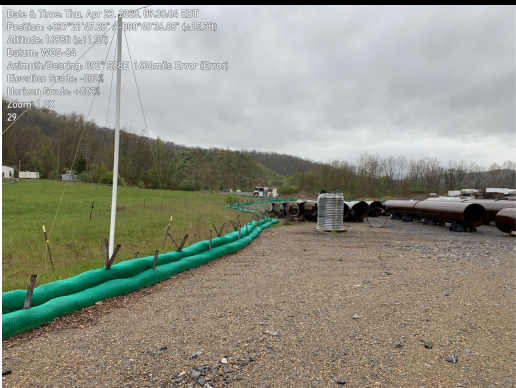
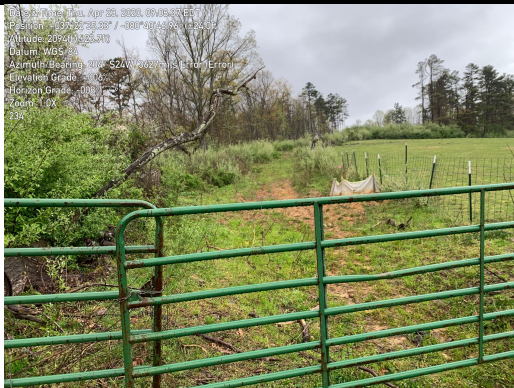
GPS Location	See picture above for GPS coordinates		GPS Location	See picture above for GPS coordinates	
Field Station#	12005+00		Field Station#	2+34	
Pic 5 Desc.	ECD's and row conditions		Pic 6 Desc.	ECD's and row conditions

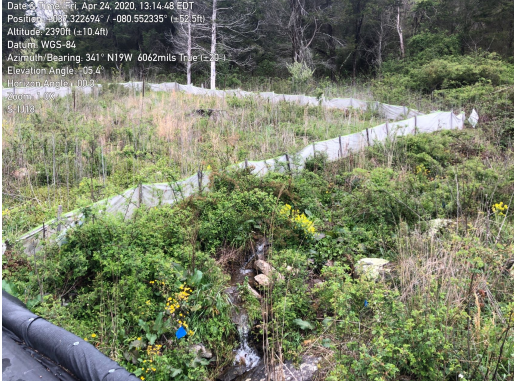
GPS Location		GPS Location	
1		2	
Field Station#		Field Station#	
11025+50		11034+00	
Pic 1 Desc.		Pic 2 Desc.	
S-IJ18 and controls.		RoW conditions and controls.

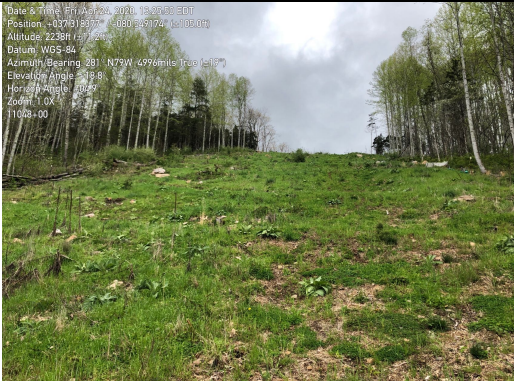
GPS Location		GPS Location	
3		4	
Field Station#		Field Station#	
11048+00		11050+14	
Pic 3 Desc.		Pic 4 Desc.	
RoW conditions and controls.		S-IJ16B and S-IJ17 and controls.

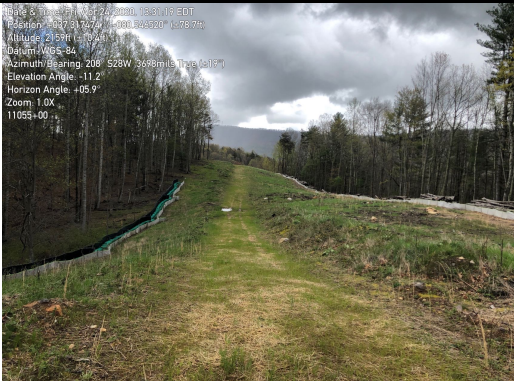
GPS Location		GPS Location	
5		6	
Field Station#		Field Station#	
11055+00		11064+50	
Pic 5 Desc.		Pic 6 Desc.	
RoW conditions and controls.		RoW conditions and controls.

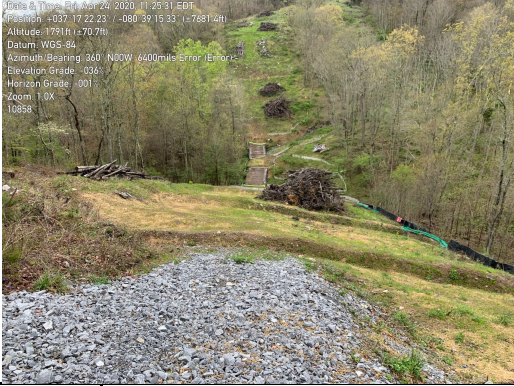
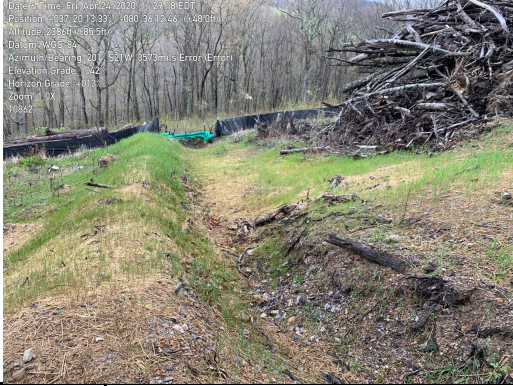
<p>Date &amp; Time: Fri, Apr 24, 2020 11:25:38 EDT Position: +037°12'23.23" / -080°39'15.33" (+7881.4m) Altitude: 1791ft (+70.7m) Datum: WGS-84 Azimuth/Bearing: 360° N00W 6400mils Error/ Error Elevation Grade: +036° Horizon Grade: +001° Zoom: 1.0X 10862</p>			
<b>GPS Location</b>	See picture above for GPS coordinates		<b>GPS Location</b>	See picture above for GPS coordinates	
<b>Field Station#</b>	10858+00		<b>Field Station#</b>	10862+00	
<b>Pic 1 Desc.</b>	ECD's and row conditions		<b>Pic 2 Desc.</b>	ECD's and row conditions

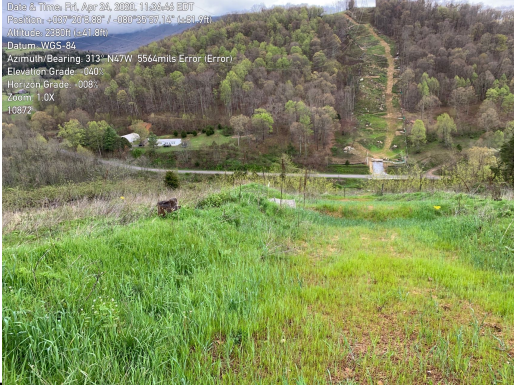
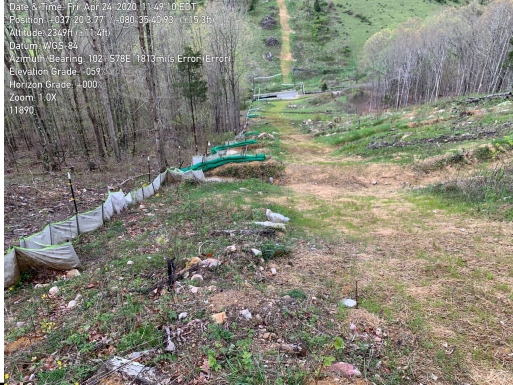
<b>GPS Location</b>	See picture above for GPS coordinates		<b>GPS Location</b>	See picture above for GPS coordinates	
<b>Field Station#</b>	10872+00		<b>Field Station#</b>	11890+00	
<b>Pic 3 Desc.</b>	ECD's and row conditions		<b>Pic 4 Desc.</b>	ECD's and row conditions

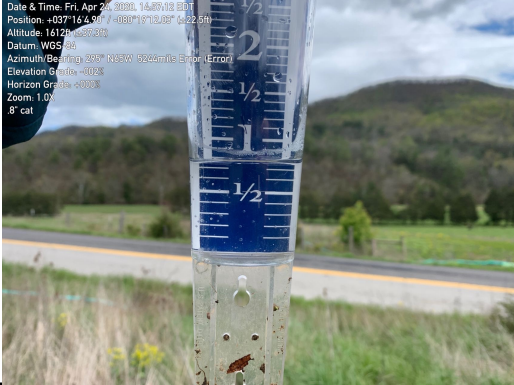
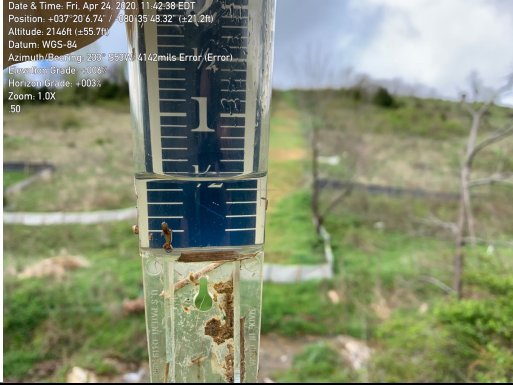
<b>Field Station#</b>	+1		<b>Field Station#</b>	+1	
<b>Pic 5 Desc.</b>	.8" of rain recorded @ Catawba		<b>Pic 6 Desc.</b>	.5" of rain recorded @ Kow Camp

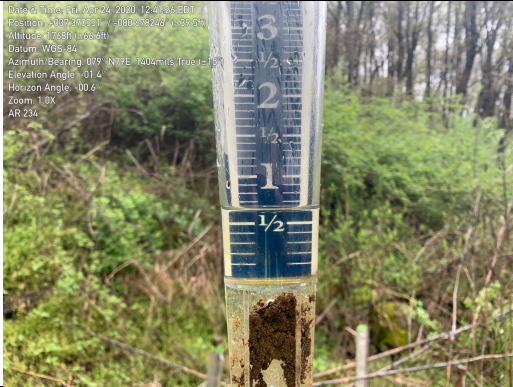
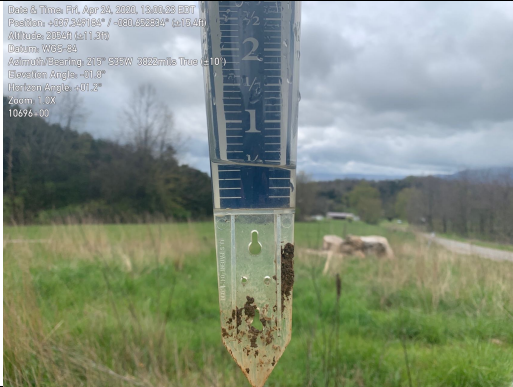
<p>Date &amp; Time: Fri, Apr 24, 2020 13:00:43 EDT Position: +037 349238 / -080 652884 (+15.4ft) Altitude: 2056ft (+11.2ft) Datum: WGS-84 Azimuth/Bearing: 103 S 72E 1920mils True (+10) Elevation Angle: -11.2 Horizon Angle: -03.0 Zoom: 1.0X 10696+00</p>			
GPS Location	See photo for GPS location.		GPS Location	See photo for GPS location.	
Field Station#	12005+00		Field Station#	10696+00	
Pic 1 Desc.	Rain gauge at Access Road 234 reads 0.6 inches.		Pic 2 Desc.	Rain gauge at Buffalo Anklets Road reads 0.5 inches.

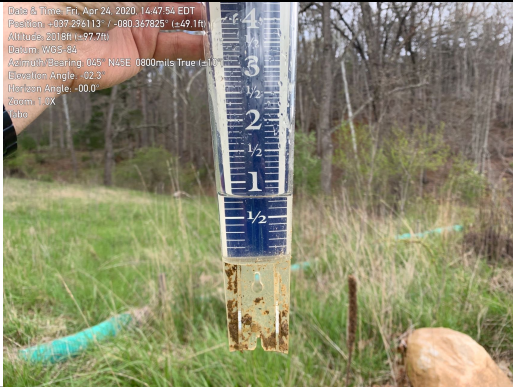
GPS Location	See photo for GPS location.		GPS Location	See photo for GPS location.	
Field Station#	11767+00		Field Station#	10696+00	
Pic 3 Desc.	Rain gauge at Mount Tabor Road reads 0.8 inches.		Pic 4 Desc.	RCE in place at Buffalo Anklets Road.

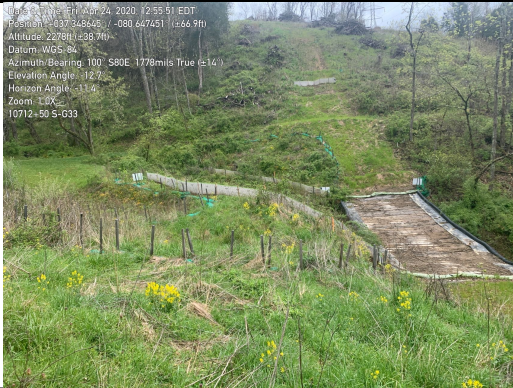
<p>Date &amp; Time: Fri, Apr 24, 2020 12:55:53 EDT Position: +037 346452 / -080 647451 (+86.9ft) Altitude: 2278ft (+38.7ft) Datum: WGS-84 Azimuth/Bearing: 100 S 80E 1778mils True (+14) Elevation Angle: -12.7 Horizon Angle: -11.9 Zoom: 1.0X 10712+50 S-G33</p>			
GPS Location	See photo for GPS location.		GPS Location	See photo for GPS location.	
Field Station#	10698+00		Field Station#	10712+50

Pic 5 Desc.	Sensitive resource buffer in place at stream S-G32.		Pic 6 Desc.	Sensitive resource buffer in place at stream S-G33.
