Visual Site Inspection Report

Project Name	H-600 Pipeline Spread G	AFE	124300137	Spread	H-600 Pipeline Spread G
Contractor	Precision			Report #	10838
Inspector	Len Kruizenga			Date/Time	5/11/2020 8:27 AM
Permit #	TBD	Inspection Type	VA SWPP	Station Begin	12005+00
State	VA	Inspection Area	Full	Station End	12005+00
County	Giles	Ground	Dry	Temperature (°F)	44.00
Municipality	N/A	Weather	Cloudy	Rain Gauge (in)	0.30
				Rain Accumulation Time (days)	1.00

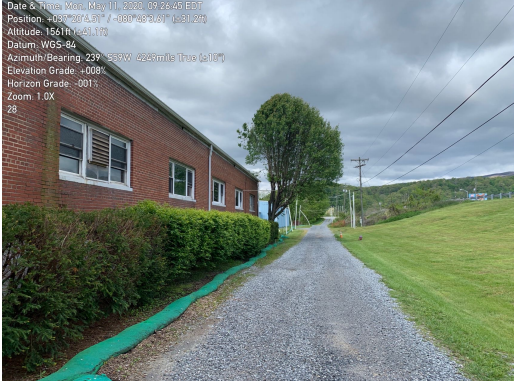
<p><small>Date & Time: Mon May 11, 2020 09:30:30 EDT Position: +037 16 43 23 / -080 24 8 96 (-1200.24) Altitude: 1263ft (+46.2ft) Datum: WGS-84 Azimuth/Bearing: 073 / N73E 123mils True (+23°) Elevation Grade: -012 Horizon Grade: -00ft Zoom: 1.0X 1" craig</small></p>			
GPS Location	See picture above for GPS coordinates		GPS Location	See picture above for GPS coordinates	
Field Station#	12005+00		Field Station#	12005+00	
Pic 1 Desc.	ECD's and row conditions		Pic 2 Desc.	ECD's and row conditions

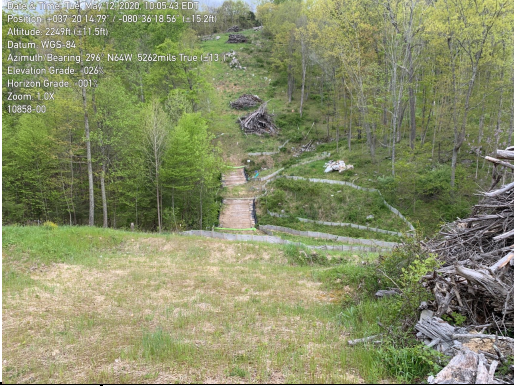
GPS Location	See picture above for GPS coordinates		GPS Location	See picture above for GPS coordinates	
Field Station#	10858+00		Field Station#	10869+00	
Pic 1 Desc.	ECD's and row conditions		Pic 2 Desc.	ECD's and row conditions

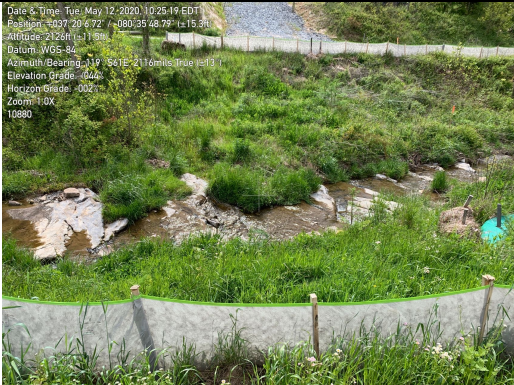
GPS Location	See picture above for GPS coordinates		GPS Location	See picture above for GPS coordinates	
Field Station#	10880+00		Field Station#	10890+00	
Pic 3 Desc.	ECD's and row conditions		Pic 4 Desc.	ECD's and row conditions

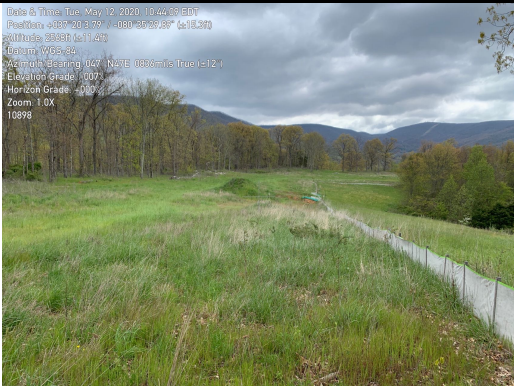
GPS Location	See picture above for GPS coordinates		GPS Location	See picture above for GPS coordinates	
Field Station#	10898+00		Field Station#	10911+00	
Pic 5 Desc.	ECD's and row conditions		Pic 6 Desc.	ECD's and row conditions

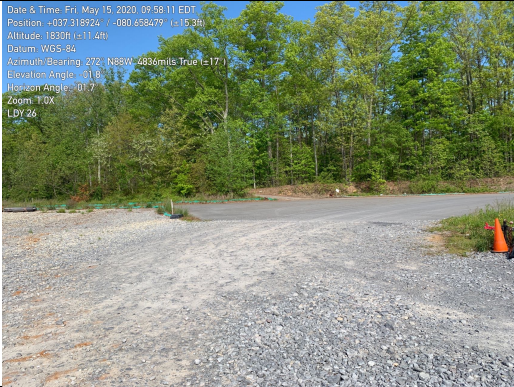
GPS Location	See photo for GPS location.		GPS Location	See photo for GPS location.	
Field Station#	12005+00		Field Station#	12005+00	
Pic 1 Desc.	RCE in place at Lay Down Yard 26 entrance.		Pic 2 Desc.	Secondary containment in place under fuel cell.	
<p>Date & Time: Fri, May 15, 2020 09:59:43 EDT Position: +037.318509 / -080.457623 / +15.31ft Altitude: 1830ft (+11.4ft) Datum: WGS-84 Azimuth/Bearing: 177° S03E 3147mils True (+17°) Elevation Angle: -02.3° Horizon Angle: -05.3° Zoom: 1.0X LBY: 26</p>

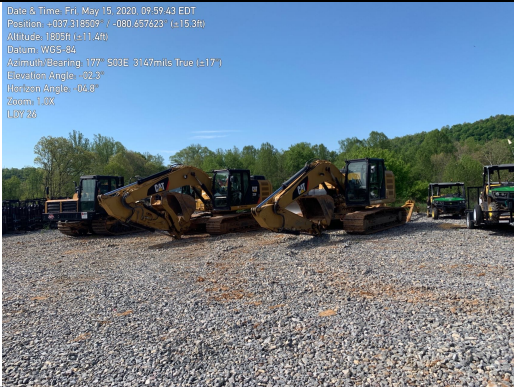
GPS Location	See photo for GPS location.		GPS Location	See photo for GPS location.	
Field Station#	12005+00		Field Station#	10883+50	
Pic 3 Desc.	Checked staged equipment for leaks.		Pic 4 Desc.	Rain gauge at Kow Camp Road reads 0.0 inches.	
<p>Date & Time: Fri, May 15, 2020 10:24:32 EDT Position: +037.318011 / -080.553578 / +17.07ft Altitude: 1830ft (+11.4ft) Datum: WGS-84 Azimuth/Bearing: 276° N84W 4907mils True (+17°) Elevation Angle: -04.8° Horizon Angle: -02.4° Zoom: 1.0X AR 26A</p>

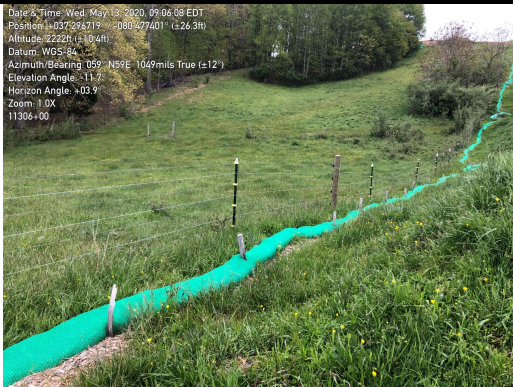
GPS Location						3					
Field Station#						11306+00					
Pic 3 Desc.						Perimeter controls functional.					
GPS Location						4					
Field Station#						11327+85					
Pic 4 Desc.						S-NN12 and controls.					
<p>Date & Time: Wed, May 13, 2020, 09:36:29 EDT Position: +037.304574 / -080.466947 (+197.5m) Altitude: 20761 (+10.4m) Datum: WGS-84 Azimuth/Bearing: 020° N20E 0356mils True (+12°) Elevation Angle: -14.4° Horizon Angle: +01.5° Zoom: 1.0X 11349+00</p>

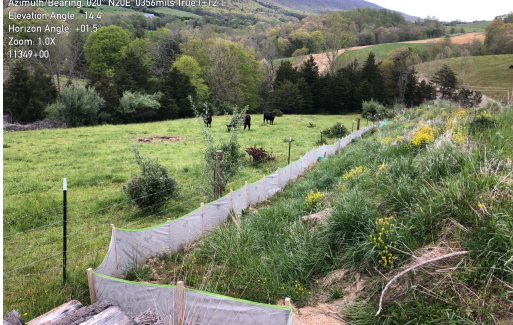
GPS Location						5					
Field Station#						11349+00					
Pic 5 Desc.						Perimeter controls functional.					
GPS Location						6					
Field Station#						11352+97					
Pic 6 Desc.						S-NN11 and controls.

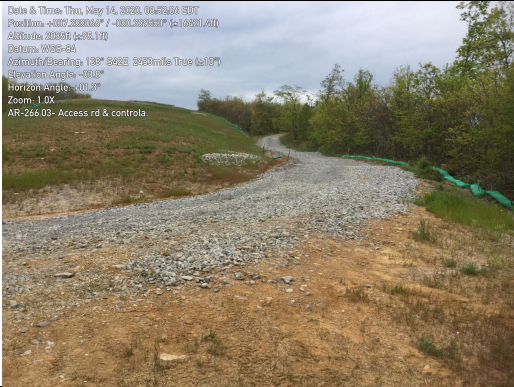
AFE	124300137	Date/Time	5/14/2020 1:44 PM	Report #	
Pictures					
<p>Date & Time: Thu, May 14, 2020, 06:45:00 EDT Position: +037.299034° / -080.327607° (±16.6ft) Altitude: 2227ft (±26.2ft) Datum: WGS-84 Azimuth/Bearing: 136° S26E 540mils True (±10°) Elevation Angle: -80.5° Horizon Angle: -01.0° Zoom: 1.0x AR-266.03- Access rd & controls</p>

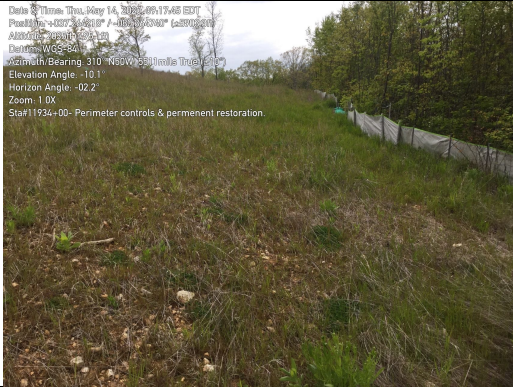
<p>Date & Time: Thu, May 14, 2020, 06:17:46 EDT Position: +037.336107° / -080.327607° (±16.6ft) Altitude: 1934ft (±39.0ft) Datum: WGS-84 Azimuth/Bearing: 310° N36W 500mils True (±10°) Elevation Angle: -10.1° Horizon Angle: -02.2° Zoom: 1.0x Sta#11934+00- Perimeter controls & permanent restoration.</p>

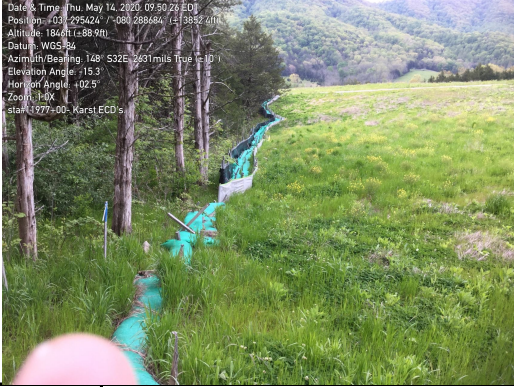
GPS Location	See photo GPS	GPS Location	See photo GPS		
Field Station#	11942+00	Field Station#	11969+50		
Pic 3 Desc.	Karst ECD's	Pic 4 Desc.	Row vegetation		
<p>Date & Time: Thu, May 14, 2020, 09:50:26 EDT Position: +037.225024° / -080.260564° (±16.6ft) Altitude: 1841ft (±88.9ft) Datum: WGS-84 Azimuth/Bearing: 148° S32E 293mils True (±10°) Elevation Angle: -15.3° Horizon Angle: +02.5° Zoom: 1.0x Sta#11977+00- Karst ECD's</p>

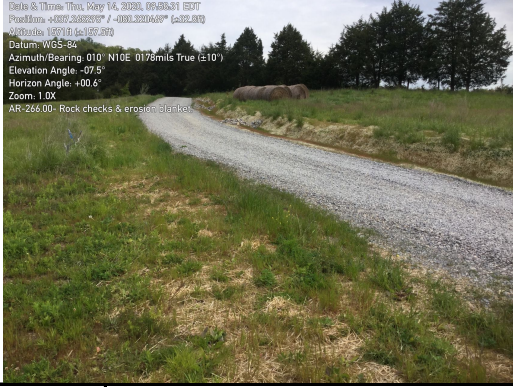
<p>Date & Time: Thu, May 14, 2020, 09:56:51 EDT Position: +037.268607° / -080.232469° (±16.6ft) Altitude: 1971ft (±39.0ft) Datum: WGS-84 Azimuth/Bearing: 010° N10E 0178mils True (±10°) Elevation Angle: -07.5° Horizon Angle: +00.6° Zoom: 1.0x AR-264.00- Rock checks & erosion control box</p>

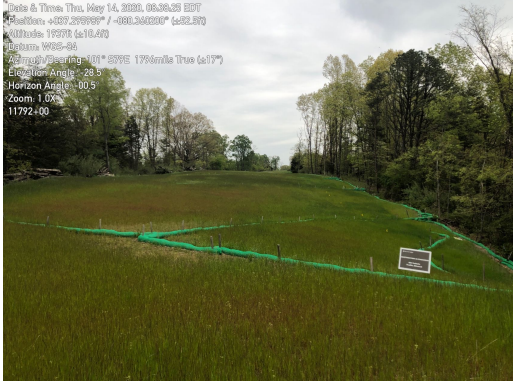
GPS Location	1		GPS Location	2	
Field Station#	11792+00		Field Station#	11818+00	
Pic 1 Desc.	Section of restored RoW showing conditions and controls.		Pic 2 Desc.	Section of restored RoW showing conditions and controls.

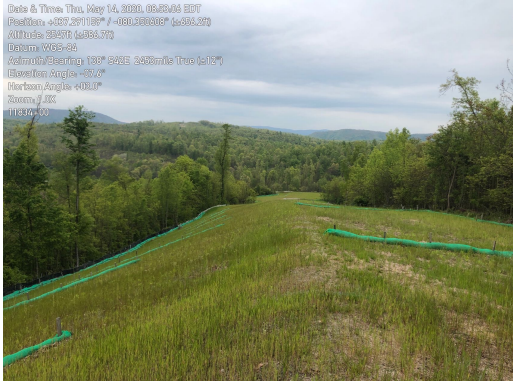
GPS Location	3		GPS Location	4	
Field Station#	11834+00		Field Station#	11841+50	
Pic 3 Desc.	Section of restored RoW showing conditions and controls.		Pic 4 Desc.	Section of restored RoW showing conditions and controls.
