# Visual Site Inspection Report

<b>Project Name</b>	H-600 Pipeline Spread G	<b>AFE</b>	124300137	<b>Spread</b>	H-600 Pipeline Spread G
<b>Contractor</b>	Precision			<b>Report #</b>	11036
<b>Inspector</b>	Jared Saunders			<b>Date/Time</b>	5/18/2020 12:21 PM
<b>Permit #</b>	TBD	<b>Inspection Type</b>	VA SWPP	<b>Station Begin</b>	10670+00
<b>State</b>	VA	<b>Inspection Area</b>	Partial	<b>Station End</b>	10750+00
<b>County</b>	Giles	<b>Ground</b>	Damp	<b>Temperature (°F)</b>	65.00
<b>Municipality</b>	N/A	<b>Weather</b>	Cloudy	<b>Rain Gauge (in)</b>	0.00
				<b>Rain Accumulation Time (days)</b>	1.00

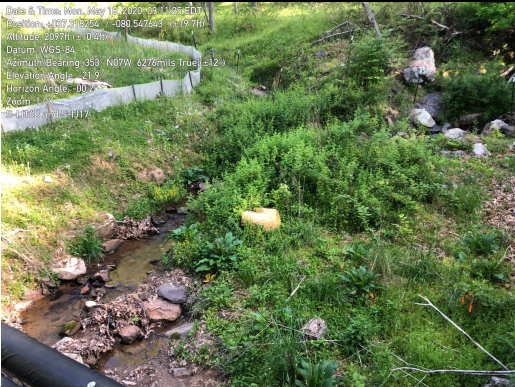
<b>GPS Location</b>	3	<b>GPS Location</b>	4		
<b>Field Station#</b>	11049+00	<b>Field Station#</b>	11050+10		
<b>Pic 3 Desc.</b>	RoW conditions and controls.	<b>Pic 4 Desc.</b>	S-IJ16B and S-IJ17 and controls.		
<p>Date &amp; Time: Mon, May 18, 2020 09:10:16 EDT  Position: +037.318070 / -080.546070 / (+105.0m)  Altitude: 2070ft (+12.3m)  Datum: WGS-84  Azimuth/Bearing: 161° S19E 262mils True (+13.4°)  Elevation Angle: -02.9°  Horizon Angle: -00.5°  Zoom: 1.0x  11055+00</p>

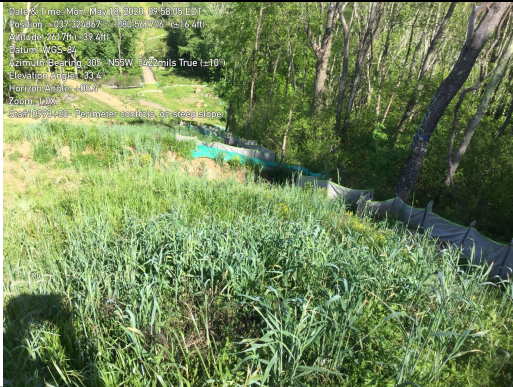
<p>Date &amp; Time: Mon, May 18, 2020 10:05:31 EDT Position: +037 32587° / -080 55003° (+16.4ft) Altitude: 2340ft (+39.4ft) Datum: WGS-84 Azimuth/Bearing: 201° N39W 4676mils True (+05°) Elevation Angle: +00.4° Horizon Angle: +00.7° Zoom: 1.0x Start 10993+00 - Perimeter controls on steep slope</p>

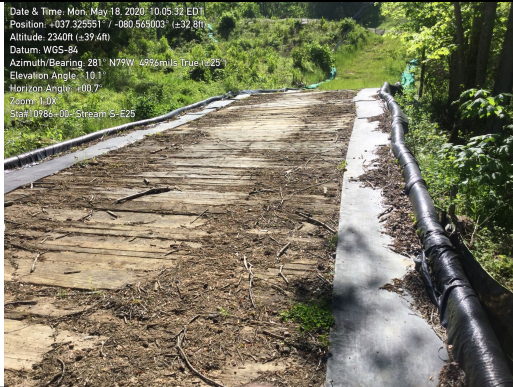
<p>Date &amp; Time: Mon, May 18, 2020 10:05:32 EDT Position: +037 32587° / -080 55003° (+16.4ft) Altitude: 2340ft (+39.4ft) Datum: WGS-84 Azimuth/Bearing: 281° N79W 4676mils True (+05°) Elevation Angle: +00.1° Horizon Angle: +00.7° Zoom: 1.0x Start 10986+00 - Stream S-E25</p>

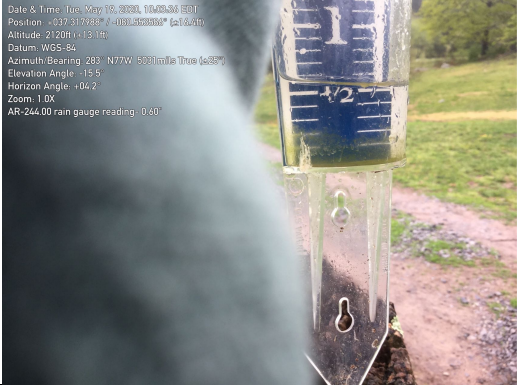
<p> <small> Date &amp; Time: Tue May 19, 2020, 10:05:34 EDT  Position: +037.317288° N +080.520380° W (s=12.42)  Altitude: 2120ft (+131ft)  Datum: WGS-84  Azimuth/Bearing: 288° N77W 533inile True (s=5)  Elevation Angle: +15.5  Horizon Angle: +04.2  Zoom: 1.0X  AR-244.00 rain gauge reading: 0.60" </small> </p>

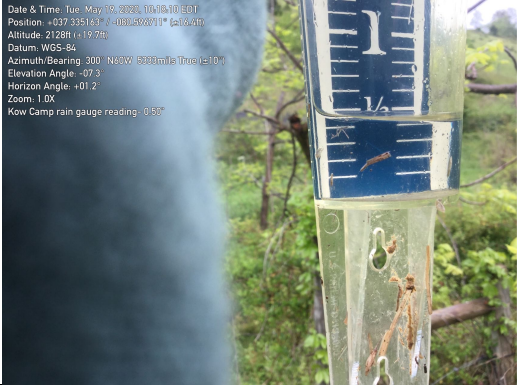
<p> <small> Date &amp; Time: Tue May 19, 2020, 10:06:10 EDT  Position: +037.335163° N +080.522711° W (s=12.42)  Altitude: 2128ft (+197ft)  Datum: WGS-84  Azimuth/Bearing: 300° N65W 638inile True (s=10)  Elevation Angle: +07.3  Horizon Angle: +01.2  Zoom: 1.0X  Kow Camp rain gauge reading: 0.50" </small> </p>			
<b>GPS Location</b>	See photo GPS	<b>GPS Location</b>	See photo GPS		
<b>Field Station#</b>	11024+00	<b>Field Station#</b>	10888+00		
<b>Pic 7 Desc.</b>	AR-244.00 rain gauge reading- 0.60"	<b>Pic 8 Desc.</b>	Kow Camp rain gauge reading- 0.50"

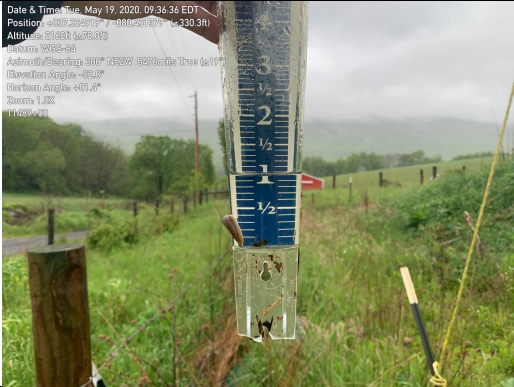
<b>GPS Location</b>	See photo for GPS location.		<b>GPS Location</b>	See photo for GPS location.	
<b>Field Station#</b>	11489+00		<b>Field Station#</b>	11767+00	
<b>Pic 1 Desc.</b>	Rain gauge at Stevers Gap Road reads 1 inch.		<b>Pic 2 Desc.</b>	Rain gauge at Mount Tabor Road 1.2 inches.

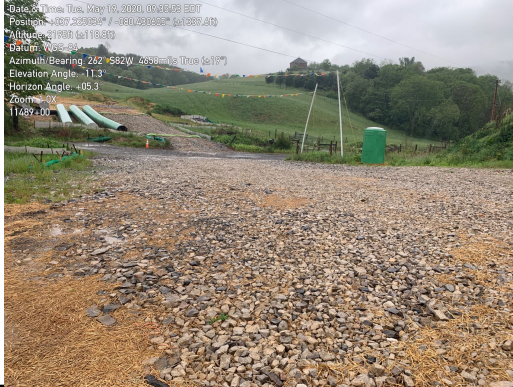
<b>GPS Location</b>	See photo for GPS location.		<b>GPS Location</b>	See photo for GPS location.	
<b>Field Station#</b>	11990+00		<b>Field Station#</b>	11489+00	
<b>Pic 3 Desc.</b>	Rain gauge at Catawba Road reads 1.5 inches.		<b>Pic 4 Desc.</b>	RCE in place Stevers Gap Road.

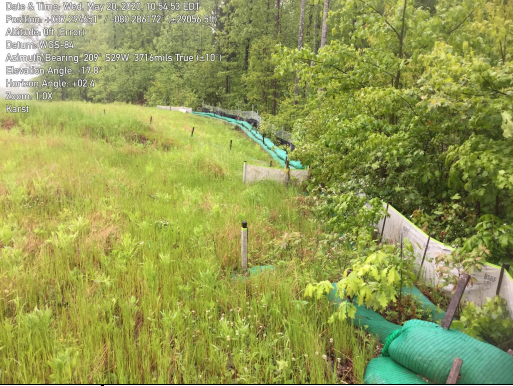
<p>Date &amp; Time: Wed May 20, 2020 10:34:55 EDT Position: +037°28'30N / -080°31'25W (+6581.7ft) Altitude: 2181ft (+124.7m) Datum: WGS-84 Azimuth/Bearing: 209° S29W 3718mils True (+10°) Elevation Angle: -17.3° Horizon Angle: +02.4° Zoom: 1.0X Karst</p>			
<b>GPS Location</b>	See photo GPS	<b>GPS Location</b>	See photo GPS		
<b>Field Station#</b>	11900+00	<b>Field Station#</b>	11942+00		
<b>Pic 1 Desc.</b>	AR-266.03	<b>Pic 2 Desc.</b>	Karst and Karst ECD's

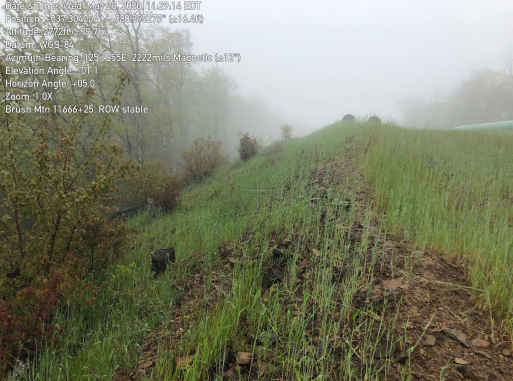
<b>GPS Location</b>	On photo	<b>GPS Location</b>	On photo		
<b>Field Station#</b>	11669+50	<b>Field Station#</b>	11666+25		
<b>Pic 1 Desc.</b>	FS188 and ROW stable.	<b>Pic 2 Desc.</b>	ROW stable with ECDs in place.

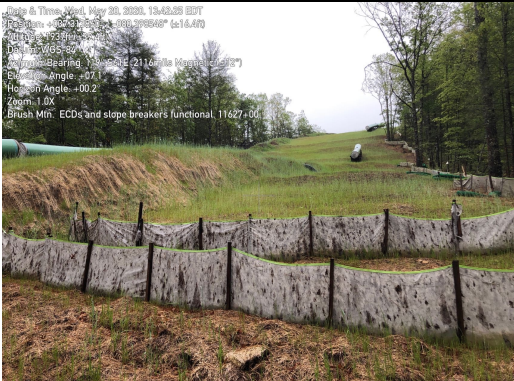
<p>Date &amp; Time: Wed, May 20, 2020, 13:41:47 EDT  Position: +037.314003° / -080.398488° (±16.4ft)  Altitude: 1935ft (±6.2m)  Datum: WGS-84  Azimuth/Bearing: 125° S35E 224mils Magnetic (±12°)  Elevation Angle: -01.0°  Horizon Angle: -01.0°  Zoom: 1.0x  Brush Min: S-HH18 crossing stable 11626+04</p>

<b>GPS Location</b>	On photo	<b>GPS Location</b>	On photo		
<b>Field Station#</b>	11627+00	<b>Field Station#</b>	11626+04		
<b>Pic 3 Desc.</b>	Steep slope and 2-tone stable.	<b>Pic 4 Desc.</b>	S-HH18 crossing is stable.		
<p>Date &amp; Time: Wed, May 20, 2020, 13:31:57 EDT  Position: +037.312742° / -080.402628° (±16.4ft)  Altitude: 1835ft (±6.2m)  Datum: WGS-84  Azimuth/Bearing: 127° S31E 223mils Magnetic (±12°)  Elevation Angle: -13.5°  Horizon Angle: -03.5°  Zoom: 1.0x  Brush Min: S-HH18 crossing</p>

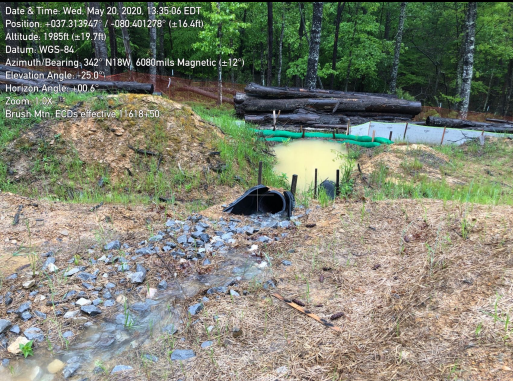
<b>GPS Location</b>	On photo	<b>GPS Location</b>	On photo		
<b>Field Station#</b>	11614+20	<b>Field Station#</b>	11618+50		
<b>Pic 5 Desc.</b>	S-RR14 crossing stable.	<b>Pic 6 Desc.</b>	Drain pipe at edge of travel lane working properly.

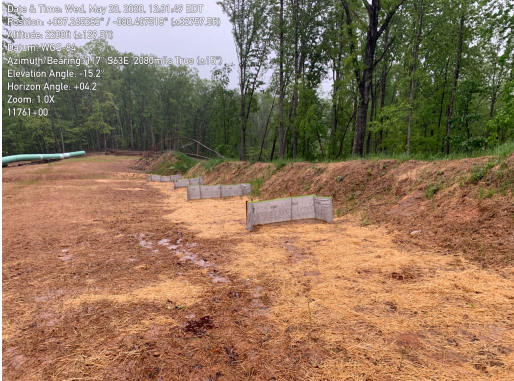
<p>Date &amp; Time: Wed, May 20, 2020, 11:37:46 EDT Position: +489.277828° / +880.594613° (+19.2m) Altitude: 2600ft (+139.3ft) Datum: WGS-84 Azimuth/Bearing: 27° S43E 2089mils True (+18°) Elevation Angle: -15.2° Horizon Angle: +04.2° Zoom: 1.0X 11761+00</p>

GPS Location	See photo for GPS location.		GPS Location	See photo for GPS location.	
Field Station#	11704+10		Field Station#	11761+00	
Pic 3 Desc.	Sensitive resource buffer in place at stream S-MN22.		Pic 4 Desc.	Priority one silt fence check in place where rilling commonly occurs.

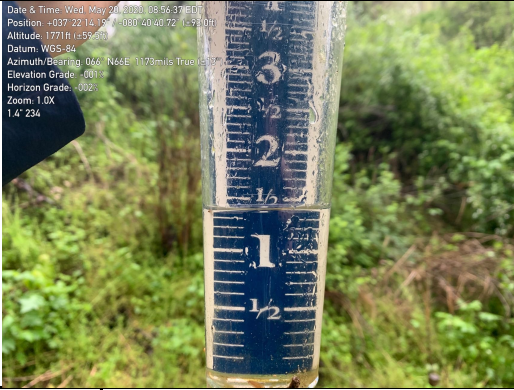
<p>Date &amp; Time: Wed, May 20, 2020, 08:56:37 EDT Position: +037 22 10.31' / -080 40 40.72' (+27.24) Altitude: 1771ft (+53.2m) Datum: WGS-84 Azimuth/Bearing: 045° N65E 1173mils True (+53°) Elevation Grade: -001° Horizon Grade: -002° Zoom: 1.0x 1.4" 234</p>

<p>Date &amp; Time: Wed, May 20, 2020, 08:48:00 EDT Position: +037 20 57.07' / -080 39 10.31' (+27.24) Altitude: 2066ft (+630.2m) Datum: WGS-84 Azimuth/Bearing: 222° S42W 3940mils True (+52°) Elevation Grade: -007° Horizon Grade: -002° Zoom: 1.0x 1.1" buffalo</p>			
<b>GPS Location</b>	See picture above for GPS coordinates		<b>GPS Location</b>	See picture above for GPS coordinates	
<b>Field Station#</b>	+1		<b>Field Station#</b>	+1	
<b>Pic 1 Desc.</b>	1.4" of rain recorded @ AR 234		<b>Pic 2 Desc.</b>	1.1" of rain recorded @ Buffalo Anklets

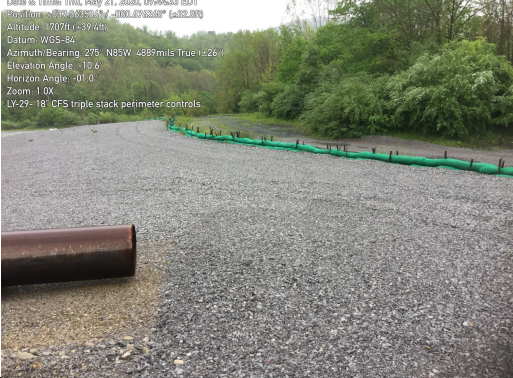
<b>GPS Location</b>	See photo GPS	<b>GPS Location</b>	See photo GPS		
<b>Field Station#</b>	12005+00	<b>Field Station#</b>	12005+00		
<b>Pic 1 Desc.</b>	LY29- PPL Materials storage	<b>Pic 2 Desc.</b>	LY 29- 18" CFS triple stack perimeter controls.

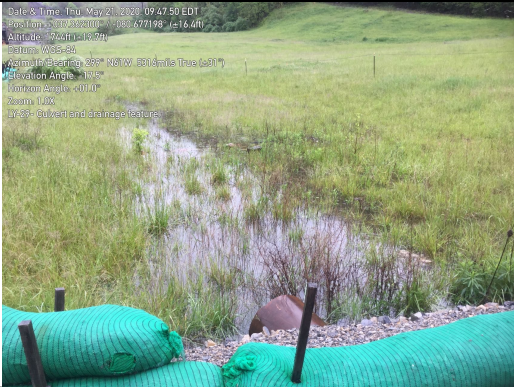
<b>GPS Location</b>	See photo GPS	<b>GPS Location</b>	See photo GPS		
<b>Field Station#</b>	12005+00	<b>Field Station#</b>	12005+00		
<b>Pic 3 Desc.</b>	LY29- Culvert and drainage feature.	<b>Pic 4 Desc.</b>	AR- 238.00		
<p>Date &amp; Time: Thu, May 21, 2020, 09:16:53 EDT  Position: +407.345200° / -080.652837° (±16.4m)  Altitude: 2046ft (±19.7m)  Datum: WGS-84  Azimuth/Bearing: 216.536W 384.0mils True (±10°)  Elevation Angle: -14.6°  Horizon Angle: +03.2°  Zoom: 1.0x  Buffalo Anklets rain gauge- 1.60"</p>

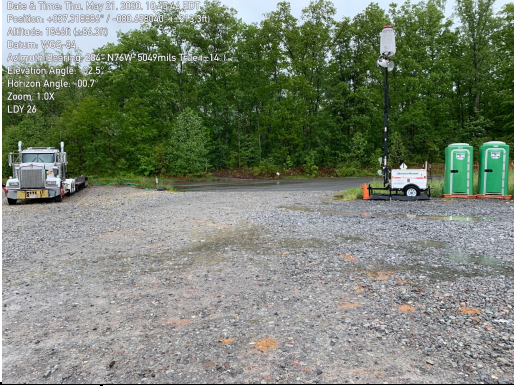
<b>GPS Location</b>		See photo for GPS location.		<b>GPS Location</b>	
<b>Field Station#</b>		12005+00		<b>Field Station#</b>	
<b>Pic 1 Desc.</b>		RCE in place Lay Down Yard 26 entrance.		<b>Pic 2 Desc.</b>	
				18 inch compost filter sock in place along LOD.	
<p>Date &amp; Time: Thu, May 21, 2020, 10:45:46 EDT  Position: +397.21660° / +080.503471° (+73.11)  Altitude: 1940' (+61.30)  Datum: WGS-84  Azimuth/Bearing: 331° 30'W 304°mils True (+10°)  Elevation Angle: -02.5°  Horizon Angle: -00.7°  Zoom: 1.0X  LDY: 26</p>

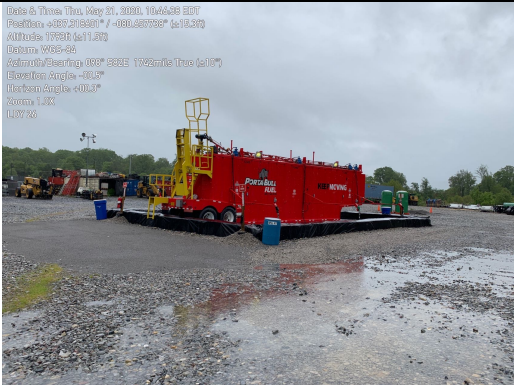
<b>GPS Location</b>		See photo for GPS location.		<b>GPS Location</b>	
<b>Field Station#</b>		12005+00		<b>Field Station#</b>	
<b>Pic 3 Desc.</b>		Secondary containment in place under fuel cell.		<b>Pic 4 Desc.</b>	
				Rain gauge at Winding Way reads 2.6 inches.	
<p>Date &amp; Time: Thu, May 21, 2020, 11:36:26 EDT  Position: +397.22110° / +080.51789° (+74.70)  Altitude: 2015' (+62.60)  Datum: WGS-84  Azimuth/Bearing: 025° N25E 044°mils True (+10°)  Elevation Angle: -02.7°  Horizon Angle: -00.8°  Zoom: 1.0X  LDY: 00</p>

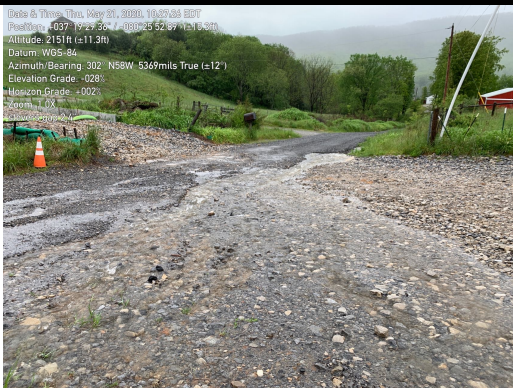
Field Station#	11489+70		Field Station#	11489+70	
Pic 5 Desc.	Water washed out state maintained road		Pic 6 Desc.	Run on from off row, stream flooded and braided

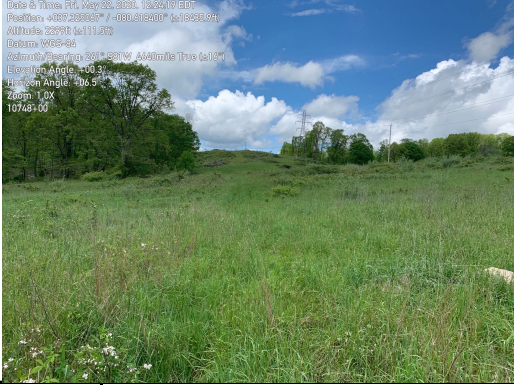
<b>GPS Location</b>	See photo for GPS location.		<b>GPS Location</b>	See photo for GPS location.	
<b>Field Station#</b>	10748+00		<b>Field Station#</b>	10696+00	
<b>Pic 3 Desc.</b>	ROW stabilized with natural vegetation growth.		<b>Pic 4 Desc.</b>	Rain gauge at Buffalo Anklets Road reads 0.5 inches.

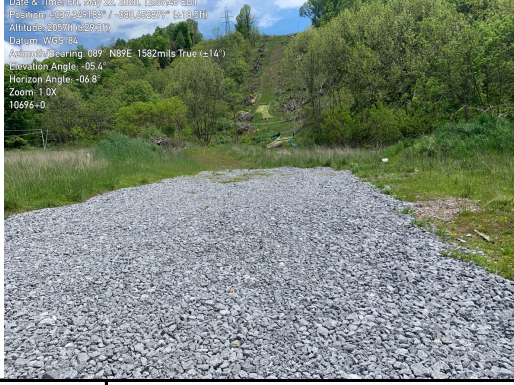
<b>GPS Location</b>	See photo for GPS location.		<b>GPS Location</b>	See photo for GPS location.	
<b>Field Station#</b>	11767+00		<b>Field Station#</b>	110696+00	
<b>Pic 5 Desc.</b>	Rain gauge at Mount Tabor Road reads 1.0 inches.		<b>Pic 6 Desc.</b>	RCE in place at Buffalo Anklets Road.
