Visual Site Inspection Report

Project Name	H-600 Pipeline Spread H	AFE	124300138	Spread	H-600 Pipeline Spread H
Contractor	Precision			Report #	7497
Inspector	Pat Davis			Date/Time	1/20/2020 4:00 PM
Permit #	TBD	Inspection Type	VA SWPP	Station Begin	+0
State	VA	Inspection Area	Partial	Station End	+0
County	Roanoke	Ground	Frozen	Temperature (°F)	34.00
Municipality	N/A	Weather	Sunny	Rain Gauge (in)	0.10
				Rain Accumulation Time (days)	0.00

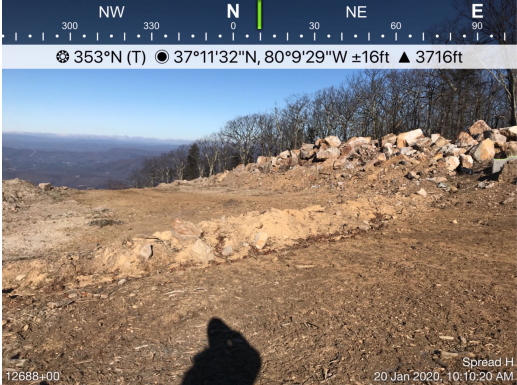
GPS Location	See photo		GPS Location	See photo	
Field Station#	12698+00		Field Station#	12686+00	
Pic 9 Desc.	SF controls in good condition near Honeysuckle Rd.		Pic 10 Desc.	SF controls have been removed in this area, perimeter controls still intact and appear to be functioning.

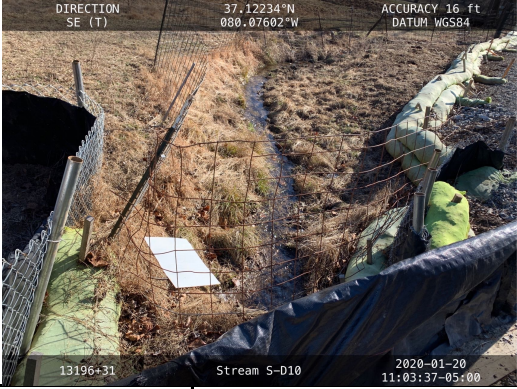
<p>DIRECTION SE (T) 37.12234°N 080.07602°W ACCURACY 16 ft DATUM WGS84</p> <p>13196+31 Stream S-D10 2020-01-20 11:03:37-05:00</p>

<p>DIRECTION SE (T) 37.10211°N 080.04090°W ACCURACY 23 ft DATUM WGS84</p> <p>13353+00 ROW condition 2020-01-20 12:27:50-05:00</p>			
GPS Location	See photo for gps location data.		GPS Location	See photo for gps location data.	
Field Station#	13196+31		Field Station#	13353+00	
Pic 7 Desc.	Photo shows stream S-D10 downstream of the access road. No issues observed.		Pic 8 Desc.	Photo shows the ROW condition from about 13353+00 to 13355+00. No issues observed.

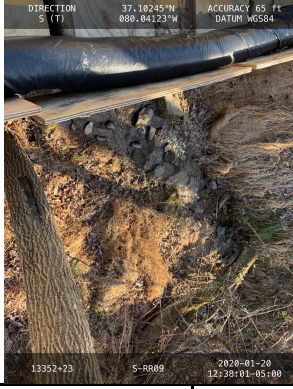
<p>DIRECTION S (T) 37.10245°N 080.04123°W ACCURACY 65 ft DATUM WGS84</p> <p>13352+23 S-RR09 2020-01-20 12:38:01-05:00</p>

GPS Location	See photo for gps location data.		GPS Location	See photo for gps location data.	
Field Station#	13352+23		Field Station#	13352+23	
Pic 9 Desc.	Photo shows stream S-RR09 downstream from the ROW. Sediment in stream appears consistent with sediment upstream from ROW.		Pic 10 Desc.	Photo shows stream S-RR09 upstream from ROW.	
Insert image here			Insert image here		
GPS Location			GPS Location		
Field Station#			Field Station#		
Pic 11 Desc.			Pic 12 Desc.

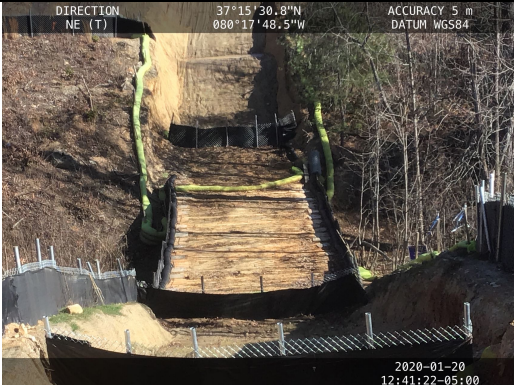
<p>DIRECTION SE (T) 37°15'26.0"N 080°16'54.2"W ACCURACY 10 m DATUM WGS84</p> <p>2020-01-20 13:15:49-05:00</p>	
GPS Location	See photo		GPS Location	See photo	
Field Station#	12176+95		Field Station#	12121+33	
Pic 3 Desc.	Stream S-MM15, facing northeast		Pic 4 Desc.	Stream S-C33, facing southeast, downstream

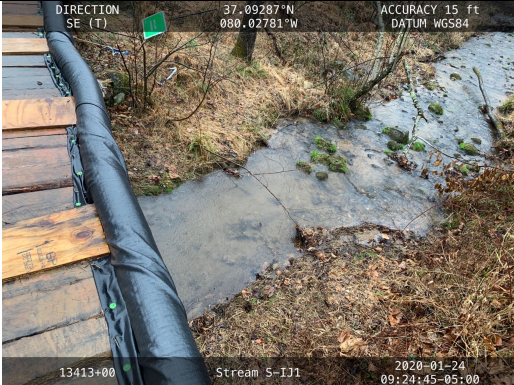
GPS Location	See photo for gps location data.		GPS Location	See photo for gps location data.	
Field Station#	13413+00		Field Station#	13317+00	
Pic 1 Desc.	Photo shows the condition of stream S-IJ1 downstream from the ROW.		Pic 2 Desc.	Photo shows the recently installed erosion control blanket.

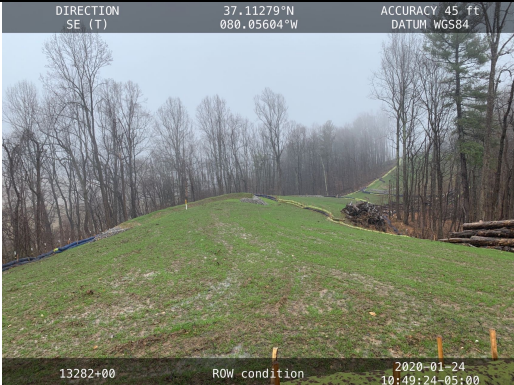
GPS Location	See photo for gps location data.		GPS Location	See photo for gps location data.	
Field Station#	13282+00		Field Station#	13290+50	
Pic 3 Desc.	Photo shows the ROW condition from about 13282+00 to 13285+00. No issues observed.		Pic 4 Desc.	Photo shows the ROW condition from about 13290+50 to 13294+00.

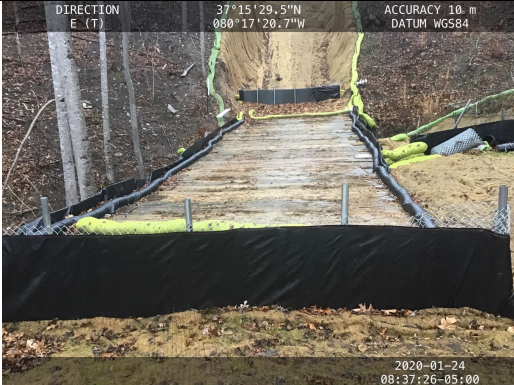
GPS Location	See photo		GPS Location	See photo	
Field Station#	12098+44		Field Station#	12008+53	
Pic 1 Desc.	Stream S-MM13, facing east		Pic 2 Desc.	Stream S-G36, facing south

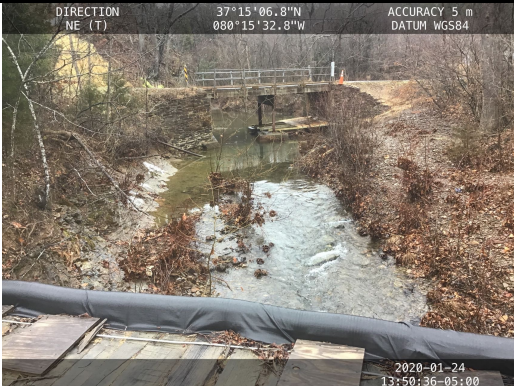
GPS Location	See photo		GPS Location	See photo	
Field Station#	12192+50		Field Station#	12196+50	
Pic 5 Desc.	Stream S-C21, Bradshaw Creek, facing northeast, upstream		Pic 6 Desc.	Stream S-OO11, facing east, upstream
