Visual Site Inspection Report

Project Name	H-600 Pipeline Spread H	AFE	124300138	Spread	H-600 Pipeline Spread H
Contractor	Precision			Report #	7763
Inspector	Logan Box			Date/Time	1/29/2020 5:30 PM
Permit #	TBD	Inspection Type	VA SWPP	Station Begin	13415+51
State	VA	Inspection Area	Partial	Station End	13670+00
County	Franklin	Ground	Damp	Temperature (°F)	48.00
Municipality	N/A	Weather	Cloudy	Rain Gauge (in)	0.00
				Rain Accumulation Time (days)	0.00

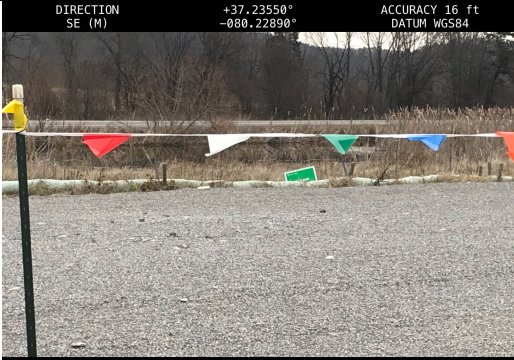
<p>DIRECTION SE (M) +37.23550° -080.22698° ACCURACY 16 ft DATUM WGS84</p> <p>MVP-PY-006_013020 Signage and buffer flagging for feature... 2020-01-30 08:30:42-05:00</p>

<p>DIRECTION E (M) +37.23567° -080.22656° ACCURACY 16 ft DATUM WGS84</p> <p>MVP-PY-006_013020 Condition of CFS north LOD 2020-01-30 08:32:10-05:00</p>			
GPS Location	MVP-PY-006 See photo for gps data		GPS Location	MVP-PY-006 See photo for gps data	
Field Station#	+0		Field Station#	+0	
Pic 1 Desc.	Signage and buffer flagging for feature in place. Looking NE.		Pic 2 Desc.	Condition of compost filter sock along North LOD. Looking E.

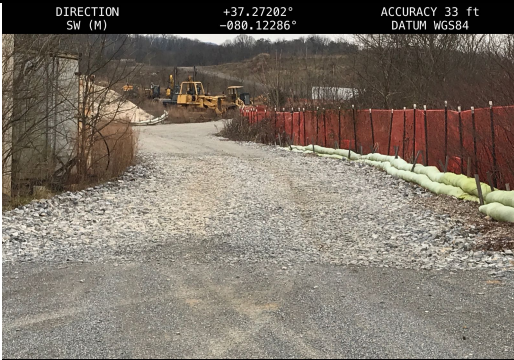
GPS Location	MVP-LY-049 See photo for gps data	GPS Location	MVP-LY-049 See photo for gps data		
Field Station#	+0	Field Station#	+0		
Pic 1 Desc.	Condition of rock on center drive. Looking SW.	Pic 2 Desc.	Condition of compost filter sock and safety fence along East LOD. Looking S.

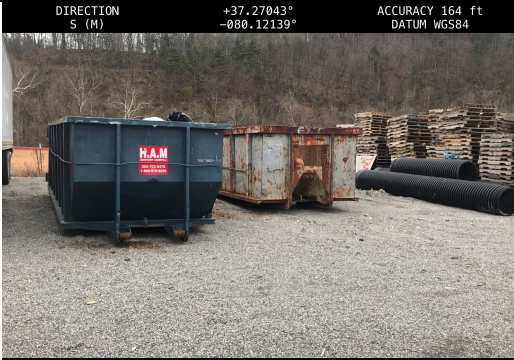
GPS Location	MVP-LY-049 See photo for gps data	GPS Location	MVP-LY-049 See photo for gps data		
Field Station#	+0	Field Station#	+0		
Pic 3 Desc.	No loose trash around south dumpsters. Looking S.	Pic 4 Desc.	Condition of containment under light plant. Looking N.

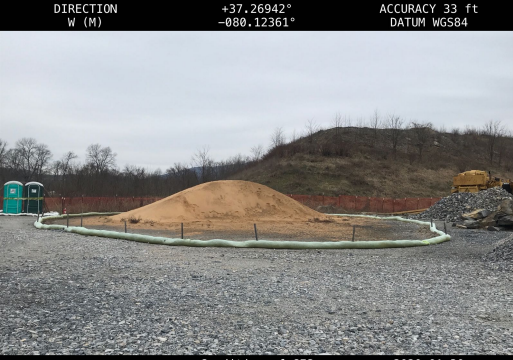
GPS Location	MVP-LY-049 See photo for gps data	GPS Location	MVP-LY-049 See photo for gps data		
Field Station#	+0	Field Station#	+0		
Pic 5 Desc.	Landowner disturbance along compost filter sock and feature. No impacts. Looking S.	Pic 6 Desc.	Condition of compost filter sock around sand pile. Looking W.

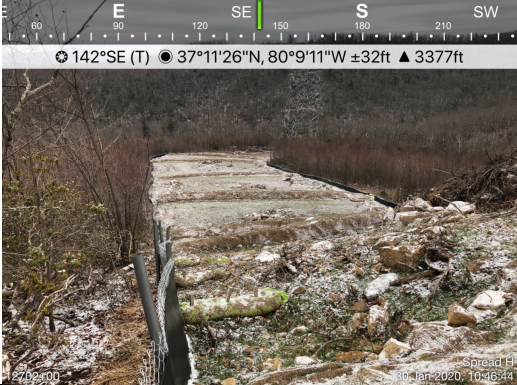
GPS Location	see photo		GPS Location	see photo	
Field Station#	12702+00		Field Station#	12710+00	
Pic 7 Desc.	Slope below AR-280 is in good condition.		Pic 8 Desc.	Sumps and waterbars throughout this area are functioning.

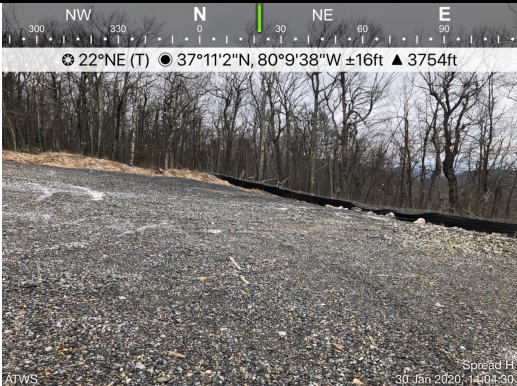
GPS Location	see photo		GPS Location	see photo	
Field Station#	280+00		Field Station#	12+25	
Pic 9 Desc.	CFS and stone in place on this AR.		Pic 10 Desc.	This ATWS remains inactive with controls in place and functioning.

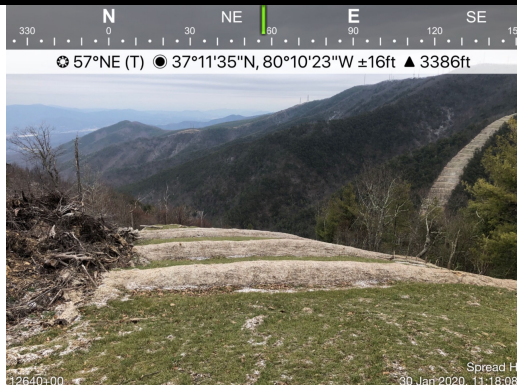
GPS Location	see photo		GPS Location	see photo	
Field Station#	12640+00		Field Station#	279+01	
Pic 11 Desc.	GAS of AR-279.01 is in good condition. Vegetation has filled in and controls are in place.		Pic 12 Desc.	CFS in place and functioning on this AR.

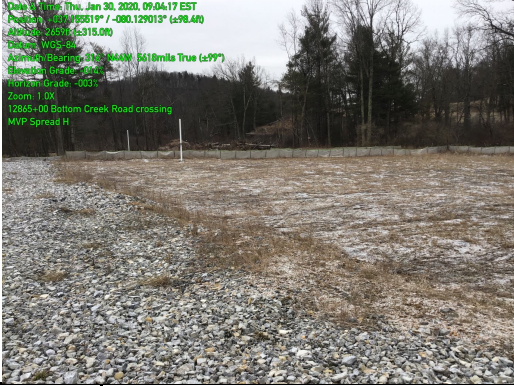
GPS Location	See pic for GPS location		GPS Location	See pic for GPS location	
Field Station#	12865+00		Field Station#	12866+00	
Pic 1 Desc.	No issues or impacts observed on the CIS of the Bottom Creek Road crossing.		Pic 2 Desc.	No issues or impacts observed on the GAS of Bottom Creek Road.

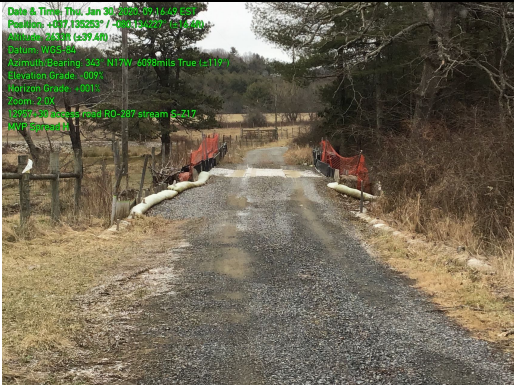
GPS Location	See pic for GPS location		GPS Location	See pic for GPS location	
Field Station#	12957+30		Field Station#	12957+30	
Pic 3 Desc.	Stream S-Z17 on access RO-287. No issues or impacts observed.		Pic 4 Desc.	Stream S-Z16 on access RO-287. No issues or impacts observed.

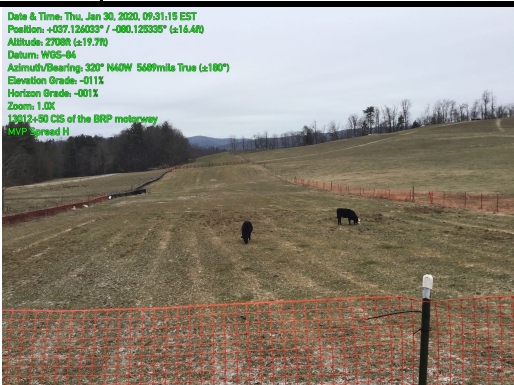
GPS Location	See pic for GPS location		GPS Location	See pic for GPS location	
Field Station#	13112+50		Field Station#	13112+75	
Pic 5 Desc.	Final restoration performed on the CIS of the BRP motorway had no issues or impacts.		Pic 6 Desc.	Final restoration performed on the GAS of the BRP motorway had no issues or impacts.

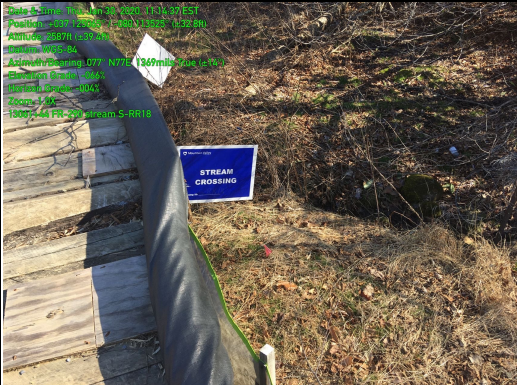
GPS Location	See pic for GPS location	GPS Location	See pic for GPS location		
Field Station#	13061+44	Field Station#	13062+00		
Pic 7 Desc.	Stream S-RR18 showed no signs of impact from the project activities.	Pic 8 Desc.	No impacts observed on the downstream side of S-G26.

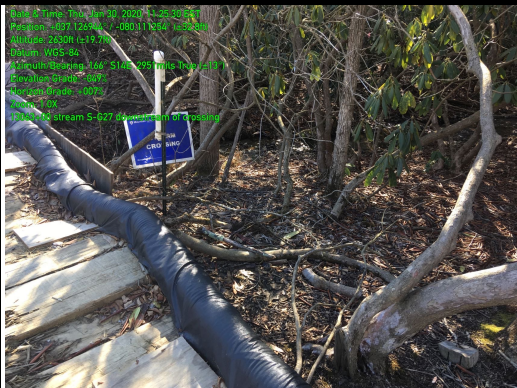
GPS Location	See pic for GPS location	GPS Location	See pic for GPS location		
Field Station#	13063+00	Field Station#	13041+00		
Pic 9 Desc.	No impacts observed on the downstream side of S-G27.	Pic 10 Desc.	No issues or impacts found at or near stream S-H1.

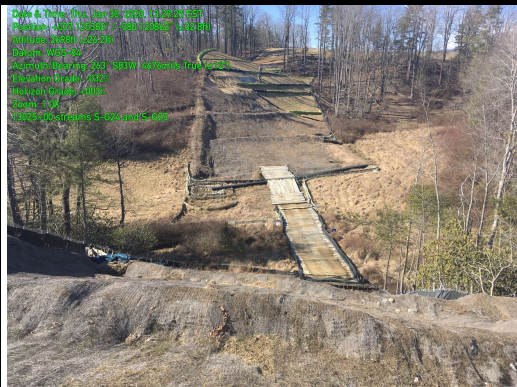
<div>Insert image here</div>			
GPS Location	See pic for GPS location	GPS Location			
Field Station#	13025+00	Field Station#			
Pic 11 Desc.	No issues or impacts observed near streams S-G24 and S-G25.	Pic 12 Desc.

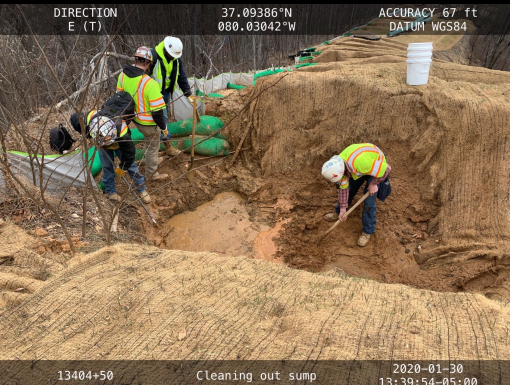
GPS Location	See photo for gps location data.		GPS Location	See photo for gps location data.	
Field Station#	13404+50		Field Station#	13352+23	
Pic 3 Desc.	Photo shows the contractor cleaning out the sump pit at about 13404+00.		Pic 4 Desc.	Photo shows the bridge over stream S-RR09. No environmental issues observed.

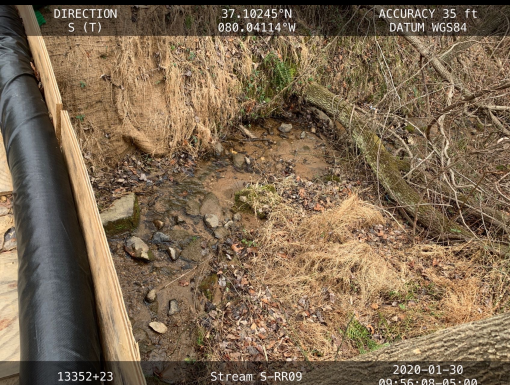
GPS Location	See photo for gps location data.		GPS Location	See photo for gps location data.	
Field Station#	13352+23		Field Station#	13375+00	
Pic 5 Desc.	Photo shows stream S-RR09 downstream from the ROW. No environmental issues observed.		Pic 6 Desc.	Photo shows the ROW condition from about 13375+00 to about 13382+00. No environmental issues observed.

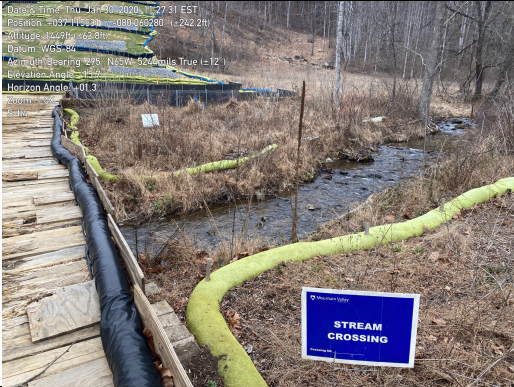
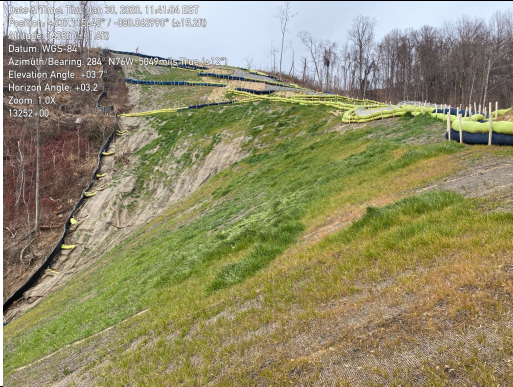
<p>Date/Time: Thu Jan 30, 2020, 11:41:04 EST Position: 2337.115668, -7080.063947 (+25.9ft) Altitude: 1762ft (+47.1ft) Datum: WGS-84 Azimuth: Bearing: 284° N74W 5049mils True (+3.7) Elevation Angle: +03.7 Horizon Angle: +03.2 Zoom: 1.0X 13252+00</p>			
GPS Location	See photo for coordinates.		GPS Location	See photo for coordinates.	
Field Station#	13262+60		Field Station#	13252+00	
Pic 1 Desc.	S-II4, upstream of equipment bridge, ECDs functioning acceptably, no changes noted to stream bed or banks.		Pic 2 Desc.	ROW stable, permanent vegetation noted, erosion control blanket functioning acceptably, no off ROW impacts noted.

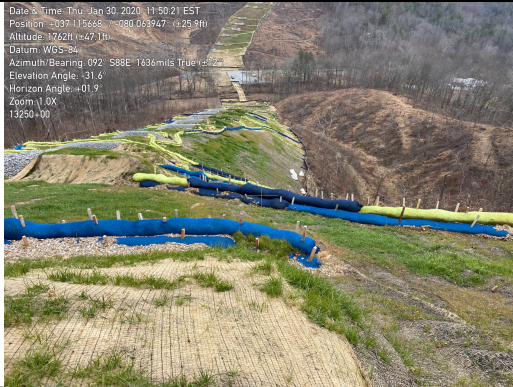
<p>Date/Time: Thu Jan 30, 2020, 11:50:21 EST Position: 2337.115668, -7080.063947 (+25.9ft) Altitude: 1762ft (+47.1ft) Datum: WGS-84 Azimuth: Bearing: 284° N74W 5049mils True (+3.7) Elevation Angle: +03.7 Horizon Angle: +03.2 Zoom: 1.0X 13251+00</p>

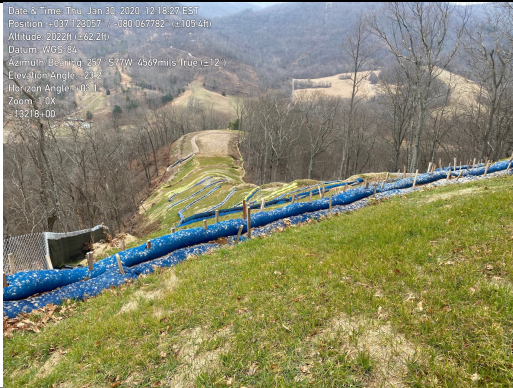
GPS Location	See photo for coordinates.		GPS Location	See photo for coordinates.	
Field Station#	13224+00		Field Station#	13218+00	
Pic 5 Desc.	ROW stabilized with good vegetative cover, permanent waterbars functioning acceptably.		Pic 6 Desc.	CFS stable, good vegetative cover noted in permanently restored area, sparse cover noted at flat in temporarily stabilized area.
