# Visual Site Inspection Report

<b>Project Name</b>	H-600 Pipeline Spread H	<b>AFE</b>	124300138	<b>Spread</b>	H-600 Pipeline Spread H	
<b>Contractor</b>	Precision			<b>Report #</b>	6711	
<b>Inspector</b>	Pat Davis			<b>Date/Time</b>	12/17/2019 4:10 PM	
<b>Permit #</b>	TBD	<b>Inspection Type</b>	VA SWPP	<b>Station Begin</b>	+0	
<b>State</b>	VA	<b>Inspection Area</b>	Partial	<b>Station End</b>	+0	
<b>County</b>	Montgomery	<b>Ground</b>	Wet	<b>Temperature (°F)</b>	42.00	
<b>Municipality</b>	N/A	<b>Weather</b>	Light Rain	<b>Rain Gauge (in)</b>	0.10	
				<b>Rain Accumulation Time (days)</b>	0.00

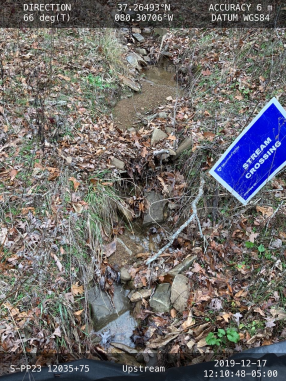
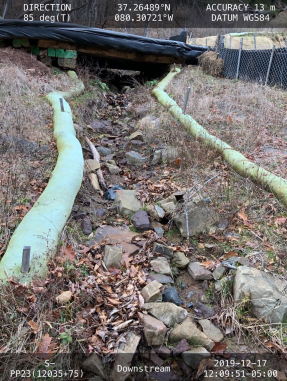
<b>GPS Location</b>	See photo GPS for location		<b>GPS Location</b>	See photo GPS for location	
<b>Field Station#</b>	12035+75		<b>Field Station#</b>	12035+75	
<b>Pic 1 Desc.</b>	Stream is clear and free of ROW sediment at time of inspection.		<b>Pic 2 Desc.</b>	Stream is clear and free of ROW sediment at time of inspection.

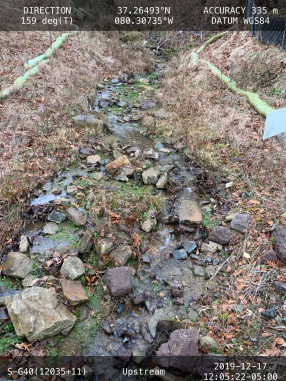
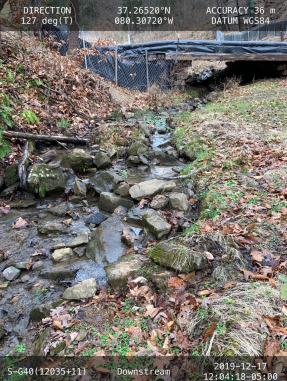
<b>GPS Location</b>	See photo GPS for location		<b>GPS Location</b>	See photo GPS for location	
<b>Field Station#</b>	12035+11		<b>Field Station#</b>	12035+21	
<b>Pic 3 Desc.</b>	No ROW sediment impacting this stream at time of inspection.		<b>Pic 4 Desc.</b>	No ROW sediment impacting this stream at time of inspection.

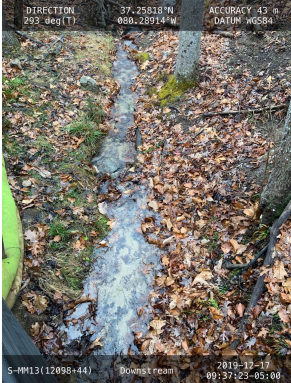
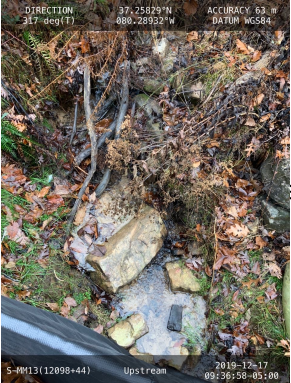
<p>Insert image here</p>	
<b>GPS Location</b>	See photo GPS for location		<b>GPS Location</b>	See photo GPS for location	
<b>Field Station#</b>	12098+44		<b>Field Station#</b>	12098+44	
<b>Pic 13 Desc.</b>	Stream is clear and free of ROW sediment at time of inspection.		<b>Pic 14 Desc.</b>	Stream is running clear and free of ROW sediment at time of inspection.

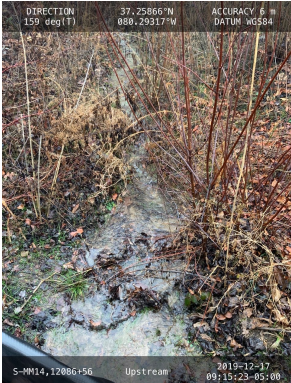
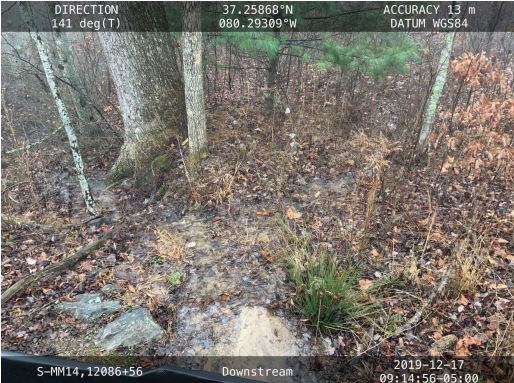
<p>Insert image here</p>	
<b>GPS Location</b>	See photo GPS for location		<b>GPS Location</b>	See photo GPS for location	
<b>Field Station#</b>	12086+56		<b>Field Station#</b>	12086+56	
<b>Pic 15 Desc.</b>	Stream is running clear and free of ROW sediment at time of inspection.		<b>Pic 16 Desc.</b>	Stream is running clear and free of ROW sediment at time of inspection.

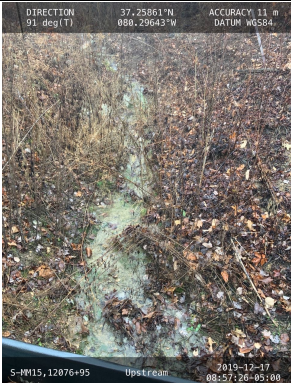
<b>Field Station#</b>	12076+95		<b>Field Station#</b>		
<b>Pic 17 Desc.</b>	Stream is running clear and free of ROW sediment at time of inspection.		<b>Pic 18 Desc.</b>	Stream is running clear and free of ROW sediment at time of inspection.

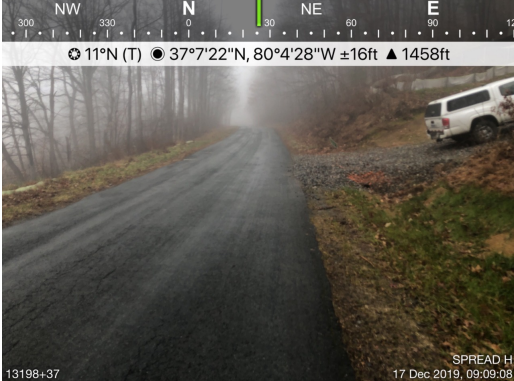
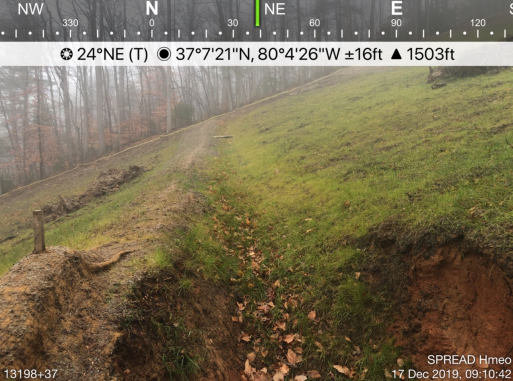
<b>GPS Location</b>	see photo	<b>GPS Location</b>	see photo		
<b>Field Station#</b>	13198+37	<b>Field Station#</b>	13198+37		
<b>Pic 1 Desc.</b>	Dillons Mill Rd. crossing and CE in good condition.	<b>Pic 2 Desc.</b>	Waterbars on this slope in good condition and functioning.

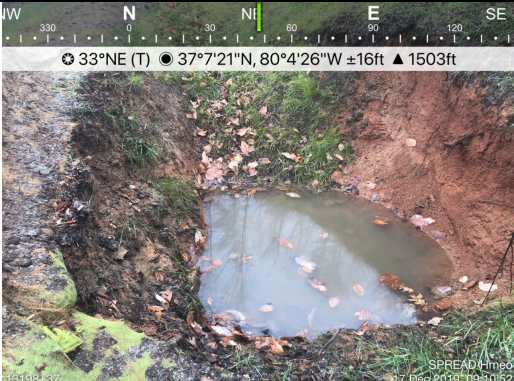
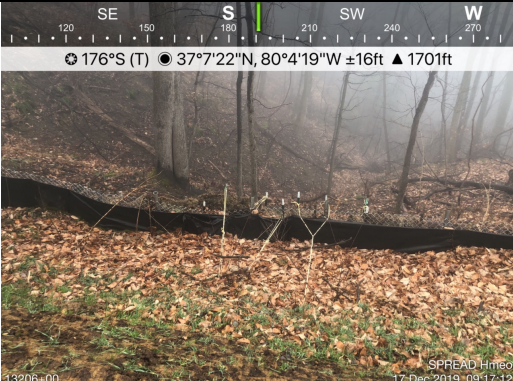
<b>GPS Location</b>	see photo	<b>GPS Location</b>	see photo		
<b>Field Station#</b>	13198+37	<b>Field Station#</b>	13206+00		
<b>Pic 3 Desc.</b>	Sumps on this slope have received small amounts of rainwater from previous rain.	<b>Pic 4 Desc.</b>	Hay bail reinforcement at this location is functioning.

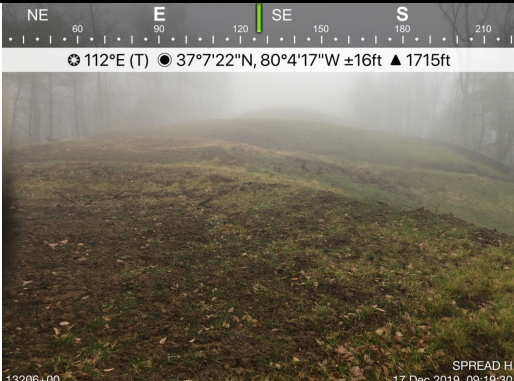
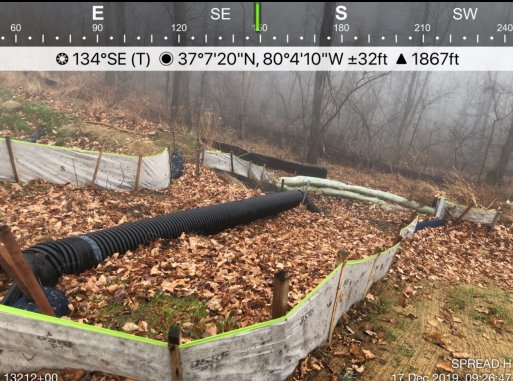
<b>GPS Location</b>	see photo	<b>GPS Location</b>	see photo		
<b>Field Station#</b>	13206+00	<b>Field Station#</b>	13212+00		
<b>Pic 5 Desc.</b>	Vegetation filling in on ROW	<b>Pic 6 Desc.</b>	Slope drain at this location in good condition and functioning.

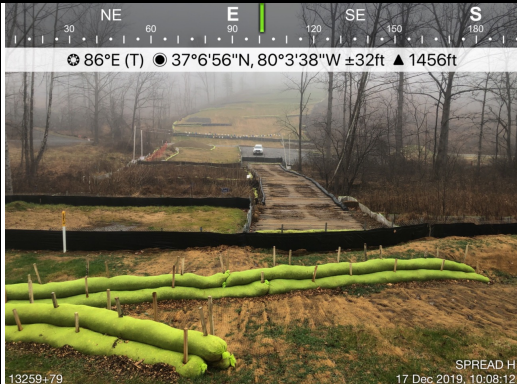
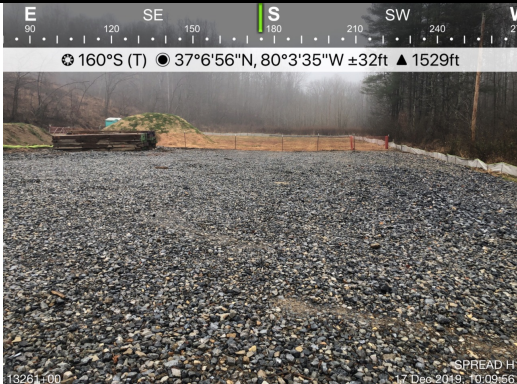
GPS Location	see photo		GPS Location	see photo	
Field Station#	13259+79		Field Station#	13261+00	
Pic 9 Desc.	stream crossing controls in place at this location.		Pic 10 Desc.	Workspace at this location remains stabilized

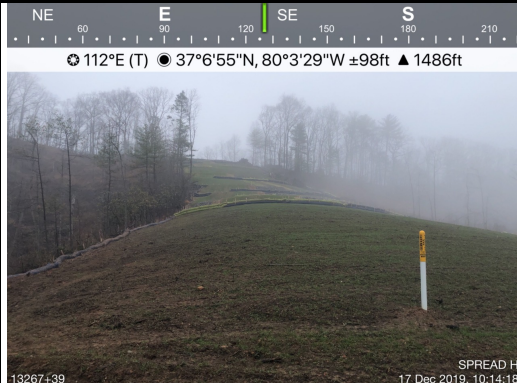
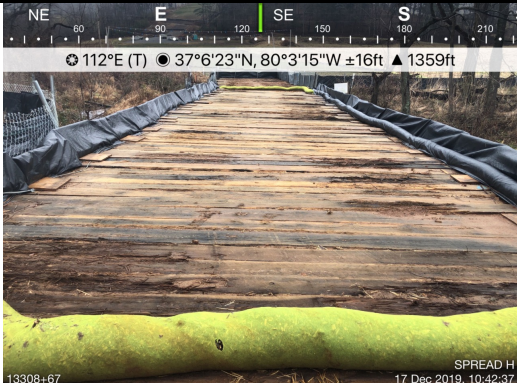
GPS Location	see photo		GPS Location	see photo	
Field Station#	13267+39		Field Station#	13308+00	
Pic 11 Desc.	GAS slope of Flanders in good condition with controls in place.		Pic 12 Desc.	stream crossing controls in place at this location.

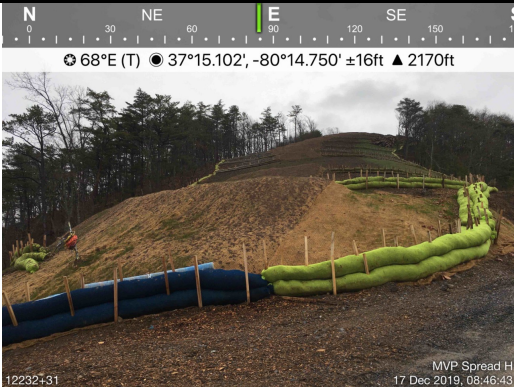
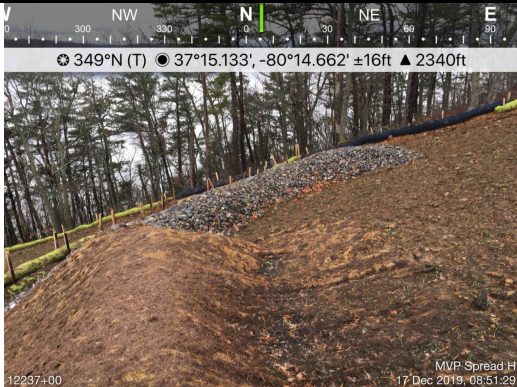
<b>GPS Location</b>	See Picture Watermark		<b>GPS Location</b>	See Picture Watermark	
<b>Field Station#</b>	12232+31		<b>Field Station#</b>	12237+00	
<b>Pic 1 Desc.</b>	Reese Mountain switchback entrance to ROW remains in good condition.		<b>Pic 2 Desc.</b>	Permanent waterbar installed and in good condition.

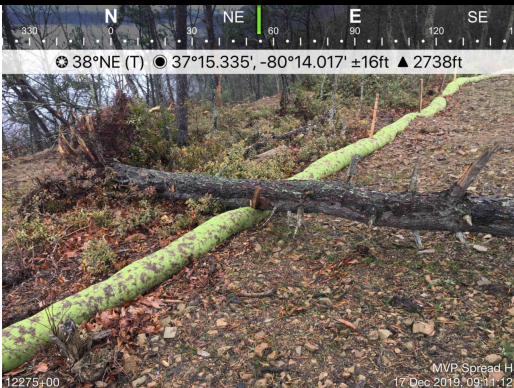
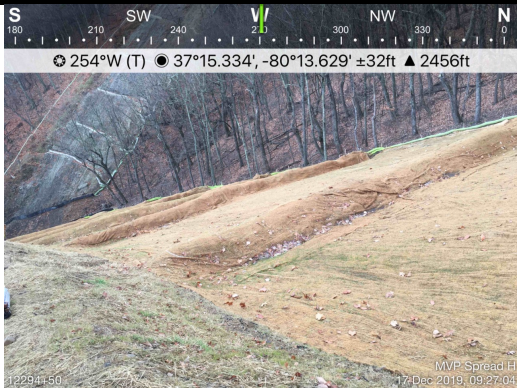
<b>GPS Location</b>	See Picture Watermark		<b>GPS Location</b>	See Picture Watermark	
<b>Field Station#</b>	12275+00		<b>Field Station#</b>	12294+50	
<b>Pic 5 Desc.</b>	Fallen tree laying on CFS. Does not appear to effect CFS's ability to filter runoff.		<b>Pic 6 Desc.</b>	GAS "V" in good condition and free of accelerated erosion.

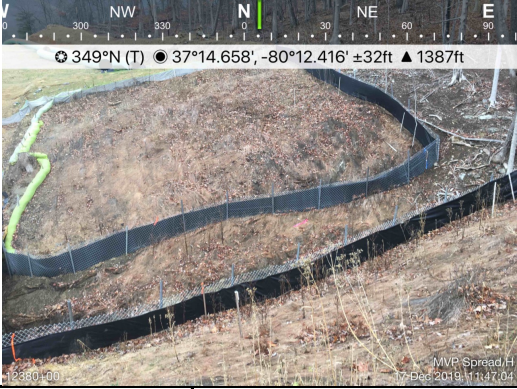
<b>GPS Location</b>	See Picture Watermark		<b>GPS Location</b>	See Picture Watermark	
<b>Field Station#</b>	12441+80		<b>Field Station#</b>	12380+00	
<b>Pic 9 Desc.</b>	Roanoke River buffer area remains in good condition and river not impacted.		<b>Pic 10 Desc.</b>	S-NN19 buffer area and controls are in good condition.

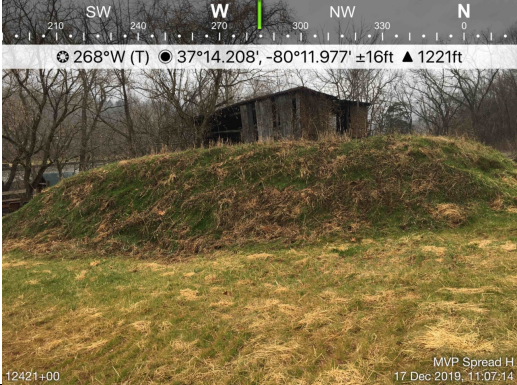
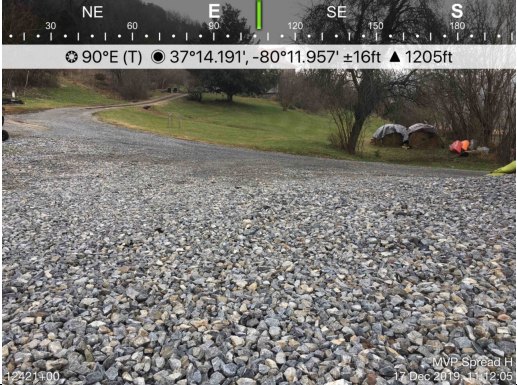
<b>GPS Location</b>	See Picture Watermark		<b>GPS Location</b>	See Picture Watermark	
<b>Field Station#</b>	12421+00		<b>Field Station#</b>	12421+00	
<b>Pic 13 Desc.</b>	Temporary soil stockpile remains well stabilized and free of accelerated erosion.		<b>Pic 14 Desc.</b>	Rock construction entrance in good condition and free of excess sediment.

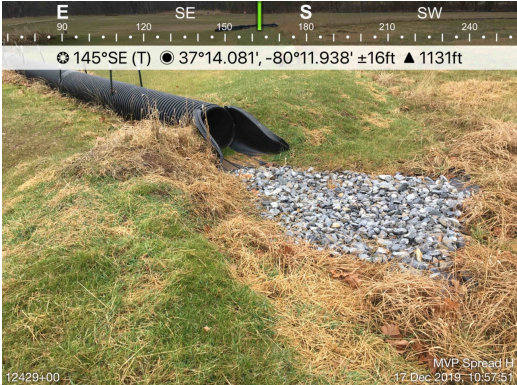
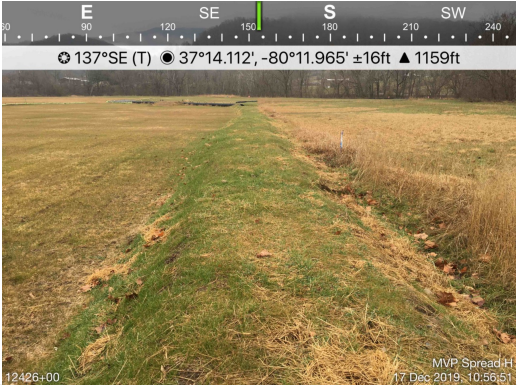
<b>GPS Location</b>	See Picture Watermark		<b>GPS Location</b>	See Picture Watermark	
<b>Field Station#</b>	12429+00		<b>Field Station#</b>	12426+00	
<b>Pic 15 Desc.</b>	Floodplain CWD pipe inlet is in good condition and free of sediment.		<b>Pic 16 Desc.</b>	CWD berm well vegetated and free of accelerated erosion.

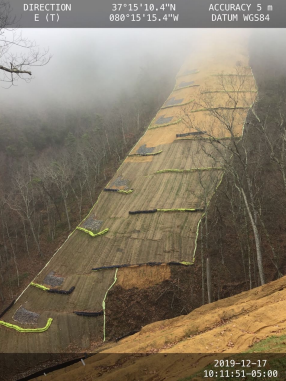
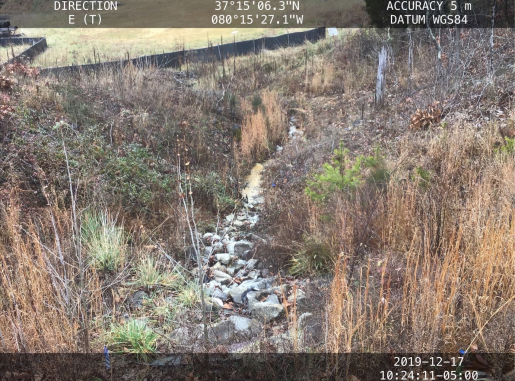
<b>GPS Location</b>	See photo		<b>GPS Location</b>	See photo	
<b>Field Station#</b>	12215+00		<b>Field Station#</b>	12197+37	
<b>Pic 1 Desc.</b>	All permanent restoration on slope below the switchback on Reese Mountain is intact and ECDs are functioning properly.		<b>Pic 2 Desc.</b>	Stream S-0011, facing east, downstream

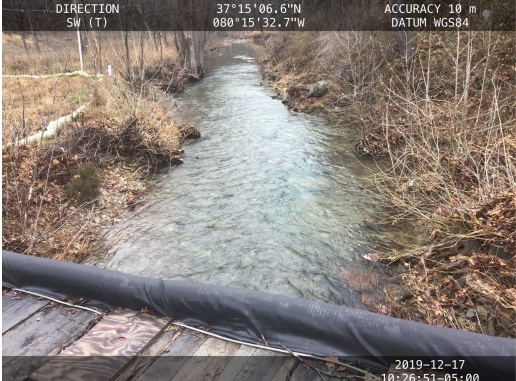
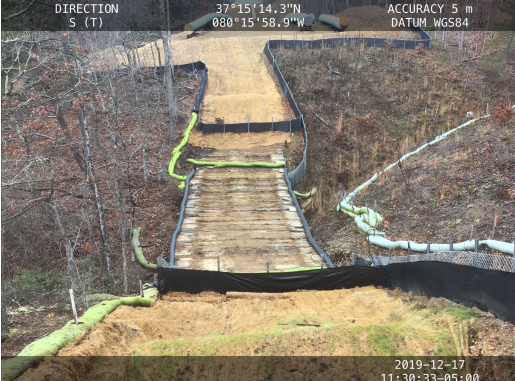
<b>GPS Location</b>	See photo		<b>GPS Location</b>	See photo	
<b>Field Station#</b>	12192+50		<b>Field Station#</b>	12166+47	
<b>Pic 3 Desc.</b>	Stream S-C21, Bradshaw Creek, facing south, downstream		<b>Pic 4 Desc.</b>	Stream S-C24, facing west

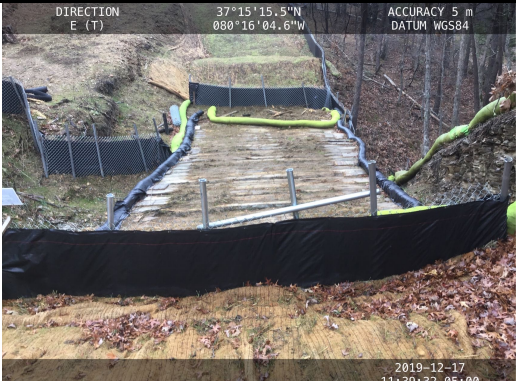
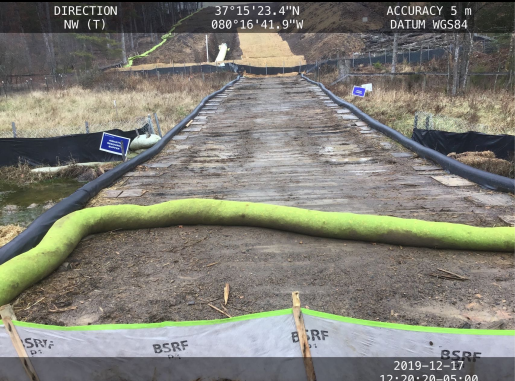
<b>GPS Location</b>	See photo		<b>GPS Location</b>	See photo	
<b>Field Station#</b>	12163+05		<b>Field Station#</b>	12132+73	
<b>Pic 5 Desc.</b>	Stream S-C25, facing east		<b>Pic 6 Desc.</b>	Stream S-C29, facing northwest

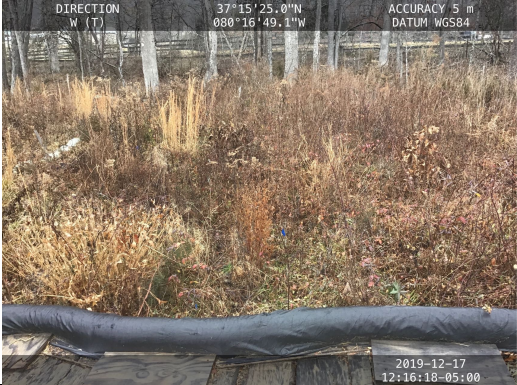
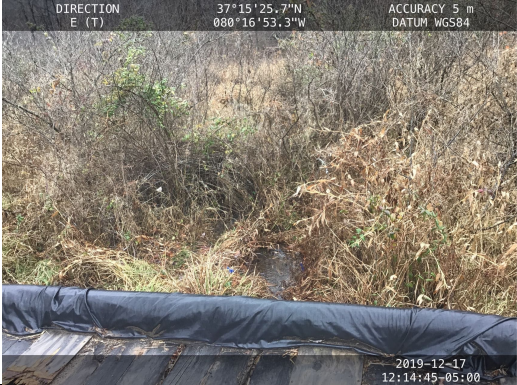
<b>GPS Location</b>	See photo		<b>GPS Location</b>	See photo	
<b>Field Station#</b>	12125+65		<b>Field Station#</b>	12121+83	
<b>Pic 7 Desc.</b>	Stream S-MM31, facing west, upstream		<b>Pic 8 Desc.</b>	Stream S-C36, facing east, downstream

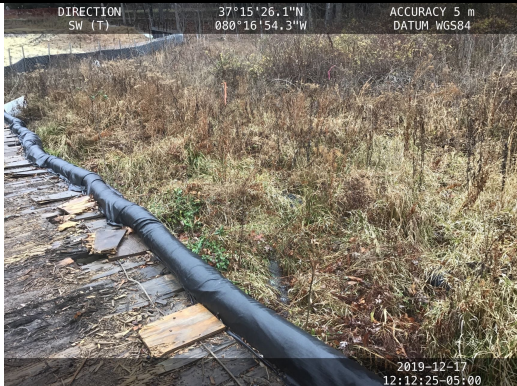
<p style="text-align: center;">Insert image here</p>			
<b>GPS Location</b>	See photo		<b>GPS Location</b>		
<b>Field Station#</b>	12121+33		<b>Field Station#</b>		
<b>Pic 9 Desc.</b>	Stream S-C33, facing southwest, upstream		<b>Pic 10 Desc.</b>		
<p style="text-align: center;">Insert image here</p>			<p style="text-align: center;">Insert image here</p>		
<b>GPS Location</b>			<b>GPS Location</b>		
<b>Field Station#</b>			<b>Field Station#</b>		
<b>Pic 11 Desc.</b>			<b>Pic 12 Desc.</b>

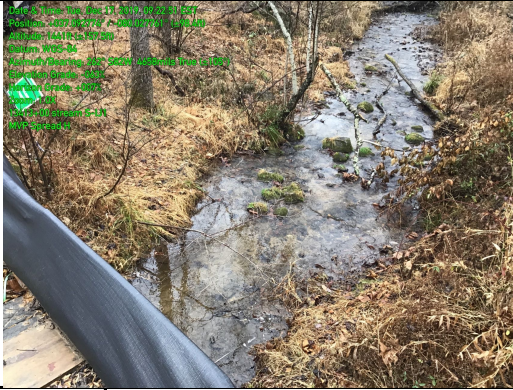
<b>GPS Location</b>	See pic for GPS location		<b>GPS Location</b>	See pic for GPS location	
<b>Field Station#</b>	13415+00		<b>Field Station#</b>	13413+00	
<b>Pic 1 Desc.</b>	0.1" total precipitation at Cahas Mountain Road		<b>Pic 2 Desc.</b>	No impacts observed at stream S-IJ1.

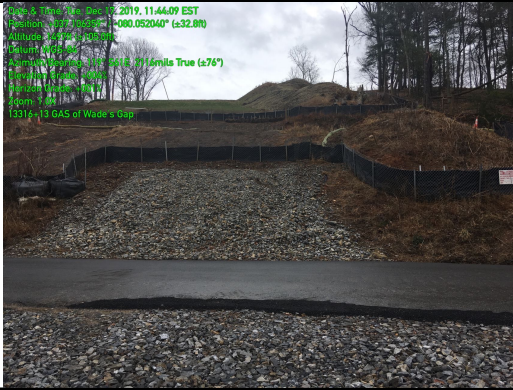
<b>GPS Location</b>	See pic for GPS location		<b>GPS Location</b>	See pic for GPS location	
<b>Field Station#</b>	13337+82		<b>Field Station#</b>	13316+13	
<b>Pic 5 Desc.</b>	No stream impacts were observed today throughout the entire area.		<b>Pic 6 Desc.</b>	No ECD deficiencies or other issues found in the area.

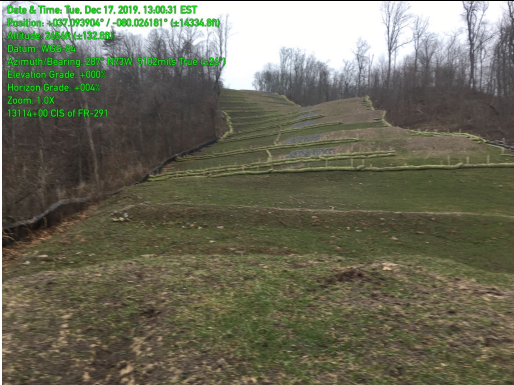
<b>GPS Location</b>	See pic for GPS location		<b>GPS Location</b>	See pic for GPS location	
<b>Field Station#</b>	13114+00		<b>Field Station#</b>	13108+00	
<b>Pic 1 Desc.</b>	Permanent restoration on the CIS of FR-291.		<b>Pic 2 Desc.</b>	No issues or impacts observed.

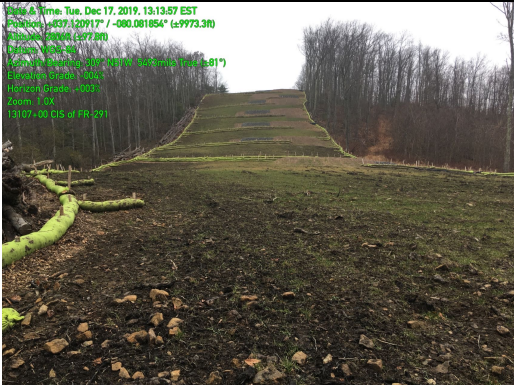
<b>GPS Location</b>	See pic for GPS location		<b>GPS Location</b>	See pic for GPS location	
<b>Field Station#</b>	13107+00		<b>Field Station#</b>	13096+00	
<b>Pic 3 Desc.</b>	No ECD deficiencies found in the area.		<b>Pic 4 Desc.</b>	Steep slope with ProGanics and FlexTera applied.

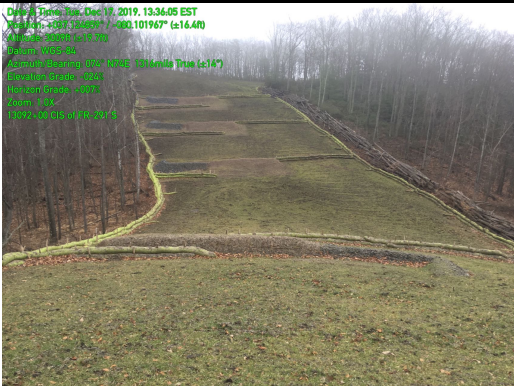
<b>GPS Location</b>	See pic for GPS location		<b>GPS Location</b>	See pic for GPS location	
<b>Field Station#</b>	13092+00		<b>Field Station#</b>	13089+00	
<b>Pic 5 Desc.</b>	ProGanics applied and no issues found.		<b>Pic 6 Desc.</b>	Trench breaker drain and rock apron installed.
