# Visual Site Inspection Report

<b>Project Name</b>	H-600 Pipeline Spread H	<b>AFE</b>	124300138	<b>Spread</b>	H-600 Pipeline Spread H
<b>Contractor</b>	Precision			<b>Report #</b>	7002
<b>Inspector</b>	Logan Box			<b>Date/Time</b>	12/31/2019 4:50 PM
<b>Permit #</b>	TBD	<b>Inspection Type</b>	VA SWPP	<b>Station Begin</b>	13415+51
<b>State</b>	VA	<b>Inspection Area</b>	Partial	<b>Station End</b>	13670+00
<b>County</b>	Franklin	<b>Ground</b>	Damp	<b>Temperature (°F)</b>	51.00
<b>Municipality</b>	N/A	<b>Weather</b>	Sunny	<b>Rain Gauge (in)</b>	0.00
				<b>Rain Accumulation Time (days)</b>	0.00

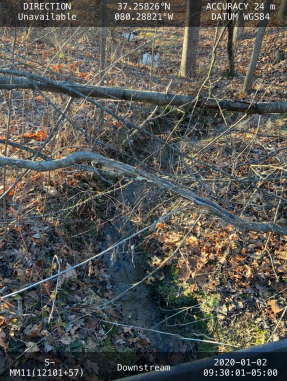
<b>GPS Location</b>	See photo GPS for location		<b>GPS Location</b>	See photo GPS for location	
<b>Field Station#</b>	12108+41		<b>Field Station#</b>	12101+57	
<b>Pic 3 Desc.</b>	Stream is flowing slow with no turbid water and no bank disturbance.		<b>Pic 4 Desc.</b>	Stream is flowing slow with no turbid water and no bank disturbance.

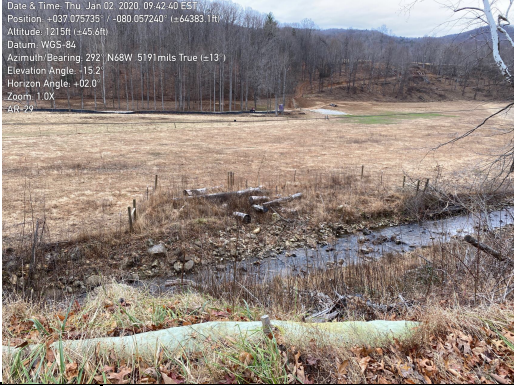
<p>Date &amp; Time: Thu Jan 02 2020 09:42:40 EST Position: +037 073735 / -080 057240 (+64363 IN) Altitude: 1215ft (+45.6m) Datum: WGS-84 Azimuth/Bearing: 292° N68W 5191mils True (+13°) Elevation Angle: -15.2° Horizon Angle: +02.0° Zoom: 1.0X S-D8 downstream</p>

<p>Date &amp; Time: Thu Jan 02 2020 09:49:48 EST Position: +037 073735 / -080 057240 (+64363 IN) Altitude: 1249ft (+38.7m) Datum: WGS-84 Azimuth/Bearing: 232° S52W 412mils True (+10°) Elevation Angle: +04.4° Horizon Angle: +00.7° Zoom: 1.0X ATWS-1055</p>		<b>GPS Location</b>	See photo for coordinates.
<b>Field Station#</b>	13196+71	<b>Field Station#</b>	13263+00	<b>Field Station#</b>	13263+00
<b>Pic 1 Desc.</b>	S-D8 and MVP-MLV-AR-29, no disturbance at stream, access road in acceptable condition, ATV noted on access road.	<b>Pic 2 Desc.</b>	ATWS-1055, restored section of alternate workspace, vegetation establishing, perimeter priority 1 fence in acceptable condition.	<b>Pic 2 Desc.</b>	ATWS-1055, restored section of alternate workspace, vegetation establishing, perimeter priority 1 fence in acceptable condition.

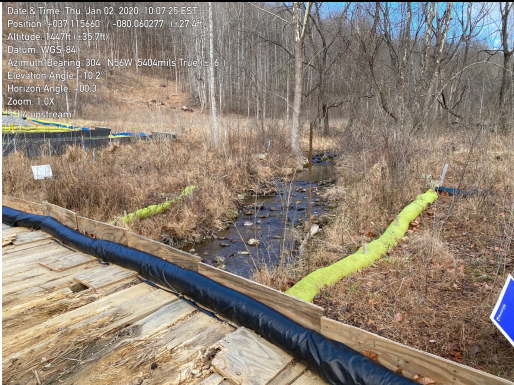
<p>Date &amp; Time: Thu Jan 02 2020 10:07:25 EST Position: +037 115460 / -080 040277 (+27.9m) Altitude: 1427ft (+43.5m) Datum: WGS-84 Azimuth/Bearing: 304° N64W 560mils True (+6°) Elevation Angle: -10.2° Horizon Angle: +00.3° Zoom: 1.0X S-II4 downstream</p>

<p>Date &amp; Time: Thu Jan 02 2020 10:08:06 EST Position: +037 115554 / -080 060462 (+15.4m) Altitude: 1453ft (+44.3m) Datum: WGS-84 Azimuth/Bearing: 267° S83W 4676mils True (+16°) Elevation Angle: +09.5° Horizon Angle: +01.3° Zoom: 1.0X S-II4 downstream</p>		<b>GPS Location</b>	See photo for coordinates.
<b>Field Station#</b>	13260+60	<b>Field Station#</b>	13260+00	<b>Field Station#</b>	13260+00
<b>Pic 3 Desc.</b>	S-II4, looking upstream of equipment bridge, ECDs functioning acceptably, stream bed and banks appear stable.	<b>Pic 4 Desc.</b>	ROW, CIS of S-II4, permanent and temporary vegetation near bridge establishing well across ROW.	<b>Pic 4 Desc.</b>	ROW, CIS of S-II4, permanent and temporary vegetation near bridge establishing well across ROW.

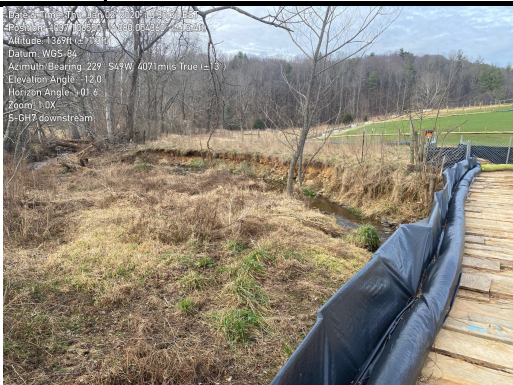
<p>Date &amp; Time: Thu Jan 02 2020 10:30:55 EST Position: +037 106364 / -080 052402 (+15.4m) Altitude: 1369ft (+41.8m) Datum: WGS-84 Azimuth/Bearing: 229° S47W 4021mils True (+13°) Elevation Angle: -12.0° Horizon Angle: +07.6° Zoom: 1.0X S-GH7 downstream</p>		<b>GPS Location</b>	See photo for coordinates.
<b>Field Station#</b>	13309+09	<b>Field Station#</b>	13309+09	<b>Field Station#</b>	13309+09
<b>Pic 5 Desc.</b>	S-GH7, looking upstream of equipment bridge, stream bed and banks appear stable, bridge in acceptable condition.	<b>Pic 6 Desc.</b>	S-GH7, looking downstream of equipment bridge, no changes noted.	<b>Pic 6 Desc.</b>	S-GH7, looking downstream of equipment bridge, no changes noted.
