Visual Site Inspection Report

Project Name	H-600 Pipeline Spread H	AFE	124300138	Spread	H-600 Pipeline Spread H
Contractor	Precision			Report #	6481
Inspector	Randy Clark			Date/Time	12/9/2019 9:11 AM
Permit #	TBD	Inspection Type	VA SWPP	Station Begin	12119+17
State	VA	Inspection Area	Partial	Station End	12234+50
County	Montgomery	Ground	Dry	Temperature (°F)	56.00
Municipality	N/A	Weather	Sunny	Rain Gauge (in)	0.00
				Rain Accumulation Time (days)	1.00

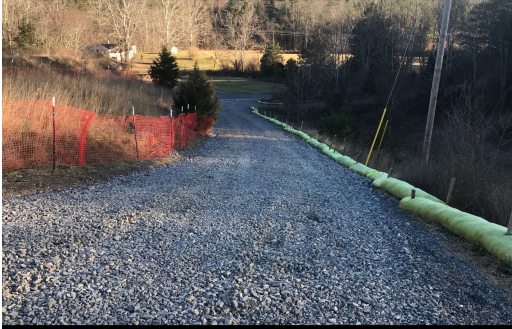
Flatwoods Area S-C36... 12120+00 2019-12-05 15:43:35-05:00	
GPS Location	Please see photo for GPS Data.		GPS Location	Please see photo for GPS Data.	
Field Station#	12122+00		Field Station#	12120+00	
Pic 1 Desc.	Area re-seeded and mulched due to light cover.		Pic 2 Desc.	S-C33, S-MM31 & S-C36 Stream bridges clean and free of spoil.	
	DIRECTION SE (T) 37.25192°N 080.26032°W ACCURACY 8 m DATUM WGS84

MVP-MN-274 Bradshaw 12189+00 2019-12-05 15:31:52-05:00			DIRECTION N (T) 37.25217°N 080.26017°W ACCURACY 4 m DATUM WGS84

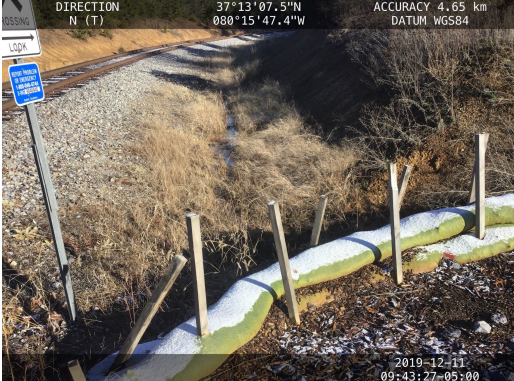
GPS Location	See photo		GPS Location	See photo	
Field Station#	12197+74		Field Station#	12197+17	
Pic 3 Desc.	East edge of railroad tracks, north side of AR 275.		Pic 4 Desc.	West edge of railroad tracks, north side of AR 275.

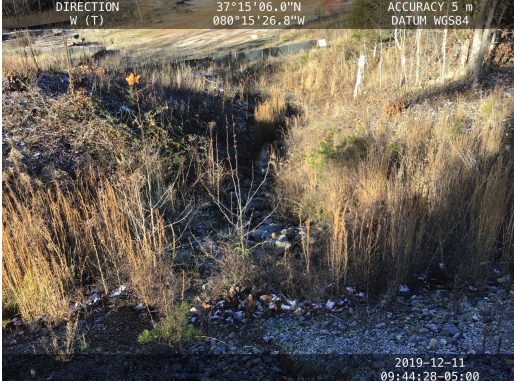
GPS Location	See photo		GPS Location	See photo	
Field Station#	12197+37		Field Station#	12192+50	
Pic 5 Desc.	Stream S-0011, facing west, downstream		Pic 6 Desc.	Stream S-C21, Bradshaw Creek, facing west

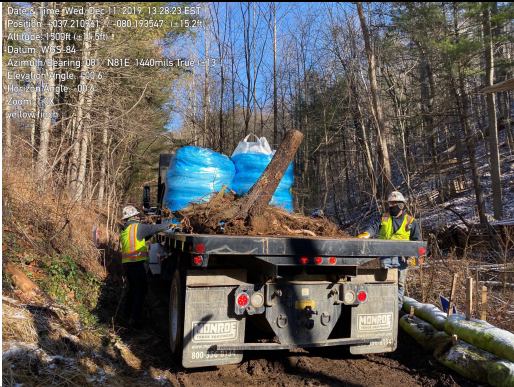
GPS Location	See photo for coordinates.		GPS Location	See photo for coordinates.	
Field Station#	12544+06		Field Station#	12544+06	
Pic 3 Desc.	MVP-MN-278.01, PPL preparing to haul off tree stump removed from ROW.		Pic 4 Desc.	MVP-MN-278.01, protesters activity and impeding contractor activities.

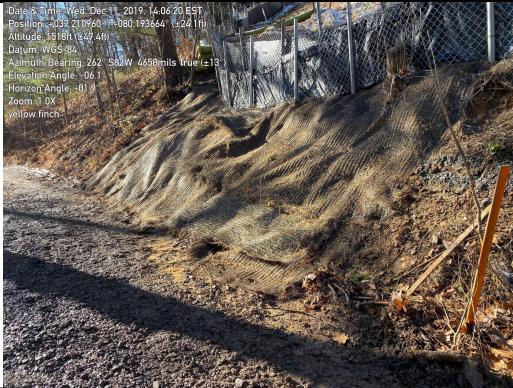
GPS Location	See photo for coordinates.		GPS Location	See photo for coordinates.	
Field Station#	12544+06		Field Station#	12544+06	
Pic 5 Desc.	MVP-MN-278.01, stump removed from roadside.		Pic 6 Desc.	MVP-MN-278.01, bank stabilized with high velocity erosion control blanket.

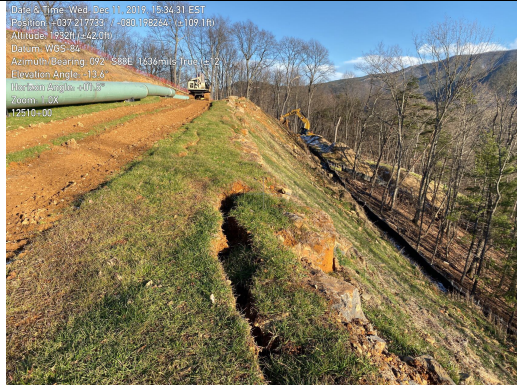
Pic 11 Desc.	Maintenance planned for tomorrow for crack along fill slope.		Pic 12 Desc.	Cleaning sump.
