# Visual Site Inspection Report

<b>Project Name</b>	H-600 Pipeline Spread H	<b>AFE</b>	124300138	<b>Spread</b>	H-600 Pipeline Spread H
<b>Contractor</b>	Precision			<b>Report #</b>	8101
<b>Inspector</b>	Logan Box			<b>Date/Time</b>	2/10/2020 5:14 PM
<b>Permit #</b>	TBD	<b>Inspection Type</b>	VA SWPP	<b>Station Begin</b>	13415+51
<b>State</b>	VA	<b>Inspection Area</b>	Partial	<b>Station End</b>	13670+00
<b>County</b>	Franklin	<b>Ground</b>	Wet	<b>Temperature (°F)</b>	42.00
<b>Municipality</b>	N/A	<b>Weather</b>	Light Rain	<b>Rain Gauge (in)</b>	0.00
				<b>Rain Accumulation Time (days)</b>	0.00

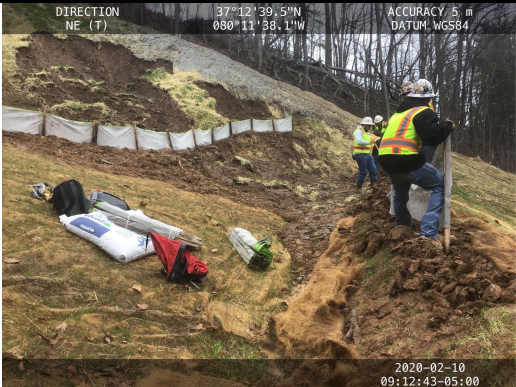
GPS Location	See photo		GPS Location	See photo	
Field Station#	125430+50		Field Station#	125129+00	
Pic 1 Desc.	Laborers worked on installing P1 silt fence on and in between waterbars to prevent more sediment from going into or over waterbars.		Pic 2 Desc.	Stockpile needs to be stabilized and sediment contained and stabilized where it has already reached the waterbar.

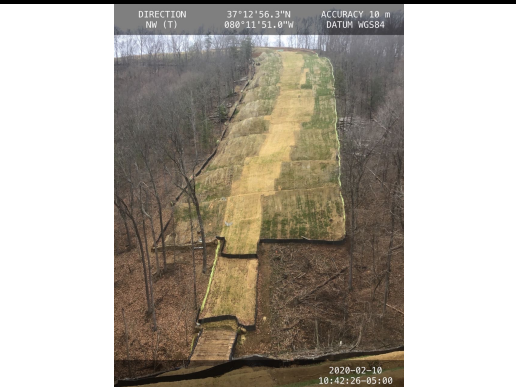
GPS Location	See photo		GPS Location	See photo	
Field Station#	12516+00		Field Station#	12519+41	
Pic 3 Desc.	Slopes on both sides of Stream S-EF19 are stable and well vegetated.		Pic 4 Desc.	Stream S-EF19, facing northwest. No signs of any impact to stream or ECDs from recent rain events.

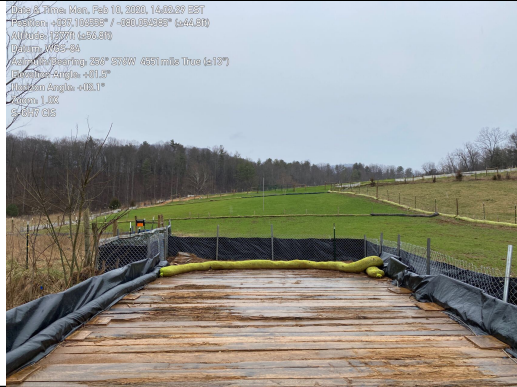
<b>Field Station#</b>	13309+00		<b>Field Station#</b>	13315+17	
<b>Pic 11 Desc.</b>	CIS of S-II4, moderate to good vegetative cover across LOD, ECDs functioning acceptably.		<b>Pic 12 Desc.</b>	Wades Gap, road crossing clean of rock and sediment, ECDs along road functioning acceptably.

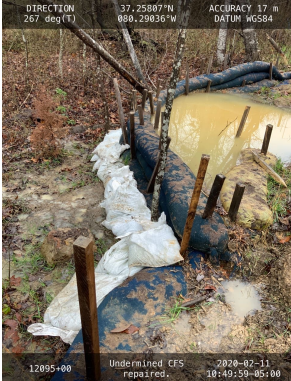
Insert image here			
<b>GPS Location</b>	See GPS for location		<b>GPS Location</b>	See GPS for location	
<b>Field Station#</b>	12095+00		<b>Field Station#</b>	12098+44	
<b>Pic 7 Desc.</b>	End treatment undercut repaired.		<b>Pic 8 Desc.</b>	Stream running clear no sediment from. ROW evident.

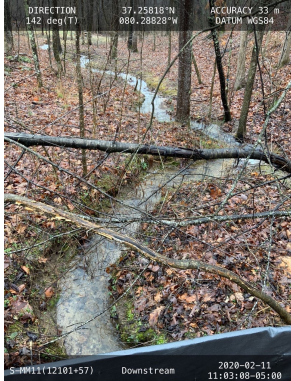
<b>GPS Location</b>	See GPS for location		<b>GPS Location</b>	See GPS for location	
<b>Field Station#</b>	12101+57		<b>Field Station#</b>	12071+80	
<b>Pic 9 Desc.</b>	Stream running clear no sediment from. ROW evident.		<b>Pic 10 Desc.</b>	Stone regrading in progress and CFS cleaned of stone.

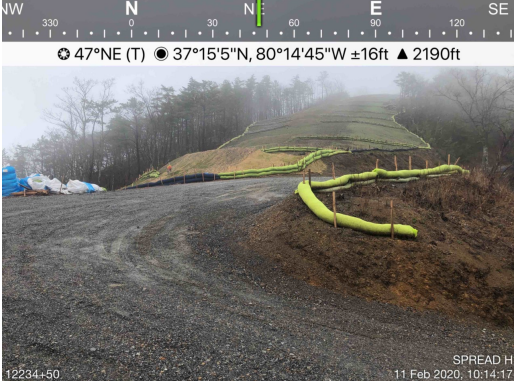
<b>GPS Location</b>	see photo		<b>GPS Location</b>	see photo	
<b>Field Station#</b>	12234+50		<b>Field Station#</b>	12236+00	
<b>Pic 1 Desc.</b>	Controls GAS of the 'Switchback' in place and functioning.		<b>Pic 2 Desc.</b>	Waterbars in good condition throughout this section.

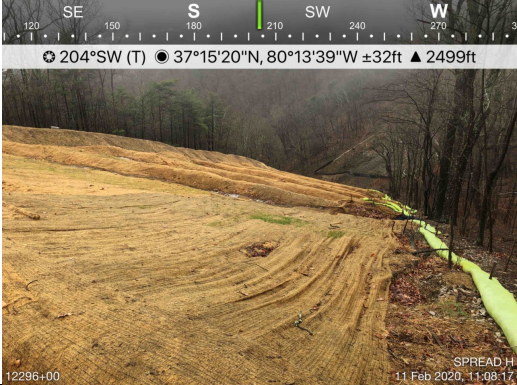
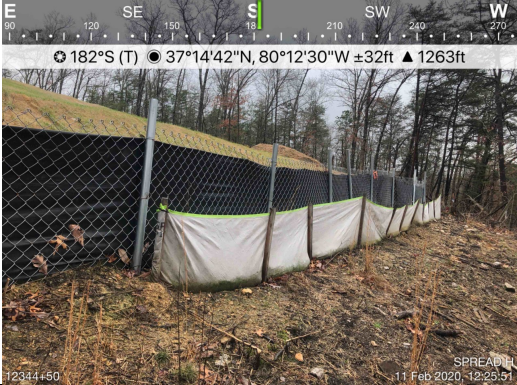
<b>GPS Location</b>	see photo		<b>GPS Location</b>	see photo	
<b>Field Station#</b>	12296+00		<b>Field Station#</b>	12344+50	
<b>Pic 7 Desc.</b>	GAS of the 'V' controls in place.		<b>Pic 8 Desc.</b>	Controls above S-0016 in place.

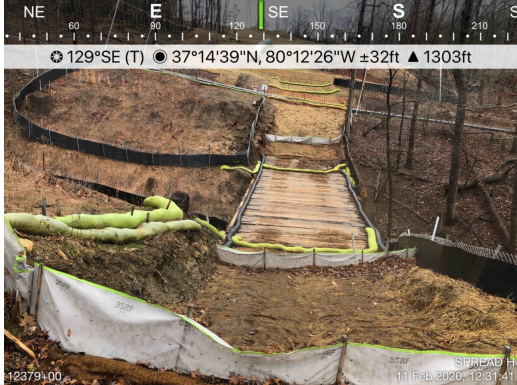
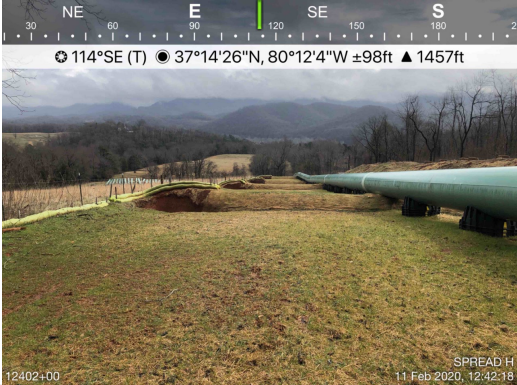
<b>GPS Location</b>	see photo		<b>GPS Location</b>	see photo	
<b>Field Station#</b>	12379+00		<b>Field Station#</b>	12402+00	
<b>Pic 9 Desc.</b>	Controls in place at stream crossing S-NN19		<b>Pic 10 Desc.</b>	Vegetation filling in and controls in place and stabilized.

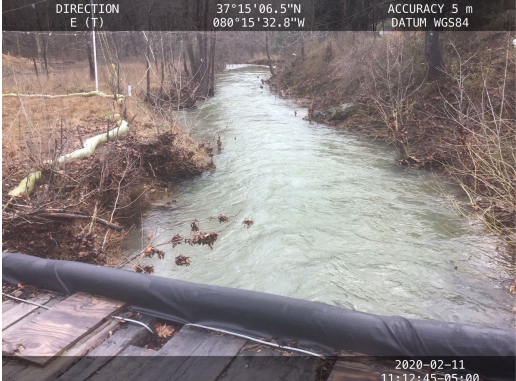
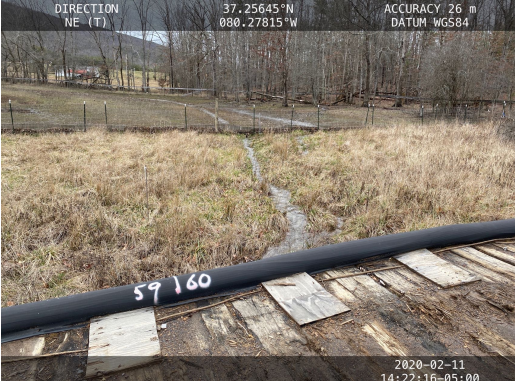
<b>GPS Location</b>	See photo		<b>GPS Location</b>	See photo	
<b>Field Station#</b>	12192+50		<b>Field Station#</b>	12132+73	
<b>Pic 3 Desc.</b>	Stream S-C21, Bradshaw Creek, facing east, downstream		<b>Pic 4 Desc.</b>	Stream S-C29, facing northeast, upstream

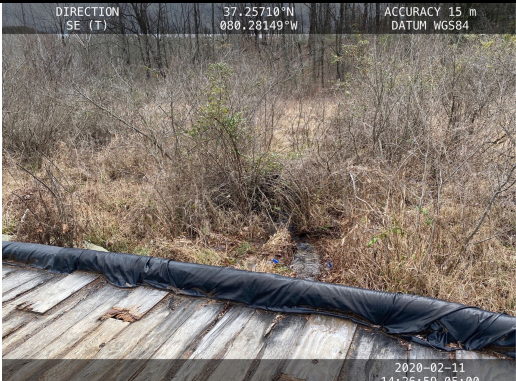
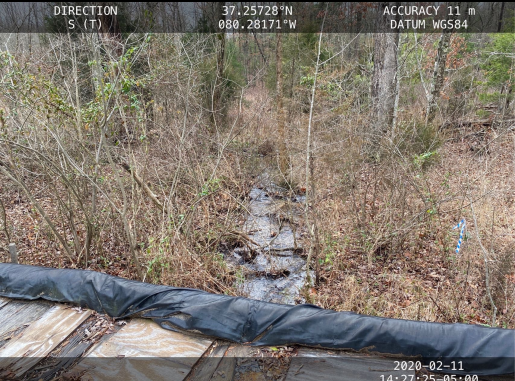
<b>GPS Location</b>	See photo		<b>GPS Location</b>	See photo	
<b>Field Station#</b>	12121+83		<b>Field Station#</b>	12121+33	
<b>Pic 5 Desc.</b>	Stream S-C36, facing southeast, downstream		<b>Pic 6 Desc.</b>	Stream S-C33, facing south, downstream

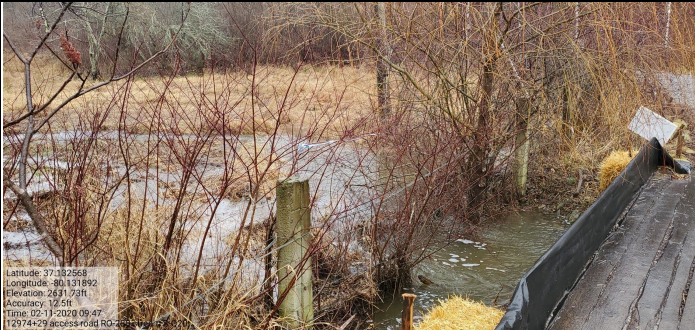
<p>Latitude: 37.132568 Longitude: -80.131892 Elevation: 2631.73ft Accuracy: 12.5ft Time: 02-11-2020 09:47 12974+29 access road RO-285</p>

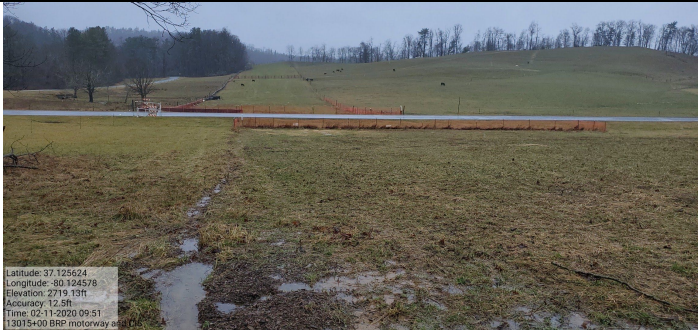
<p>Latitude: 37.125624 Longitude: -80.124578 Elevation: 2719.13ft Accuracy: 12.5ft Time: 02-11-2020 09:51 13015+00 BRP motorway</p>		
GPS Location	See pic for GPS location		GPS Location	See pic for GPS location	
Field Station#	12974+29		Field Station#	13015+00	
Pic 7 Desc.	Debris on upstream side of culvert causing water levels to rise. No association with project.		Pic 8 Desc.	The BRP remains in good condition with no issues or impacts throughout the area.

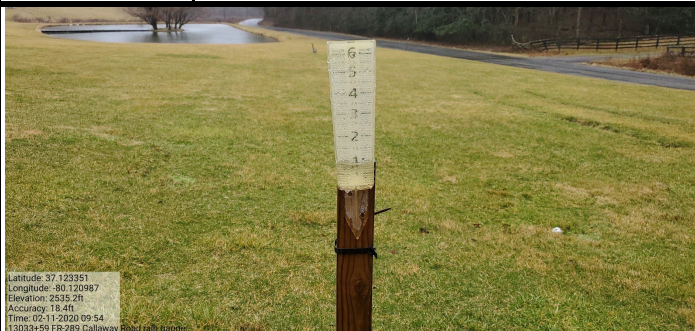
<p>Latitude: 37.123351 Longitude: -80.120987 Elevation: 2535.2ft Accuracy: 18.4ft Time: 02-11-2020 09:54 13033+59 FR-285 Callaway Road rain gauge</p>

GPS Location	See pic for GPS location		GPS Location	See pic for GPS location	
Field Station#	13033+59		Field Station#	13060+75	
Pic 9 Desc.	1.0" total precipitation at Callaway Road rain gauge.		Pic 10 Desc.	No impacts to streams S-G26 to S-G27 to report.

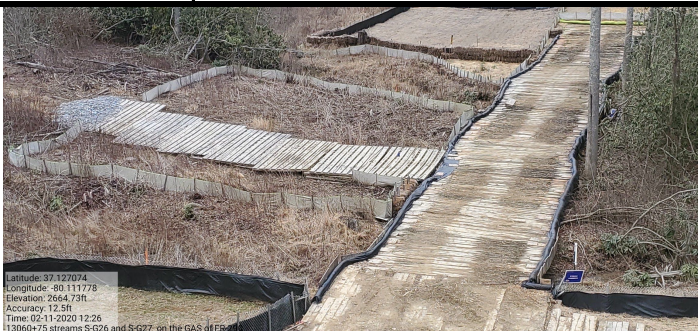
<p>Latitude: 37.127074 Longitude: -80.111778 Elevation: 2654.73ft Accuracy: 12.5ft Time: 02-11-2020 12:26 13060+75 streams S-G26 and S-G27 on the GAS of FR-290</p>

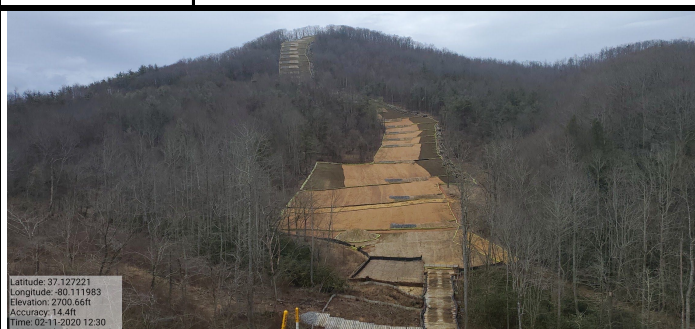
<p>Latitude: 37.127221 Longitude: -80.111983 Elevation: 2700.66ft Accuracy: 14.4ft Time: 02-11-2020 12:30 13059+75 looking at GAS of FR-290</p>

<p>Latitude: 37.127897 Longitude: -80.112902 Elevation: 2776.31ft Accuracy: 12.5ft Time: 02-11-2020 12:34 13052+00 GIS of FR-290</p>		
GPS Location	See pic for GPS location		GPS Location	See pic for GPS location	
Field Station#	13059+75		Field Station#	13057+00	
Pic 11 Desc.	No ECD deficiencies or maintenance issues were found on the GAS of FR-290.		Pic 12 Desc.	Vegetation has turned brown. Straw mulch remains in place as temporary stabilization.

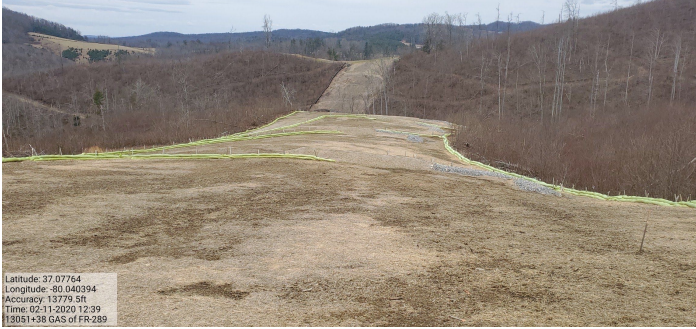
<p>Latitude: 37.07764 Longitude: -80.040394 Accuracy: 13.779 ft Time: 02/11/2020 12:39 13051+38 GAS of FR-289</p>

<p>Latitude: 37.12781 Longitude: -80.116204 Elevation: 2692.03ft Accuracy: 15.7ft Time: 02/11/2020 12:47 13044+00 GAS of FR-289 stream S-H1</p>		
<b>GPS Location</b>	See pic for GPS location		<b>GPS Location</b>	See pic for GPS location	
<b>Field Station#</b>	13051+38		<b>Field Station#</b>	13044+00	
<b>Pic 13 Desc.</b>	No maintenance required at this time between FR-289 and FR-290.		<b>Pic 14 Desc.</b>	No signs of sediment impact near stream S-H1.	
Insert image here			Insert image here		
<b>GPS Location</b>			<b>GPS Location</b>		
<b>Field Station#</b>			<b>Field Station#</b>		
<b>Pic 15 Desc.</b>			<b>Pic 16 Desc.</b>		
Insert image here			Insert image here		
<b>GPS Location</b>			<b>GPS Location</b>

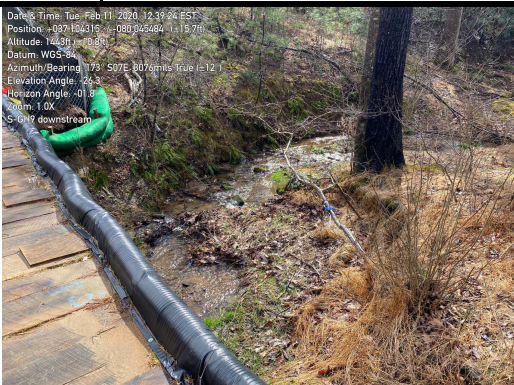
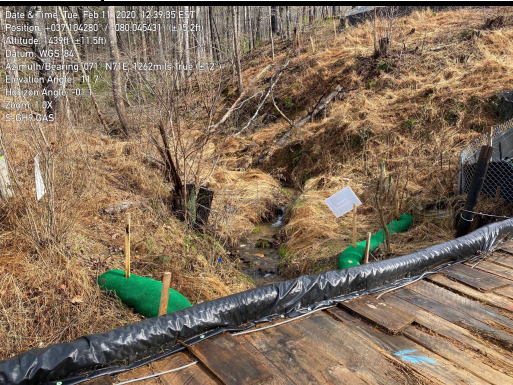
<b>Field Station#</b>	13337+13		<b>Field Station#</b>	13337+13	
<b>Pic 5 Desc.</b>	S-GH9, downstream side of equipment bridge, water clear, native sediment accumulation noted.		<b>Pic 6 Desc.</b>	S-GH9, upstream side of equipment bridge, ECDs functioning acceptably.

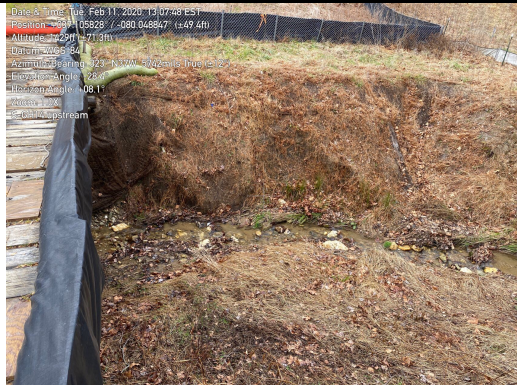
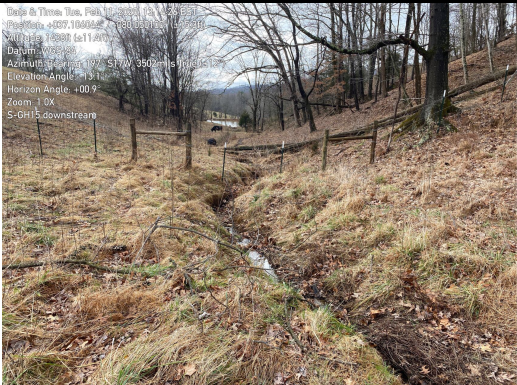
<b>Field Station#</b>	13325+30		<b>Field Station#</b>	13321+47	
<b>Pic 11 Desc.</b>	S-GH14, upstream side of equipment bridge, beds and banks stable, water flowing clear.		<b>Pic 12 Desc.</b>	S-GH15, downstream side of equipment bridge, cattle noted in stream downstream of ROW.

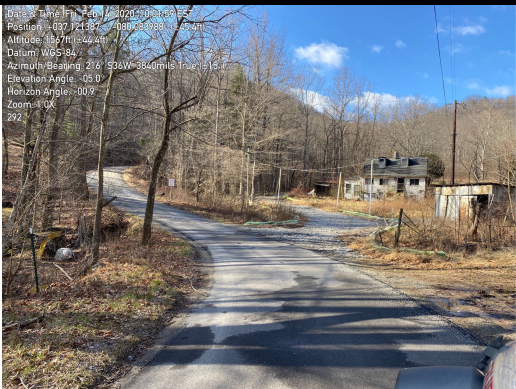
<p>Date &amp; Time: Fri, Feb 14, 2020 10:22:00 EST Position: +037.124301 / -080.075973 (+308.6ft) Altitude: 1222ft (+103.5ft) Datum: WGS-84 Azimuth/Bearing: 276° NB&amp;W 4871mils True (+15°) Elevation Angle: -05.0° Horizon Angle: -00.9° Zoom: 1.0x AR-29</p>

<p>Date &amp; Time: Fri, Feb 14, 2020 10:12:21 EST Position: +037.124301 / -080.075973 (+308.6ft) Altitude: 1222ft (+103.5ft) Datum: WGS-84 Azimuth/Bearing: 276° NB&amp;W 4871mils True (+15°) Elevation Angle: -05.0° Horizon Angle: -00.9° Zoom: 1.0x AR-29</p>	
GPS Location	See photo for coordinates.		GPS Location	See photo for coordinates.	
Field Station#	13142+00		Field Station#	13190+00	
Pic 1 Desc.	MVP-FR-292, access road in acceptable condition, ECDs functioning acceptably.		Pic 2 Desc.	MVP-AR-29, access road in acceptable condition, cattle disturbance noted.

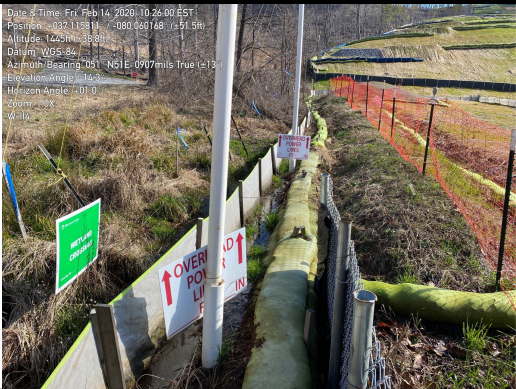
<p>Date &amp; Time: Fri, Feb 14, 2020 10:26:00 EST Position: +037.115814 / -080.060168 (+315.5ft) Altitude: 1226ft (+107.2ft) Datum: WGS-84 Azimuth/Bearing: 051° N&amp;E 0907mils True (+13°) Elevation Angle: +01.0° Horizon Angle: -00.0° Zoom: 1.0x W-II4</p>

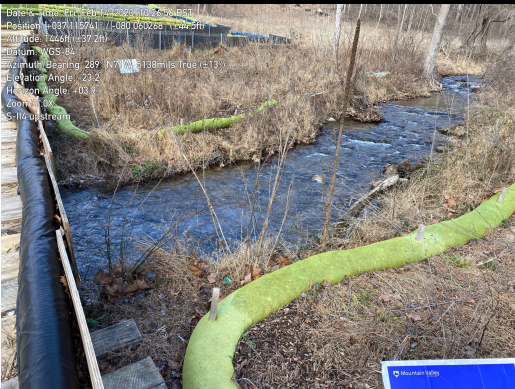
<p>Date &amp; Time: Fri, Feb 14, 2020 10:26:00 EST Position: +037.115814 / -080.060168 (+315.5ft) Altitude: 1226ft (+107.2ft) Datum: WGS-84 Azimuth/Bearing: 289° W&amp;W 138mils True (+13°) Elevation Angle: -23.2° Horizon Angle: -00.3° Zoom: 1.0x S-II4-upstream</p>	
GPS Location	See photo for coordinates.		GPS Location	See photo for coordinates.	
Field Station#	13261+00		Field Station#	13260+60	
Pic 3 Desc.	W-II4, water from wetland flowing along perimeter ECDs.		Pic 4 Desc.	S-II4, upstream side of equipment bridge, ECDs functioning acceptably.

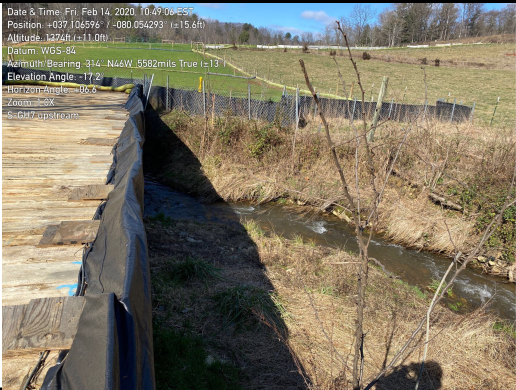
GPS Location	See photo for coordinates.		GPS Location	See photo for coordinates.	
Field Station#	13309+09		Field Station#	13306+00	
Pic 5 Desc.	S-GH7, upstream side of equipment bridge, ECDs functioning acceptably.		Pic 6 Desc.	ROW stabilized.
